GEOLOGICAL LOG OF CORE DRILL

Project: JICA Study Team: Landslide Protection Page: 1 / 2
 Core Drill #: Y-7 Site Location: Colonia 14 de Febrero Ref. #: B-8
 Elevation: 939.70 Inclination (Angle with respect to Horizontal): Vertical (90°)
 Log Elaborated by: Ing. Raul Flores Peñalba Date: November 3, 2001

Project: JICA Study Team: Landslide Protection **Page:** 1 / 2
Core Drill #: A-1 **Site Location:** Col. El Porvenir Facing IHSS **Ref. #:** B-9
Elevation: 940.60 **Inclination (Angle with respect to Horizontal):** Vertical (90°)
Log Elaborated by: Ing. Raul Flores Peñalba **Date:** November 6, 2001

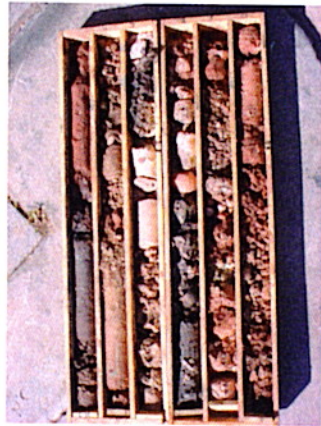
2.50~11.00m
organic contain detritus

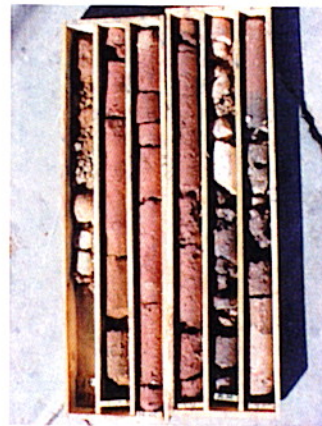
11.00~19.65m
Detritus (sand, boulder)

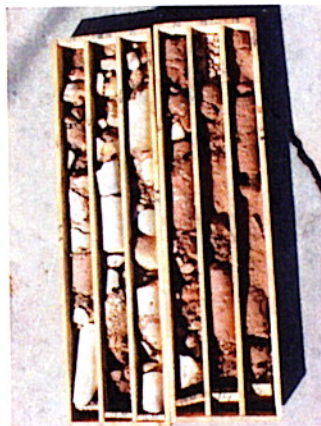
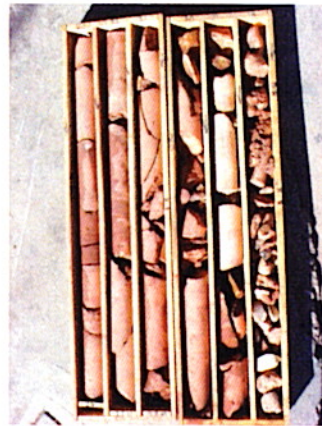
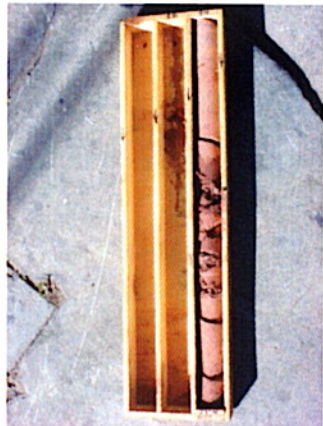
20.00~
m
F. Rio Chiquito

24.50
shear

Deiftlus: area of rhyolite boulders interbedded within lenses of clay

Rock contact composed of lutite (shale) or sandstone due to small particles of quartz present on core, red color

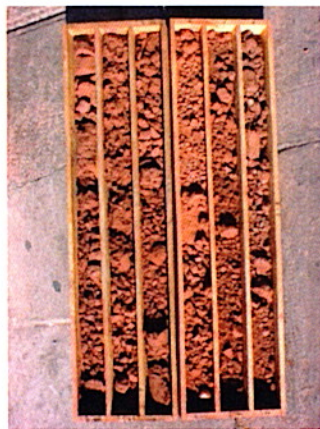
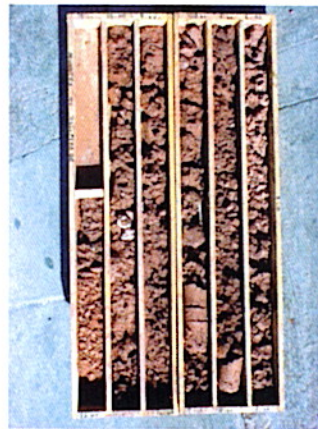
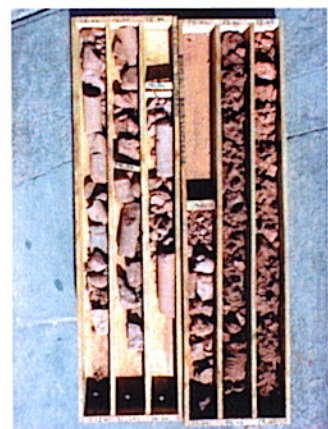
0.00~14.50m Detritus

Red clayey soil with scattered gravels of rock material, possibly detritus of myolite rocks

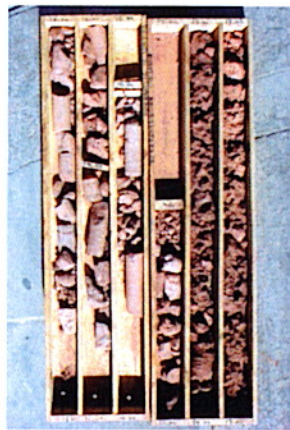
14.50m~
F. Rio Chiquito

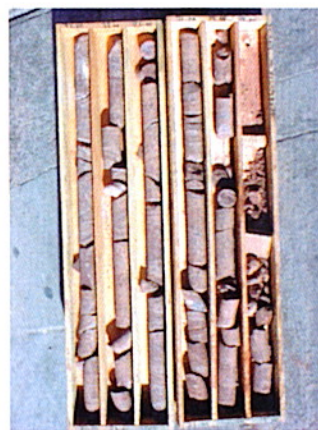
19.00m~
Sound Rock

Rock composed of lutite (shale) or sandstone due to small particles of quartz present on core, red color with white bands of gypsum
