GEOLOGICAL LOG OF CORE DRILL

Project: JICA Study Team: Landslide Protection Page: 1 / 1
 Core Drill #: Y-1 Site Location: By river, left margin, near market Ref. #: C-1
 Elevation: 917.90 Inclination (Angle with respect to Horizontal): _____ Vertical (90°) _____
 Log Elaborated by: Ing. Raul Flores Peñalba Date: October-05, 2001

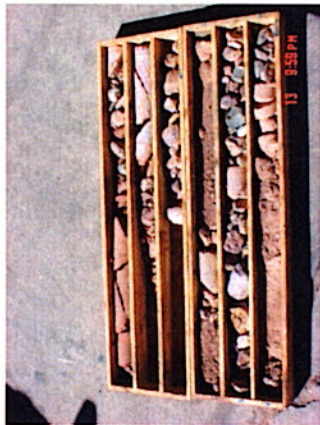
0.00 ~ 5.50m
Alluvial Sediment

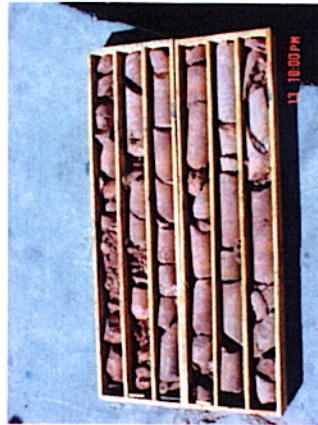
5.50m ~
F. Rio Chiquito
6.50 ~ 12.00m
Sound Rock

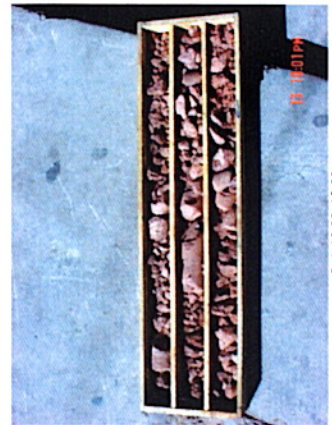
12.00m ~
Small Particles Rock

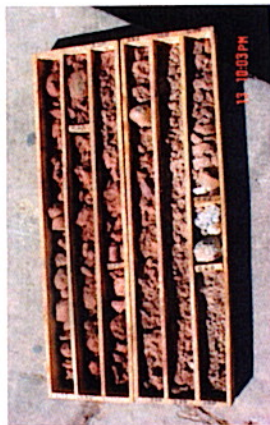
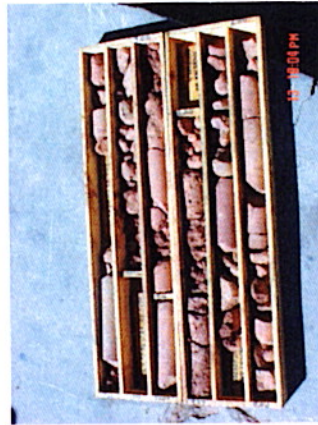
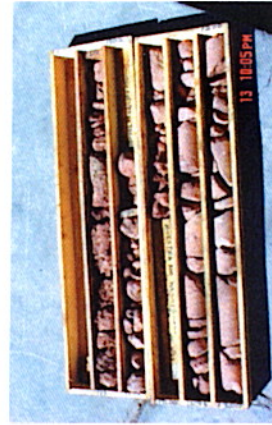
0.45 ~ 5.00m
alluvial material and artificial rock

5.00 ~ m
F. Rio Chiquito

7.80 ~ 9.20m
Fracture

14.50 ~ 17.00m
Fracture zone ?

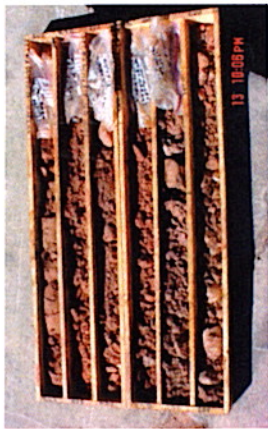
C-2b 0.00-1.00m

1.00~5.00m
alluvial material

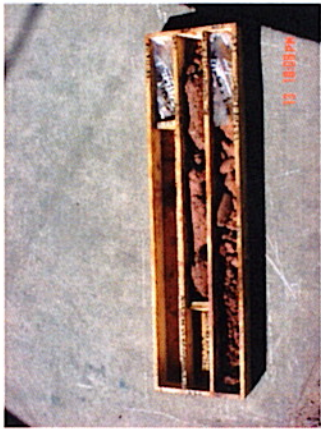
C-2b 6.00-8.00m

5.00~ m
F. Rio Chiquito (weathered rock)
