GEOLOGICAL LOG OF CORE DRILL

Project: JICA Study Team: Landslide Protection Page: 1 / 3
Core Drill #: A-2 Site Location: Middle terrace beside lagoon Ref. #: R-4
Elevation: 940.00 Inclinacion (Angle with respect to Horizontal): Vertical (90°)
Log Elaborated by: Ing. Raul Flores Peñalba Date: November 26, 2001

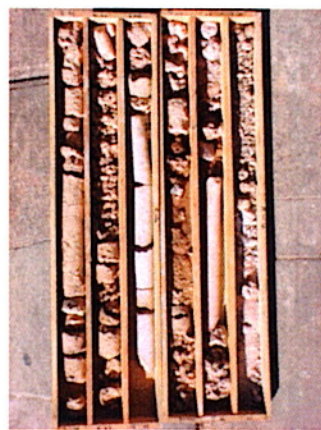
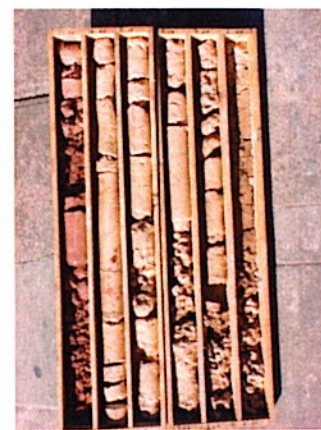
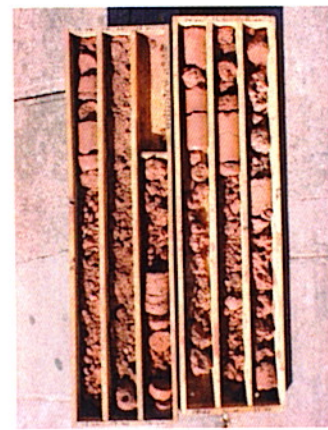
1.00~4.10m
Detritus

4.10~11.00m
Lan

12.00~
m
F. Rio Chiquito
(very altered and sheared)

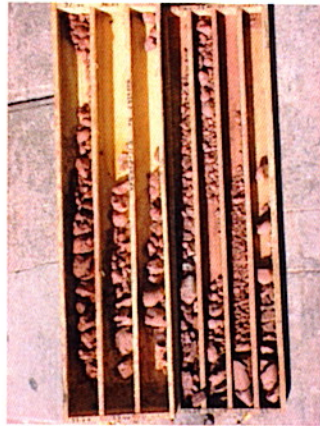
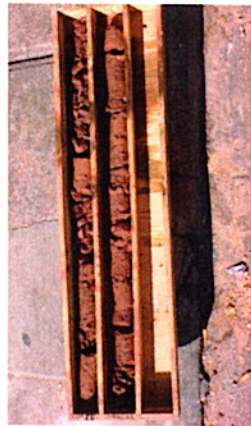
32.00~33.00m
shear zone

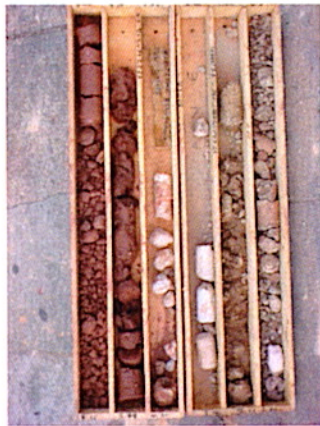
0.00~4.00m
Detritus

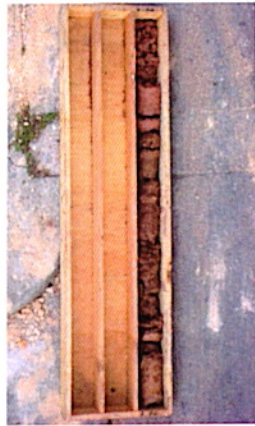
4.00~ m
F. Rio Chiquito (very altered)

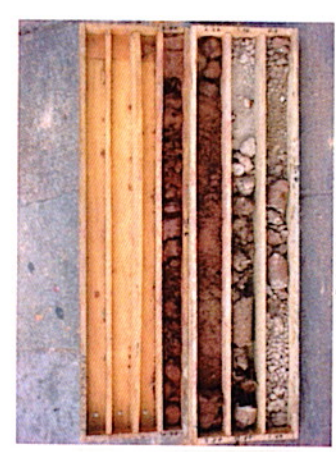
0.00~3.25m
 Detritus

3.25~ m
 F. Rio Chiquito
