**Table-A Bridge Inventory Sheet (Sheet No. 4-1)**

Name of Bridge	Bridge No.4 (Tsenkher River)		Crossing River/Road		*River (Tsenkher)		Date of Inspection	Apr.18.24, 2001	Inspection by	Y.Takai, B.Enkhtaivan	
Km Post	211.1 km		Construction by		Mongolian/Russian		Date of Construction	1962	Maintenance by		
Type of Bridge	Superstructure	Wooden deck slab, wooden beam		Design Loading			Russian Standard, H-18	Load limitation	No	*Yes	
	Substructure	Abutment		Design Standard							
Length of Bridge		Pier	wooden pile		Skew of Bridge		*Square	Skew	Curve (deg.R= )

Table-C Photograph Sheet (Sheet No. 4-4)

**Table-A Bridge Inventory Sheet (Sheet No. 5-1)**

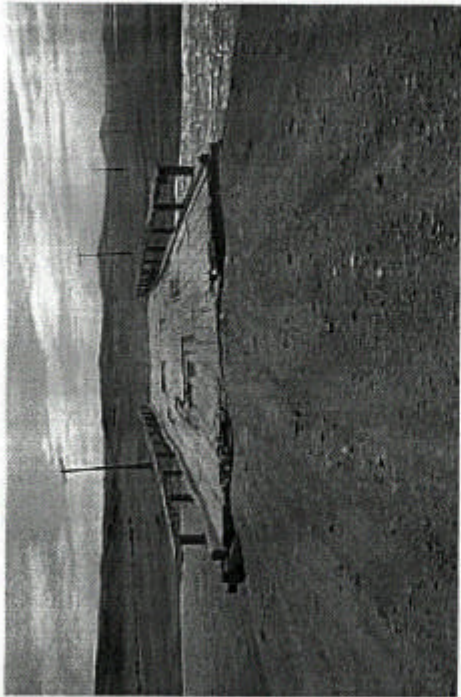
<p>Comment of Photo</p> <p>Bridge Surface</p> <ul style="list-style-type: none"> <li>* Gap between approach and bridge surface</li> <li>* Impassable for heavy truck, and trailer etc</li> </ul>

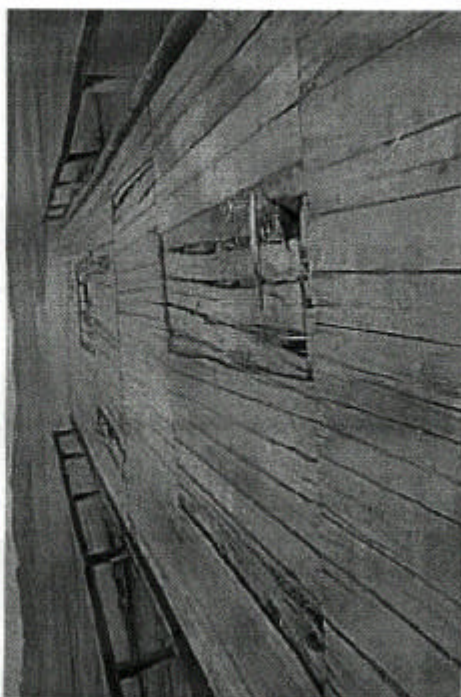
<p>Comment of Photo</p> <p>Bridge Surface</p> <ul style="list-style-type: none"> <li>* Damaged Wooden Slab</li> </ul>

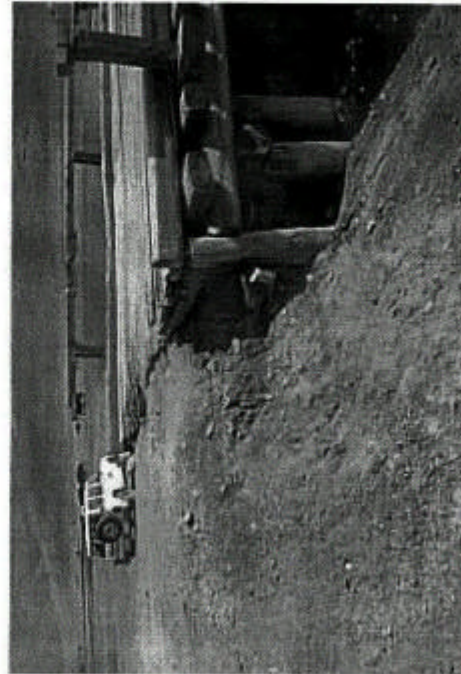
<p>Comment of Photo</p> <p>No Protection at Abutment</p> <ul style="list-style-type: none"> <li>* Gap and Scoured at Abutment approach</li> </ul>	<p>69</p>	<p>68</p>

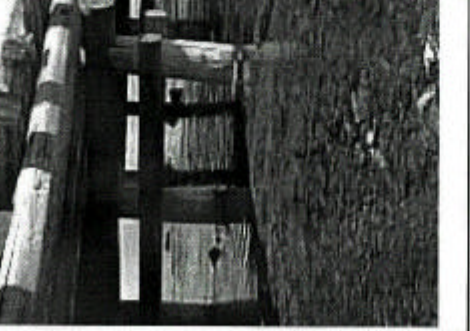
<p>Comment of Photo</p> <p>Pier Pile and Slab (April 24)</p> <ul style="list-style-type: none"> <li>Settled slab, and inclined wooden pier piles</li> </ul>
70	Location / Place :	Location / Place :	Location / Place :	71

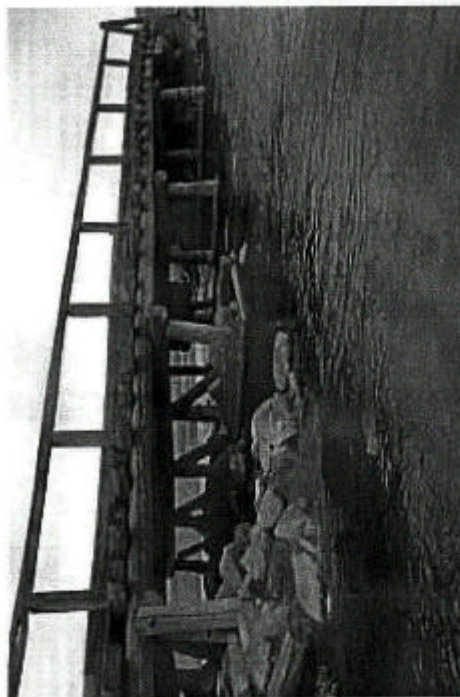
<p>Comment of Photo</p> <p>Wooden Structure and Inclined Pier Pile (April 18)</p>

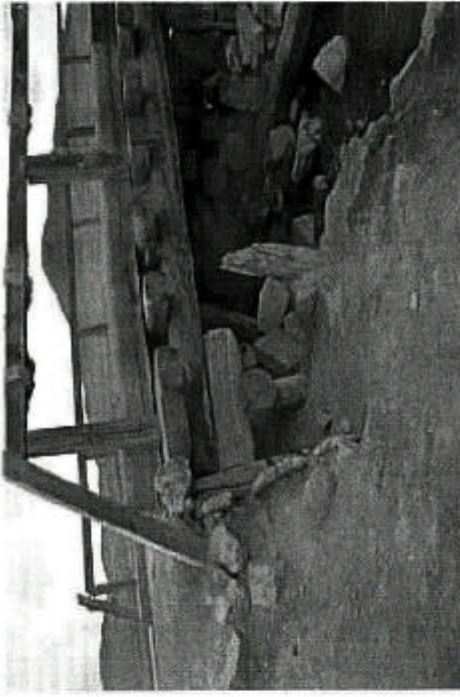
<Existing conditions of bridge/culvert> See Table-C photograph		<Remarks> Mark * : Correspond Defects Approach and abutments are scoured and broken. The heavy vehicles can not pass on the bridge from view point of durability.	
---	--	---	--

<p>Approach and Abutment</p> <p>* Scoured approach parts</p>
80

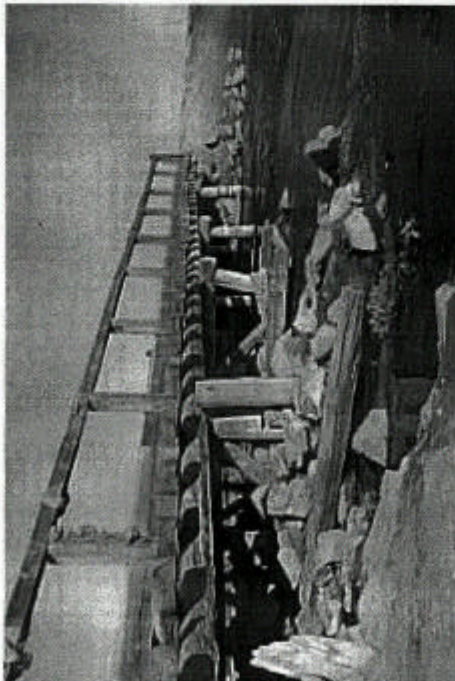
<p>029</p>	<p>Location / Place :</p>	<p>Comment of Photo</p> <p>Wooden Beam and Inclined Pier Piling (April 24)</p>
