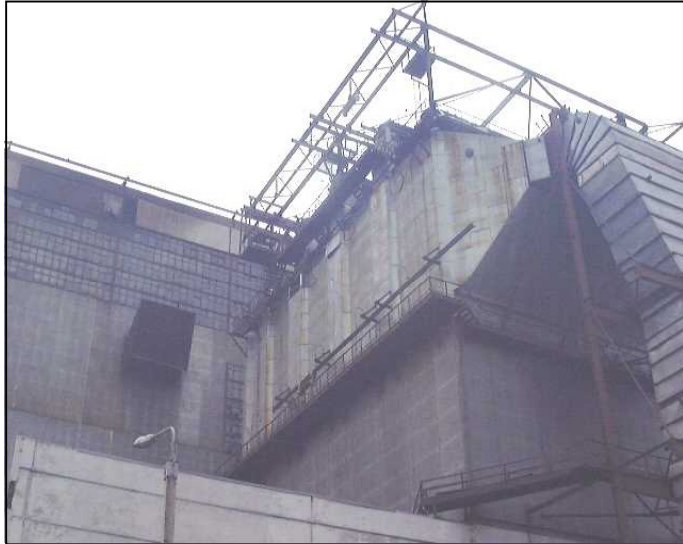
Fig.5.1-1

- (1) Under JICA Grant Aid, rehabilitation for the ESP (replacement of rapping device and these motors, and repair for ashes air transportation at bottom of hopper) was implemented. Since then, ESP is operating with a constant collection efficiency.
- (2) When repair parts were not available, parts for section No.4 were used for sections No.1 to No.3.
- (3) Ash leak is occurring from ESP ducts and ash treatment equipment.

Repair work for leakage from ESP and ash treatment equipment.

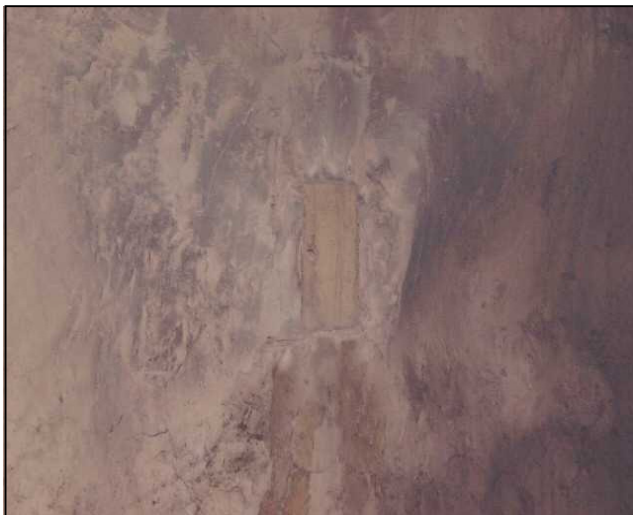
Fig.5.1-2

- (1) Although 100 set Sootblowers per boiler were installed originally, it was removed at the time when the Baganuur coal with which ashes cannot adhere to inside furnace wall easily burned.
- (2) Since the ash melting temperature of Shivee-ovoo coal is lower than Baganuur coal, Shivee-ovoo coal clinkers adhere easily on the inside furnace wall. If Shivee-ovoo coal is used more, it creates possible trouble by clinkers.

- (1) Since both kinds of coal are from the same coalfield, ash properties are expected to become similar to those of Baganuur coal when mining of Shivee-ovoo coal is developed from the surface to the depths.
- (2) The necessity of sootblowers is being studied by confirming changes of boiler combustion and ash properties.

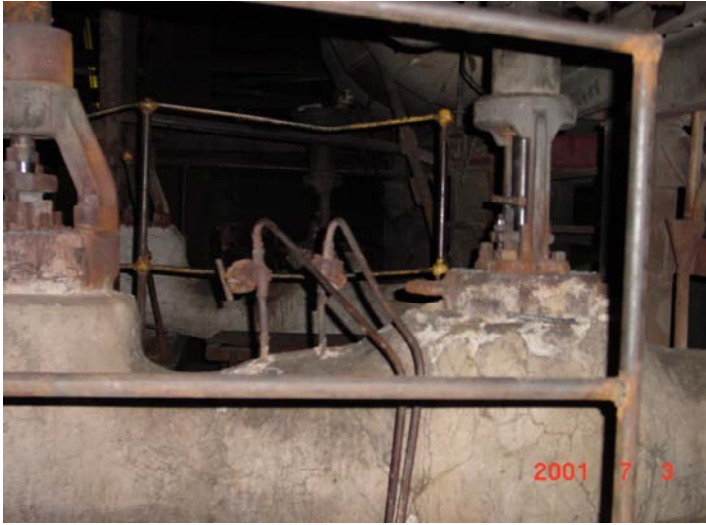
Fig.5.1-3

(1) Equipment of auxiliary steam temp and press reducing control valves for plant start-up serves to lower steam temperature and pressure from $140\text{kg/cm}^2 / 555^\circ\text{C}$ to $16\text{kg/cm}^2 / 250^\circ\text{C}$. Since many device failures occur, the supplier implements overhaul once every 2 years.

(2) This equipment has many and various failures such as steam leak and valve stem sticking.

Equipment of auxiliary steam temp and press reducing control valves for plant start-up is very important to enable auxiliary steam headers before turbine start-up.

To increase reliability of the equipment, whole devices are to be replaced, such as press control valves, temp control valves, press transmitters, temp sensors, temp indicators, flow transmitters, flow indicators, and control system.

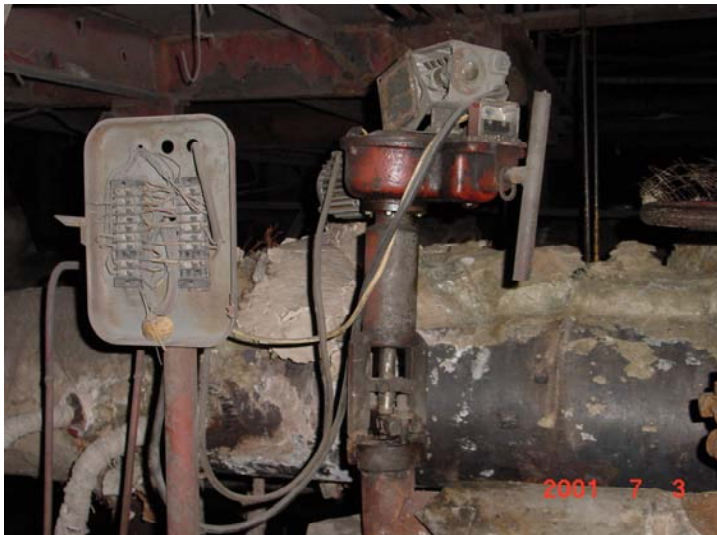
Fig.5.1-4

Equipment of auxiliary steam temp and press reducing control valves for normal conditions is overhauled once every 4 years and has been damaged very heavily causing steam leak and valve stem sticking many times.

Equipment of auxiliary steam temp and press reducing control valves for normal plant conditions is very important to keep auxiliary steam header pressure when auxiliary steam supply is not available from turbine extraction.

To increase reliability of the equipment, whole devices are to be replaced, such as press control valves, temp control valves, press transmitters, temp sensors, temp indicators, flow transmitters, flow indicators, and control system.
