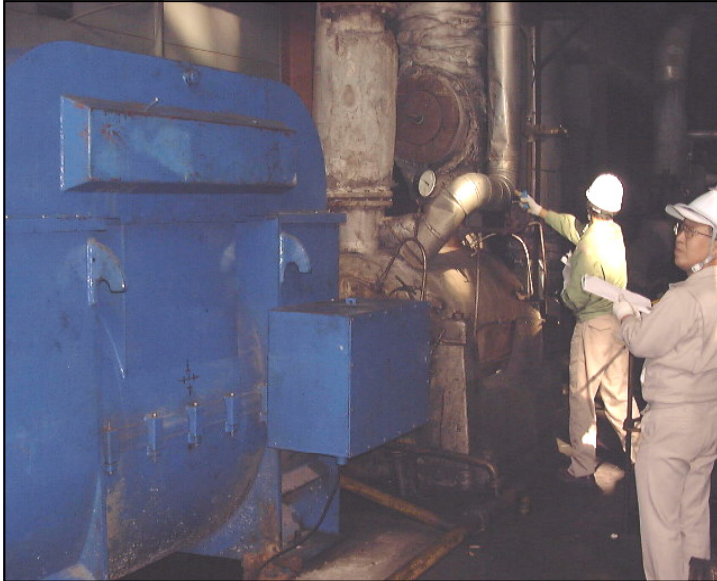
Fig.5.1-5

(1) The pumps and motors of feed water pump equipment have a high failure frequency because of being superannuated, and TES4 has difficulty in maintenance and repair work.

(2) Feed water flow control is done by the FW control valves. At start-up of FW pump, a large shock is given to the FW system.

Feed water pump equipment is replaced by new equipment with variable speed inverter type motors. The feed water rate depends on the motor variable speed or rotation. By this rehabilitation, a reduction of the failure rate of FW control valves etc, and a large saving of auxiliary power consumption are expected.

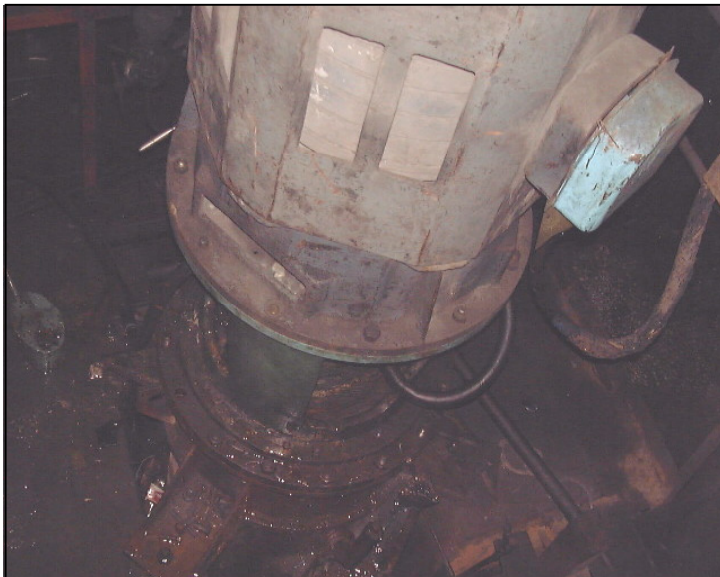
Fig.5.1-6

Condenser pumps were replaced several years ago. The number of pumps was changed from 3 sets to 2 sets (from horizontal axis type to vertical axis type) per each turbine. Since then, although pump capacity is rated, response to load change became important. As a result, the impeller has been damaged by cavitation and the pump shaft has broken.

Replacement with a condenser pump and motors is required and, at the same time, review for control system is being implemented to include control valve for condenser level control to correspond to pump capacity.

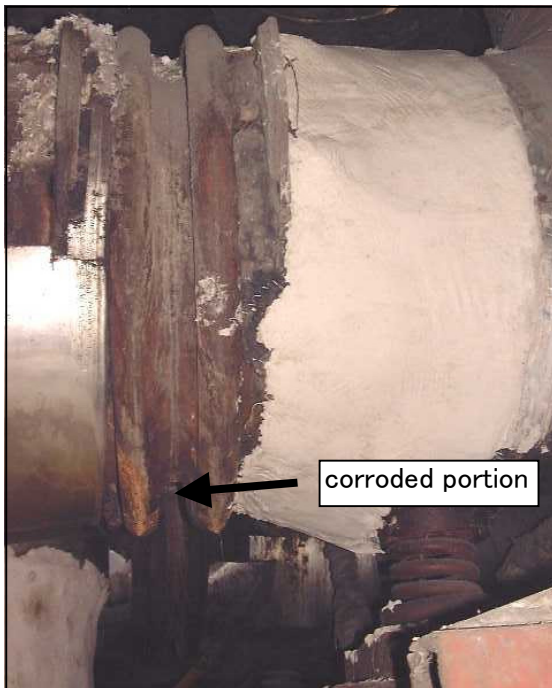
Fig.5.1-7

For drain tube clogging, drain pipes had been removed from expansion joints in condenser and extraction lines. In the consequently drained portion, there has been considerable corrosion. Leakage from those corroded portions is one of the factors of the decline of the condenser vacuum.

All expansion joints are to be replaced with new ones and drain pipes which had been removed are to be re-installed.

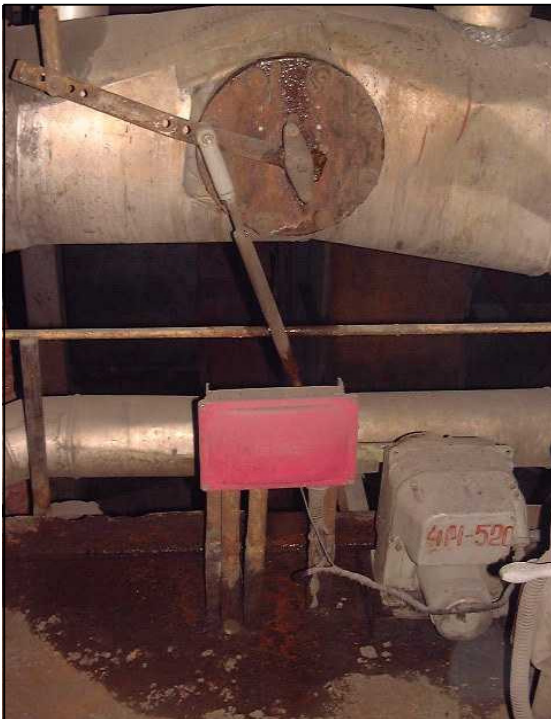
Fig.5.1-8

Although the valves in vacuum lines were of water-sealing type originally, these valves were changed to grand packing type during later repair work. This change caused vacuum leakage and is one of the factors of the decline of the condenser vacuum.

All valves in the vacuum lines are to be replaced with water-sealing type.

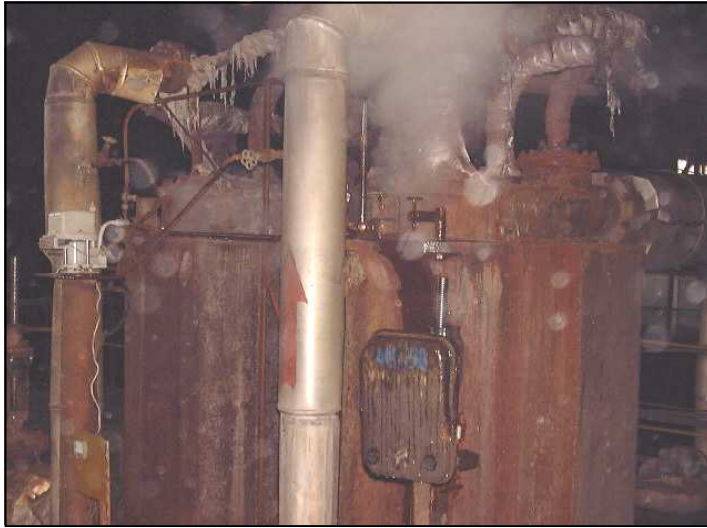
Fig.5.1-9

Ejectors have overhaul and repair work once every 4 years. Various portions including 3 stages type nozzle, however, have been worn-out and leak and have become one of the factors of the decline of the condenser vacuum.

Since recovery of ejector performance by repair work is expected to be impossible because various portions are worn-out and leaking, ejectors are to be replaced.

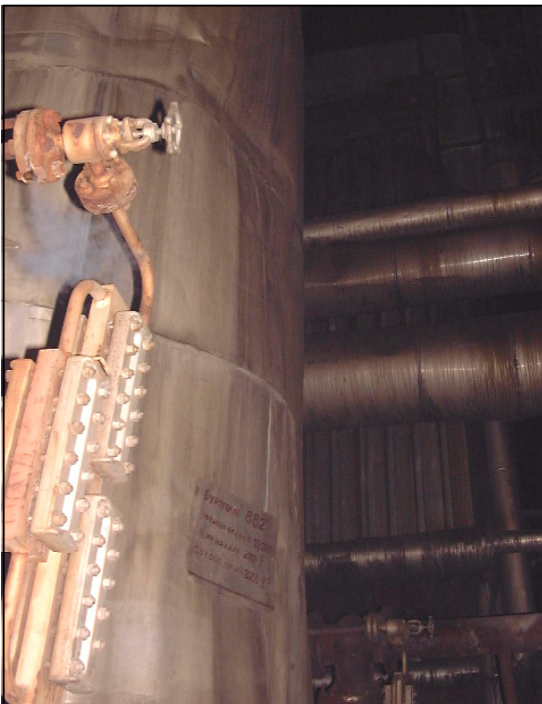
Fig.5.1-10

Since many failures of HP/LP feed water heaters occurred, such as deterioration of thermal insulation and leaks from valves/vent valves, plant efficiency has become lower and also these failures relate to causes of failure of surrounding devices/equipment.

HP/LP feed water heaters are important devices to keep rated turbine efficiency. HP/LP feed water heaters are to be replaced.

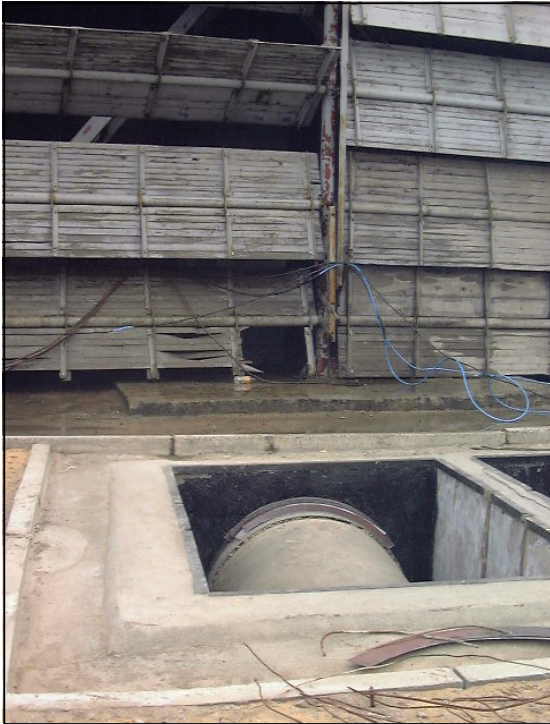
Fig.5.1-11

- (1) Mechanical filter equipment is being used in repairing at No.1 and No.2 cooling towers. There is, however, no mechanical filter provided for No.3 cooling tower.
- (2) Since mechanical filters are installed at the bottom of the cooling tower, cleaning is carried out only when it is shut down.

- (1) Because of the removal of foreign substances and performance improvement of No.1 and 2 cooling towers, TES4 has a plan to change the filter mesh size from 50mm to 10mm.
- (2) TES4 has a plan to manufacture and install a mechanical filter for No. 3.
- (3) TES4 has a plan to install dust removal equipment featuring an automatic washing function which can be cleaned during

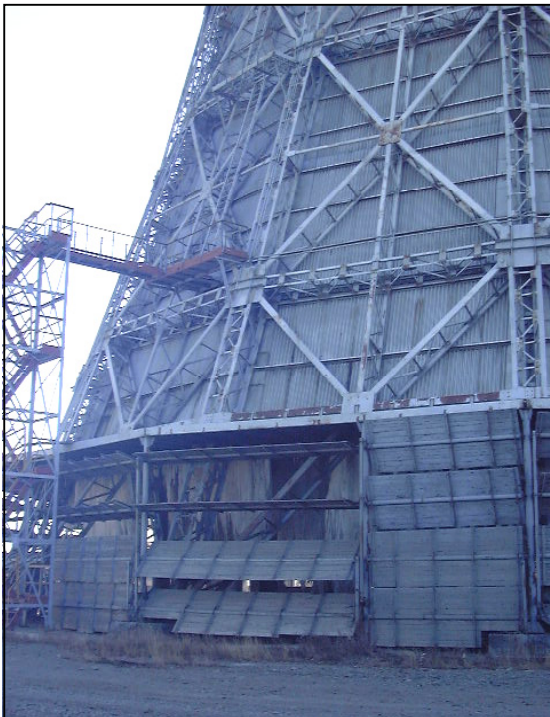
Fig.5.1-12

- (1) An icicle formed inside the cooling tower in winter fell, and the nozzles and eliminators in the lower portion of the cooling tower were broken by it. This decreased plant efficiency, and increased vaporized spray water. These also become factors which enlarge icicles of the upper portion of the cooling tower.
- (2) Garbage, such as sand and plastic, has entered from the lower opening portion of the cooling tower, has blocked condenser tubes, and has accumulated on the lower pit portions of the cooling tower.

- (1) In winter, icicles shall be removed periodically.
- (2) Repair the eliminators and nozzles periodically.
- (3) Clean lower pit portions of the cooling towers periodically.
- (4) The possibility of a radiator type was studied. The study result is shown in Ex 5.1-1.

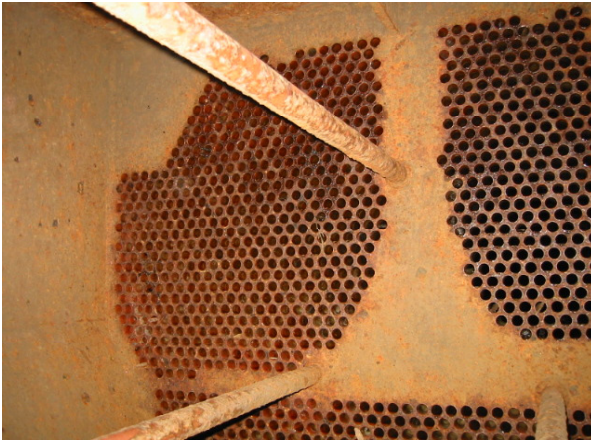
Fig.5.1-13

Groundwater is used for condenser cooling water. Problems, such as clogging by ground dust and foreign substances from the cooling tower, and a decrease of cooling water because of discharging bearing cooling water, have occurred.

- (1) Maintenance of dust collecting equipment.
- (2) Keep cleaning condenser tube periodically.
- (3) Restoration of bearing cooling water return piping.
- (4) The possibility of condenser tube washing equipment was studied. The study result is shown in Ex 5.1-2.
