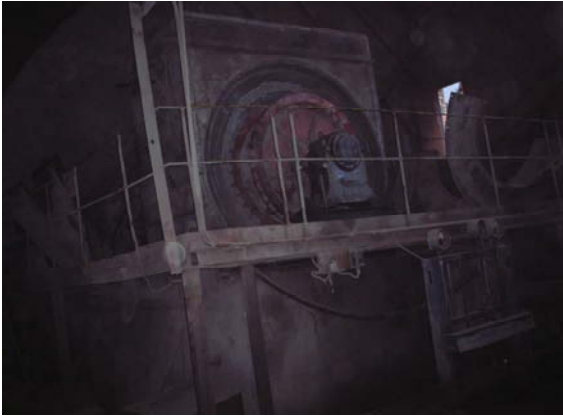
Fig.5.1-19

- (1) Since start-up/shutdown is so frequent, there have been various kinds of damage and accidents on the motors such as the bearing metal, the stator surface according to the rotor by this bearing metal damage (short circuit of the laminating silicon steel plate), and melting of the connection section of rotor end ring and coil.
- (2) Since an interlock is not provided, restrictions of start-up motor are not protected. As a result, degradation of equipment is brought about.
- (3) Repair correspondence in the power plant is difficult for failure of the short circuit of the silicon steel plate, melting of the end ring, etc., and the power plant depends on other countries such as Russia etc. for those repairs.

The motors of FDF and IDF for No.1 to 8 boilers are to be replaced with new ones equipped with an interlock system.

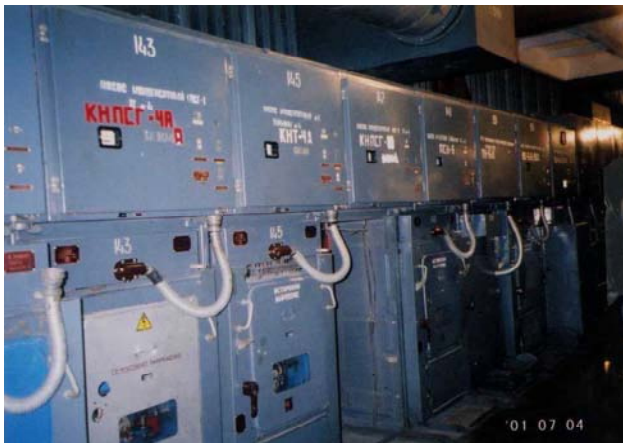
Fig.5.1-20

Present HV switchgears are of OCB type and because they are an old type, there have been problems, such as spare parts unavailability and frequent malfunctions.

HV switchgears, especially those with a high frequency of fault, will be replaced with new ones of VCB type.

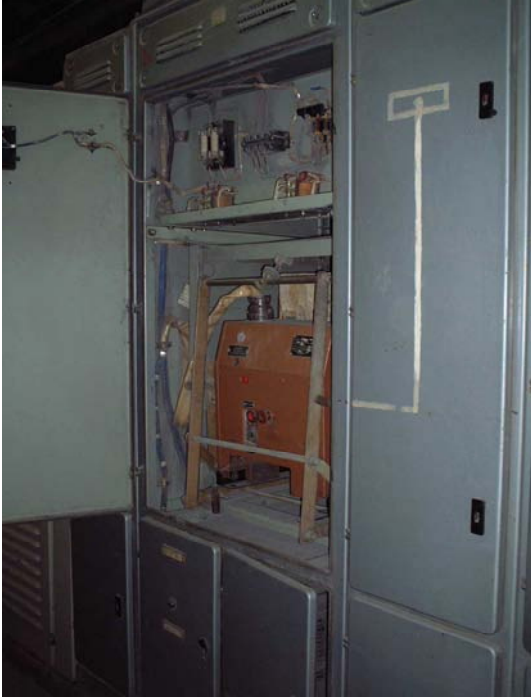
Present HV switchgears are of MBB type and because they are an old type, there have been problems, such as spare parts unavailability and frequent malfunctions.

The LV switchgears important for auxiliaries equipment of boilers and turbines will be replaced.

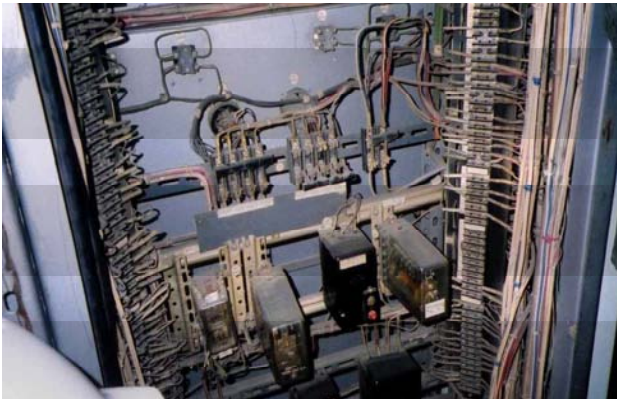
(1) The present generator protection system equipment is made in Russia.

It was superannuated and problems, such as its incorrect operation, have increased significantly.

(2) Because of spare parts unavailability, repair and setting changes are very difficult.

All the protection relays of No. 1 - 6 generator will be replaced.
