1.1 Distribution Pipe

THE STUDY ON REHABILITATION OF DAR ES SALAAM WATER SUPPLY

TRIAL DIGGING OF DISTRIBUTION PIPES

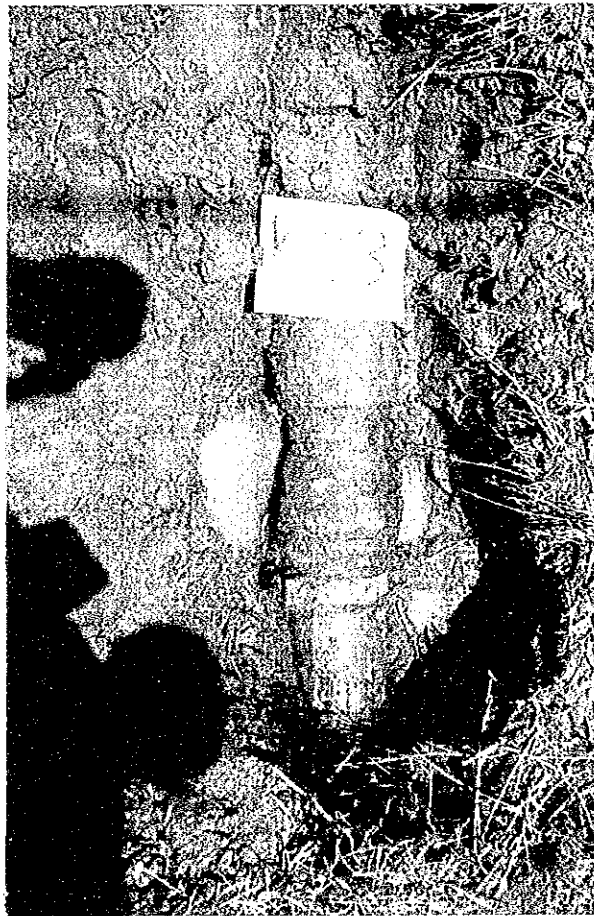
KAWA(1/2)

NUMBER OF TRIAL DIGGING	KW 1	KW 2	KW 3	KW 4	KW 5	KW 6	KW 7
DATE TO BE DIGGED OUT	FEB.22	FEB.16	FEB.16	JAN.11	JAN.10	FEB.15	JAN.10
INSIDE DIAMETER (MM)	200	400	150	200	150	150	250
MATERIAL OF PIPE	CIP	S.P.	CIP	CIP	CIP	CIP	CIP
TYPE OF CONNECTION	MEC. J.	FLANGE	MEC. J.	MEC. J.	MEC. J.	MEC. J.	COUPLE.
SURFACE CORROSION(AVE.) (MM)	1.0	---	1.0	0.5	0.4	1.2	0.7
YEAR OF INSTALLATION	1965	1954	1954	1960	1960	1950	1965
COVERING DEPTH (M)	0.90	1.50	0.50	0.90	0.50	1.00	1.00
CONDITION FOR WATER LEAKAGE	GOOD	NOT USED	GOOD	GOOD	GOOD	GOOD	GOOD

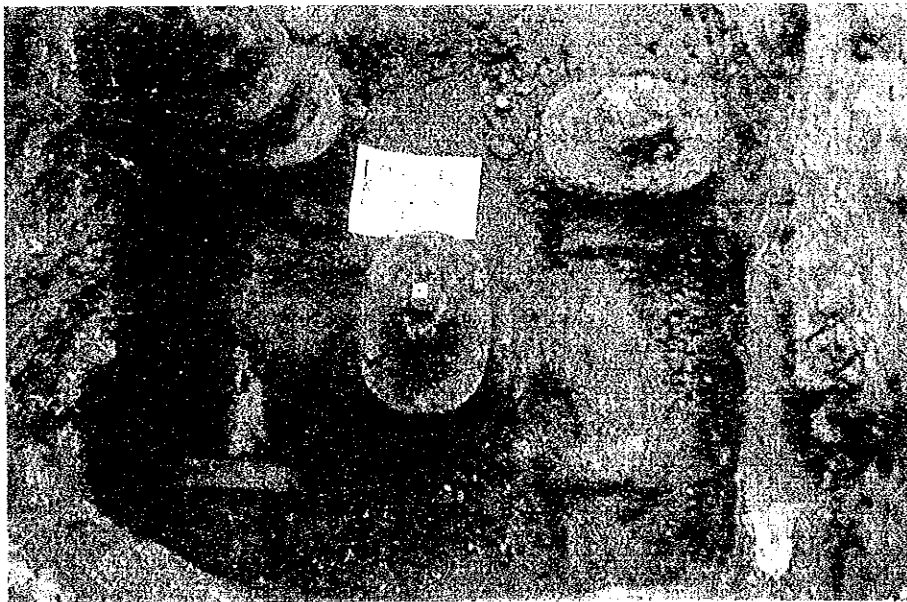
KAWE(2/2)

NUMBER OF TRIAL DIGGING	KW 8						
DATE TO BE DIGGED OUT	FEB. 21						
INSIDE DIAMETER (MM)	200						
MATERIAL OF PIPE	CIP						
TYPE OF CONNECTION	FLANGE						
SURFACE CORROSION(AVE.)(MM)	0.4						
YEAR OF INSTALLATION	1955						
COVERING DEPTH (M)	1.30						
CONDITION FOR WATER LEAKAGE	GOOD

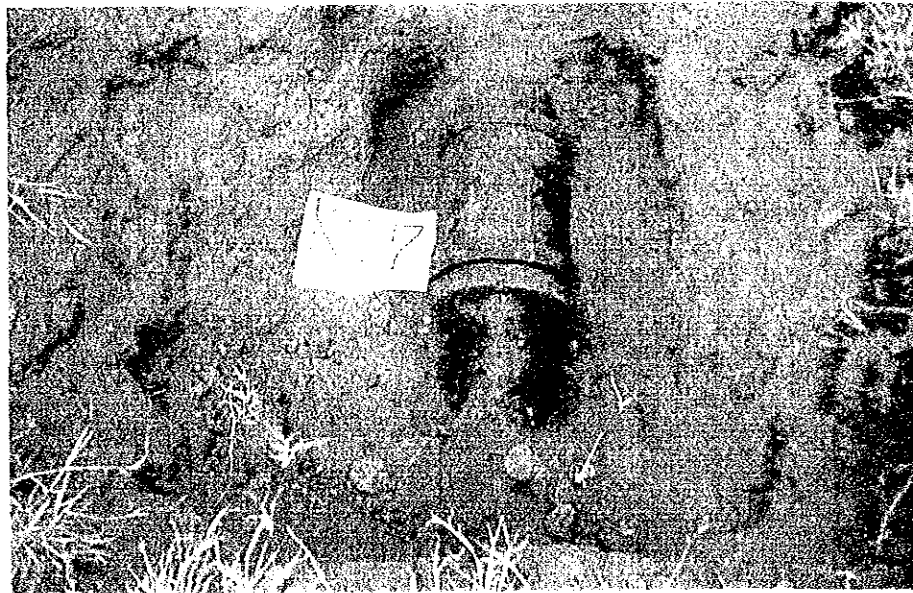
KINONDONI(1/3)

NUMBER OF TRIAL DIGGING	KI 1	KI 2	KI 4	KI 6	KI 7	KI 8	KI 9
DATE TO BE DIGGED OUT	FEB.12	FEB.12	FEB.9	FEB.9	FEB.8	FEB.12	FEB.12
INSIDE DIAMETER (MM)	1350	1200	200	150	200	525	750
MATERIAL OF PIPE	PCP	PCP	CIP	CIP	CIP	CIP	CIP
TYPE OF CONNECTION	---	---	MEC. J.	MEC. J.	COLLAR	COUPL.	MEC. J.
SURFACE CORROSION(AVE.) (MM)	---	---	0.6	0.4	0.5	---	---
YEAR OF INSTALLATION	1950	1950	1970	1967	1952	1960	1976
COVERING DEPTH (M)	3.50	3.00	0.80	0.50	0.70	0.40	2.00
CONDITION FOR WATER LEAKAGE	GOOD	GOOD	GOOD	GOOD	GOOD	GOOD	GOOD

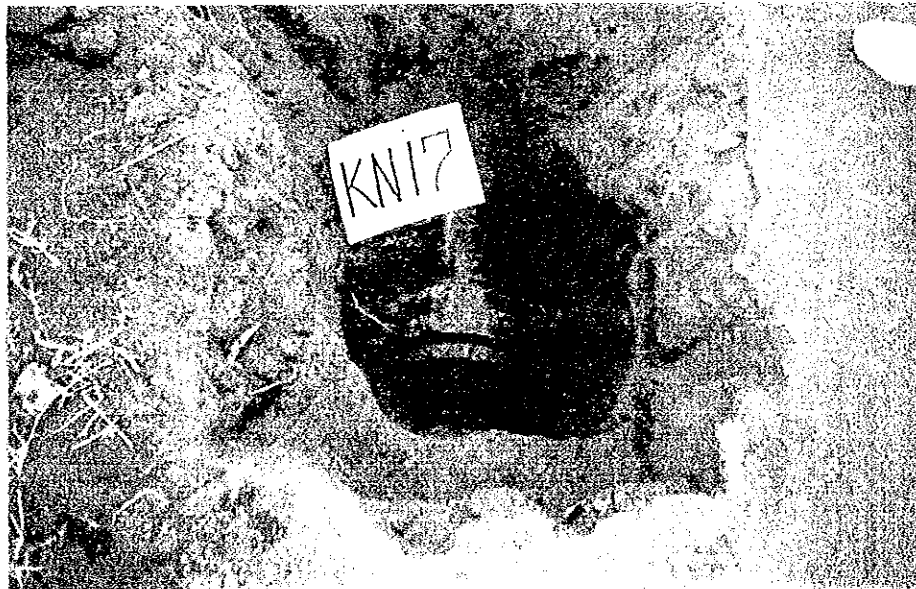
KINONDONI (2/3)

NUMBER OF TRIAL DIGGING	KI 10	KI 11	KI 12	KI 14	KI 15	KI 16	KI 17
DATE TO BE DIGGED OUT	FEB. 9	FEB. 9	FEB. 9	FEB. 9	FEB. 9	FEB. 8	JAN. 26
INSIDE DIAMETER (MM)	150	200	200	150	150	100	150
MATERIAL OF PIPE	CIP	CIP	CIP	CIP	CIP	CIP	CIP
TYPE OF CONNECTION	MEC. J.	MEC. J.	MEC. J.	MEC. J.	MEC. J.	MEC. J.	MEC. J.
SURFACE CORROSION(AVE.) (MM)	0.7	0.7	1.1	0.3	0.7	0.5	0.3
YEAR OF INSTALLATION	1960	1967	1970	1967	1967	1966	1966
COVERING DEPTH (M)	0.40	0.10	0.40	0.50	0.40	0.70	0.70
CONDITION FOR WATER LEAKAGE	GOOD	GOOD	GOOD	GOOD	GOOD	GOOD	GOOD

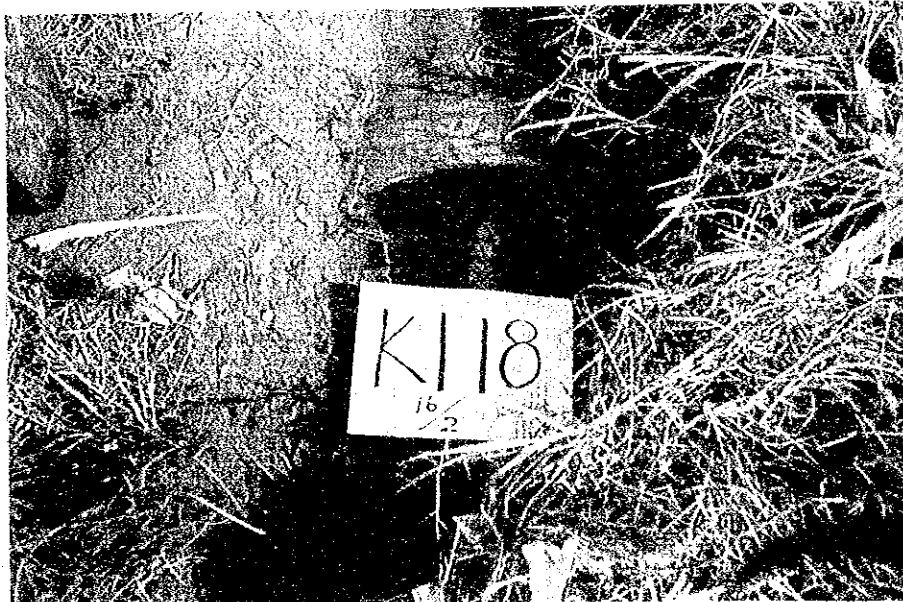
KINONDONI (3/3)

NUMBER OF TRIAL DIGGING	KI 18						
DATE TO BE DIGGED OUT	FEB. 16						
INSIDE DIAMETER (MM)	400						
MATERIAL OF PIPE	CIP						
TYPE OF CONNECTION	MEC. J.						
SURFACE CORROSION(AVE.)(MM)	0.3						
YEAR OF INSTALLATION	1970						
COVERING DEPTH (M)	0.50						
CONDITION FOR WATER LEAKAGE	GOOD

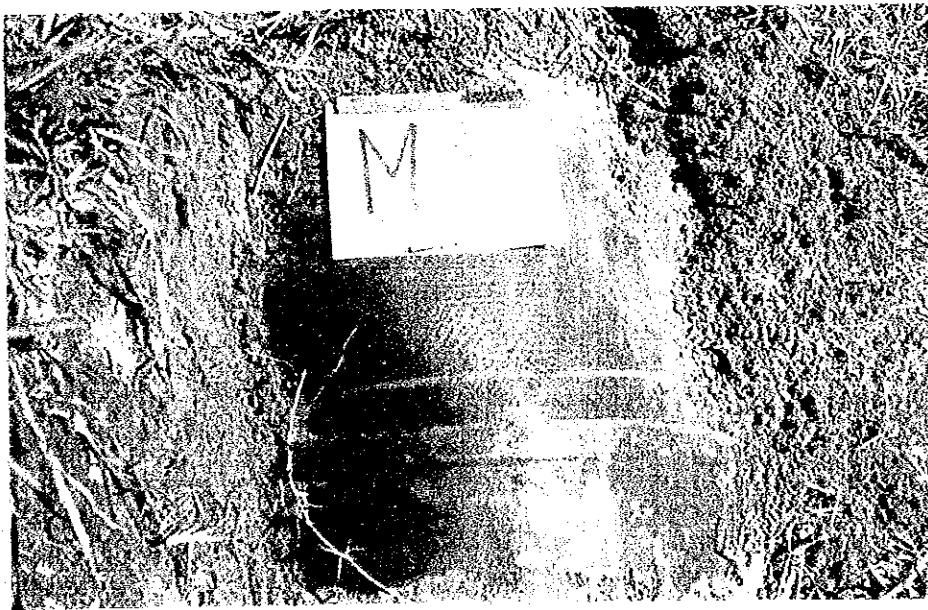
MAGOMENI(1/2)

NUMBER OF TRIAL DIGGING	MN 1	MN 3	MN 5	MN 7	MN 8	MN 9	MN 10
DATE TO BE DIGGED OUT	JAN. 4	JAN. 3	JAN. 3	JAN. 5	FEB. 12	FEB. 23	JAN. 5
INSIDE DIAMETER (MM)	600	525	525	700	750	600	525
MATERIAL OF PIPE	S.P	S.P	S.P	S.P	CIP	S.P	S.P
TYPE OF CONNECTION	WELD.	SLLEVE	SLLEVE	WELD.	MEC. J.	COUPL.	SLLEVE
SURFACE CORROSION(AVE.)(MM)	---	---	---	---	0.2	---	---
YEAR OF INSTALLATION	1965?	1965?	1965?	1965?	1985	1980	1975
COVERING DEPTH (M)	0.50	0.40	0.50	1.30	1.40	0.20	1.20
CONDITION FOR WATER LEAKAGE	GOOD	GOOD	GOOD	GOOD	GOOD	GOOD	GOOD

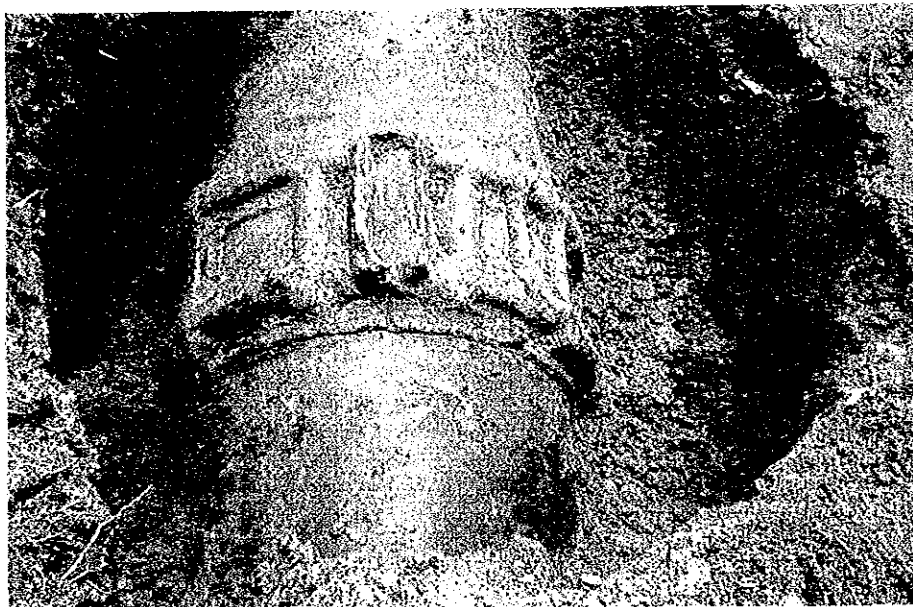
MAGOMENI(2/2)

NUMBER OF TRIAL DIGGING	MN 11	MN 12	MN 14	MN 16	MN 17	MN 18	MN 19
DATE TO BE DIGGED OUT	JAN. 5	FEB. 15	FEB. 15	FEB. 22	JAN. 6	FEB. 21	JAN. 6
INSIDE DIAMETER (MM)	525	525	750	375	200	750	375
MATERIAL OF PIPE	S.P	CIP	CIP	CIP	CIP	CP	DCIP
TYPE OF CONNECTION	SLEEVE	COLLAR	MEC. J.	MEC. J.	MEC. J.	SOCKET	MEC. J.
SURFACE CORROSION(AVE.) (MM)	---	---	0.3	0.8	0.7	---	0.7
YEAR OF INSTALLATION	1975	1965	1985	1980	1980	1970	1970
COVERING DEPTH (M)	0.30	1.20	1.90	0.80	0.70	2.65	1.00
CONDITION FOR WATER LEAKAGE	GOOD	GOOD	GOOD	GOOD	GOOD	GOOD	GOOD

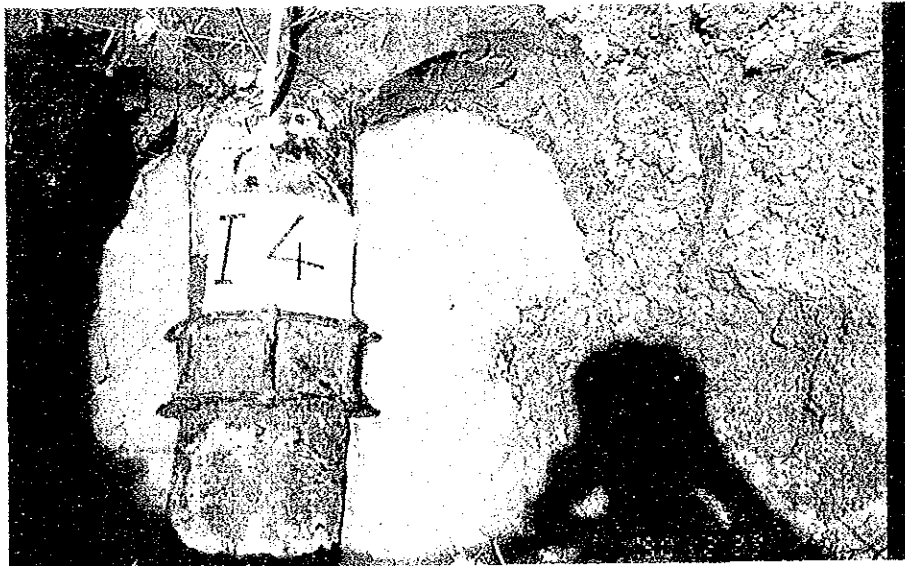
ILALA(1/2)

NUMBER OF TRIAL DIGGING	IL 3	IL 4	IL 5	IL 7	IL 10	IL 15	IL 17
DATE TO BE DIGGED OUT	JAN. 20	FEB. 22	FEB. 22	JAN. 2	JAN. 20	FEB. 23	JAN. 2
INSIDE DIAMETER (MM)	400	300	300	525	400	200	300
MATERIAL OF PIPE	S.P.	CIP.	CIP	S.P.	CIP	CIP	DCIP
TYPE OF CONNECTION	SLEEVE	COUPL.	MEC. J.	SLEEVE	SOCKET	MEC. J.	SOCKET
SURFACE CORROSION(AVE.) (MM)	---	0.3	0.4	---	3.4	0.8	0.9
YEAR OF INSTALLATION	1955	1967	1967	1965	1965	1965	1970
COVERING DEPTH (M)	0.40	0.70	0.90	0.80	0.50	0.85	1.00
CONDITION FOR WATER LEAKAGE	GOOD	GOOD	GOOD	GOOD	GOOD	GOOD	GOOD

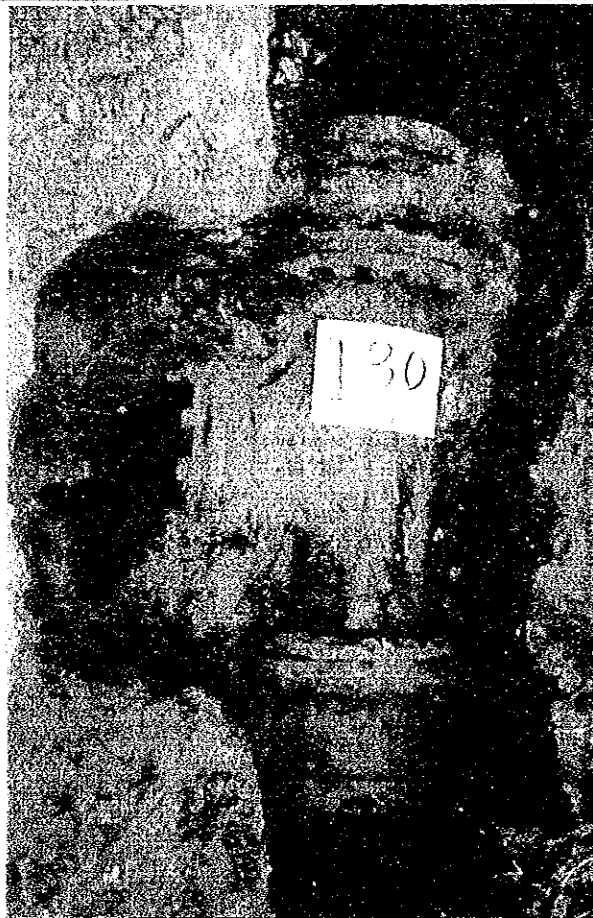
ILALA(2/2)

NUMBER OF TRIAL DIGGING	IL 18	IL 22	IL 24	IL 28	IL 30	IL 32	IL 36
DATE TO BE DIGGED OUT	JAN. 22	FEB. 21	JAN. 22	FEB. 21	FEB. 21	FEB. 21	FEB. 19
INSIDE DIAMETER (MM)	300	150	150	200	250	250	200
MATERIAL OF PIPE	CIP	CIP	CIP	CIP	CIP	CIP	CIP
TYPE OF CONNECTION	SOCKET	FLANGE	MEC. J.	SOCKET	MEC. J.	---	MEC. J.
SURFACE CORROSION(AVE.) (MM)	2.1	0.9	0.5	0.7	0.4	1.0	---
YEAR OF INSTALLATION	1965	1965	1965	1965	1979	1960	1950
COVERING DEPTH (M)	1.00	0.70	1.00	0.90	0.70	1.00	1.20
CONDITION FOR WATER LEAKAGE	GOOD	GOOD	GOOD	GOOD	GOOD	GOOD	BAD

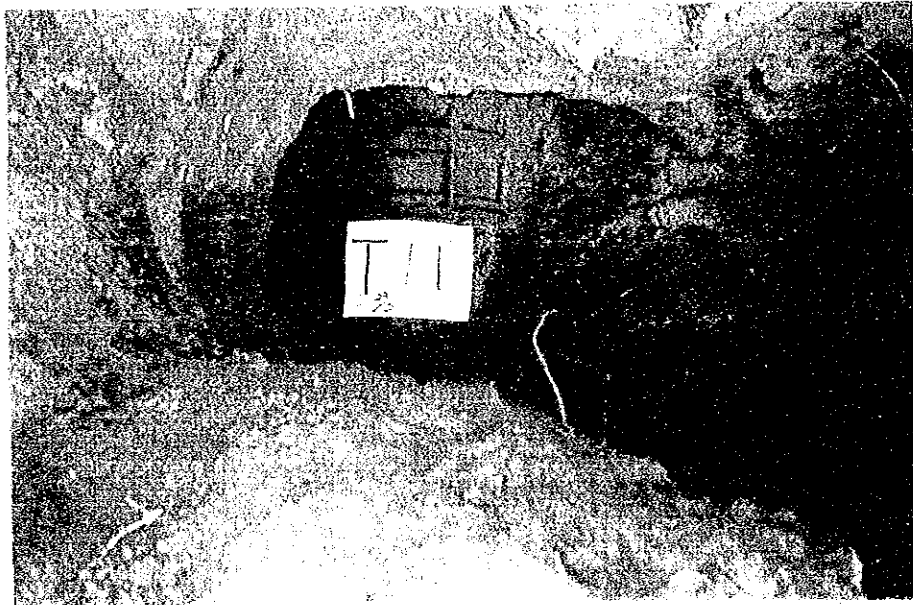
TEMEKE(2/3)

NUMBER OF TRIAL DIGGING	TK 9	TK 11	TK 12	TK 13	TK 17	TK 18	TK 20
DATE TO BE DIGGED OUT	FEB. 23	FEB. 23	FEB. 22	FEB. 23	JAN. 19	JAN. 19	FEB. 22
INSIDE DIAMETER (MM)	200	400	250	200	150	300	250
MATERIAL OF PIPE	CIP	CIP	CIP	CIP	CIP	CIP	CIP
TYPE OF CONNECTION	WELD.	COUPLE	MEC. J.	MEC. J.	MEC. J.	SOCKET	MEC. J.
SURFACE CORROSION(AVE.)(MM)	---	---	0.2	0.3	1.0	0.5	0.9
YEAR OF INSTALLATION	1960	1974	1951	1953	1960	1960	1960
COVERING DEPTH (M)	0.80	1.60	0.90	0.90	0.50	1.40	0.70
CONDITION FOR WATER LEAKAGE	GOOD	GOOD	GOOD	GOOD	GOOD	GOOD	GOOD

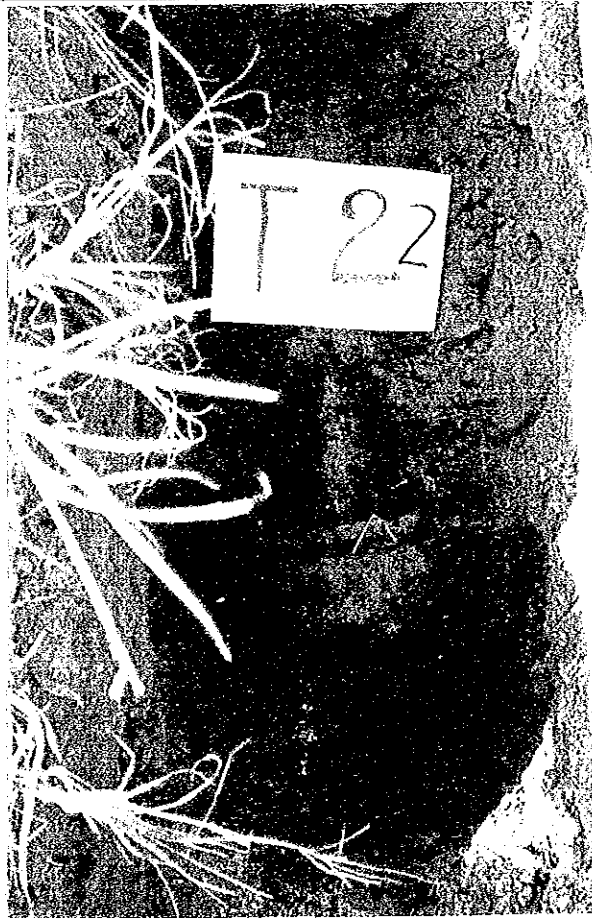
TEMEKE(3/3)

NUMBER OF TRIAL DIGGING	TK 22						
DATE TO BE DIGGED OUT	FEB. 22						
INSIDE DIAMETER (MM)	150						
MATERIAL OF PIPE	CIP						
TYPE OF CONNECTION	MEC. J.						
SURFACE CORROSION(AVE.) (MM)	0.9						
YEAR OF INSTALLATION	1951.						
COVERING DEPTH (M)	0.95						
CONDITION FOR WATER LEAKAGE	GOOD

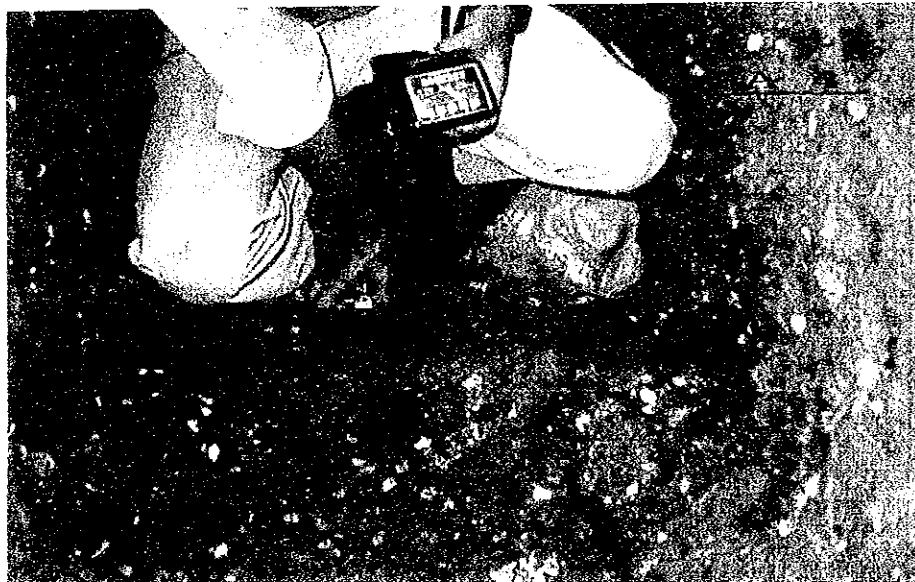
KARIAKOO(1/2)

NUMBER OF TRIAL DIGGING	KA 1	KA 2	KA 3	KA 4	KA 5	KA 6	KA 7
DATE TO BE DIGGED OUT	DEC. 22	DEC. 22	DEC. 22	DEC. 22	DEC. 22	DEC. 22	DEC. 22
INSIDE DIAMETER (MM)	100	100	150	100	100	100	100
MATERIAL OF PIPE	CIP	CIP	CIP	CIP	CIP	CIP	CIP
TYPE OF CONNECTION	MEC. J.	SOCKET	MEC. J.	MEC. J.	MEC. J.	MEC. J.	MEC. J.
SURFACE CORROSION(AVE.)(MM)	0.3	0.7	0.9	1.4	1.1	1.4	0.7
YEAR OF INSTALLATION	1965	1965	1965	1965	1965	1965	1965
COVERING DEPTH (M)	0.75	1.20	0.50	0.90	0.65	0.80	0.70
CONDITION FOR WATER LEAKAGE	GOOD	GOOD	GOOD	GOOD	GOOD	GOOD	GOOD

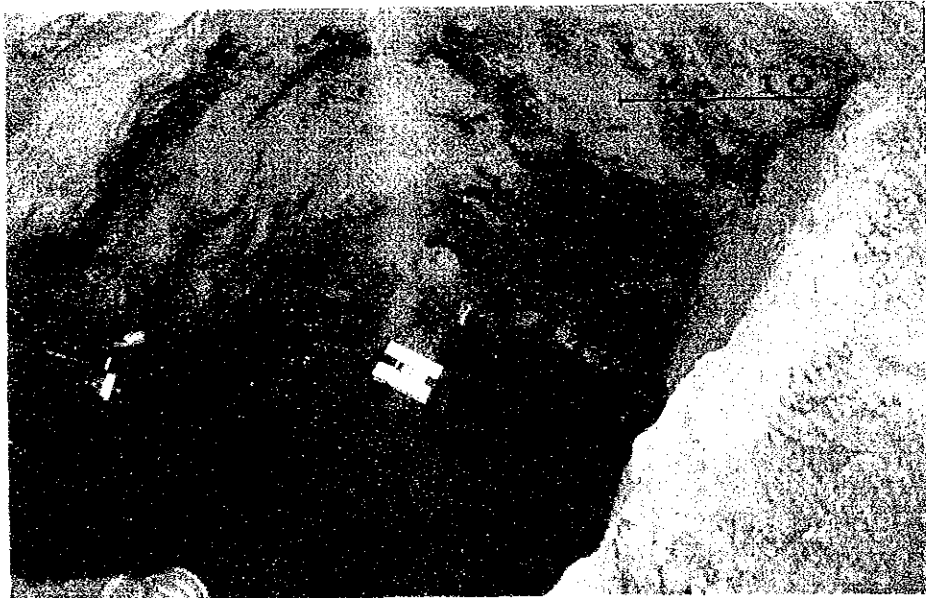
KARIAKOO(2/2)

NUMBER OF TRIAL DIGGING	KA 8	KA 9	KA 10	KA 11			
DATE TO BE DIGGED OUT	DEC. 23	DEC. 23	DEC. 23	DEC. 23			
INSIDE DIAMETER (MM)	150	100	100	100			
MATERIAL OF PIPE	CIP	CIP	CIP	CIP			
TYPE OF CONNECTION	MEC. J.	MEC. J.	MEC. J.	SOCKET			
SURFACE CORROSION(AVE.) (MM)	0.8	0.7	0.5	0.7			
YEAR OF INSTALLATION	1965	1965	1965	1965			
COVERING DEPTH (M)	1.00	0.75	0.80	0.65			
CONDITION FOR WATER LEAKAGE	GOOD	GOOD	GOOD	GOOD

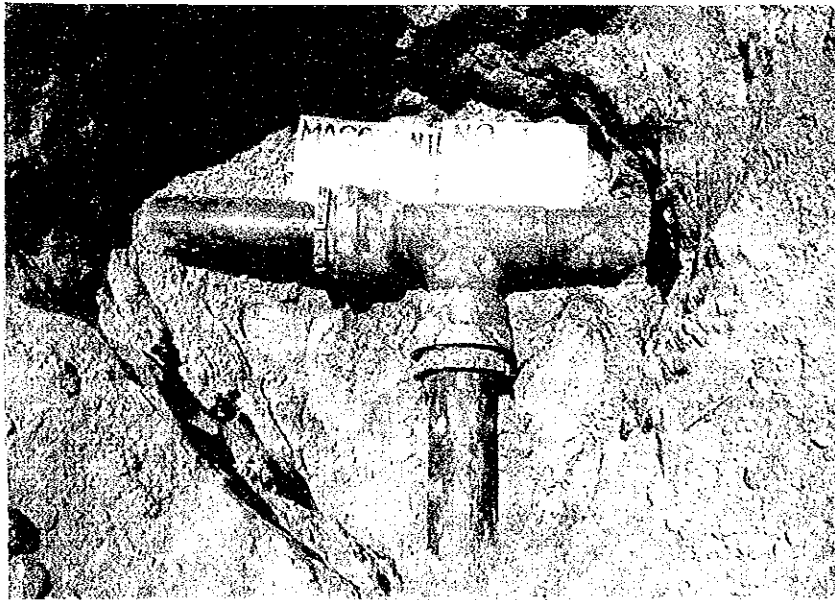
NAME OF MODEL AREA MAGOMENI (1/2)

NUMBER OF TRIAL DIGGING	MN 1	MN 2	MN 3	MN 4	MN 5	MN 6	MN 7
DATE TO BE DIGGED OUT	FEB. 2	FEB. 2	FEB. 2	FEB. 3	FEB. 3	FEB. 6	FEB. 6
INSIDE DIAMETER (MM)	100	100	100	100,75	100,75	100	150
MATERIAL OF PIPE	CIP	CIP	CIP	CIP	CIP	CIP	CIP
TYPE OF CONNECTION	MEC. J.	MEC. J.	MEC. J.	MEC. J.	MEC. J.	MEC. J.	MEC. J.
SURFACE CORROSION(AVE.) (MM)	0.2	0.2	0.0	0.0	0.1	0.1	1.0
YEAR OF INSTALLATION	1959	1959	1959	1959	1959	1959	1959
COVERING DEPTH (M)	0.80	0.90	0.90	1.20	0.75	0.80	0.90
CONDITION FOR WATER LEAKAGE	GOOD	GOOD	GOOD	GOOD	GOOD	GOOD	GOOD

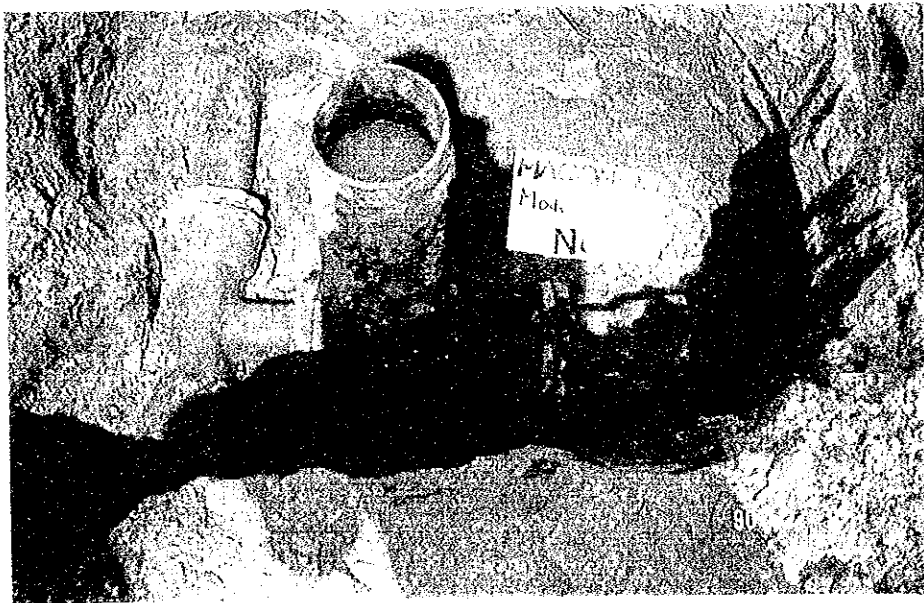
NAME OF MODEL ARE MAGOMENI (2/2)

NUMBER OF TRIAL DIGGING	MN 8	MN 9	MN 10				
DATE TO BE DIGGED OUT	FEB. 6	FEB. 3	FEB. 7				
INSIDE DIAMETER (MM)	100	100	100,75				
MATERIAL OF PIPE	CIP	CIP	CIP				
TYPE OF CONNECTION	MEC. J.	FERR.	MEC. J.				
SURFACE CORROSION(AVE.)(MM)	1.2	0.6	0.3				
YEAR OF INSTALLATION	1959	1959	1959				
COVERING DEPTH (M)	0.70	0.80	0.65				
CONDITION FOR WATER LEAKAGE	GOOD	GOOD	GOOD

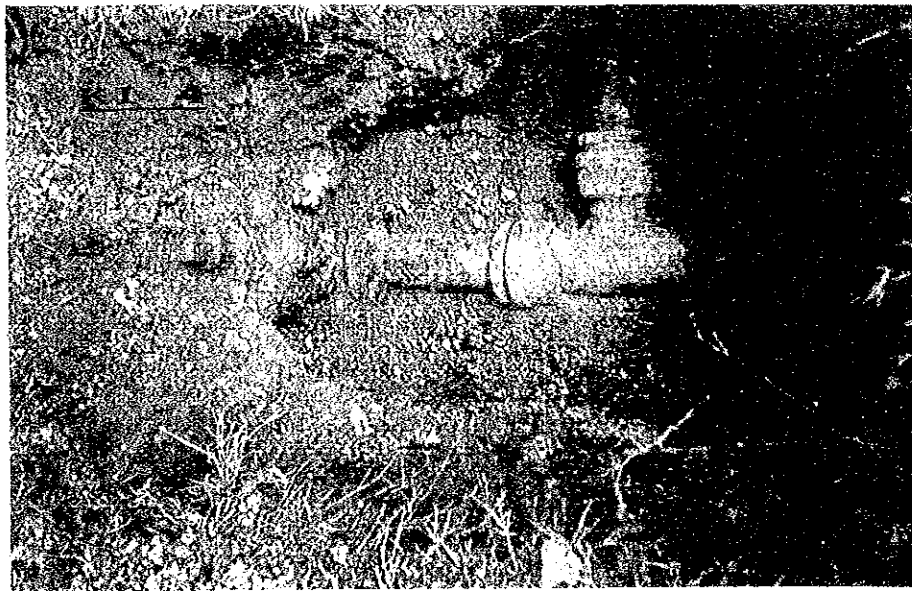
NAME OF MODEL AREA KINONDONI (1/2)

NUMBER OF TRIAL DIGGING	KI 1	KI 2	KI 3	KI 4	KI 5	KI 6	KI 7
DATE TO BE DIGGED OUT	DEC. 28	DEC. 28	DEC. 29	DEC. 28	DEC. 28	DEC. 28	DEC. 28
INSIDE DIAMETER (MM)	100	100	100	100	100	100	100
MATERIAL OF PIPE	CIP	CIP	CIP	CIP	CIP	CIP	CIP
TYPE OF CONNECTION	MEC. J.	MEC. J.	MEC. J.	MEC. J.	MEC. J.	MEC. J.	MEC. J.
SURFACE CORROSION(AVE.) (MM)	0.4	0.3	0.3	0.5	0.5	0.4	0.3
YEAR OF INSTALLATION	1970	1970	1970	1970	1980	1970	1970
COVERING DEPTH (M)	0.50	0.70	0.70	0.65	0.30	0.40	0.60
CONDITION FOR WATER LEAKAGE	GOOD	GOOD	GOOD	GOOD	GOOD	GOOD	GOOD

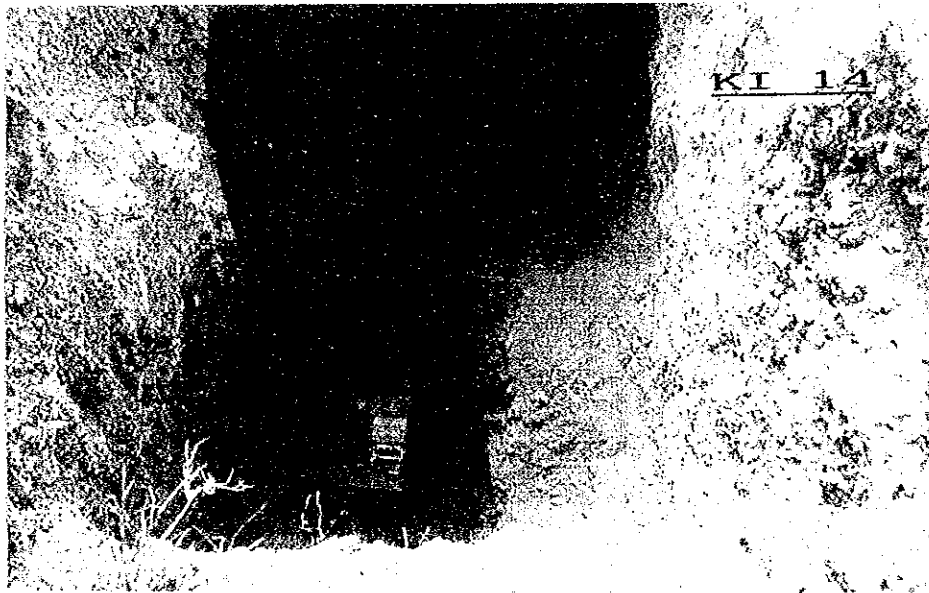
NAME OF MODEL AREA KINONDONI (2/2)

KI 8	KI 9	KI 10	KI 11	KI 12	KI 13	KI 14
NUMBER OF TRIAL DIGGING							
DATE TO BE DIGGED OUT	DEC. 22	DEC. 22	DEC. 22	JAN. 30	FEB. 2	JAN. 31	JAN. 29
INSIDE DIAMETER (MM)	100	100	100	100	100	100	200
MATERIAL OF PIPE	CIP	CIP	CIP	CIP	CIP	CIP	CIP
TYPE OF CONNECTION	MEC. J	MEC. J	MEC. J	MEC. J	MEC. J	MEC. J	MEC. J.
SURFACE CORROSION(AVE.) (MM)	0.2	1.2	1.2	0.4	0.3	0.3	0.44
YEAR OF INSTALLATION	1968	1968	1968	1968	1968	1968	1965?
COVERING DEPTH (M)	0.60	0.90	0.70	0.70	0.65	1.15	2.50
CONDITION FOR WATER LEAKAGE	GOOD	GOOD	GOOD	GOOD	GOOD	GOOD	GOOD

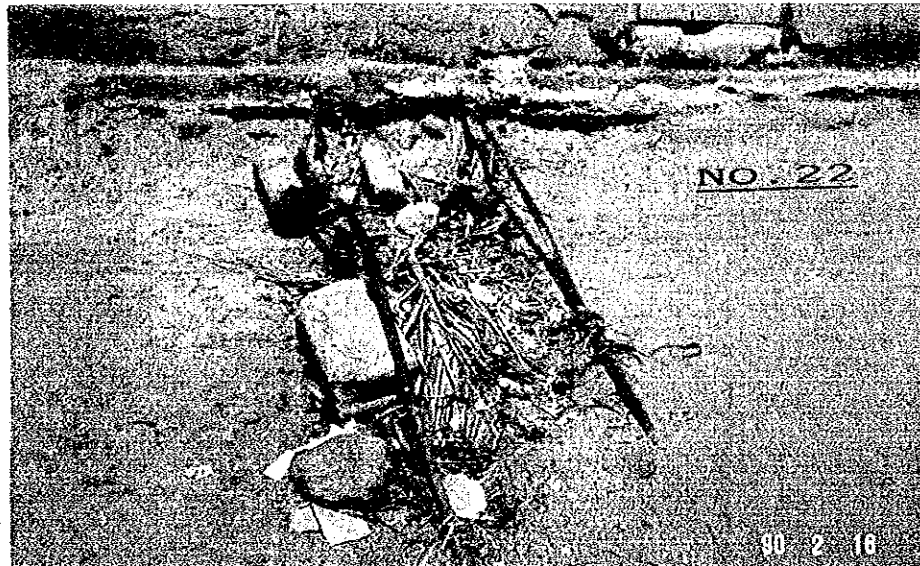
MAGOMENI (1/2)

NUMBER OF TRIAL DIGGING	MN 1	MN 2	MN 3	MN 4	MN 5	MN 6	MN 7
DATE TO BE DIGGED OUT	FEB. 24	FEB. 28	FEB. 4	FEB. 4	FEB. 6	FEB. 16	FEB. 24
DIAMETER OF SERVICE PIPE (MM)	20	25	20	20	20	20	20
MATERIAL OF PIPE	PVC	PVC	GP	GP	GP	GP	PVC, PV
CONDITION OF SERVICE PIPE	GOOD	NO GOOD	NO GOOD	GOOD	NO GOOD	NO GOOD	GOOD
YEAR OF INSTALLATION	1967	1988	1964	1973	1965	1965	1975?
COVERING DEPTH (M)	0.20	0.30	0.20	0.20	0.20	0.00	0.10
CONDITION FOR WATER LEAKAGE	GOOD	GOOD	NO GOOD	GOOD	GOOD	GOOD	GOOD
HOUSE NUMBER	NO. 11	NO. 12	NO. 19	NO. 85	NO. 13	NO. 22	NO. 201

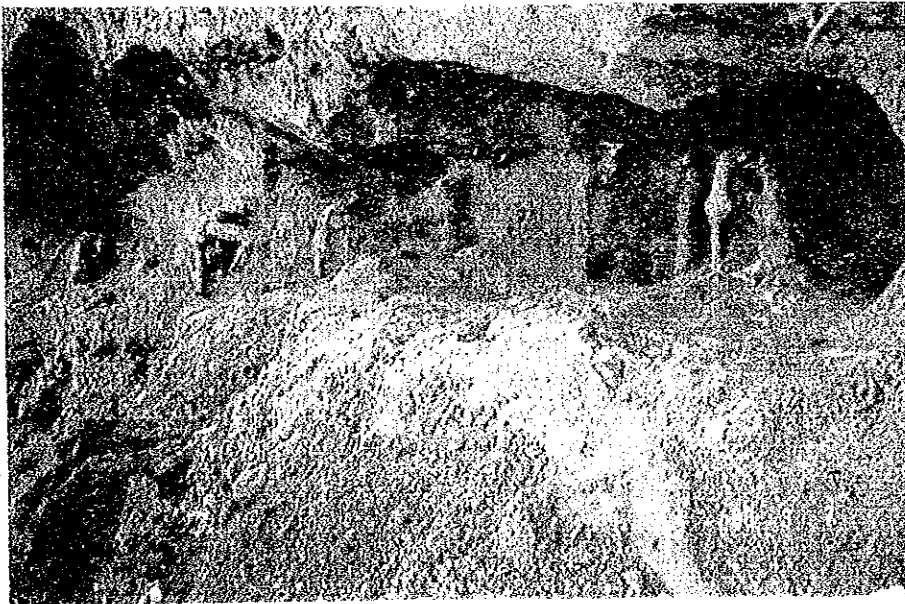
NUMBER OF TRIAL DIGGING	MN 8	MN 9	MN 10	MN 11	MN 12	MN 13	MN 14
DATE TO BE DIGGED OUT	FEB. 24	FEB. 28	FEB. 28	MAR. 6	FEB. 24	MAR. 7	MAR. 8
DIAMETER OF SERVICE PIPE (MM)	20	25	20	20	20/25	20/25	20
MATERIAL OF PIPE	PVC	PVC	GP	GP/PVC	GP/PVC	GP/PVC	GP
CONDITION OF SERVICE PIPE	NO GOOD	GOOD	GOOD	GOOD	NO GOOD	GOOD	GOOD
YEAR OF INSTALLATION	1980?	1988	1989	1966	1967	1970	1965
COVERING DEPTH (M)	0.10	0.30	0.20	0.40	0.30	0.40	0.35
CONDITION FOR WATER LEAKAGE	NO GOOD	GOOD	NO GOOD	GOOD	GOOD	GOOD	GOOD
HOUSE NUMBER	NO. 206A	NO. 4	NO. 307	NO. 15	NO. 152	NO. 157	NO. 181
