CHAPTER 5

PRESENT CONDITIONS, PROBLEMS, AND PROPOSED REHABILITATION OF TRANSMISSION, SUBSTATION, AND DISTRIBUTION FACILITIES

5.1 Dar es Salaam

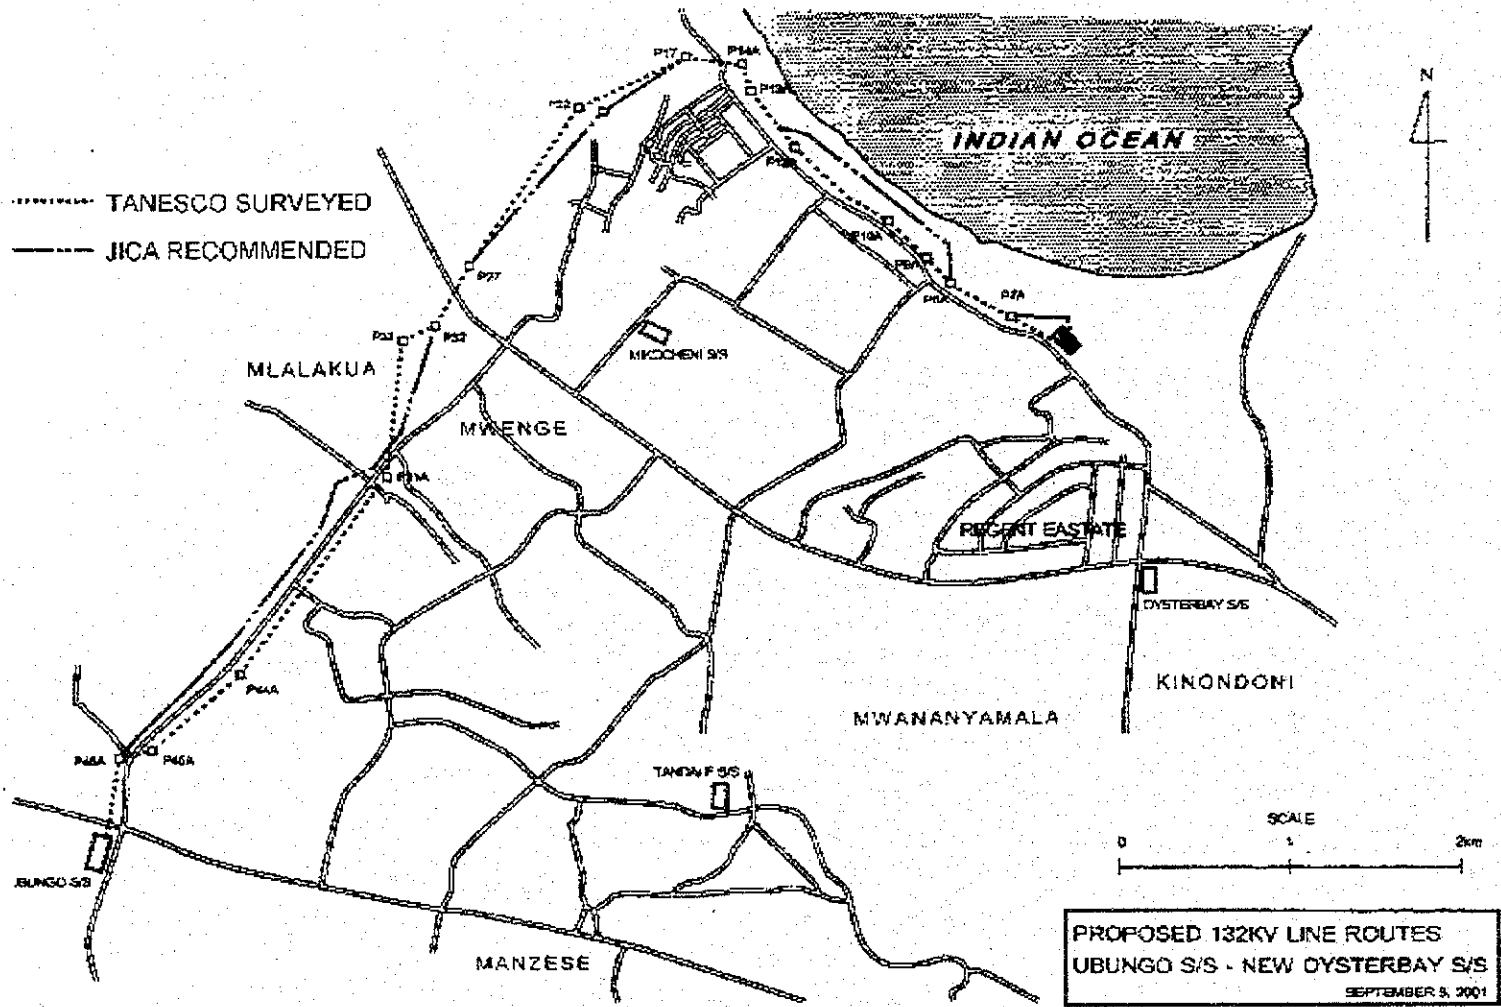
Fig.5.1.1 Proposed 132kV Line Route from Ubungo S/S to New Oysterbay S/S

Team made the following comments and presented its recommended route (see Fig. 5.1.1).
