5.2 Arusha

(1) Present conditions and problems of substation facilities in Arusha

CHAPTER 5 PRESENT CONDITIONS, PROBLEMS, AND PROPOSED REHABILITATION OF TRANSMISSION, SUBSTATION AND DISTRIBUTION FACILITIES

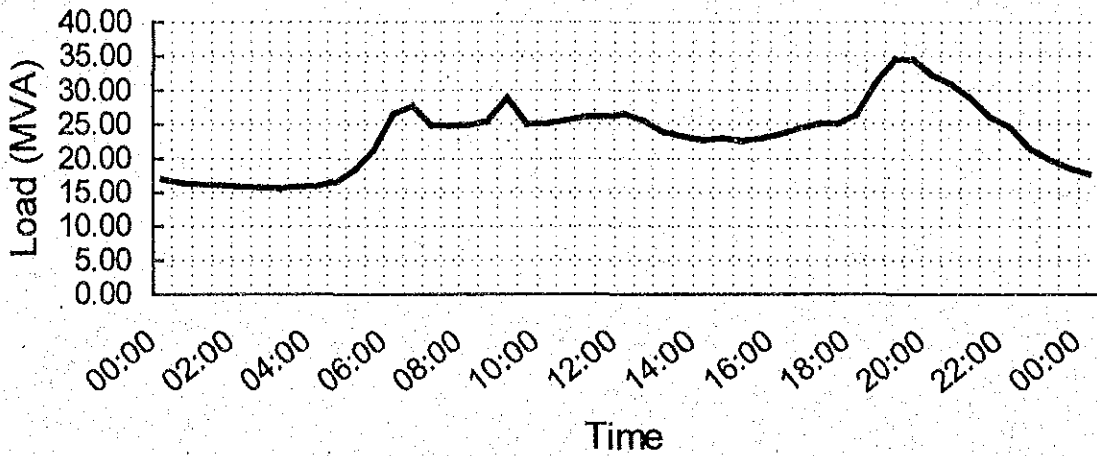
Fig.5.2.1 Measured Load Record of Njiro S/S 33kV Feeder

However, as already mentioned, the 132 kV/33 kV transformers of the Njiro S/S are already under an overload and have no extra supply capacity to feed new 33 kV lines. Because of this, even if the project to boost the long-distance distribution lines to 33 kV is completed as planned, they can only be operated with 11 kV for some time, hence the project will not produce the desired effect in the near future. It is, therefore, necessary first to reinforce the 33 kV supply capacity of the Njiro S/S and secure sufficient capacity to

The 33 kV side of the Njiro S/S has already been overloaded and if this situation cannot be remedied, there is concern that it should become necessary to limit the power supply by load shedding, etc. so as to prevent burnouts of the transformation devices and that the problem of voltage drops in the Monduli and Usa River areas should remain unsettled.

NJIRO SS 33KV FEEDER TOTAL LOAD (Sep. 24, 2001)

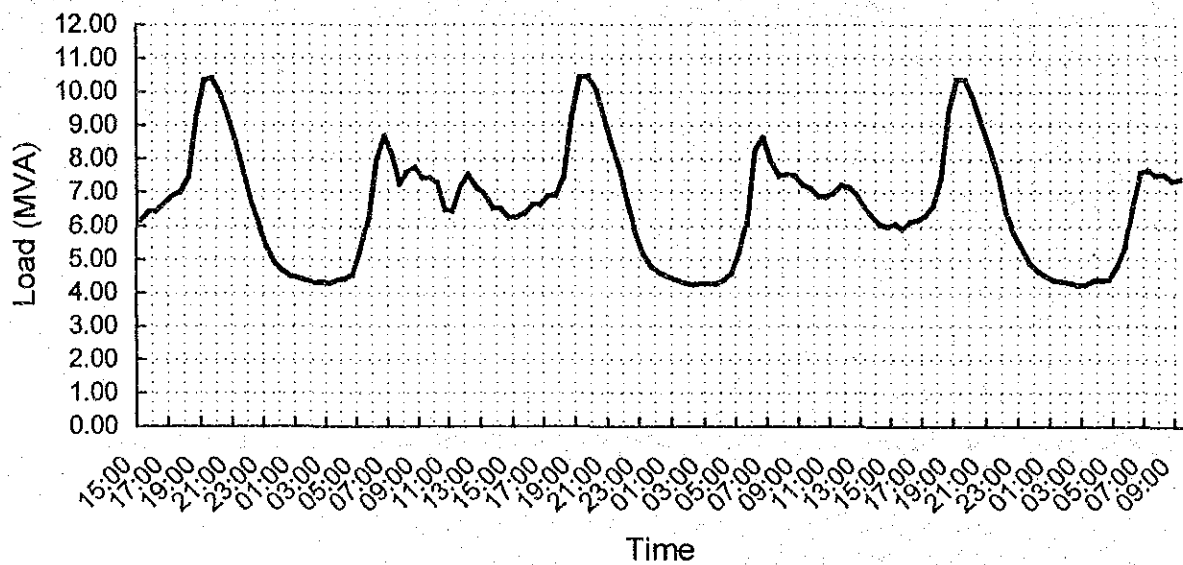
Fig.5.2.2 Measured Load Record of Mt. Meru S/S

MT MERU SS LOAD (Sep. 19 to 22, 2001)

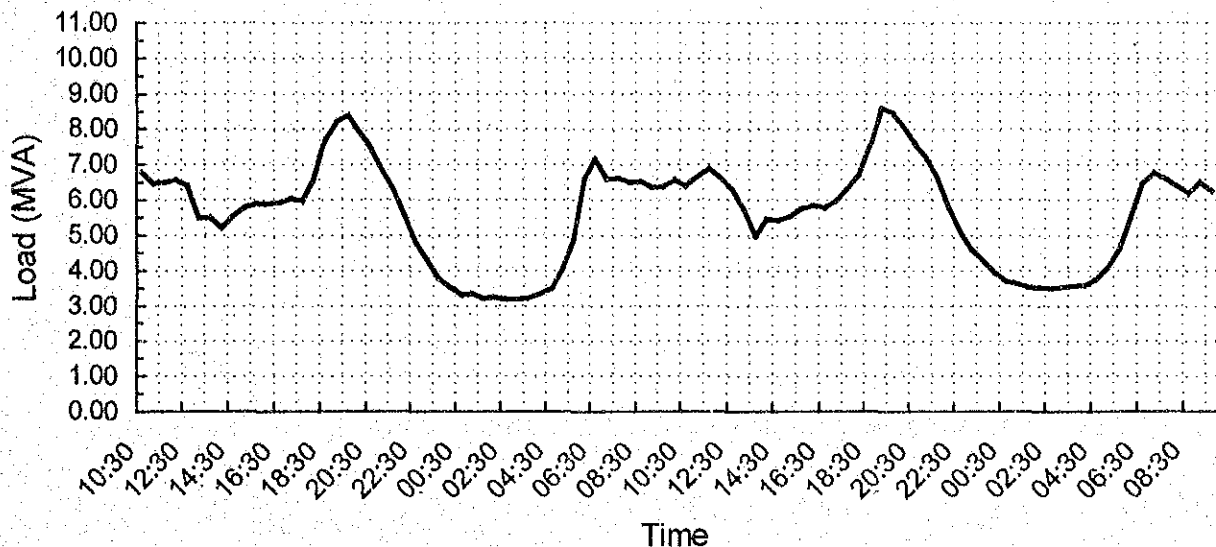
Fig.5.2.3 Measured Load Record of Unga LTD S/S

**Unga LTD SS LOAD
(Sep. 20 to 22, 2001)**

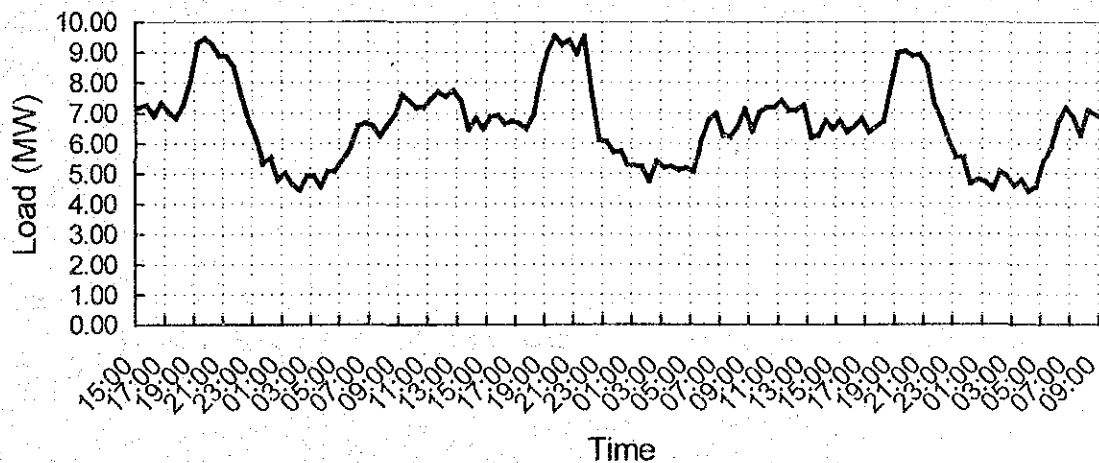
Fig.5.3.1 Measured Load Record of Boma Mbuluzi S/S

Boma Mbuluzi SS LOAD (Sep. 11 to 14, 2001)

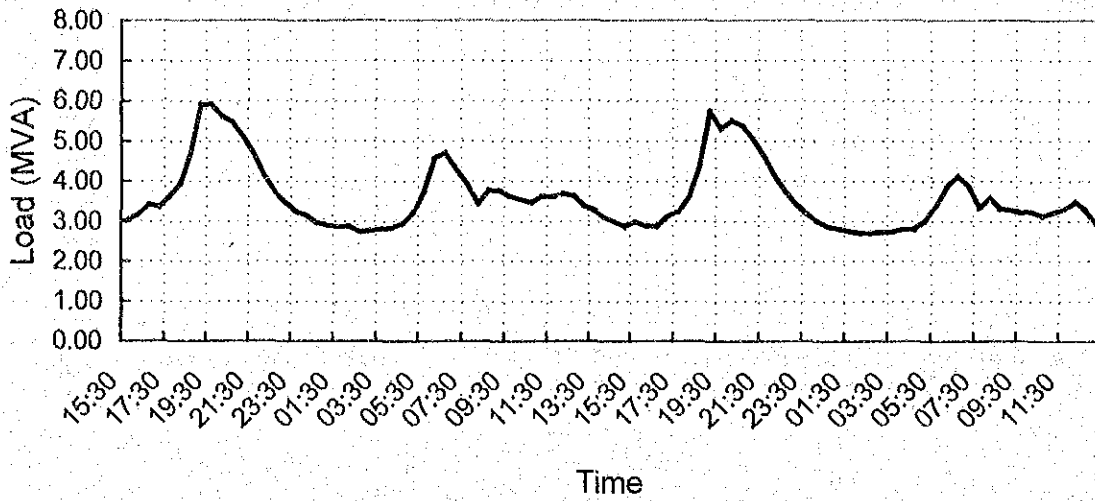
Fig.5.3.2 Measured Load Record of Trade School S/S

TRADE SCHOOL SS LOAD (Sep. 13 to 15, 2001)
