**Perspective**  
The Project for Rehabilitation of  
Floating Pump Stations in Upper Egypt  
(Phase )  
Arab Republic of Egypt

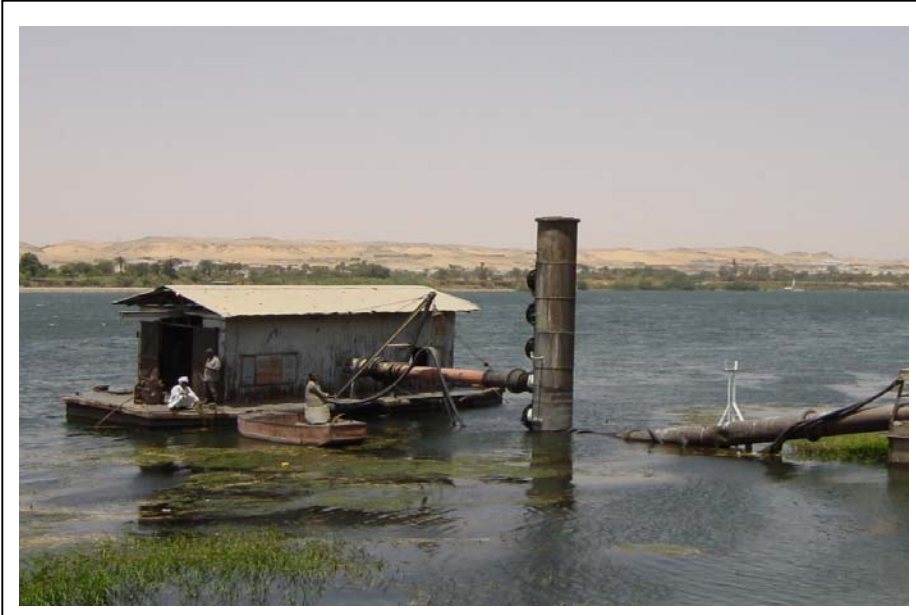
**No.22 Sahel Alakaba Kebli**

View of the existing floating pump station, discharge tower, connection pipe and discharge pipe. Pump operator moves by small ship.

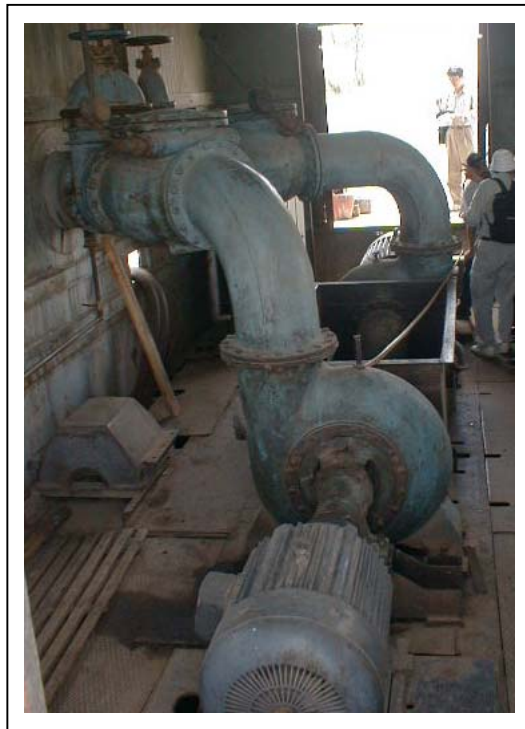
**No.22 Sahel Alakaba Kebli**

Inside view of pump station and its facilities. Steel box at the center is the suction sump.

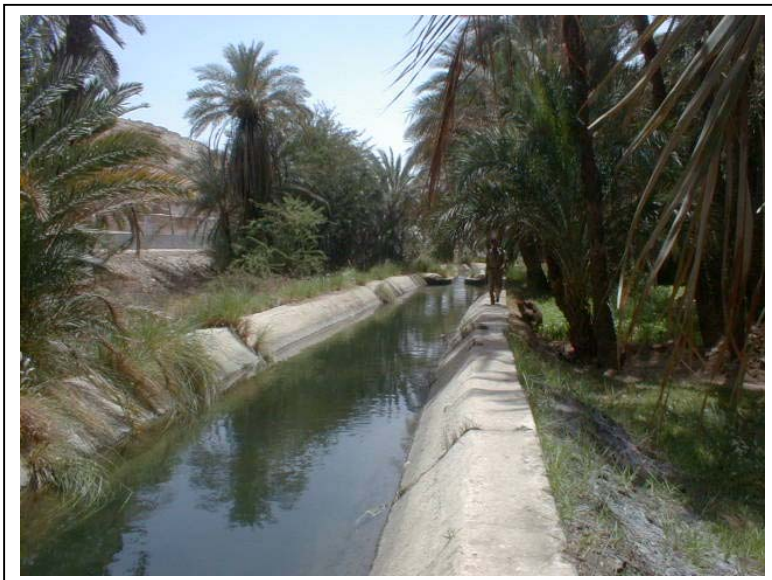
**No.22 Sahel Alakaba Kebli**

View of the main canal connected with the discharge sump of the pump station. Upstream of the canal is lined by concrete. Many Meska canals are directly connected to this canal.

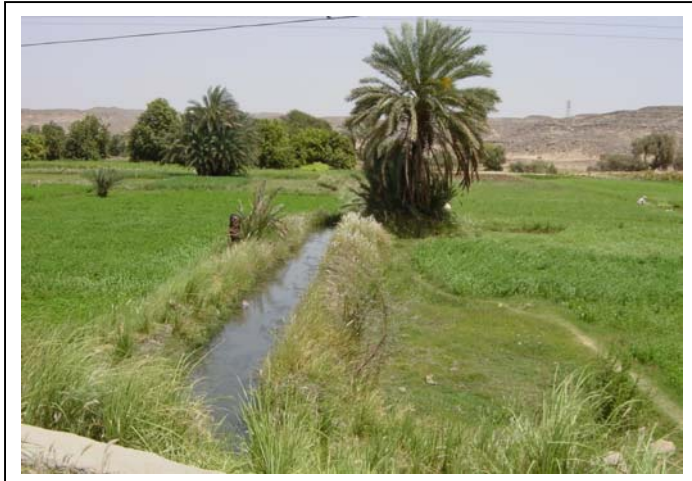
**No.22 Sahel Alakaba Kebli**

Beneficial area planted with Berseem clover. Mangoes and dates are also planted. Expansion area is seen in the back.

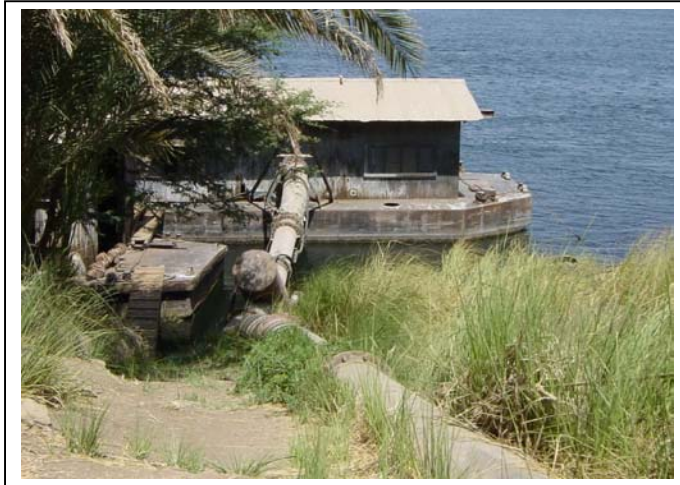
**No.23 Al Rakikin Sahel**

View of floating pump station, connection pipe and discharge pipe. Discharge tower is inclined-type.

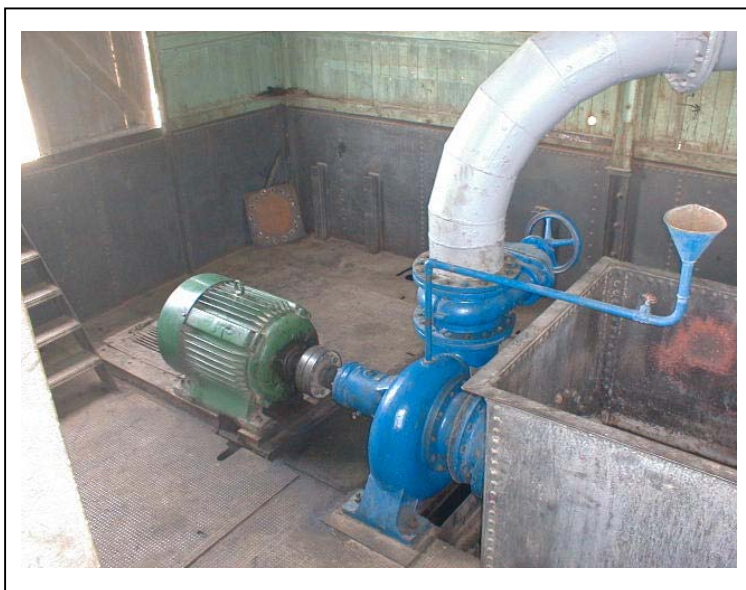
**No.23 Al Rakikin Sahel**

View of inside floating pump station. Pump, motor and discharge pipe are re-painted. The steel box at right is the suction sump.

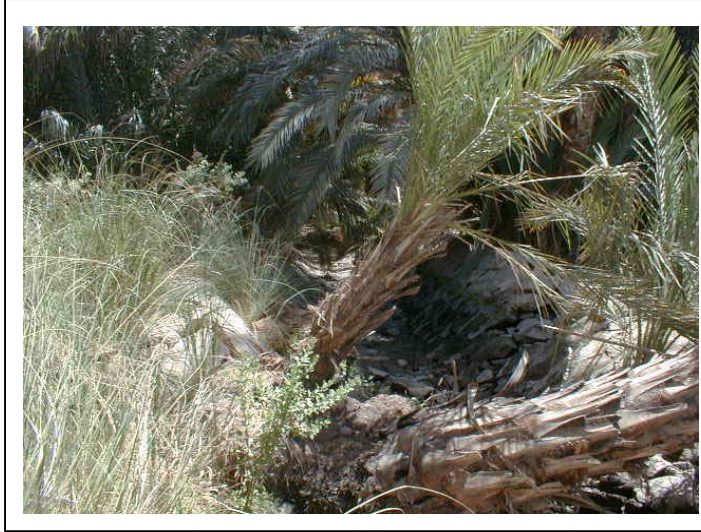
**No.23 Al Rakikin Sahel**

Main canal connected with the discharge sump, which is lined with stone masonry up to about 10m from the discharge sump but downstream is earth canal.

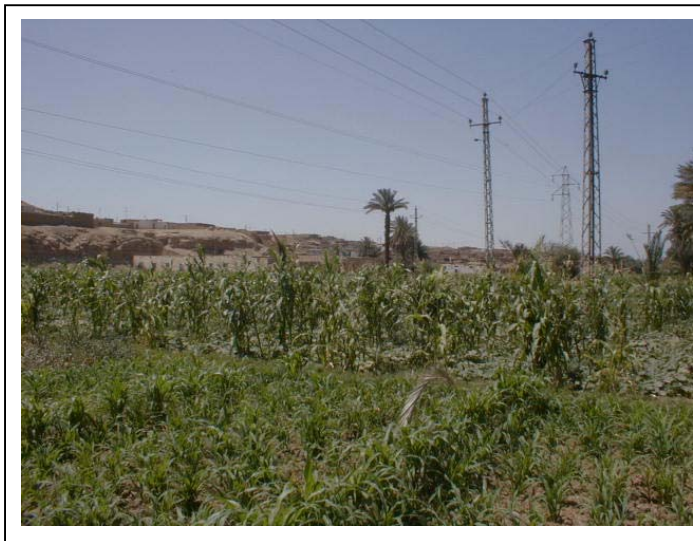
**No.23 Al Rakikin Sahel**

Irrigation area is located along the Nile River with 80m to 100m in width, and pump station at the middle. Photo shows the irrigation area near the pump station.

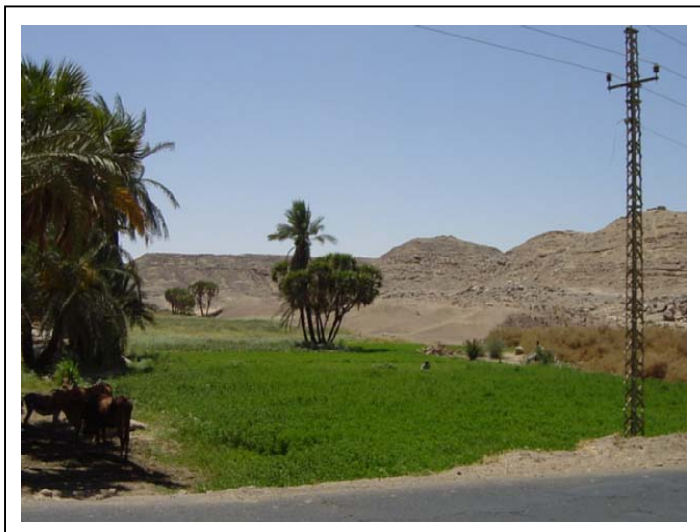
**No.23 Al Rakikin Sahel**

The irrigable area is limited because of topographic condition, and small area located at rocky hills is also an important cultivable area.

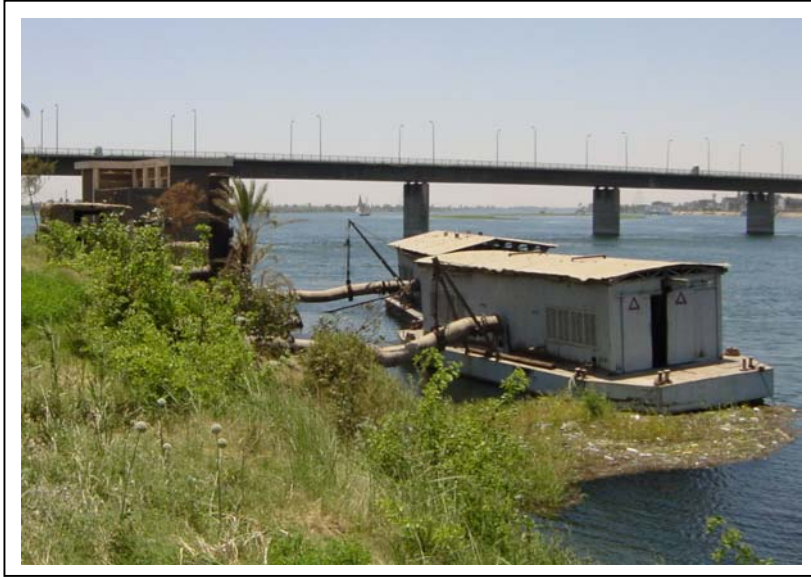
### No.24 Blowkher

There are two existing floating pump stations with the capacity of  $0.75 \text{ m}^3/\text{s} \times 2$  units (front), and  $0.35 \text{ m}^3 \times 2$  units (back). In addition, fixed-type pump station exists at left. The Edfu Bridge (back).

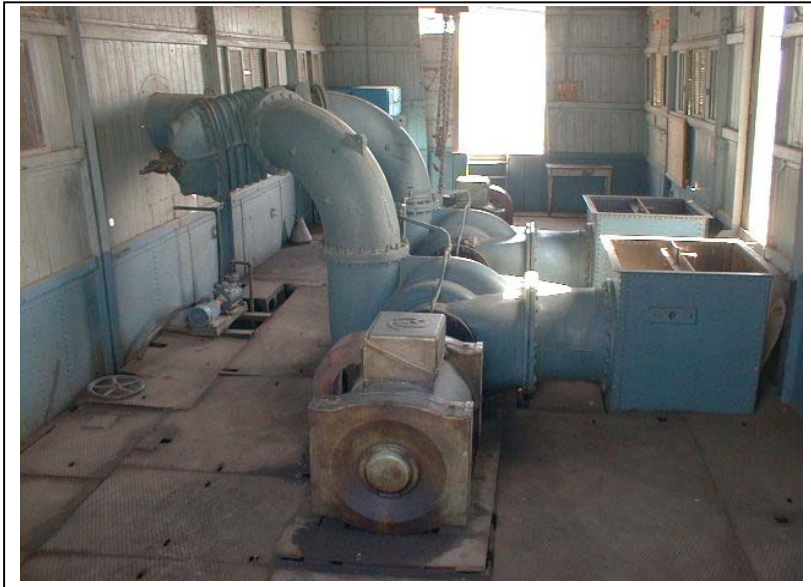
### No.24 Blowkher

Inside view of the existing floating pump station (capacity:  $0.75 \text{ m}^3/\text{s} \times 2$  units).

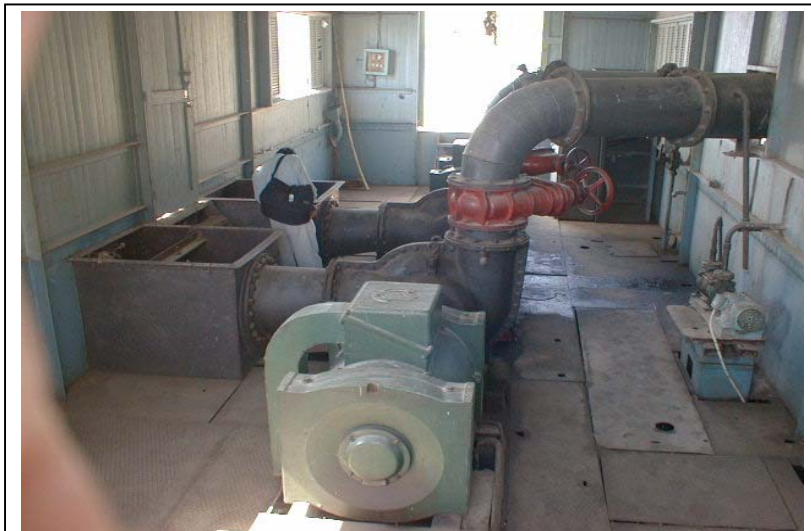
### No.24 Blowkher

Inside view of the existing floating pump station (capacity:  $0.35 \text{ m}^3/\text{s} \times 2$  units).

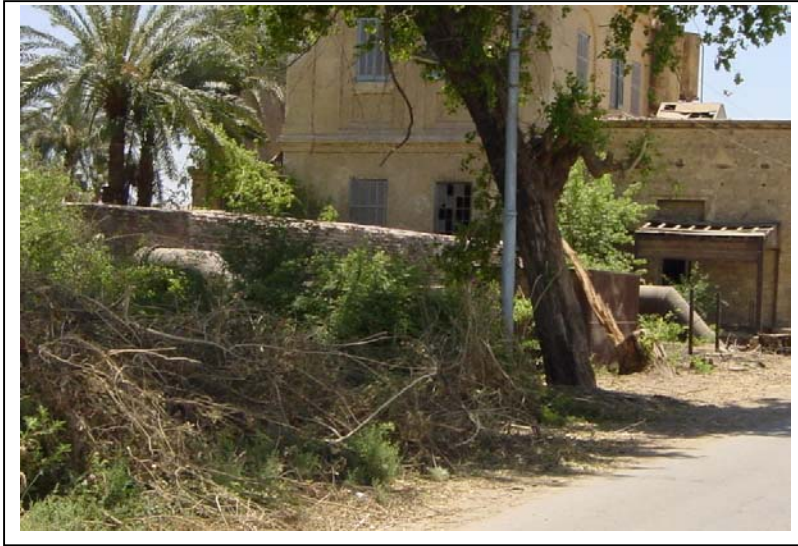
**No.24 Blowkher**

View of the brick-made discharge sump, which inside is lined with concrete.

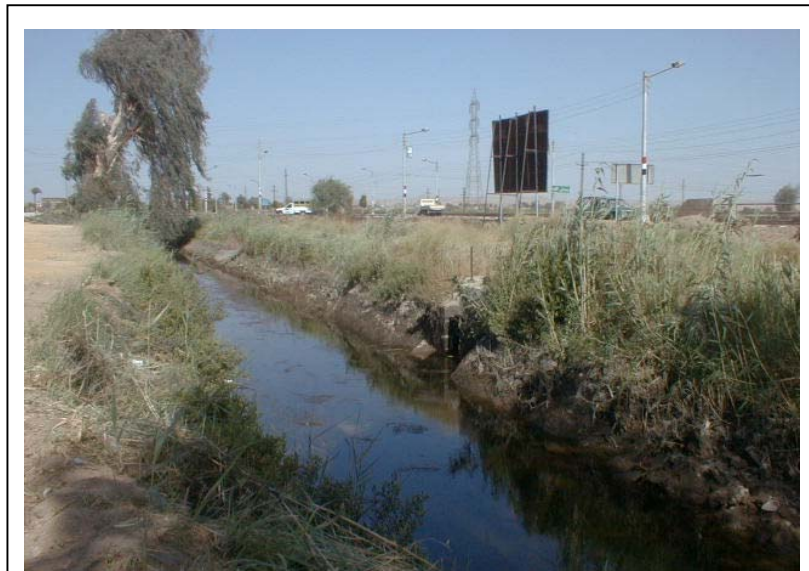
**No.24 Blowkher**

Branch canal flowing down along road connected with the Edfu Bridge, which is lined with stones.

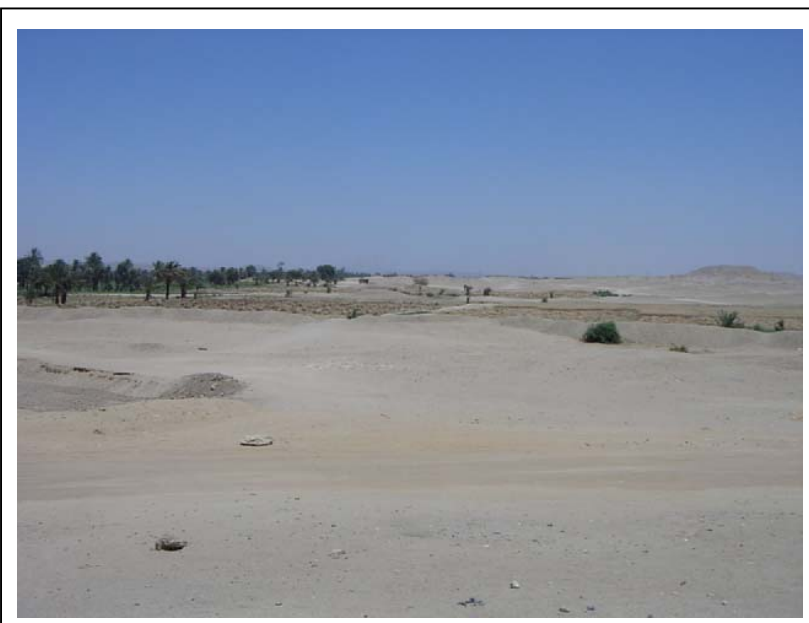
**No.24 Blowkher**

View of a part of the expansion area, which is partly reclaimed using a little water of a drainage canal.

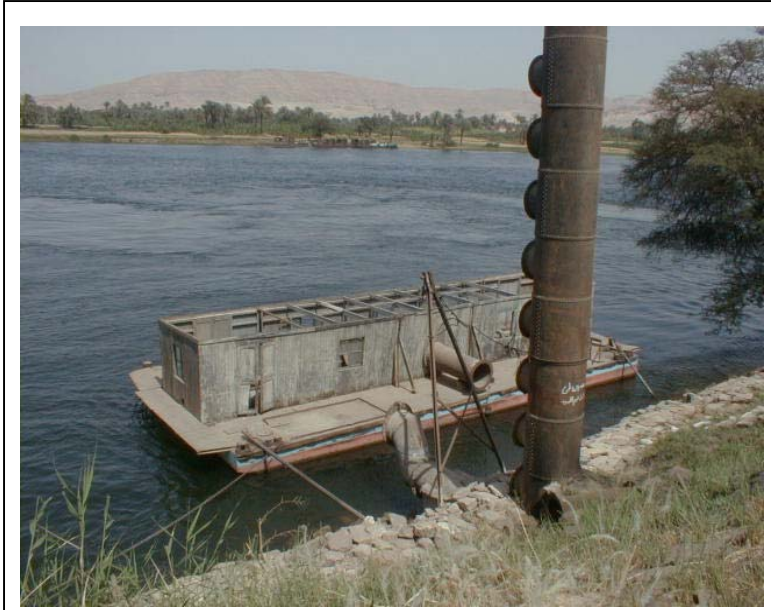
**No.25 El Ghorera**

Abandoned floating pump station. Pump, motor and pipe are deteriorated.

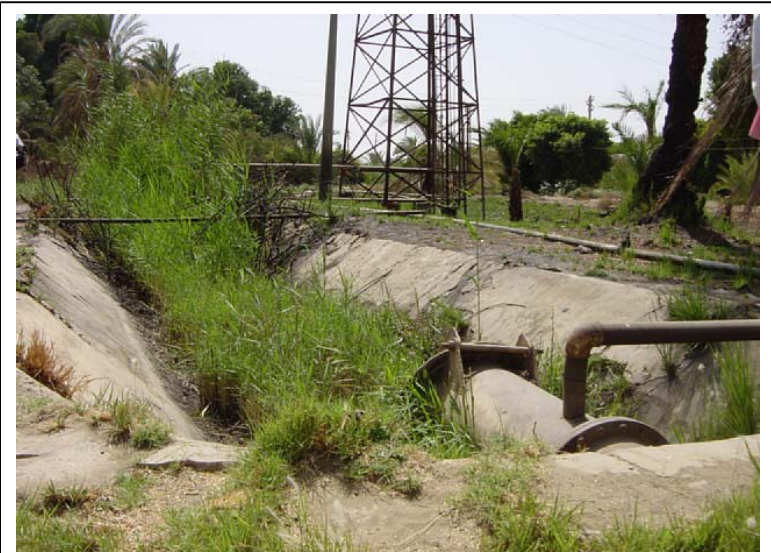
**No.25 El Ghorera**

View of the discharge sump and canal.

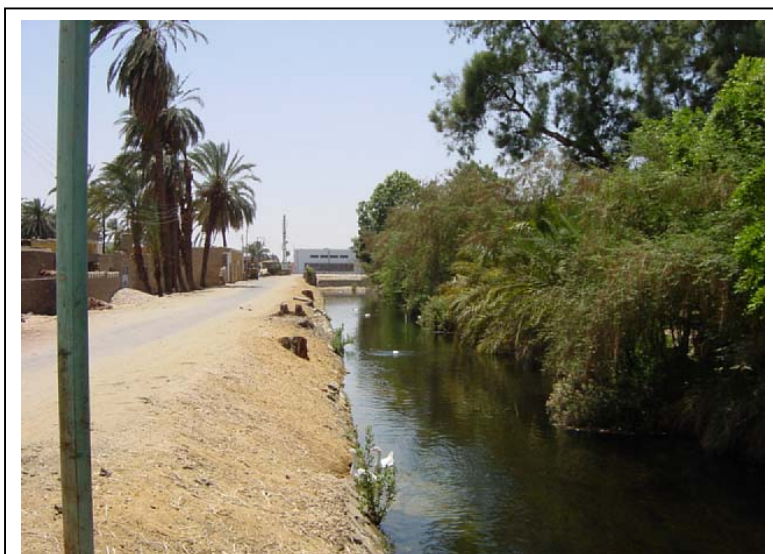
**No.25 El Ghorera**

View of the downstream of the main canal connected with the pump station. Water discharged from the fixed-type pump station (0.5m<sup>3</sup>/s x 3 units) is flowing. The fixed-type pump station of Ghorera • Asfun(back) located along the Asfun canal. The main canal turns to right at the top.

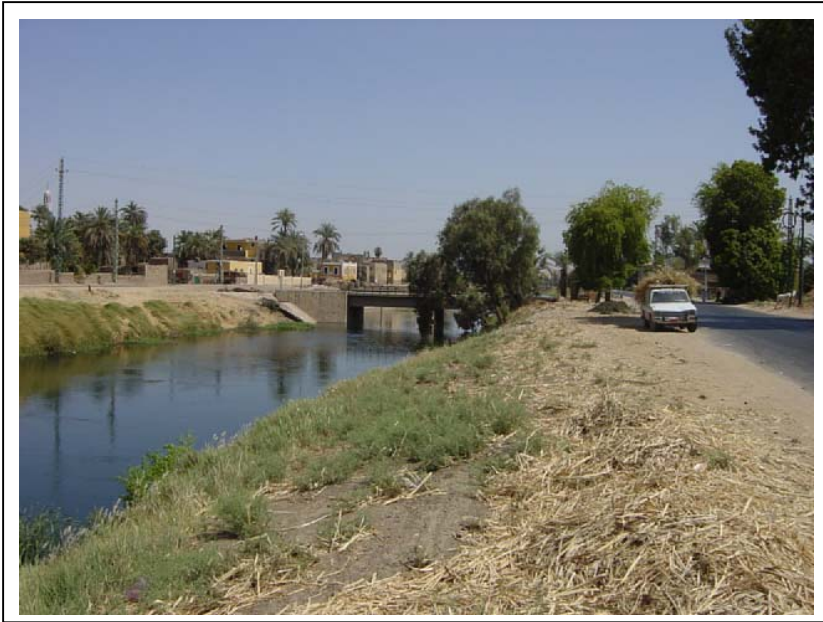
**No.25 El Ghorera**

View of the upstream of the Asfun canal, which has an intake at the Esna barrage.

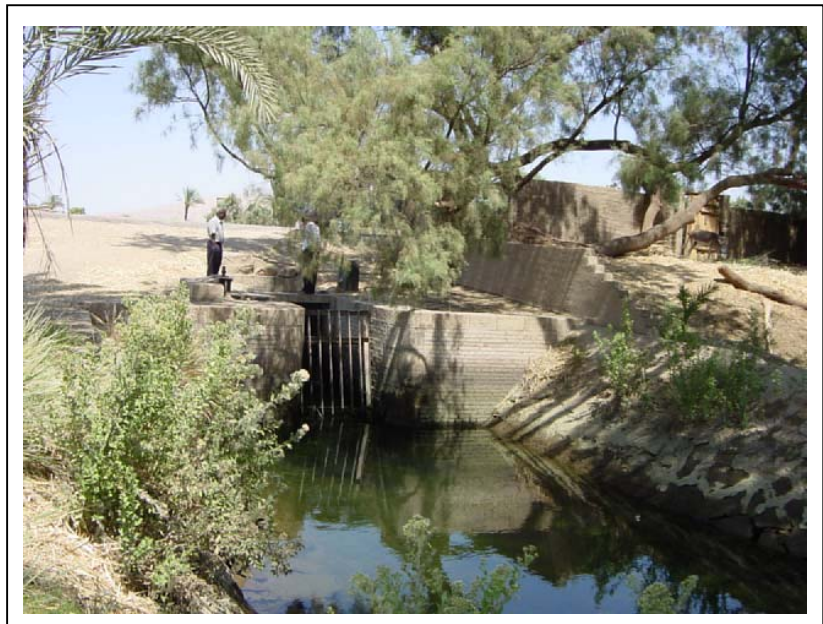
**No.25 El Ghorera**

Outlet of the siphon of the Asfun canal

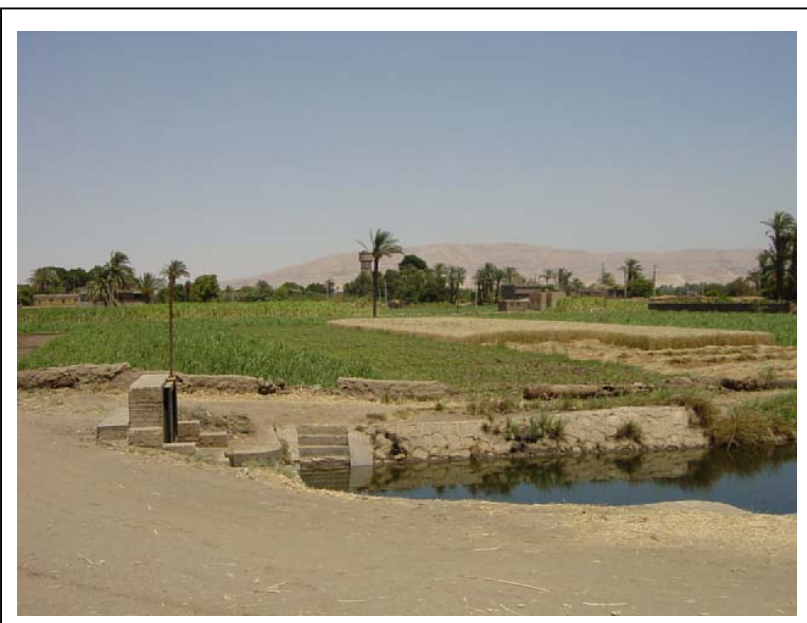
**No.25 El Ghorera**

View of the beneficial area and tail-end of the main canal. The canal is divided into two branch canals here, one to siphon to cross the Asfun canal

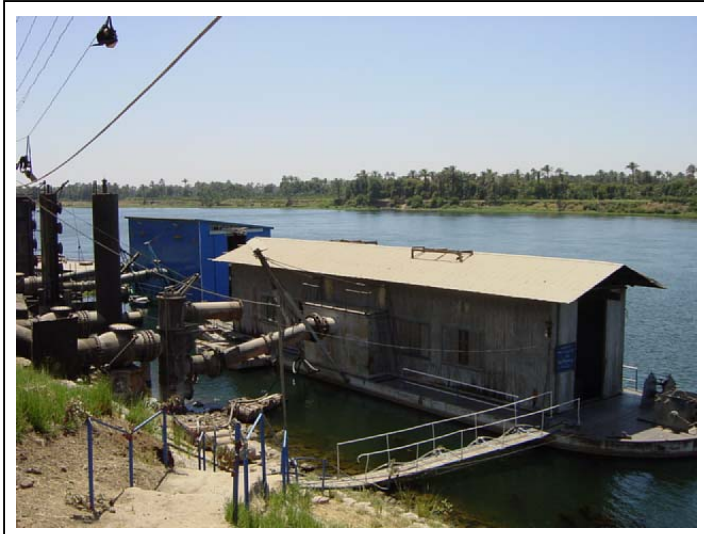
**No. 26 El Biadiea El Ollia**

View of the existing pump stations. The floating pump station installed by the grant aid of Japan (Phase 1) exists at the back.

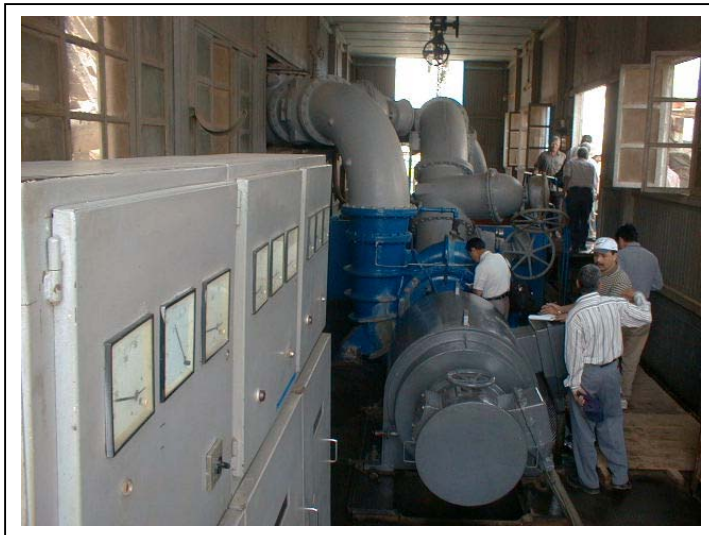
**No. 26 El Biadiea El Ollia**

Inside view of the existing floating pump station. Pump, motor, discharge pipe and control panel are seen. There are two units of pumping facilities, which can be operated with parallel and series operation, resulting in complicated discharge pipe system.

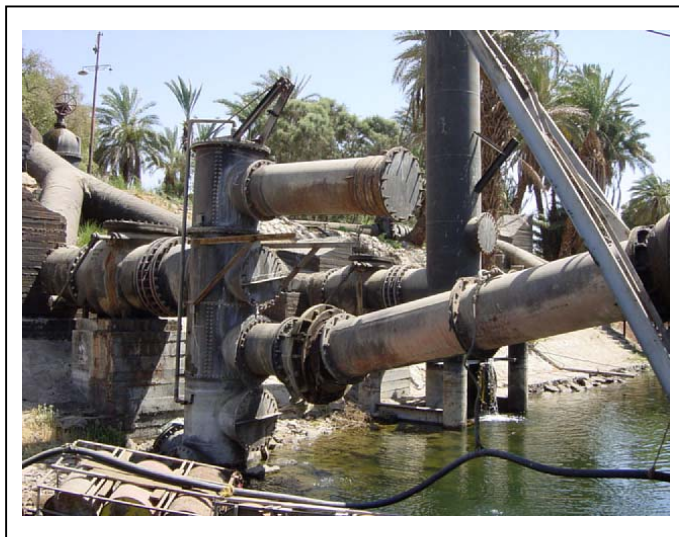
**No. 26 El Biadiea El Ollia**

View of the connection pipe and discharge tower.

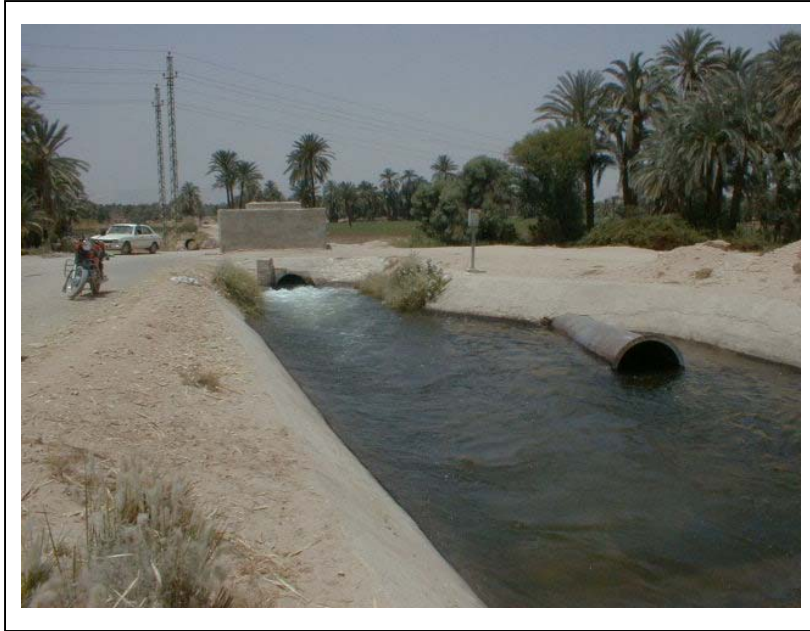
**No.26 El Biadiea El Ollia**

There are two type in canal system, namely, high main canal and low main canal in the area. The view is the discharge sump of the high main canal, which is discharged from the floating pump station in the length of about 1 km with steel pipe of 1.2m diameters. The pipe at right is the outlet of the discharge pipe from the fixed-type pump station.

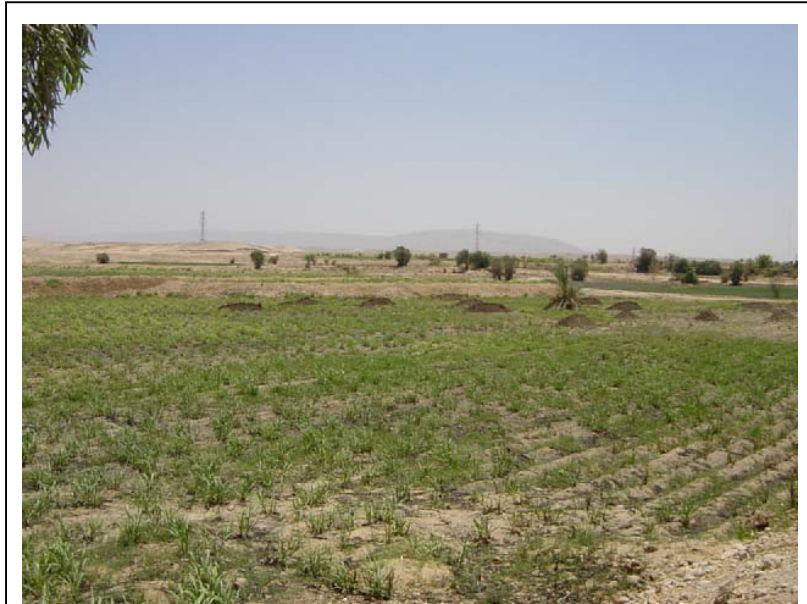
**No.26 El Biadiea El Ollia**

View of the area irrigated by the high main canal, which was reclaimed recently.

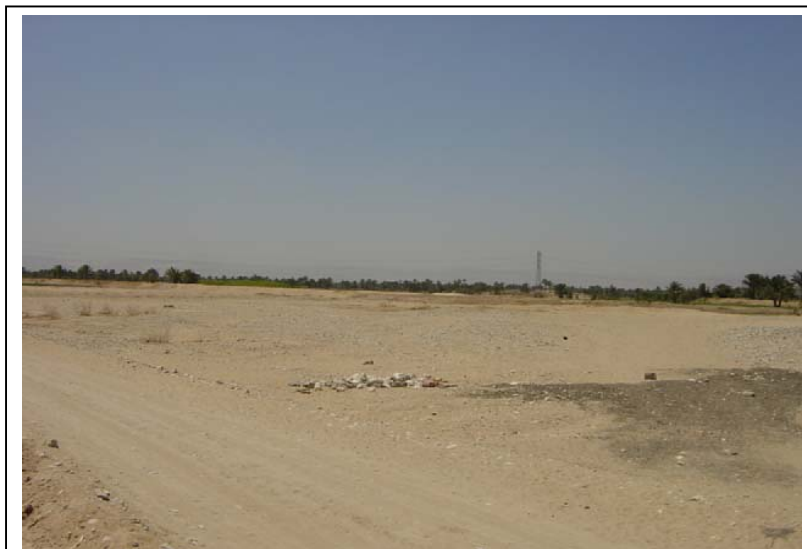
**No.26 El Biadiea El Ollia**

View of the expansion area, which is flood plain of small Wadi with flat topographic condition. Far view is the existing beneficial area.
