**Chapter 9.**  
**Evaluation of Urban Vulnerability**

### **9.1. Buildings**

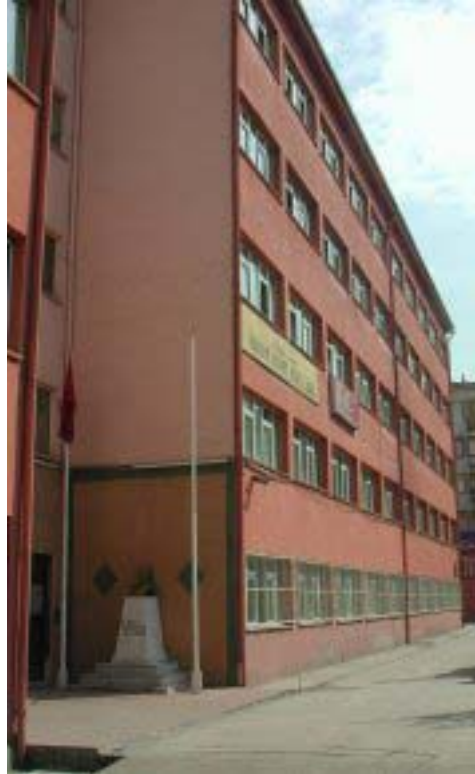
Photo 9.1.1 ÜSKÜDAR TİCARET MESLEK LİSESİ

The lowest  $I_s$  value of each investigated buildings at 1st story are 0.108 for Üsküdar Ticaret Meslek Lisesi and 0.189 for Hazerfen Ahmet Çelebi İlköğretim Okulu. Therefore, it is possible that these buildings may collapse or heavily damage under the condition of 1992 Erzincan Earthquake. It is easily presumed that almost all the school buildings may have

- The story that was designed as a basement was made as 1st story by unknown reason. It means that it is similar to the building with added stories after completion of construction illegally. Nevertheless, cross section of the columns and walls were not increased appropriately. Therefore, the  $I_s$  value of the buildings is lower than the value that is required to endure the earthquake motion similar to 1992 Erzincan Earthquake. If the 1st story of Hazerfen Ahmet Çelebi İlköğretim Okulu was constructed as the basement as of original drawing and water leakage is not observed,  $I_s$  value increase from 0.189 to 0.429. This assumption means that Hazerfen Ahmet Çelebi İlköğretim Okulu could endure the earthquake similar to 1992 Erzincan Earthquake, if the building constructed following original design and maintained carefully.

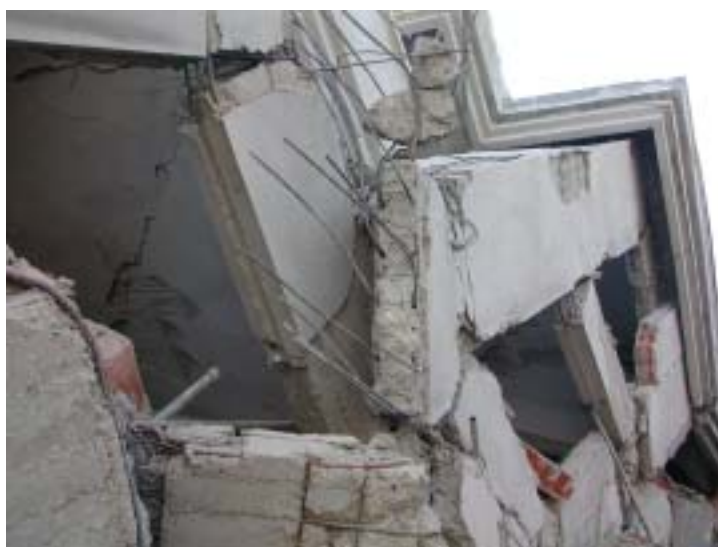
The re-bar is not connected appropriately through the story. This point has been designated as a reason why the collapse caused by failure of column-beam connection is predominant in Turkey. However, the evident collapse of this kind was observed even at 2002 AFYON Earthquake. This point out that problem in column-beam connection was not improved: nevertheless, brittleness of that part have been cautioned since 1992 Erzincan Earthquake.

If fixing of the stirrup end is insufficient, then bar may slip off, and column itself does not exert vertical load-carrying capacity.

**Photo 9.1.3 An Example of the Failure between the Column and the Beam**

Typical distruction mode of Turkish buildings is pulling out of re-bar in the column-beam connection because fixing of re-bar is not sufficient. So the textbook of seminar emphasize that the re-bar must be connected appropriately through the story. Steel plate jacketting of column was not observed in Istanbul area, but this method is introduced in textbook. Connecting by bolt through the story is recommended even the steel plate jacketting.

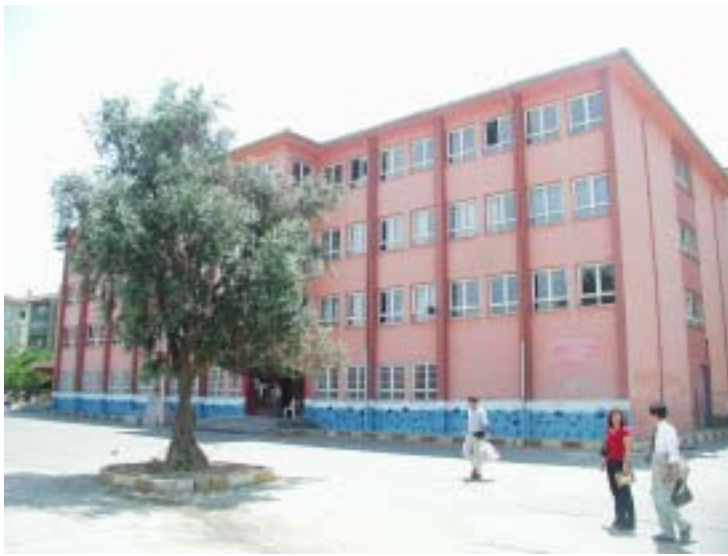
**Photo 9.2.1 Primary School: Large Floor Area (A) to Height (H) Ratio**

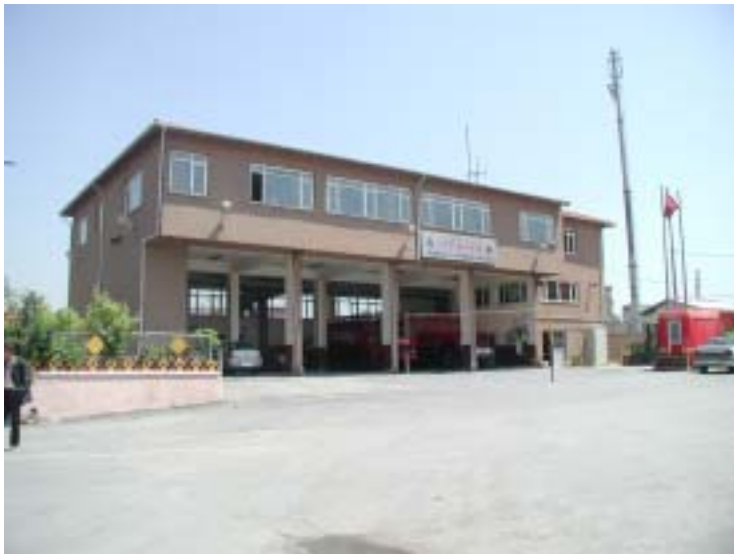
**Photo 9.2.2 Fire Fighting Station: Garage and Office within the Same Building**

The damage rate of the fire fighting facilities is 4% to 12% lower than that of all the buildings. It could be because the buildings are RC structured and lower than or equal to 3 stories. However, a fire fighter station inherits weak structure against earthquake: the first floor of the building as garage has only 3 walls and the rest is open to the street and the walls are made of bricks. The stations need to be evaluated for earthquake resistibility and strengthen.
