FEASIBILITY STUDY

CHAPTER 1
INVENTORY SURVEY FOR
PROJECT ROADS

1.2 Road Inventory Survey

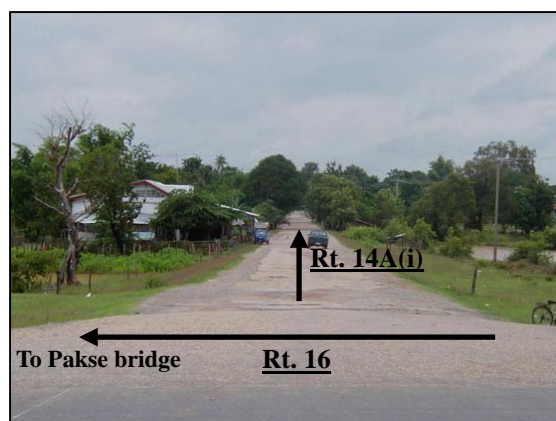
Figure 1.2.4 Present Status of Junction with Route 16

This section starts from Ban Houay Phek (i.e., the junction with Route 16) and ends at 25km point in Champasack Town Section. Figure 1.2.4 shows the starting point. Up until the 5.3 km mark, this section consists of a route that was a former provincial road. After that, the Study Team could not detect any sort of road structure fit for motorized vehicles. Thirty-three percent of this section length consists of road constructed via labor-based methods, while the other 67 % has no road structure to speak of. Furthermore, there are no bridge structures fit for motorized traffic.

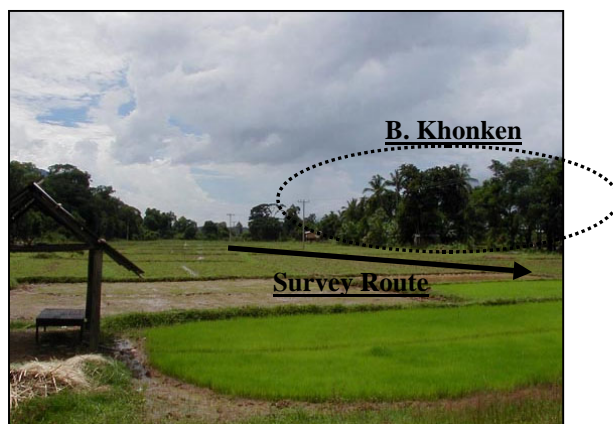
Figure 1.2.5 Survey Route behind Village (17.4km)

The villages on this section, of which there are seven, are shown in Table 1.2.2. The villages' names in brackets means that the survey route runs behind those villages (see Figure 1.2.5). This is because the existing road in some villages is too narrow (less than 2.0m), with houses located at the edge of the road, and the improvement of this road would require a large number of these houses to be removed. It is therefore recommended that these roads remain as they are and that the improving road alignment in these villages should detour the villages and access from these villages to the proposed road be provided.

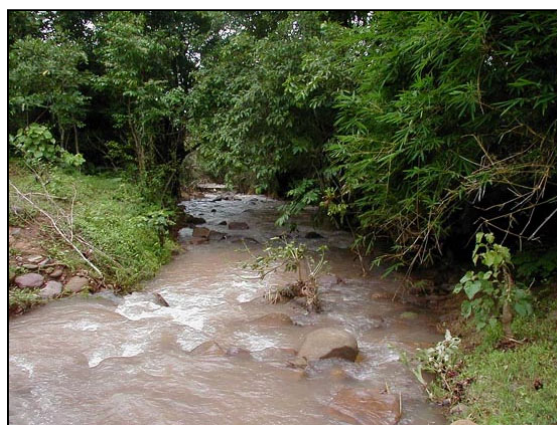
Figure 1.2.6 Mountain Stream (8.0km)

Large numbers of rivers and streams flow from mountains down to the area located between the 6.0 km and 13.0 km posts (see Figure 1.2.6). Especially, during the rainy season, these rivers and streams overflow and adequate drainage facilities should be designed.

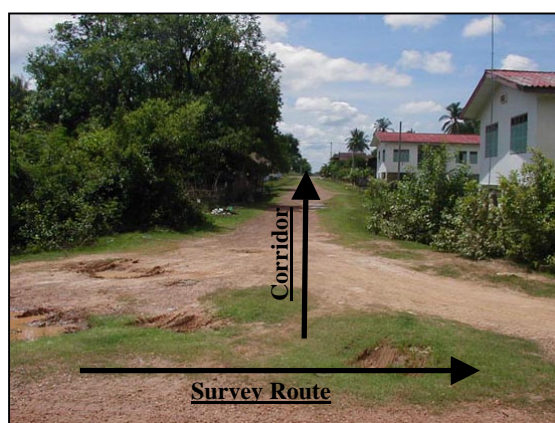
Figure 1.2.8 Access Road to Existing Route 14A (at 28.0km)

This section of the survey route is an existing farm road, and is located approximately 150m from existing Route 14A. There are 11 access roads (earth surface, average width is 3.5m) between the farm road and Route 14A (see Figure 1.2.8). This section is characterized by 2 sub-sections consisting of paddy fields (25km–27km) and a village (27km–29km). Typical cross sections for these 2 sub-sections are shown in Figure 1.2.9.

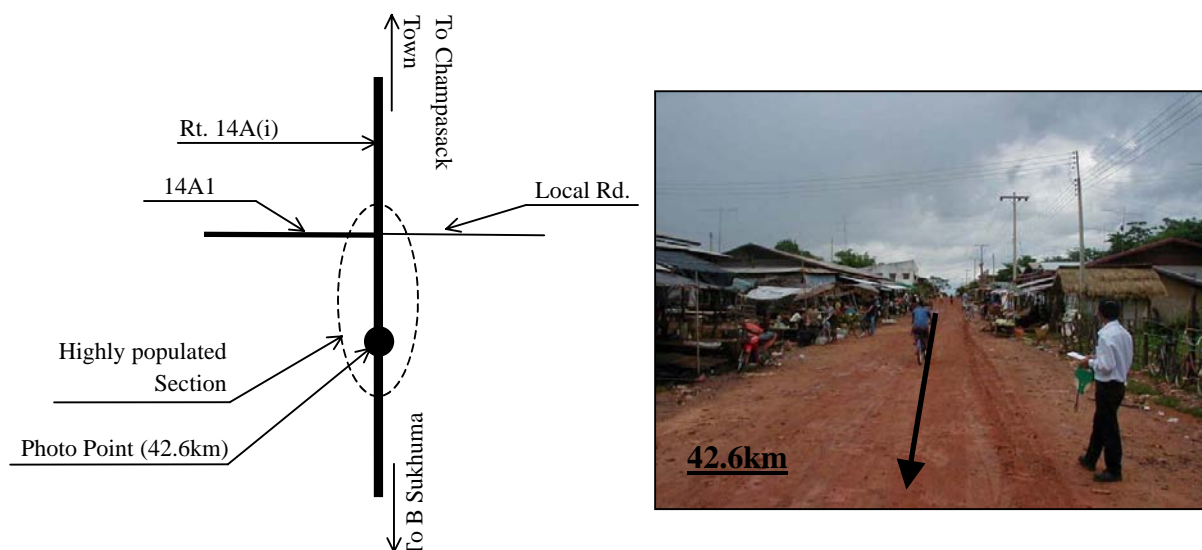
Figure 1.2.16 Sketch & Photograph of Ban Dontalat

This section of the survey route goes through the village of Ban Dontalat and road width is more than 4.5m. However, a large number of houses border the road without any clearance. These houses also seem rather costly as compared with average village houses. Furthermore, there is a local market and storehouses. Figure 1.2.16 shows a sketch and photograph of this section. Note that two classified roads (namely, Route 14A and Route 14A1) meet at this section (42.3 km). Figure 1.2.17 gives a view of the junction.

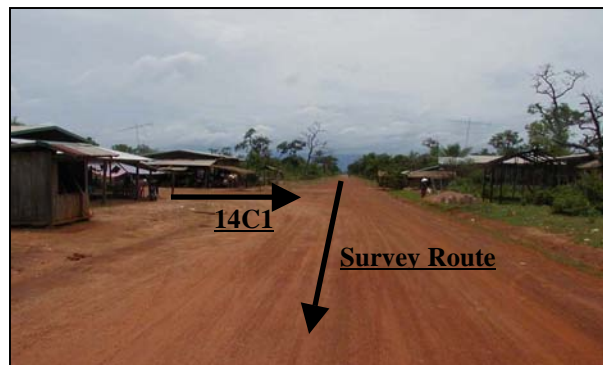
Figure 1.2.20 Present Status of Junction with Route 14C1 (at 55.55km)

There is a junction with Route 14C1 at the 55.55 km mark in Ban Samyak. Improvement of this junction should be considered in the design stage. Figure 1.2.20 shows the present state of the junction.

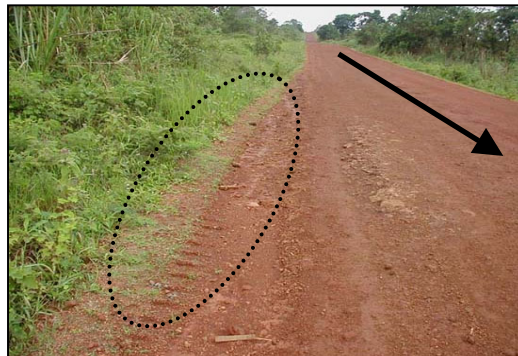
Surface roughness is evaluated as B (i.e. $40\text{km/h} < V$), in spite of there being no side ditches and rutting on both sides of the road. This condition is due to surface water flows that have eroded the surface (see Figure 1.2.24).

Figure 1.2.24 Damaged Surface – Rutting (at 2.0km)

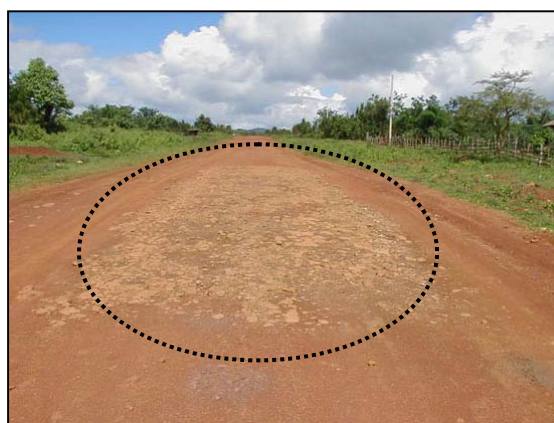
Road width is more than 4.5m on 89% of this section, and there are no side ditches. Surface roughness is evaluated as A and B, but some rutting and ravelling was found on the road surface and aggregate is visible on some portions of the road (see Figure 1.2.26). Based on the Road Design Manual, 97% of the terrain is designated as level and 3% as rolling. Residents of villages on this section are from a minority called ‘Lao Theuang’. They plant and harvest coffee beans to make their living. Twenty-nine percent of land-use is for coffee plantations and 46% is forests and bush .

Figure 1.2.26 Damaged Surface – Ravelling (at 8.9km)

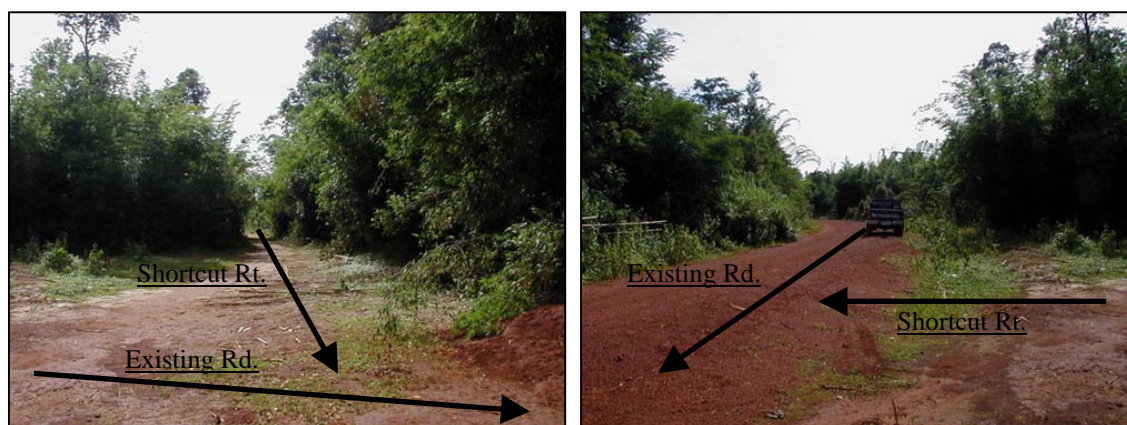
Figure 1.2.30 Present Status of Junction with Existing Road (42.2km)

Eighty percent of this section does not have a road structure and the other 20% is a very narrow road (less than 2.0m in width). Land-use consists namely of forest (88%) and coffee plantations (12%). Typical views of this section are shown in Figure 1.2.29. The survey route crosses 1 river (possibly a bridge is required) and 3 streams (possible culverts are required) on this section. The shortcut section joins up with existing road at the 42.2 km point. The present status of this junction is as shown in Figure 1.2.30.

The junction with the existing road should be improved to ensure sight distance and should be taken up in the design stage.

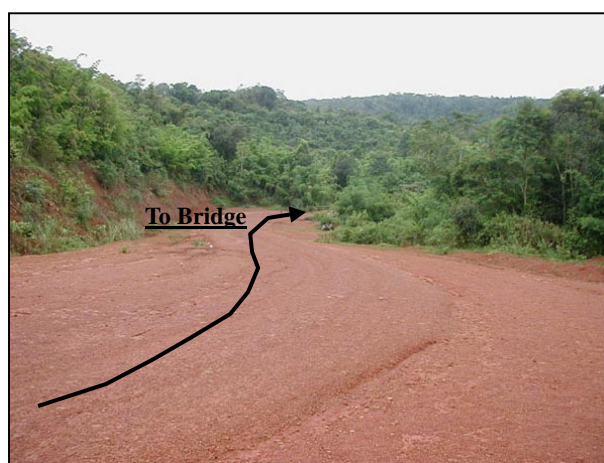
Figure 1.2.34 Present Status of Bridge Approach (10.3km)

Regarding the existing bridge between the 10.3 – 10.7 km mark, improvement to the vertical and horizontal alignments should be considered. Figure 1.2.33 shows the layout of the existing bridge approach and improved alignment. A photograph indicating the present status of the bridge approach is shown in Figure 1.2.34.

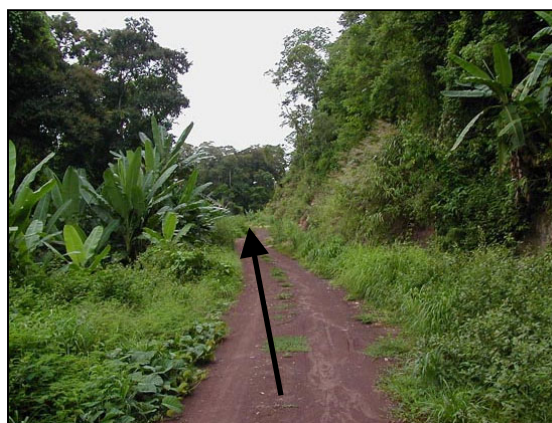
Figure 1.2.36 Typical Cross Section on Steep Mountain Section (at 53.9km)

The present road structure of this section is inadequate for heavy traffic or high-speed travel. Road width is less than 4.5m over 88% of the section, and the horizontal and vertical alignment does not ensure proper sight distance. A typical cross section of this section is shown in Figure 1.2.36.

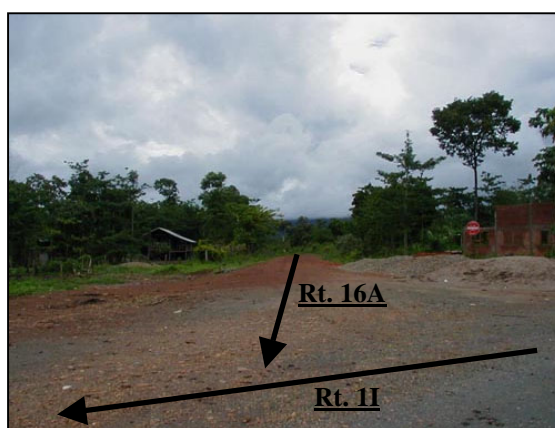
Figure 1.2.40 Present Status of Jct. with Route 1I (64.5km)

The survey route ends at the junction with Route 1I at Ban Lak 52. Structural improvement for the junction should be discussed in the design stage. Figure 1.2.40 shows the present status of the junction.
