ANNEXES FOR FEASIBILITY STUDY

ANNEX F-1

**SUMMARY OF PRESENT CONDITION OF
SURVEY ROUTE**

BRIDGE INVENTORY SURVEY DATA

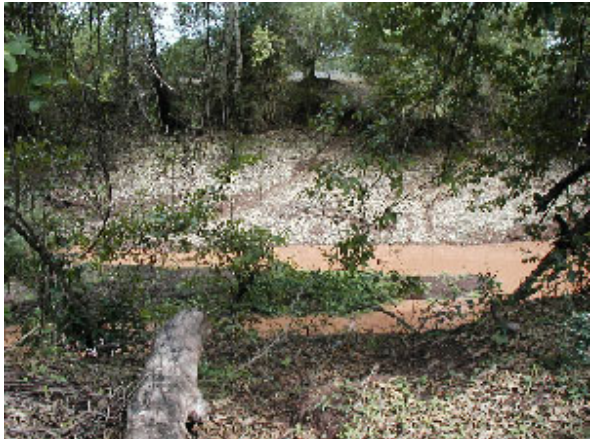
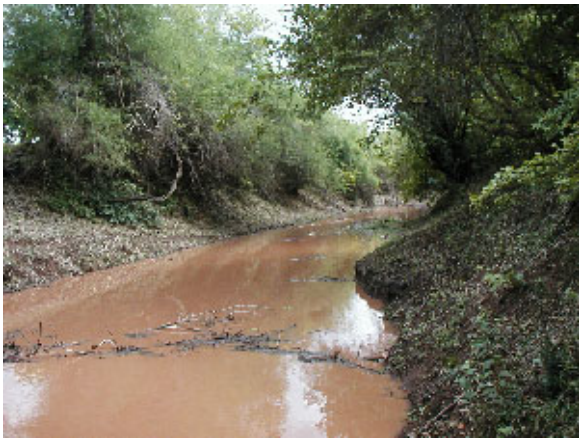
Route : 14A(i)	Km Post: 5+390 m	Village Name: Ban Natakou	
Bridge or River Name: 1 Houy Thok River			
Existence of Bridge:	Yes / No	Within or Outside of Village: Within / Outside	
Existing Bridge Condition	Bridg Length.(m):	Span Arrangement(m):	
	Carriageway & Pede. Width(m):		
	Superstructure type:	Load Capacity(t):	
	Girder Description:		
	Substructure Type:	Pier: Abutment:	
	Protection Work:		
	Damage Condition	Girder:	
		Slab:	
		Substructure:	-
		Bank Protection:	
	Others: -		
River Condition	Yearly Low Water Level(m): No water	Yearly High Water Level (m): GL+0.0	
	Highest Water Level(m): GL+1.5m(1978)	River Width(m): 22 m	
	Riverbed Material: Silt	Gradient: 1/1000 (V=0.2m/s Existing)	
	Height between Riverbed and Riverbanks: 6 m		
Surrounding Conditions	Land Use: Agricultural field	No. Houses Affected: Noting	
	UXO: Not reported		
Other Info.	-A proposed bridge site will be affected by backwater from Mekong. - The highest water level is reported in 1978

Comments	-Since the river is meandering, alignment should be set at the point which the river channel is stable and flood water level is relatively high. - New alignment will be set at north side of the village to avoid relocation of houses

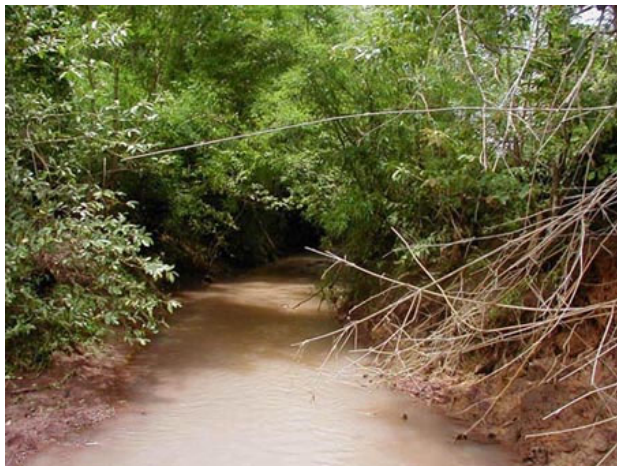
Route : 14A(i)	Km Post: 7+450 m	Village Name: Ban Nonghoy	
Bridge or River Name: 2 Huay Maknao River			
Existence of Bridge:	Yes / No	Within or Outside of Village: Within / Outside	
Existing Bridge Condition	Bridg Length.(m):	Span Arrangement(m):	
	Carriageway & Pede. Width(m):		
	Superstructure type:	Load Capacity(t):	
	Girder Description:		
	Substructure Type:	Pier: Abutment:	
	Protection Work:		
	Damage Condition	Girder:	
		Slab:	
		Substructure:	-
		Bank Protection:	
	Others: -		
River Condition	Yearly Low Water Level(m): No water	Yearly High Water Level (m): 1.5m	
	Highest Water Level(m):	River Width(m): 5m	
	Riverbed Material: Silt	Gradient: 1/1000	
	Height between Riverbed and Riverbanks: 2 m		
Surrounding Conditions	Land Use: Agricultural field	No. Houses Affected: Noting	
	UXO: Not reported		
Other Info.	- No affection of backwater from Mekong River		
Comments	- Box culvert shall be appropriate for this crossing point in consideration with narrow river width and low river height.

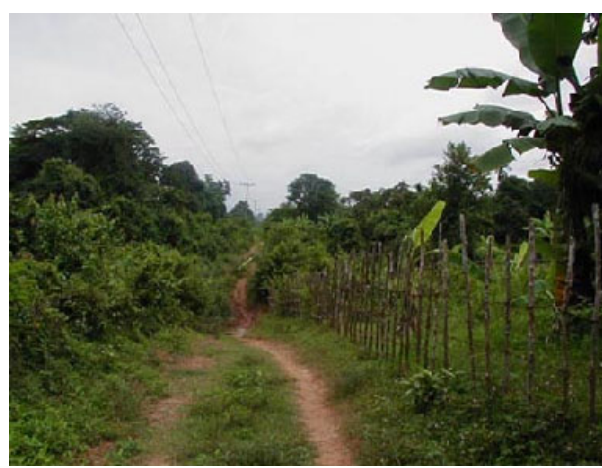
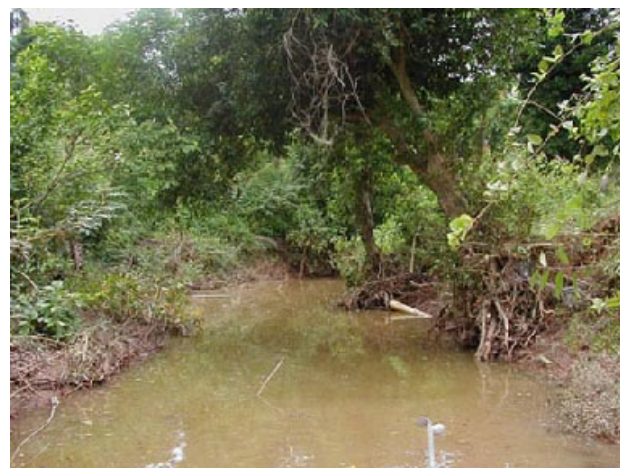
Route :14A(i)	Km Post: 7+950 m	Village Name: -	
Bridge or River Name: 3 Huay Namsan River			
Existence of Bridge:	Yes / No	Within or Outside of Village: Within / Outside	
Existing Bridge Condition	Bridg Length.(m):	Span Arrangement(m):	
	Carriageway & Ped. Width(m):		
	Superstructure type:	Load Capacity(t):	
	Girder Description:		
	Substructure Type:	Pier: Abutment:	
	Protection Work:		
	Damage Condition	Girder:	
		Slab:	
		Substructure:	-
		Bank Protection:	
Others: -			
River Condition	Yearly Low Water Level(m): No water	Yearly High Water Level (m): 1.5m	
	Highest Water Level(m): not available	River Width(m): 8m	
	Riverbed Material: Silt	Gradient: 1/1000	
	Height between Riverbed and Riverbanks: 2 m		
Surrounding Conditions	Land Use: agricultural area	No. Houses Affected: Noting	
	UXO: Not reported		
Other Info.	- Little affection of backwater from Mekong River		
Comments	- Box culvert shall be appropriate for this crossing point in consideration with narrow river width and lower HWL.

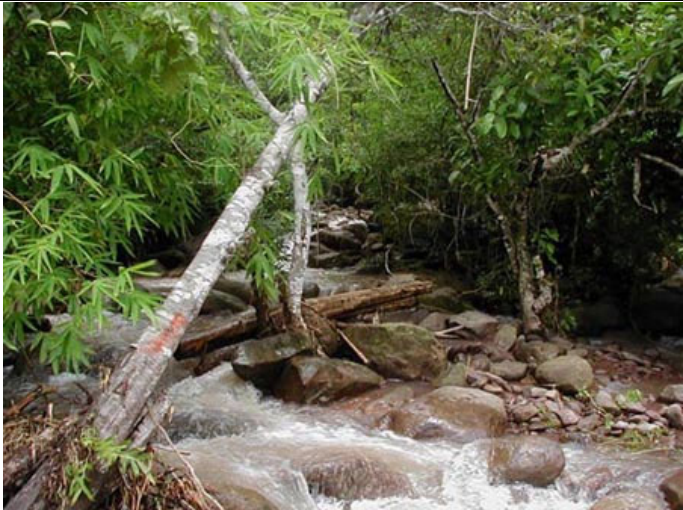
Route : 14A(i)	Km Post: 9+480 m	Village Name: -	
Bridge or River Name: 7: No name			
Existence of Bridge:	Yes / No	Within or Outside of Village: Within / Outside	
Existing Bridge Condition	Bridge Length.(m):	Span Arrangement(m):	
	Carriageway & Ped. Width(m):		
	Superstructure type:	Load Capacity(t):	
	Girder Description:		
	Substructure Type:	Pier: Abutment:	
	Protection Work:		
	Damage Condition	Girder:	
		Slab:	
		Substructure:	-
		Bank Protection:	
	Others: -		
River Condition	Yearly Low Water Level(m): No water	Yearly High Water Level (m): 0.5m	
	Highest Water Level(m): 1.0m	River Width(m): 8m	
	Riverbed Material: boulders	Gradient: 1/20	
	Height between Riverbed and Riverbanks: 1.0 m		
Surrounding Conditions	Land Use: bush	No. Houses Affected: Nothing	
	UXO: Not reported		
Other Info.	- No affection of backwater from Mekong River		
Comments	- Box culvert shall be appropriate at this crossing point in consideration with narrow river width and lower HWL.

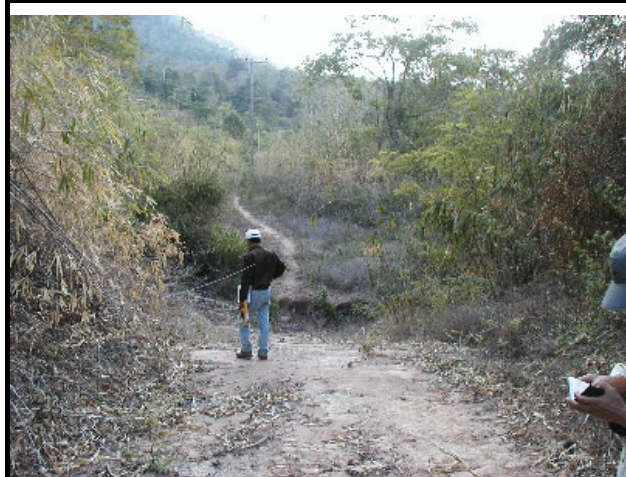
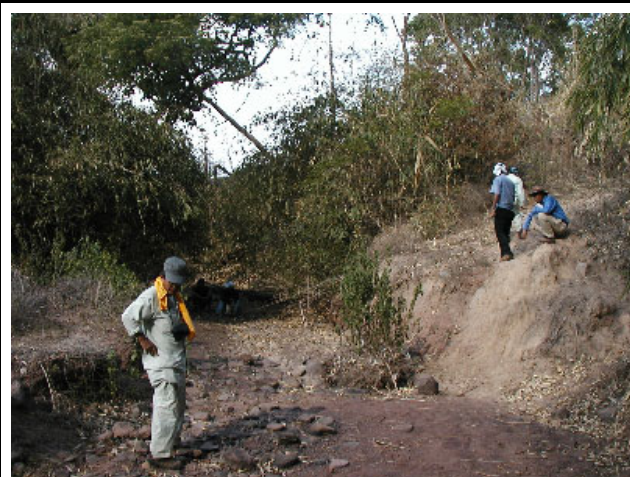
Route : 14A(i)	Km Post:	Village Name: -	
Bridge or River Name: 8 Huay Imet (Nangnam) River			
Existence of Bridge:	Yes / No	Within or Outside of Village: Within / Outside	
Existing Bridge Condition	Bridg Length.(m):	Span Arrangement(m):	
	Carriageway & Ped. Width(m):		
	Superstructure type:	Load Capacity(t):	
	Girder Description:		
	Substructure Type:	Pier: Abutment:	
	Protection Work:		
	Damage Condition	Girder:	
		Slab:	
		Substructure:	-
		Bank Protection:	
Others: -			
River Condition	Yearly Low Water Level(m): 0 m	Yearly High Water Level (m):	
	Highest Flood Water Level(m):	River Width(m): 10 m	
	Riverbed Material: Boulders & sand	Gradient: 1/500	
	Height between Riverbed & River bank or Bridge Surface(m): 2m (LB), 5m(RB)		
Surrounding Conditions	Land Use: Forest & Bush	No. Houses Affected: No houses around river	
	UXO: Not Reported		
Other Info.	- Bedrock exposed at the right bank - The river menders near the proposed bridge site. Some branch stream come together?

Comments	-The bridge length should be carefully examined based on hydrological analysis. - The crossing point should be also carefully examined considering the stability of the channel.

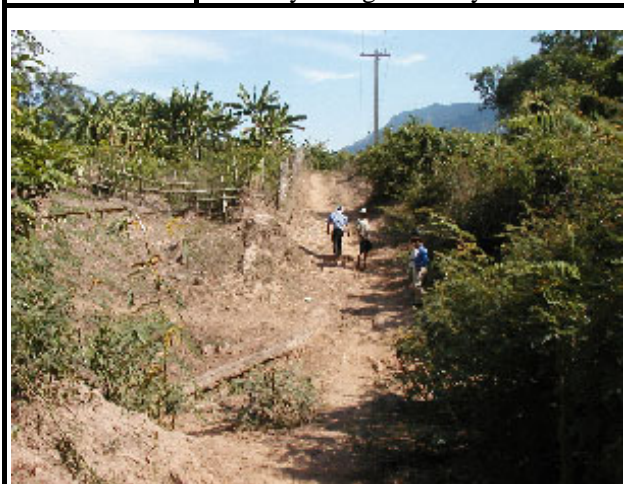
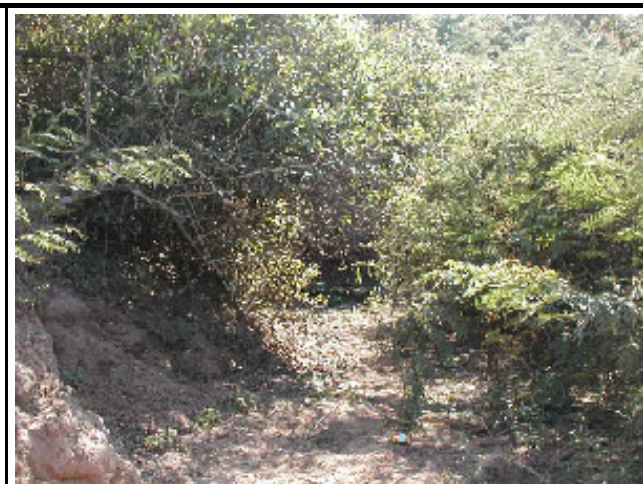
Route : 14A(i)	Km Post: 13+630m	Village Name: B Houapakho	
Bridge or River Name: 11 Huay Thakhong River			
Existence of Bridge:	Yes / No	Within or Outside of Village: Within / Outside	
Existing Bridge Condition	Bridg Length.(m):	Span Arrangement(m):	
	Carriageway & Pede. Width(m):		
	Superstructure type:	Load Capacity(t):	
	Girder Description:		
	Substructure Type:	Pier: Abutment:	
	Protection Work:		
	Damage Condition	Girder:	
		Slab:	.
		Substructure:	-
		Bank Protection:	
	Others: -		
River Condition	Yearly Low Water Level(m): 0 m	Yearly High Water Level (m): RB+3-4m	
	Highest Water Level(m): RB+5m (2000)	River Width(m): 30 m	
	Riverbed Material: Silt	Gradient: 1/1000	
	Height between Riverbed & River bank or Bridge Surface(m): 4.8 m		
Surrounding Conditions	Land Use: Agricultural Use(banana trees)	No. Houses Affected: Nothing	
	UXO: Not Reported		
Other Info.	-The water level at the crossing point will be affected by backwater from Mekong -The crossing point is located just north of the village.

Comments	- A bridge structure will be appropriate and the bridge level should be carefully examined based on the hydrological analysis

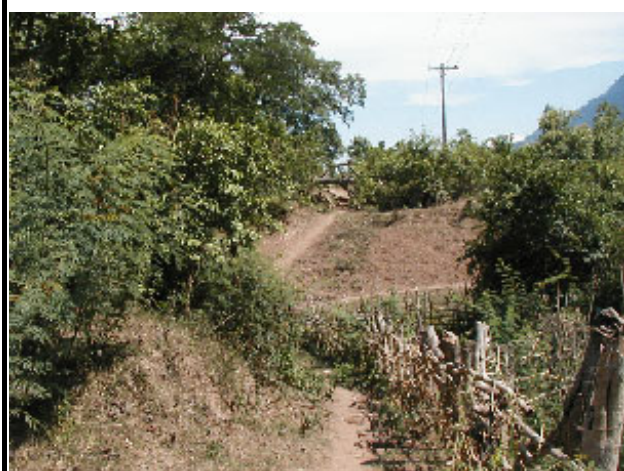
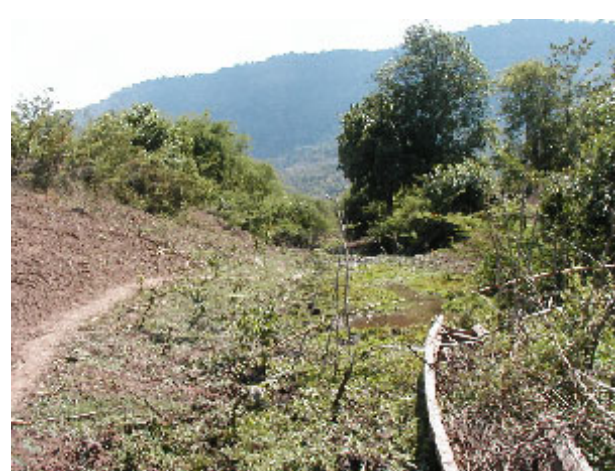
Route : 14A(i)	Km Post: 14+540m	Village Name: B Houapakho	
Bridge or River Name: 12 Huay Tabxan River			
Existence of Bridge:	Yes / No	Within or Outside of Village: Within / Outside	
Existing Bridge Condition	Bridg Length.(m):	Span Arrangement(m):	
	Carriageway & Pede. Width(m):		
	Superstructure type:	Load Capacity(t):	
	Girder Description:		
	Substructure Type:	Pier: Abutment:	
	Protection Work:		
	Damage Condition	Girder:	
		Slab:	.
		Substructure:	-
		Bank Protection:	
	Others: -		
River Condition	Yearly Low Water Level(m): 0.2 m	Yearly High Water Level (m): RB+3-4m	
	Highest Water Level(m): GL+0 (2000)	River Width(m): 40m	
	Riverbed Material: Silt	Gradient: 1/1000	
	Height between Riverbed & River bank or Bridge Surface(m): 4.7m		
Surrounding Conditions	Land Use: Agricultural Use	No. Houses Affected: Nothing	
	UXO: Not Reported		
Other Info.	-The water level at the crossing point will be affected by backwater from Mekong - A branch stream enters into this river just upstream side of the crossing point. - This river is located just south of the village, in which more than 500 residences live.

Comments	- The crossing point will be carefully examined considering the meeting point of the branch stream.

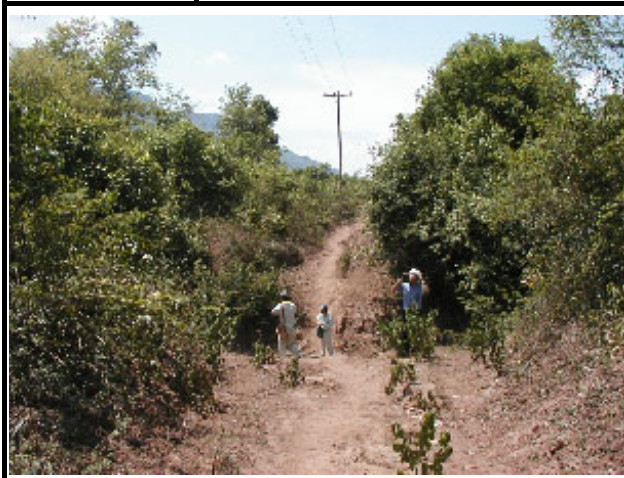
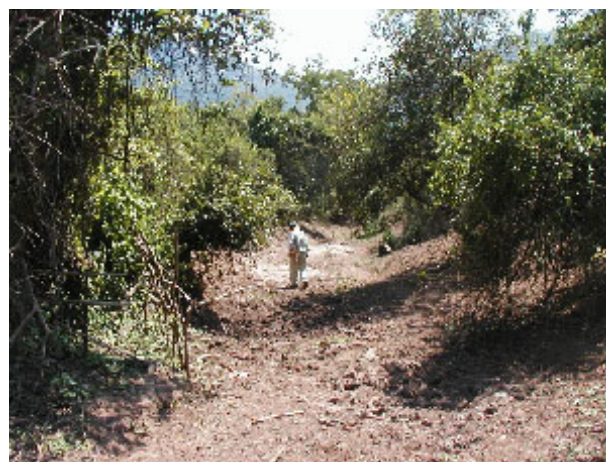
Route : 14A(i)	Km Post: 15+820m	Village Name: -	
Bridge or River Name: 13 Huay Khoneliao River			
Existence of Bridge:	Yes / No	Within or Outside of Village: Within / Outside	
Existing Bridge Condition	Bridg Length.(m):	Span Arrangement(m):	
	Carriageway & Pede. Width(m):		
	Superstructure type:	Load Capacity(t):	
	Girder Description:		
	Substructure Type:	Pier: Abutment:	
	Protection Work:		
	Damage Condition	Girder:	
		Slab:	.
		Substructure:	-
		Bank Protection:	
	Others: -		
River Condition	Yearly Low Water Level(m): 0 m	Yearly High Water Level (m):	
	Highest Water Level(m): RB+6m (2000)	River Width(m): 15-20 m	
	Riverbed Material: Bedrock & silt	Gradient: 1/1000	
	Height between Riverbed & River bank or Bridge Surface(m): 5 m		
Surrounding Conditions	Land Use: Bush & banana field	No. Houses Affected: Nothing	
	UXO: Not Reported		
Other Info.	- The water level at the crossing point will be affected by backwater from Mekong - Sandstone, bedrock, exposed at the riverbed.

Comments	- A bridge structure will be appropriate for this site.

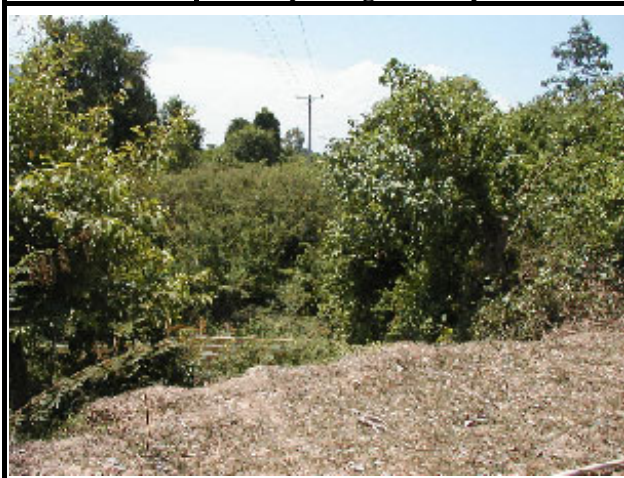
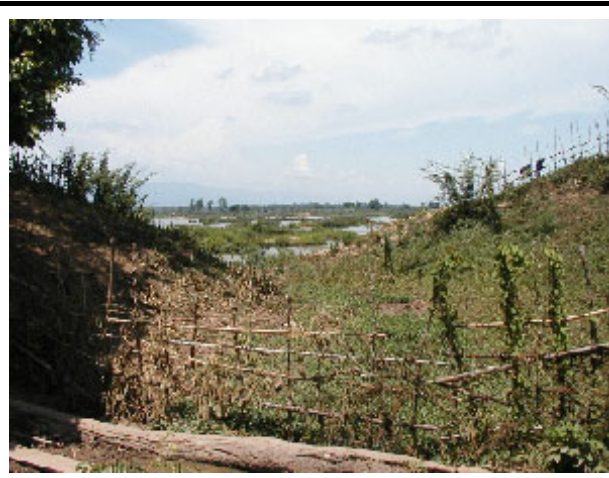
Route : 14A(i)	Km Post: 17+040m	Village Name: Ban Khoneken	
Bridge or River Name: 14 Huay Khoneken River			
Existence of Bridge:	Yes / No	Within or Outside of Village: Within / Outside	
Existing Bridge Condition	Bridge Length.(m):	Span Arrangement(m):	
	Carriageway & Ped. Width(m):		
	Superstructure type:	Load Capacity(t):	
	Girder Description:		
	Substructure Type:	Pier: Abutment:	
	Protection Work:		
	Damage Condition	Girder:	
		Slab:	
		Substructure:	-
		Bank Protection:	
	Others: -		
River Condition	Yearly Low Water Level(m): 0.3 m	Yearly High Water Level (m): 6.0m	
	Highest Water Level(m): 9.0m	River Width(m): 22-40 m	
	Riverbed Material: Silt	Gradient: 1/1000	
	Height between Riverbed & River bank or Bridge Surface(m): 5 m		
Surrounding Conditions	Land Use: Agricultural Use (paddy field)	No. Houses Affected: Nothing	
	UXO: Not Reported		
Other Info.	<ul style="list-style-type: none"> - The water level at the crossing point will be affected by backwater from Mekong - The crossing point is located just north of the village and the river menders - The flood water level in 1978 is quite high at this point (GL+1.2m(2000))

Comments	- A bridge structure will be appropriate and the bridge level should be carefully examined based on the hydrological analysis

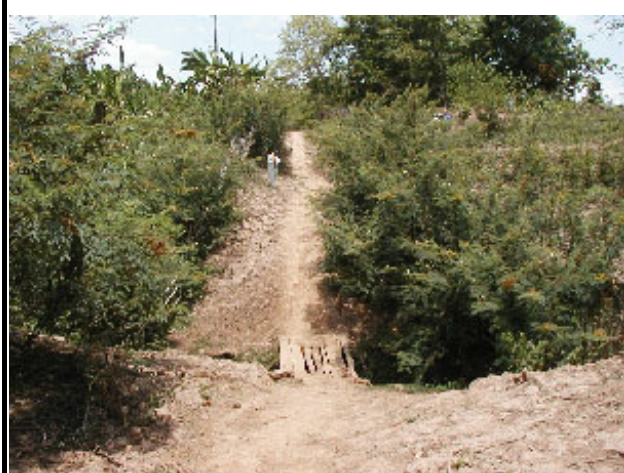
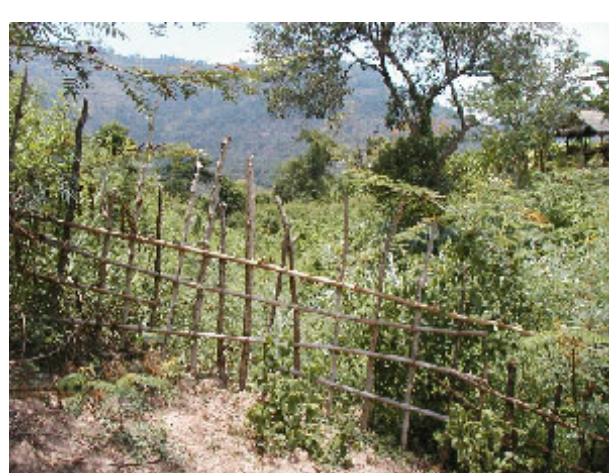
Route : 14A(i)	Km Post: 18+320 m	Village Name: Ban Khonken	
Bridge or River Name: 15 Huay Hong River			
Existence of Bridge:	Yes / No	Within or Outside of Village: Within / Outside	
Existing Bridge Condition	Bridge Length.(m):	Span Arrangement(m):	
	Carriageway & Ped. Width(m):		
	Superstructure type:	Load Capacity(t):	
	Girder Description:		
	Substructure Type:	Pier: Abutment:	
	Protection Work:		
	Damage Condition	Girder:	
		Slab:	.
		Substructure:	-
		Bank Protection:	
Others:		-	
River Condition	Yearly Low Water Level(m): 0 m	Yearly High Water Level (m): 6.0m	
	Highest Water Level(m): 9.0m	River Width(m): 15-35 m	
	Riverbed Material: Silt	Gradient: 1/1000	
	Height between Riverbed & River bank or Bridge Surface(m): 10 m		
Surrounding Conditions	Land Use: Agricultural Use (banana field)	No. Houses Affected:	
	UXO: Not Reported		
Other Info.	-The water level at the crossing point will be affected by backwater from Mekong -The crossing point is located just south of the village and a vehicle can not pass this river. -Sugarcane is cultivated on the river slope.

Comments	- A bridge structure will be appropriate and the bridge level should be carefully examined based on the hydrological analysis

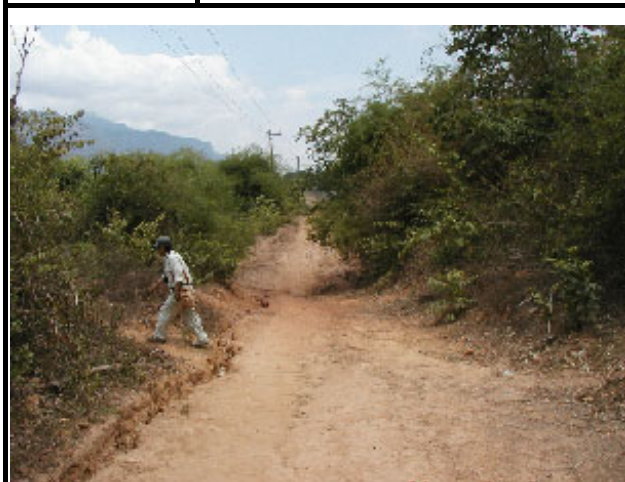
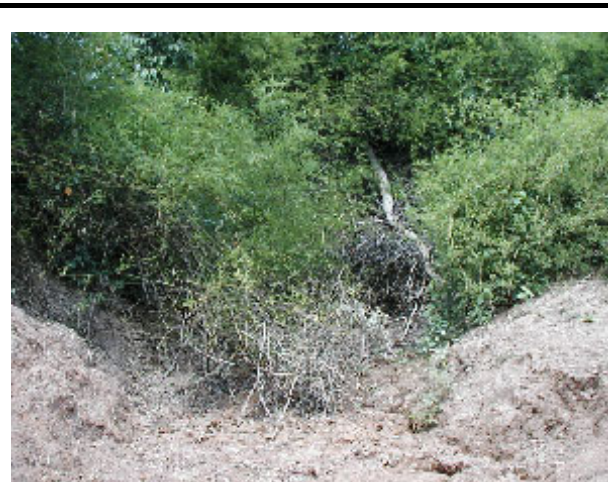
Route : 14A(i)	Km Post: 19+890 m	Village Name: Ban Khangneng	
Bridge or River Name: 17 Huay Dua River			
Existence of Bridge:	Yes / No	Within or Outside of Village: Within / Outside	
Existing Bridge Condition	Bridge Length.(m):	Span Arrangement(m):	
	Carriageway & Ped. Width(m):		
	Superstructure type:	Load Capacity(t):	
	Girder Description:		
	Substructure Type:	Pier: Abutment:	
	Protection Work:		
	Damage Condition	Girder:	
		Slab:	.
		Substructure:	-
		Bank Protection:	
	Others: -		
River Condition	Yearly Low Water Level(m): 0 m	Yearly High Water Level (m): 3.2m	
	Highest Water Level(m): GL+1.0m(2000)	River Width(m): 10 m	
	Riverbed Material: Silt	Gradient: 1/1000	
	Height between Riverbed & River bank or Bridge Surface(m): 4.2m		
Surrounding Conditions	Land Use: Agricultural Use (paddy field)	No. Houses Affected: a few houses may	
	UXO: Not Reported		
Other Info.	- The water level at the crossing point will be affected by backwater from Mekong - The crossing point is located just north of the village.

Comments	- A culvert structure will be appropriate because of small catchment area.

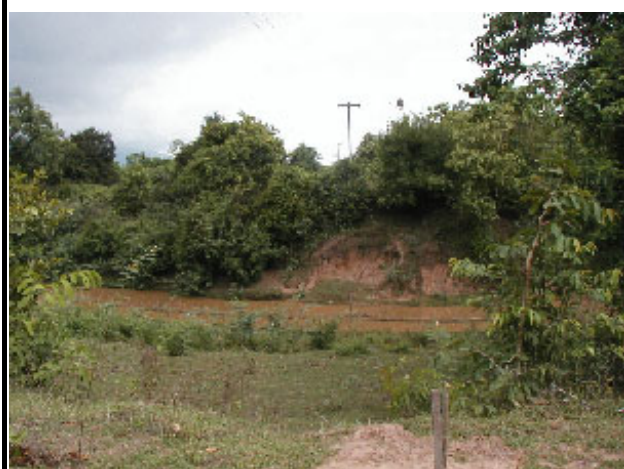
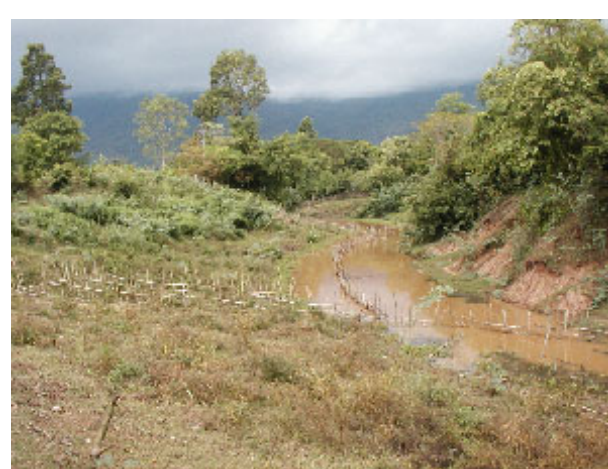
Route : 14A(i)	Km Post: 21+430m	Village Name: Ban Vaxai	
Bridge or River Name: 18 Huay Sai River			
Existence of Bridge:	Yes / No	Within or Outside of Village: Within / Outside	
Existing Bridge Condition	Bridge Length.(m):	Span Arrangement(m):	
	Carriageway & Ped. Width(m):		
	Superstructure type:	Load Capacity(t):	
	Girder Description:		
	Substructure Type:	Pier: Abutment:	
	Protection Work:		
	Damage Condition	Girder:	
		Slab:	
		Substructure:	-
		Bank Protection:	
	Others: -		
River Condition	Yearly Low Water Level(m): 0.3 m	Yearly High Water Level (m): 6.5m	
	Highest Water Level(m): GL-1m (2000)	River Width(m): 50 m	
	Riverbed Material: Silt	Gradient: 1/5000 (V=0.1m/s)	
	Height between Riverbed & River bank or Bridge Surface(m): 8.1 m		
Surrounding Conditions	Land Use: Agricultural Use (paddy field)	No. Houses Affected: Nothing	
	UXO: Not Reported		
Other Info.	- The water level at the crossing point will be affected by backwater from Mekong - The crossing point is located just north of the village and the river menders moderately.

Comments	- A bridge structure will be appropriate and abutment location should be examined. - The bridge level should be carefully examined based on the hydrological analysis

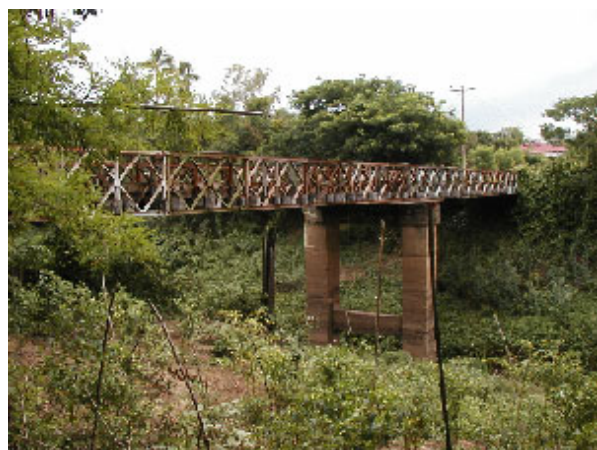
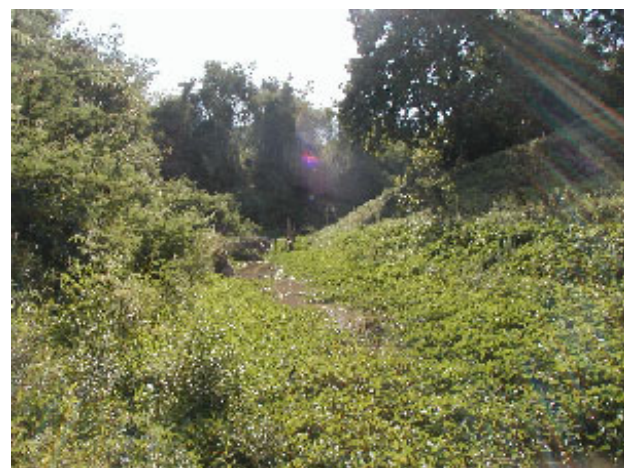
Route : 14A(i)	Km Post: 28.9 km	Village Name: Champasack Town	
Bridge or River Name: 20 Huay Phaban Bridge			
Existence of Bridge:	Yes / No	Within or Outside of Village: Within / Outside	
Existing Bridge Condition	Bridge Length.(m): 49.0 m	Span Arrangement(m): 24.5 m x 2	
	Carriageway & Pede. Width(m): 3.6 m		
	Superstructure type: Bailey	Load Capacity(t): 15 ton	
	Girder Description: Double panel is applied		
	Substructure Type:	Pier: RC H-Frame Type Abutment: RC	
	Protection Work: Not observed		
	Damage Condition	Girder: Minor corrosion is observed	
		Wooden slab has minor damages with loss of a part of	
		Slab: slab wood.	
		Substructure: Sound	
	Bank Protection: -		
	Others: Corrosion on other steel parts but not serious damage		
River Condition	Yearly Low Water Level(m): 0 m	Yearly High Water Level (m): 6 m	
	Highest Water Level(m): Top of pier or Bridge surface-0.75m(2000)	River Width(m): 36-75 m	
	Riverbed Material: Silt	Gradient: 1/1000

Height between Riverbed & River bank or Bridge Surface(m): 8 m		
Surrounding Conditions	Land Use: Fruit trees and bush	No. Houses Affected: Nothing	
	UXO: Not Reported		
Other Info.	<ul style="list-style-type: none"> - Since new alignment will be set at 200m upstream side, the bridge site will be moved. -The water level at the crossing point will be affected by backwater from Mekong. - Previous flood records are marked on a pier of the existing bridge. 		
Comments	-The proposed bridge is required with similar scale of the existing bridge. Since the river menders at upstream side, the crossing point should be set at a place where the channel is stable.

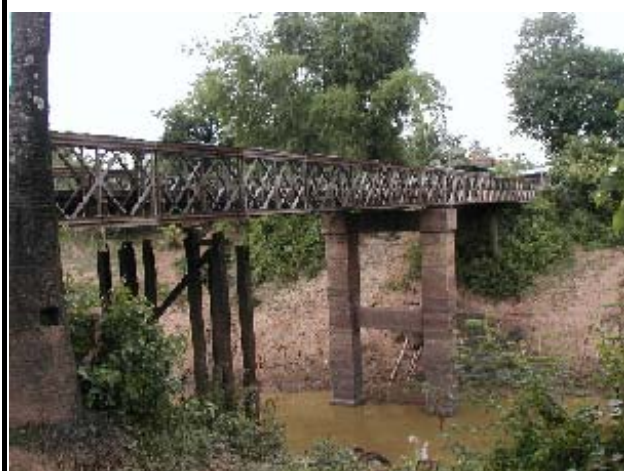
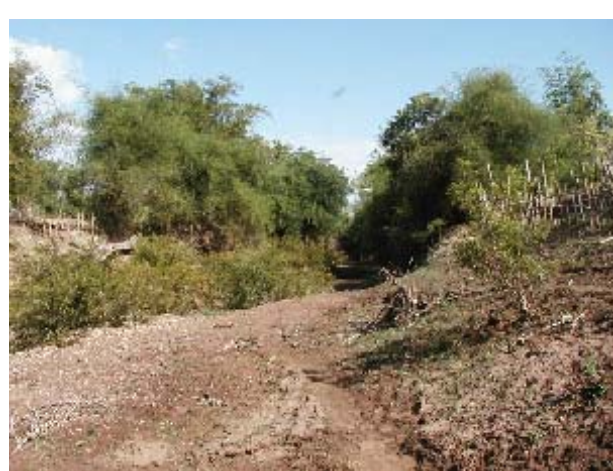
Route : 14A(i)	Km Post: 32+210m	Village Name: Ban Khoneken	
Bridge or River Name: 21-1 Huay Sahoua River			
Existence of Bridge:	Yes / No	Within or Outside of Village: Within / Outside	
Existing Bridge Condition	Bridge Length.(m): 48.7 m	Span Arrangement(m): 24.5 m x 2	
	Carriageway & Ped. Width(m): 4.2 m		
	Superstructure type: Bailey Type	Load Capacity(t): ?	
	Girder Description: Double panel is mainly applied (a double panel with beam at some parts)		
	Substructure Type:	Pier: RC Frame Type Abutment: RC Frame type	
	Protection Work: Not observed		
	Damage Condition	Girder: Minor corrosion is observed.	
		Slab: Small damages with loss of wooden slab are observed	
		Substructure: Sound	
		Bank Protection: -	
Others: Corrosion on cross-beams and bracings but not serious			
River Condition (Proposed site)	Yearly Low Water Level(m): 0.2 m	Yearly High Water Level (m): 5m	
	Highest Water Level(m): 7.0m	River Width(m): 35 m

Riverbed Material: gravels, sand & silt	Gradient: 1/1000	
	Height between Riverbed & River bank or Bridge Surface(m): 5.5 m		
Surrounding Conditions	Land Use: Paddy Field	No. Houses Affected	
	UXO: Not Reported		
Other Info.	- The river menders significantly. - Alignment will be shifted to 1km upstream side due to detouring the ancient city area		
Comments	- The crossing point should be selected the place where the channel is stable. Backwater from Mekong may not be affected at the proposed bridge site.

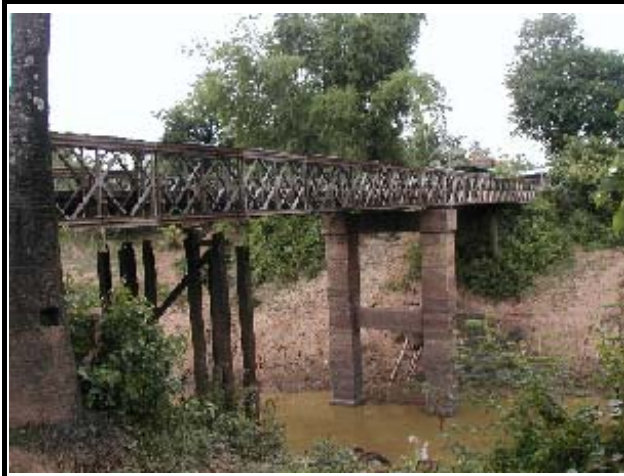
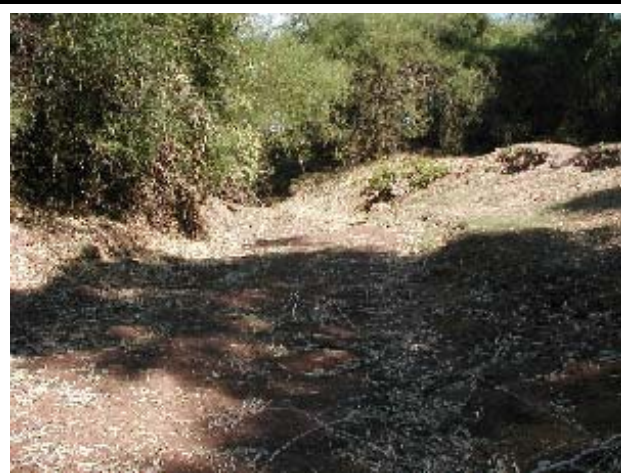
Route : 14A(i)	Km Post: 32+620 m	Village Name: -	
Bridge or River Name: 21-2 Huay Sahoua River			
Existence of Bridge:	Yes / No	Within or Outside of Village: Within / Outside	
Existing Bridge Condition	Bridge Length.(m): 48.7 m	Span Arrangement(m): 24.5 m x 2	
	Carriageway & Ped. Width(m): 4.2 m		
	Superstructure type: Bailey Type	Load Capacity(t): ?	
	Girder Description: Double panel is mainly applied (a double panel with beam at some parts)		
	Substructure Type:	Pier: RC Frame Type Abutment: RC Frame type	
	Protection Work: Not observed		
	Damage Condition	Girder: Minor corrosion is observed.	
		Slab: Small damages with loss of wooden slab are observed	
		Substructure: Sound	
		Bank Protection: -	
Others: Corrosion on cross-beams and bracings but not serious			
River Condition (Proposed site)	Yearly Low Water Level(m): 0 m	Yearly High Water Level (m): 3 m	
	Highest Water Level(m): 4.1m	River Width(m): 10 m

Riverbed Material: sand	Gradient: 1/500	
	Height between Riverbed & River bank or Bridge Surface(m): 3.6 m		
Surrounding Conditions	Land Use: Paddy Field	No. Houses Affected: Nothing	
	UXO: Not Reported		
Other Info.	- Alignment will be shifted to 1km upstream side due to detouring the ancient city area		
Comments	- The crossing point should be selected the place where the channel is stable. Backwater from Mekong may not be affected at the proposed bridge site.

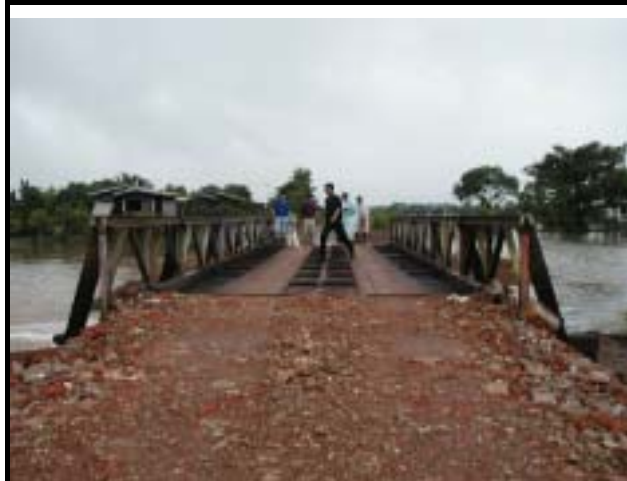
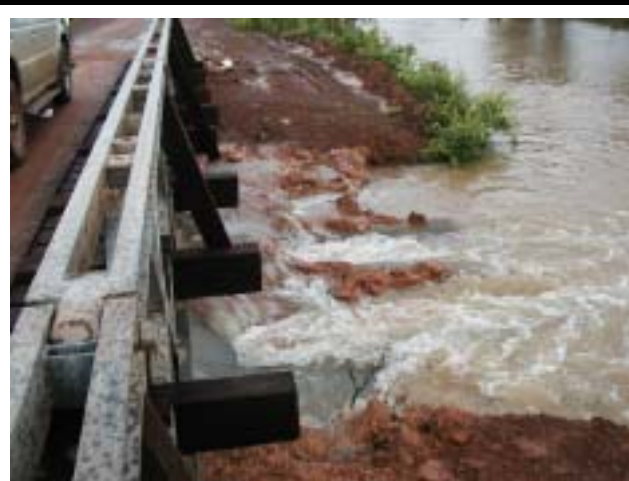
Route : 14A(i)	Km Post: 39+600m	Village Name: Ban Dontalat	
Bridge or River Name: 22-1 No name			
Existence of Bridge:	Yes / No	Within or Outside of Village: Within / Outside	
Existing Bridge Condition	Bridge Length.(m): 15m	Span Arrangement(m): 15m (slab:12.2m)	
	Carriageway & Ped. Width(m): 3.5 m		
	Superstructure type: Bailey	Load Capacity(t): Not indicated	
	Girder Description: Single panel is utilized		
	Substructure Type:	Pier: - Abutment: -	
	Protection Work: Not observed		
	Damage Condition	Girder: Minor corrosion is observed	
		Slab: No damage	
		Substructure: -	
		Bank Protection: -	
Others: -			
River Condition	Yearly Low Water Level(m): 0 m	Yearly High Water Level (m): Br surface-0.5m	
	Highest Water Level(m): Br. surface -0.5m (2002)	River Width(m): 10 m	
	Riverbed Material: Silt	Gradient: 1/50	
	Height between Riverbed & River bank or Bridge Surface(m): 2 m		
Surrounding Conditions	Land Use: Agricultural Use (paddy field)	No. Houses Affected: nothing

UXO: Not Reported		
Other Info.	- Two pipe culvers of 0.8 m in diameter were originally installed at this crossing point but those were destroyed due to lack of flow capacity of the culverts and replaced by a bailey bridge. One pipe is observed not to function due to maybe debris in the pipe.		
Comments	- The structure type should be studied on the basis of an analysis on causes of destruction.

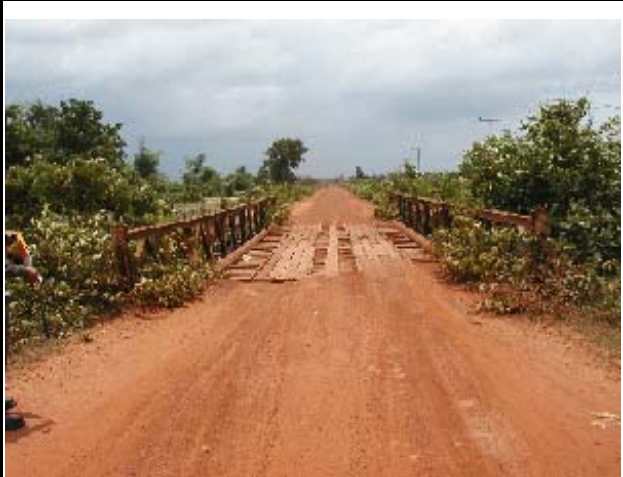
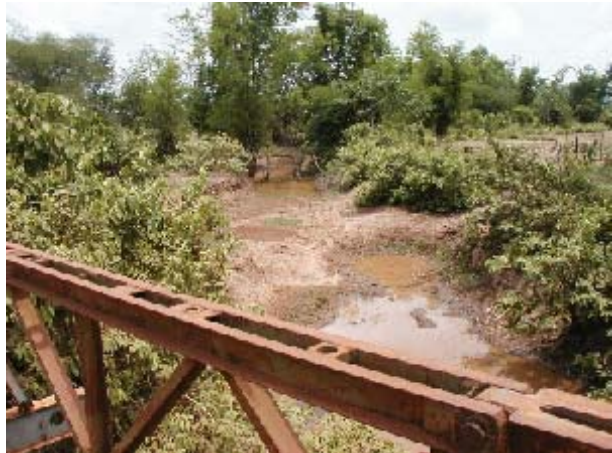
Route : 14A(i)	Km Post: 40+610m	Village Name: Ban Dontalat	
Bridge or River Name: 22-2 Huay Thateng River			
Existence of Bridge:	Yes / No	Within or Outside of Village: Within / Outside	
Existing Bridge Condition	Bridge Length.(m): 18.5m	Span Arrangement(m): 18.5m (slab:12.2m)	
	Carriageway & Ped. Width(m): 3.9 m		
	Superstructure type: Bailey	Load Capacity(t): Not indicated	
	Girder Description: Single panel is utilized		
	Substructure Type:	Pier: - Abutment: RC frame type	
	Protection Work: Not observed		
	Damage Condition	Girder: Minor corrosion is observed	
		Slab: Small damages such as loss of parts of wooden slab	
		Substructure: -	
		Bank Protection: -	
Others: 1-2 mm corrosion on cross beam & braising not serious			
River Condition	Yearly Low Water Level(m): 0.5 m	Yearly High Water Level (m): Br surface-0.5m	
	Highest Water Level(m): Br. surface -0.5m (2000)	River Width(m): 12 m	
	Riverbed Material: Silt	Gradient: 1/5000 (almost no flow)

Height between Riverbed & River bank or Bridge Surface(m): 3.2 m		
Surrounding Conditions	Land Use: Agricultural Use (paddy field)	No. Houses Affected: a few houses	
	UXO: Not Reported		
Other Info.	- The water level at the crossing point won't be affected by backwater from Mekong and the surrounding area is inundated during rainy season. - Drainage works including cross-sectional culverts have been improved along the road.		
Comments	-The new bridge should be set at the same position considering the straight alignment -The bridge length should be considered on the basis of hydrological analysis

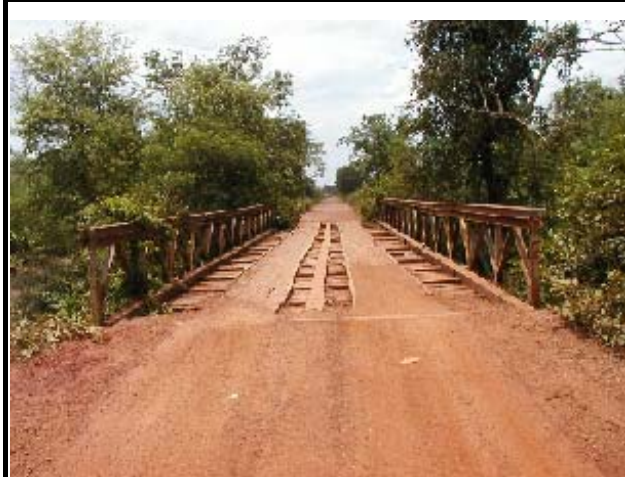
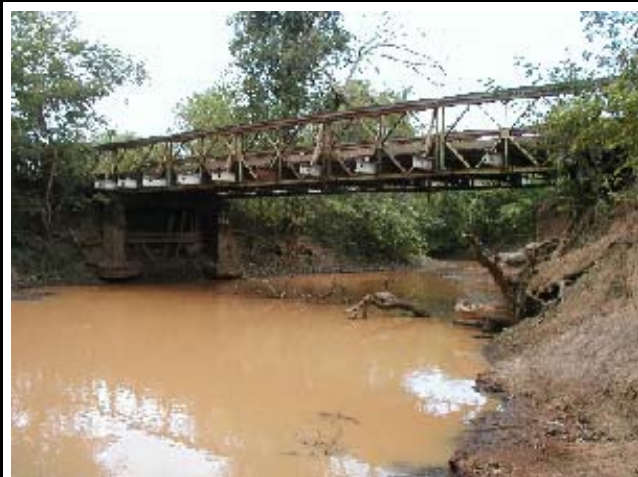
Route : 14A(i)	Km Post: 45+490 m	Village Name: Ban Nongbeng	
Bridge or River Name: 23 Huay Manpha River			
Existence of Bridge:	Yes / No	Within or Outside of Village: Within / Outside	
Existing Bridge Condition	Bridge Length.(m): 24.5 m	Span Arrangement(m): 24.5m	
	Carriageway & Ped. Width(m): 4.2 m		
	Superstructure type: Bailey Type	Load Capacity(t): ?	
	Girder Description: Single panel with beam is applied.		
	Substructure Type:	Pier: - Abutment: RC frame type	
	Protection Work: Not observed		
	Damage Condition	Girder: Minor corrosion is observed	
		Slab: Fair condition with small damages	
		Substructure: Not observed	
		Bank Protection: -	
River Condition	Yearly Low Water Level(m): 0.2 m but no water at upstream side	Yearly High Water Level (m): Br.surface-1.5m	
	Highest Water Level(m): Br.surface-1.5m	River Width(m): 22m	
	Riverbed Material: Silt	Gradient: 1/1000	
	Height between Riverbed & River bank or Bridge Surface(m): 4 m

Surrounding Conditions	Land Use: Bush & agricultural use	No. Houses Affected: Nothing	
	UXO: Not Reported		
Other Info.	- Previous abutments inclined due to scouring under the bridge so that the bridge was replaced by one with the longer span. - Backwater from Mekong is not affected at the bridge site.		
Comments	- The proposed bridge should be set at the same position to keep good alignment. The surrounding area is sometimes inundated in rainy season.

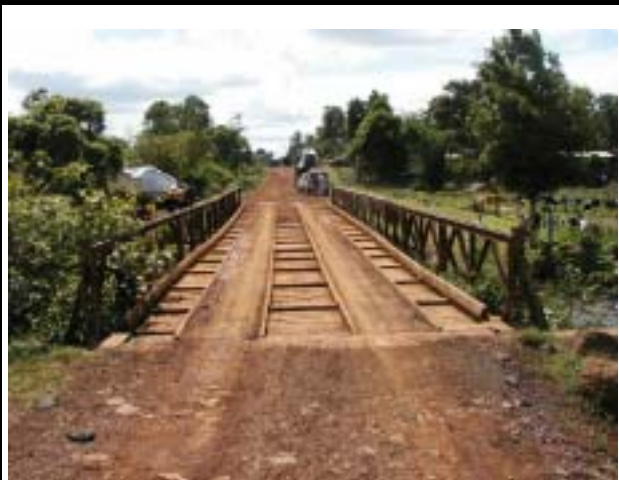
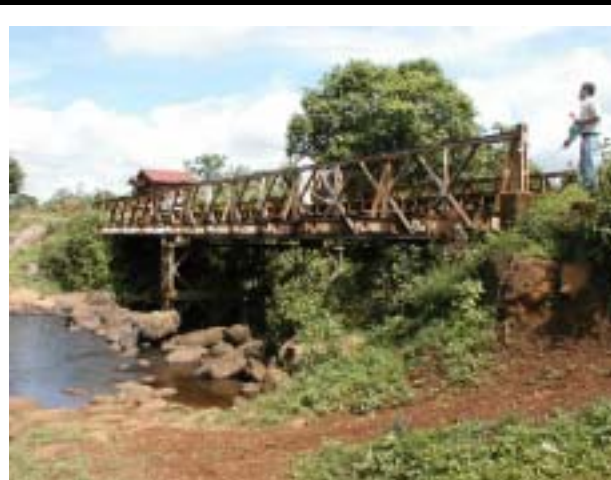
Route : 16A	Km Post: 17.8km	Village Name: Nkh.l No.34	
Bridge or River Name: Huay Mckchan-Gunai			
Existence of Bridge:	Yes / No	Within or Outside of Village: Within / Outside	
Existing Bridge Condition	Bridg Length.(m): 25.0 m	Span Arrangement(m): 12.5m x 2	
	Carriageway & Pede. Width(m):	0 m + 4.5m + 0 m	
	Superstructure type: Bailey	Load Capacity(t): not indicated	
	Girder Description: Single truss panel is applied.		
	Substructure Type:	Pier: Steel-frame pier Abutment: Gravity concrete	
	Height between Riverbed & Bridge Surface(m): 3.2m		
	Damage Condition	Girder: Minor corrosion is observed	
		Slab: Wooden slab keeps relatively fair condition.	
		Substructure: -	
		Bank Protection: No protection work	
Others: -			
River Condition	Yearly Low Water Level(m): 0.3-0.5m	Yearly High Water Level (m):	
	Highest Flood Water Level(m): RB+2.0m	River Width(m): 20-25 m	
	Riverbed Material: Boulders & sand	Gradient: 1/200

Surrounding Conditions	Land Use: Residential area	No. Houses Affected: No	
	UXO: not reported		
Other Info.	-River water is utilized for washing or water supply by local people. -Two streams come together at upstream side of the bridge.		
Comments	-Existing Bridge should be replaced by permanent bridge with 2 lane carriageway. -New bridge center should be kept at same position in order to keep good road alignment

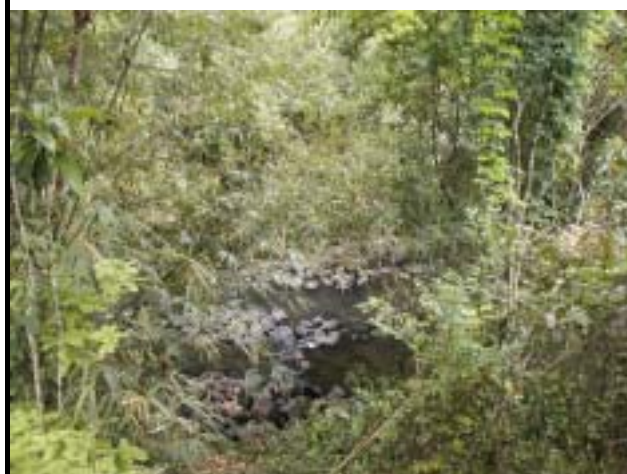
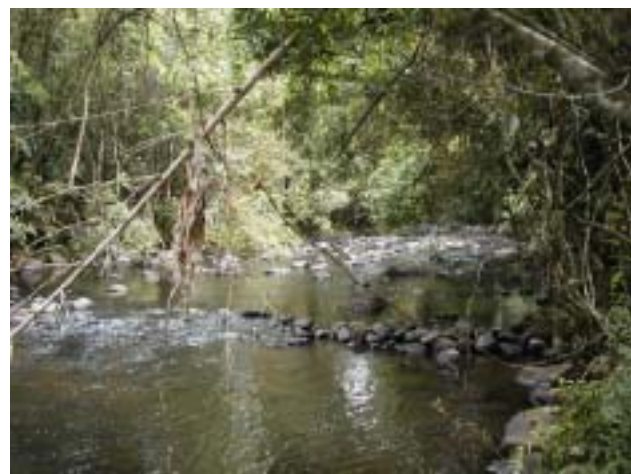
Route :16A	Km Post:39.5km	Village Name: No Village	
Bridge or River Name: Huay Namtang River			
Existence of Bridge:	Yes / No	Within or Outside of Village: Within / Outside	
Existing Bridge Condition	Bridg Length.(m):	Span Arrangement(m):	
	Carriageway & Ped. Width(m):		
	Superstructure type:	Load Capacity(t):	
	Girder Description:		
	Substructure Type:	Pier: Abutment:	
	Height between Riverbed & Bridge Surface(m):		
	Damage Condition	Girder:	
		Slab:	
		Substructure: -	
		Bank Protection:	
Others: -			
River Condition	Yearly Low Water Level(m): 0.5 m	Yearly High Water Level (m):	
	Highest Flood Water Level(m): 2.0m	River Width(m): 25-30 m	
	Riverbed Material: Boulders and sand	Gradient: 1/500	
Surrounding Conditions	Land Use: Forest	No. Houses Affected: Nothing	
	UXO: Not reported		
Other Info.	- The height between riverbed and ground level at left bank is approximately 10m. - River channel at the proposed bridge site is straight and stable.

Comments	-Approach road alignment should be carefully studied to meet geometry standard.

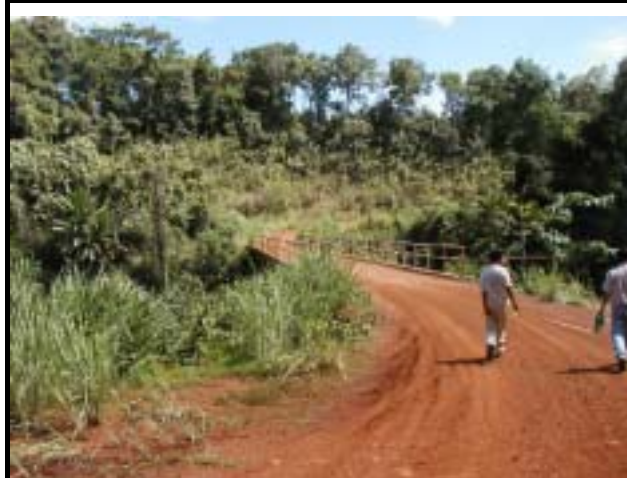
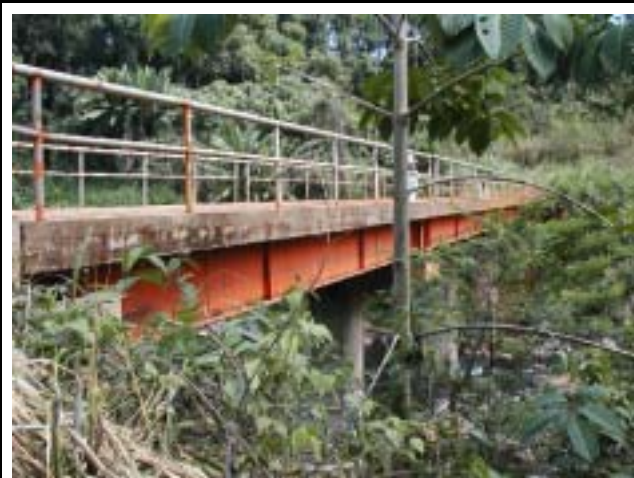
Route : 16A	Km Post: 52.4 km	Village Name: -	
Bridge or River Name: Xe Katam River Bridge			
Existence of Bridge:	Yes / No	Within or Outside of Village: Within / Outside	
Existing Bridge Condition	Bridg Length.(m): 48.4 m	Span Arrangement(m): 12.1m x 4	
	Carriageway & Ped. Width(m): 0 m + 4.5 m + 0 m		
	Superstructure type: Steel-I Girder	Load Capacity(t): Not indicated	
	Girder Description: 4-girders with 0.8m in depth		
	Substructure Type:	Pier: RC T shaped Abutment: RC Reversed T	
	Protection Work: Dry masonry with large boulders protects around abutments		
	Height between Riverbed & Bridge Surface(m): 10.2 m		
	Damage Condition	Girder: Minor corrosion under the drainage pipe is observed	
		Slab: No damage	
		Substructure: Sound	
Bank Protection: No damage			
Others: Handrail has no damage. No expansion joint is set.			
River Condition	Yearly Low Water Level(m): 0.5 m	Yearly High Water Level (m):	
	Highest Flood Water Level(m):	River Width(m): 40 m

Riverbed Material: Boulders and sand	Gradient: 1/500	
Surrounding Conditions	Land Use: forest	No. Houses Affected: Nothing	
	UXO: Unknown		
Other Info.	- The bridge was constructed by Daewoo as a part of an access road to the dam site in 1995. - Horizontal alignment of the approach roads should be improved.		
Comments	- The existing bridge shall be examined with designated design live load for this project. If it bears the live load, additional one-lane bridge is required at either up or down streamside.

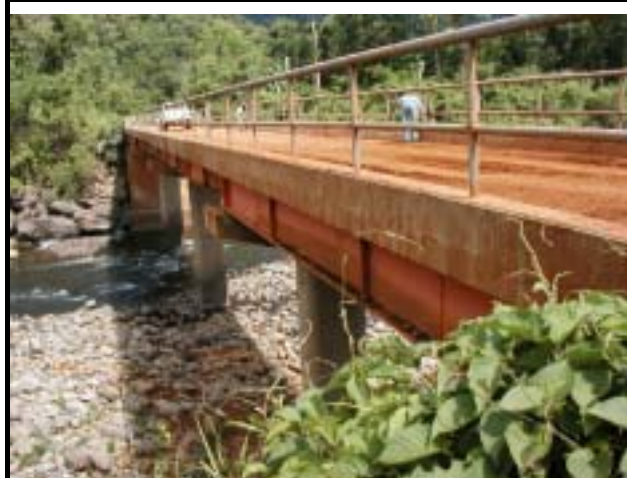
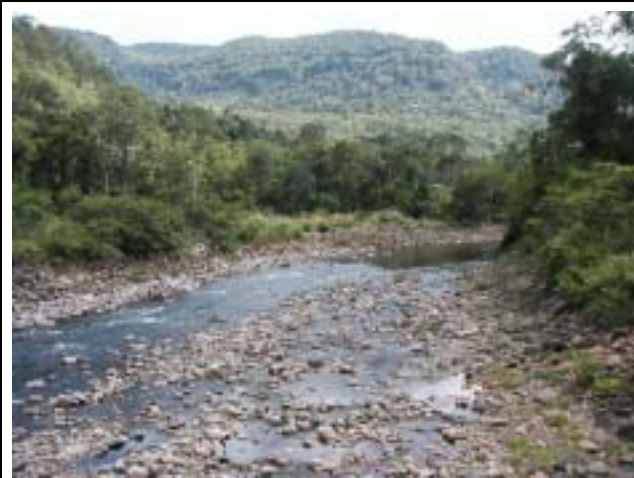
Route : 16A	Km Post: 58.1 km	Village Name: -	
Bridge or River Name: Xe Namnoy River 1			
Existence of Bridge:	Yes / No	Within or Outside of Village: Within / Outside	
Existing Bridge Condition	Bridg Length.(m): 50.4 m	Span Arrangement(m): 12.3 + 18.0 + 18.0 + 12.1	
	Carriageway & Ped. Width(m): 0 m + 4.5 m + 0 m		
	Superstructure type: Steel-I Girder	Load Capacity(t): Not indicated	
	Girder Description: Side span : 4-girders with 0.8m in depth are arranged. : Center span: 6-girders with 0.8m in depth are arranged.		
	Substructure Type:	Pier: RC T shaped Abutment: RC Reversed T	
	Protection Work: Dry masonry with large boulders protect around abutments.		
	Height between Riverbed & Bridge Surface(m): 9.1-10.7 m		
	Damage Condition	Girder: Minor corrosion under the drainage pipes are observed	
		Slab: No cracks and looks sound	
		Substructure: No damage	
Bank Protection: No damage			
Others: Handrail has no damage and no expansion joint.

River Condition	Yearly Low Water Level(m): 1.0 m	Yearly High Water Level (m):	
	Highest Flood Water Level(m): 7m +RB	River Width(m): 40-45m	
	Riverbed Material: Boulders and sand	Gradient: 1/300 (V=1-1.5m/s)	
Surrounding Conditions	Land Use: Forest and bush	No. Houses Affected: Nothing	
	UXO: Unknown		
Other Info.	- The bridge was constructed by Daewoo as a part of an access road to the dam site in 1995. - River has detour stream route at flooding. A few houses are located 200m upstream side		
Comments	- The existing bridge shall be examined with designated design live load for this project. If it bears the live load, additional one-lane bridge is required at either up or down streamside.

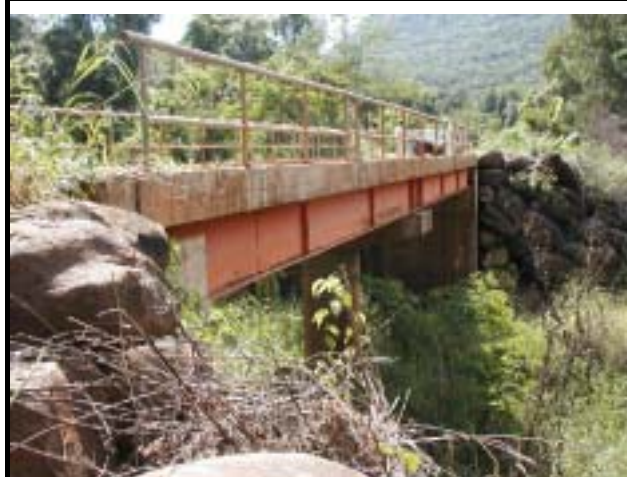
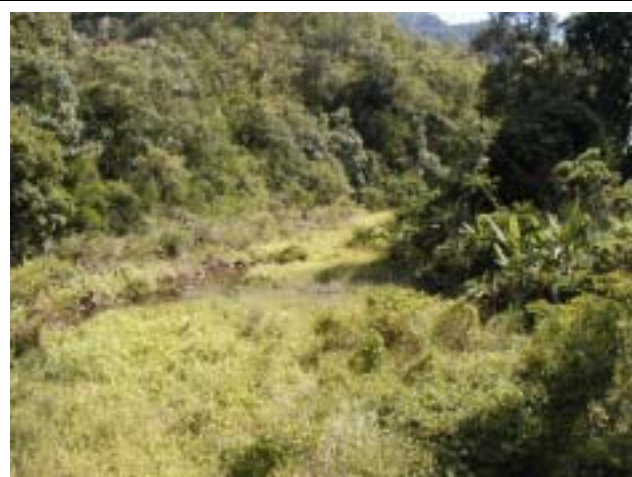
Route : 16A	Km Post: 58.3 km	Village Name: -	
Bridge or River Name: Xe Namnoy 2			
Existence of Bridge:	Yes / No	Within or Outside of Village: Within / Outside	
Existing Bridge Condition	Bridg Length.(m): 24.2 m	Span Arrangement(m): 12.1 m x 2	
	Carriageway & Ped. Width(m): 0 m + 4.5 m + 0 m		
	Superstructure type: Steel-I Girder	Load Capacity(t): Not indicated	
	Girder Description: 4-girders with 0.8 m in depth are arranged		
	Substructure Type:	Pier: RC T-shaped Abutment: RC Reversed T	
	Protection Work: Dry masonry with large boulders protect around abutments.		
	Height between Riverbed & Bridge Surface(m): 7.1 m		
	Damage Condition	Girder: Minor corrosion under the drainage pipe are observed	
		Slab: -	
		Substructure: No damage	
Bank Protection: Looks stable			
Others: No damages on handrail. No expansion joints			
River Condition	Yearly Low Water Level(m): No water	Yearly High Water Level (m):	
	Highest Flood Water Level(m):	River Width(m): 20 m

Riverbed Material: medium boulders & sand	Gradient: ?	
Surrounding Conditions	Land Use: Bush	No. Houses Affected: Nothing	
	UXO: Not reported		
Other Info.	- The bridge was constructed by Daewoo as a part of an access road to the dam site in 1995. - This river is a detour stream of Xe Namnoy at flooding so that there is no water in dry season		
Comments	- The existing bridge shall be examined with designated design live load for this project. If it bears the live load, additional one-lane bridge is required at either up or down streamside.

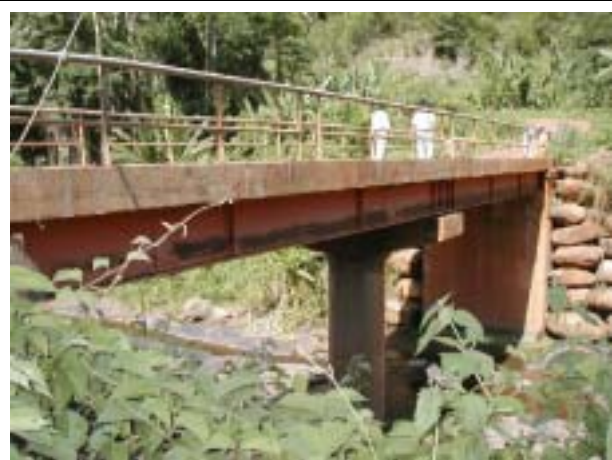
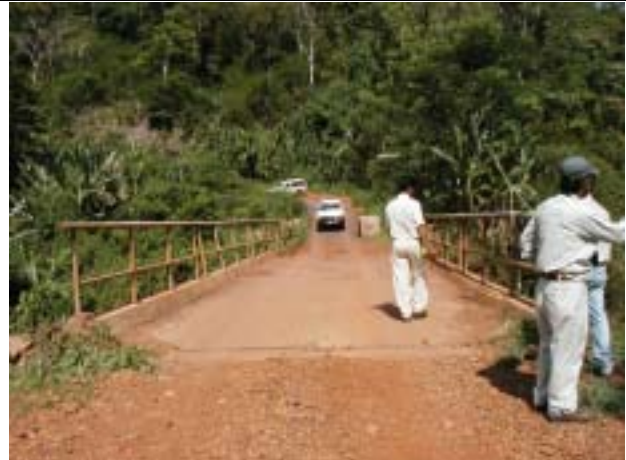
Route : 16A	Km Post: 58.6 km	Village Name: -	
Bridge or River Name: Xe Katak-Tok River			
Existence of Bridge:	Yes / No	Within or Outside of Village: Within / Outside	
Existing Bridge Condition	Bridg Length.(m): 24.2 m	Span Arrangement(m): 12.1 m x 2	
	Carriageway & Ped. Width(m): 0 m + 4.5 m + 0 m		
	Superstructure type: Steel-I Girder	Load Capacity(t): Not indicated	
	Girder Description: 4-girders with 0.8m in depth are arranged		
	Substructure Type:	Pier: RC T-shaped Abutment: RC Reversed-T	
	Protection Work: Dry Masonry with large boulders protect around abutments		
	Height between Riverbed & Bridge Surface(m): 7.4 m		
	Damage Condition	Girder: Minor corrosion under the drainage pipes are observed	
		Slab: Looks sound	
		Substructure: No damage	
Bank Protection: Stable			
Others: Damage on handrail at upstream side due to vehicle collision. No expansion joint.			
River Condition	Yearly Low Water Level(m): 0.2 m	Yearly High Water Level (m):

Highest Flood Water Level(m):	River Width(m): 20 m	
	Riverbed Material: Sand rock exposes	Gradient: 1/500	
Surrounding Conditions	Land Use: Forest and bush	No. Houses Affected: Nothing	
	UXO: Not reported		
Other Info.	-Hydro dam is located at 13 km upstream but discharge from the dam maybe not affected to HWL at the bridge site due to no water level adjusting gate at the dam		
Comments	- Alignment of the approach road at the right bank should be improved. -The existing bridge shall be examined with designated design live load for this project. If it bears the live load, additional one-lane bridge is required at either up or down streamside.
