ANNEXES FOR FEASIBILITY STUDY

ANNEX F-1

**SUMMARY OF PRESENT CONDITION OF
SURVEY ROUTE**

BRIDGE INVENTORY SURVEY DATA

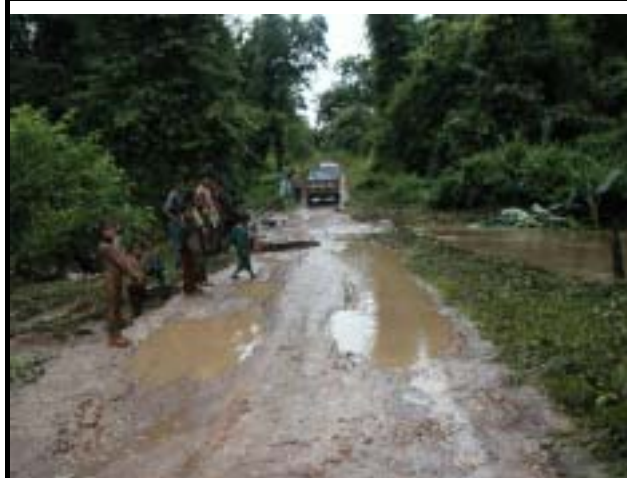
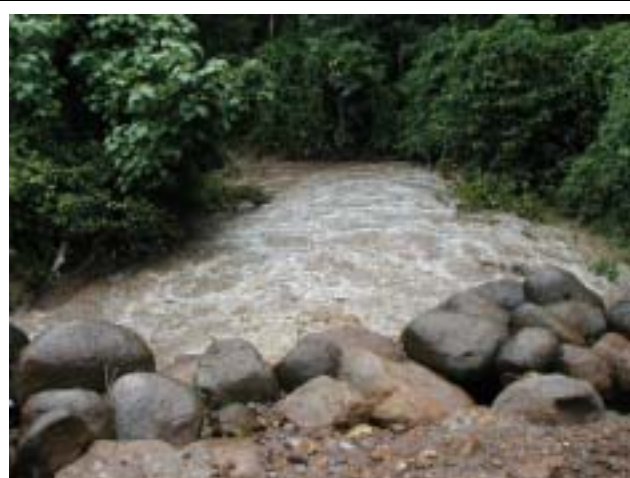
Route : 16A	Km Post: 61+473	Village Name: -	
Bridge or River Name: No name			
Existence of structure:	Yes / No	2.0m pipe culvert	
Existing Bridge Condition	Bridg Length.(m):	Span Arrangement(m):	
	Carriageway & Ped. Width(m):		
	Superstructure type:	Load Capacity(t):	
	Girder Description:		
	Substructure Type:	Pier: Abutment:	
	Protection Work:		
	<u>Damage Condition</u>	Girder:	
		Slab:	.
		Substructure:	-
		Bank Protection:	
Others:		-	
River Condition	Yearly Low Water Level(m):	Yearly High Water Level (m): GL+1.0m	
	Highest Flood Water Level(m): GL+1.0m	River Width(m): 10m	
	Riverbed Material: boulder+silt	Gradient: 1/100	
	Height between Riverbed & River bank or Bridge Surface(m): 3.0m		
Surrounding Conditions	Land Use: forest	No. Houses Affected: No	
	UXO: not reported		
Other Info.	2.0m in diameter of pipe culvert is set at the crossing point. However, the overflow of the stream was observed in rainy season. The overflowed area spread 20m in length and 1m in the maximum depth. This occurs 3 to 4 times a year.

Comments	The type of crossing structure shall be well examined in consideration with river condition and its characteristics.
