PART III
ENGINEERING SURVEY

DATA COLLECTION, ANALYSIS AND REVIEW OF THE FEASIBILITY STUDY

3.3 Field Reconnaissance Survey along the Proposed Bypass Corridors

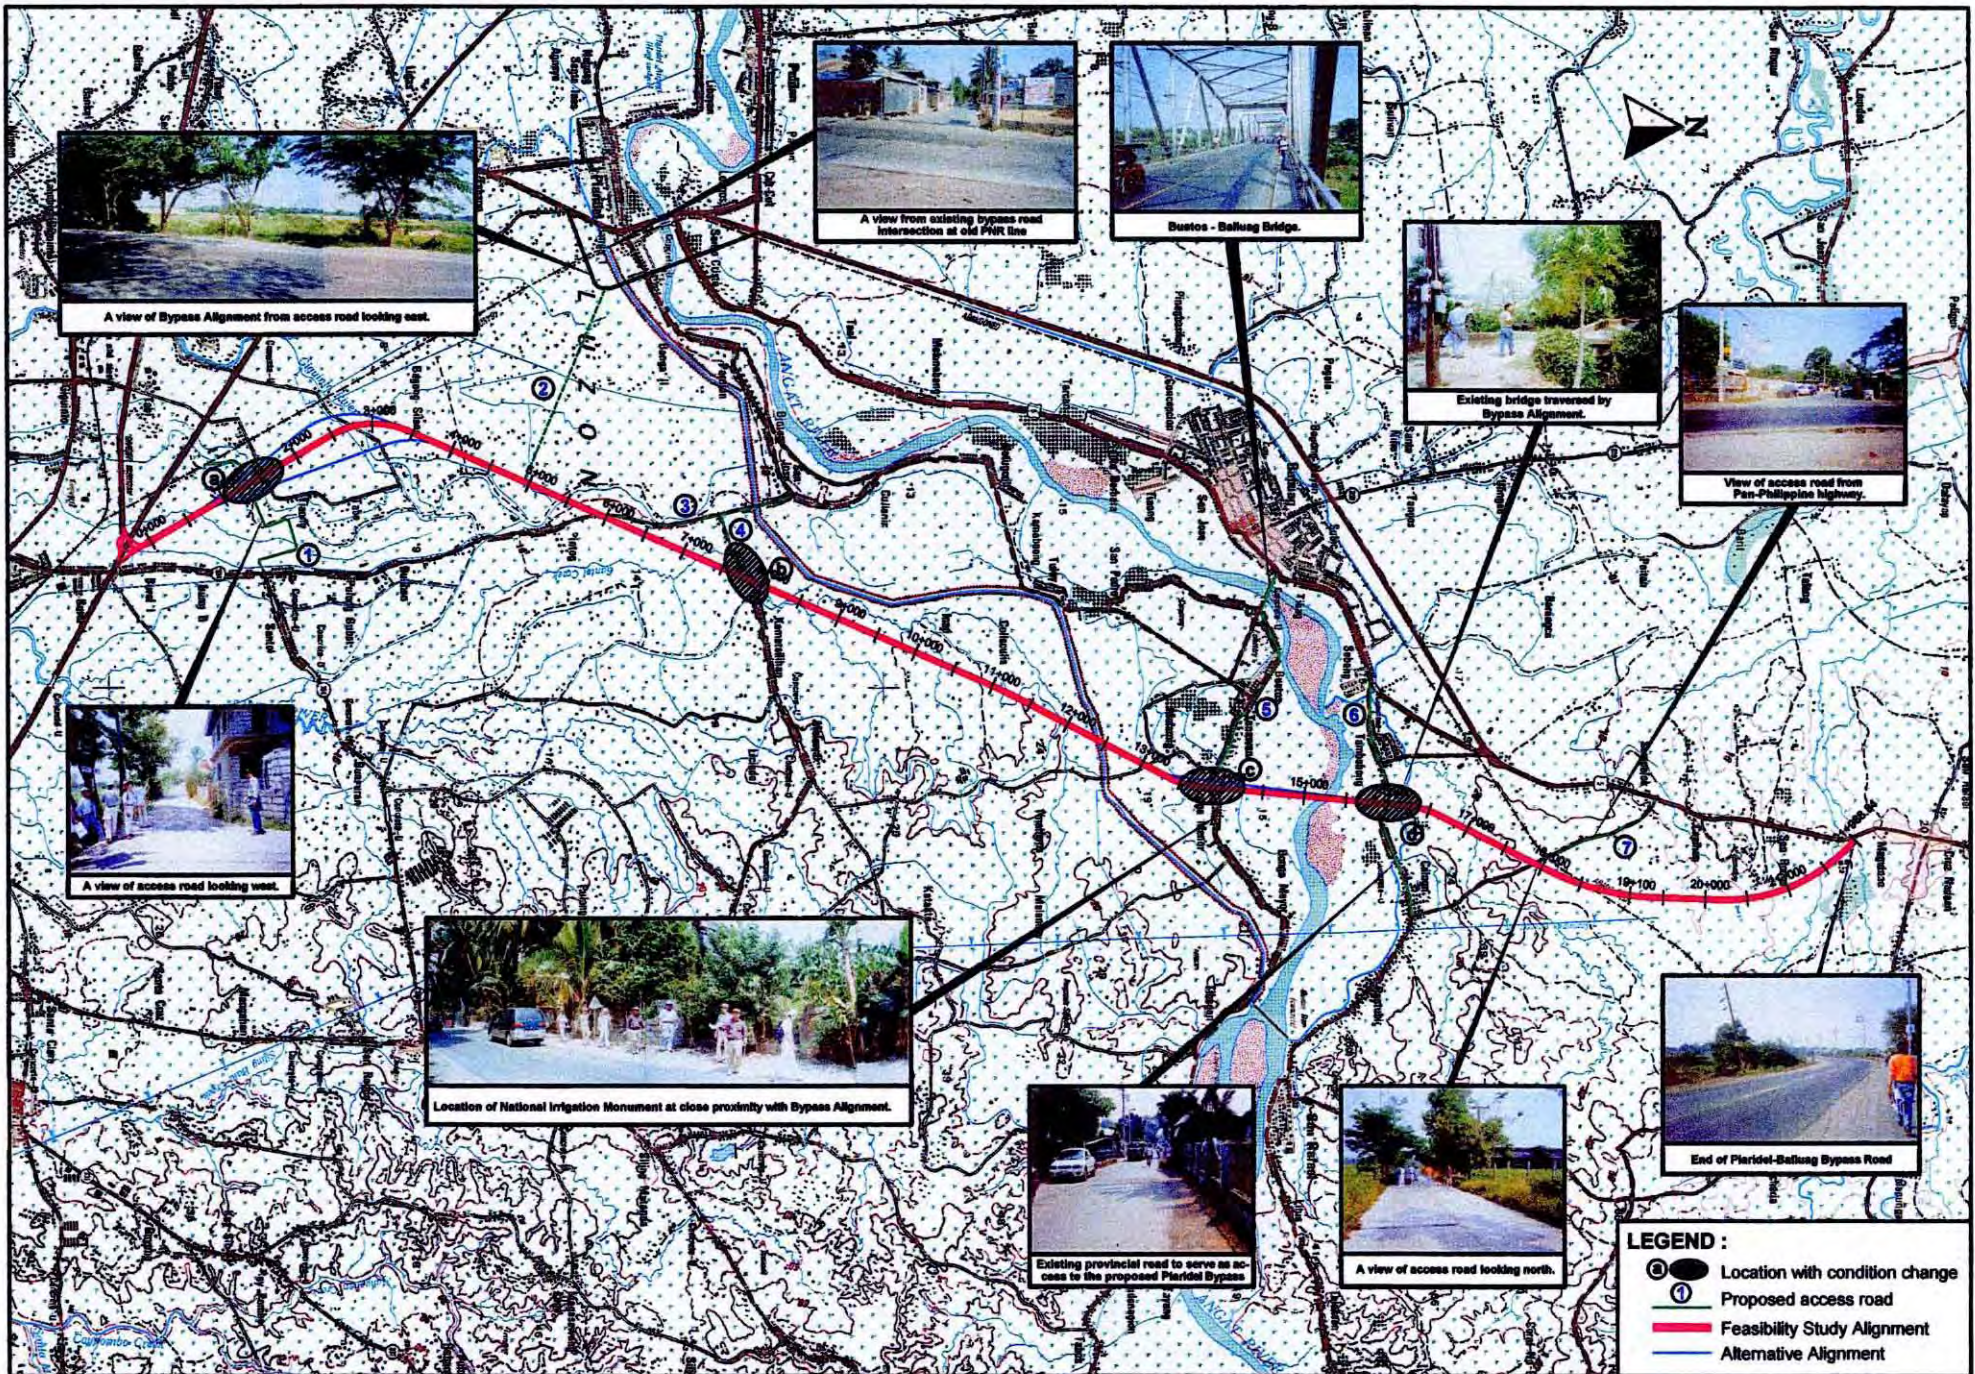
FIGURE 3.3-1 PRESENT CONDITION OF PLARIDEL BYPASS CORRIDOR

- a) Construction of an 18-hectare subdivision at approx. Sta. 01+550 was on-going. This new development was directly traversed by the proposed alignment.

- e) There were no changes in the condition of the proposed alignment at the beginning point at the Buroi Interchange and at the end point along the existing Pan-Philippine Highway.

- 1) *Balagtas Agricultural School Road* - This was an existing 1.97 km long with 4.80m wide travelway in good condition. There was no shoulder although shoulders were provided on sections along rice paddies. On residential section, the existing road could be improved by widening along the south side.

- 2) *New Access Road* - Still non-existent, this 2.48 km long proposed road with 6.70m wide travelway and 1.50m shoulder on both sides will directly connect the Sta. Rita Bypass with the proposed Bypass. The road corridor which traverses on rice paddies and agro-industrial zone area was confirmed to be clear of obstruction.

- 3) *Balagtas-Bustos Road* - This 2.45 km long provincial road with 4.85m wide travelway and 0.50m shoulders consisted of PCCP and PCCP with Ac overlay in good to fair conditions. No occurrence of flooding along the entire stretch had been confirmed during interview with local residents. Widening to 6.10m while maintaining a shoulder width of 0.50m could be

accommodated since the existing corridor width varies from 7.10 to 7.50 meters.

- 4) *San Jose-Camachilhan Road* - This 1.05km long provincial road with 5.00m wide and 1.0m shoulders consist of PCCP in fair condition. The whole section however, was identified as flooded section. This was observed from the elevation of the existing bridge located along the section. According to the local residents 1.3m deep flood have occurred during heavy rains.

- 5) *Bustos-Angat Road* - This 2.45km long national road with 6.10m width and 0.50m shoulders consisted of PCCP and PCCP with AC overlay in good to fair condition. Widening is not possible as the section traverses through densely residential area. Traffic condition could be improved with proper mitigation measures such as pavement marking/stripping, road maintenance, etc.. No occurrence of flooding throughout the section was confirmed with the local residents.

- 6) *Baliuag-San Rafael Road* - This 2.65km long provincial road with 5.00m width and 1.0m shoulders consisted of PCCP and AC overlay in fair condition. Distresses such as potholes and crackings were present throughout the section. Maintenance is needed in order to stop further deterioration of the existing pavement. No flooding was identified.

- 7) *Sampaloc-San Rafael Road* - The section of 1.80 km provincial road consisted of fairly new PCCP with 6.10m travelway. However, some sections already showed distresses such as wide cracking and depressions, a clear indication of failed subgrade. Shoulder ranged in width from 0.50 to 1.0m. There was no flood occurrence throughout the section.

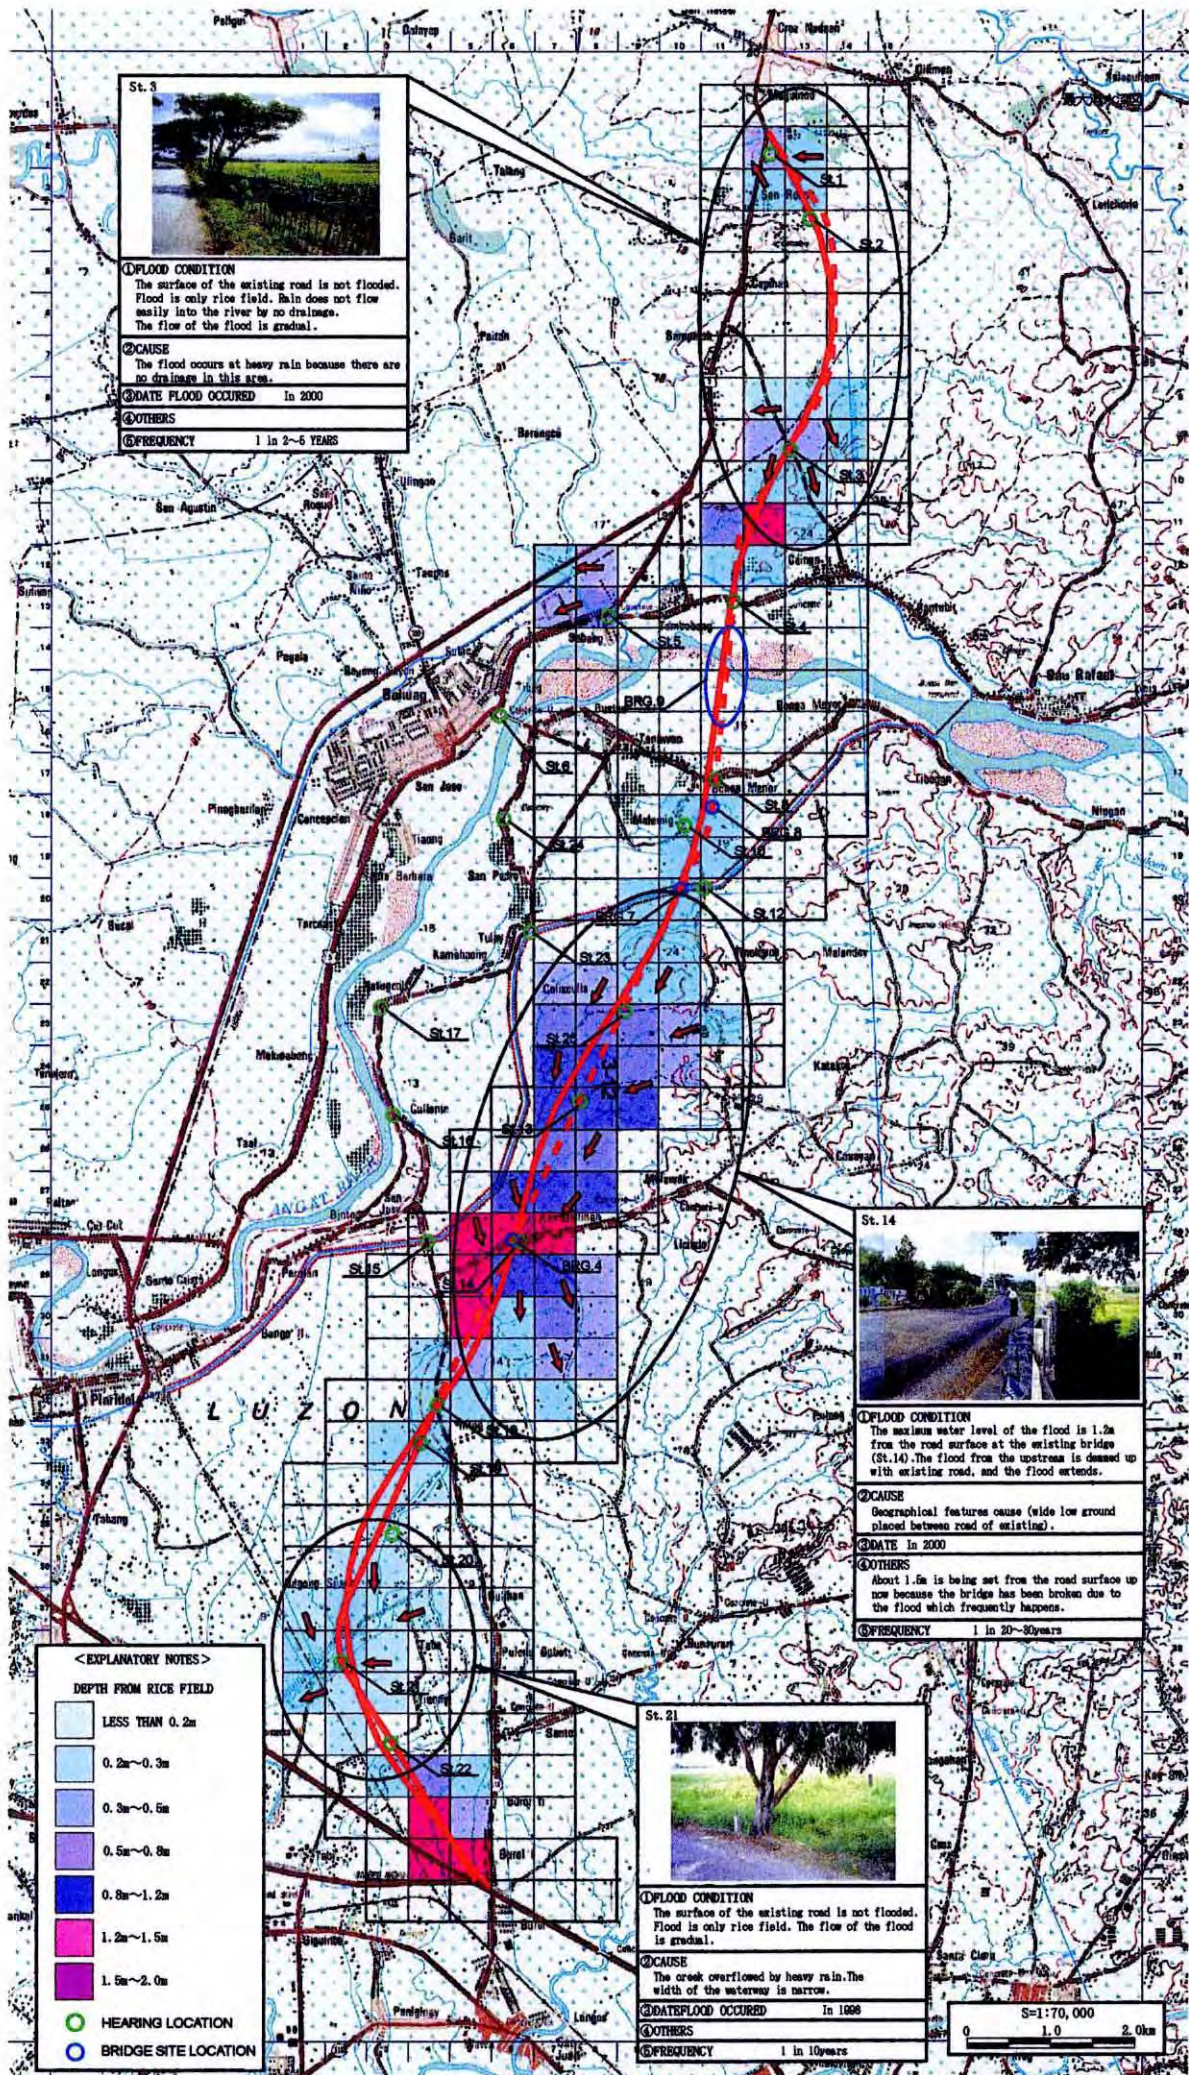
FIGURE 3.3-2 FLOOD AREA MAP (PLARIDEL BYPASS)

FLOOD CONDITION
The surface of the existing road is not flooded. Flood is only rice field. Rain does not flow easily into the river by no drainage. The flow of the flood is gradual.

CAUSE
The flood occurs at heavy rain because there are no drainage in this area.

FLOOD CONDITION
The maximum water level of the flood is 1.2m from the road surface at the existing bridge (St.14). The flood from the upstream is dammed up with existing road, and the flood extends.

CAUSE
Geographical features cause (wide low ground placed between road of existing).

OTHERS
About 1.5m is being set from the road surface up now because the bridge has been broken due to the flood which frequently happens.

FLOOD CONDITION
The surface of the existing road is not flooded. Flood is only rice field. The flow of the flood is gradual.

CAUSE
The creek overflowed by heavy rain. The width of the waterway is narrow.

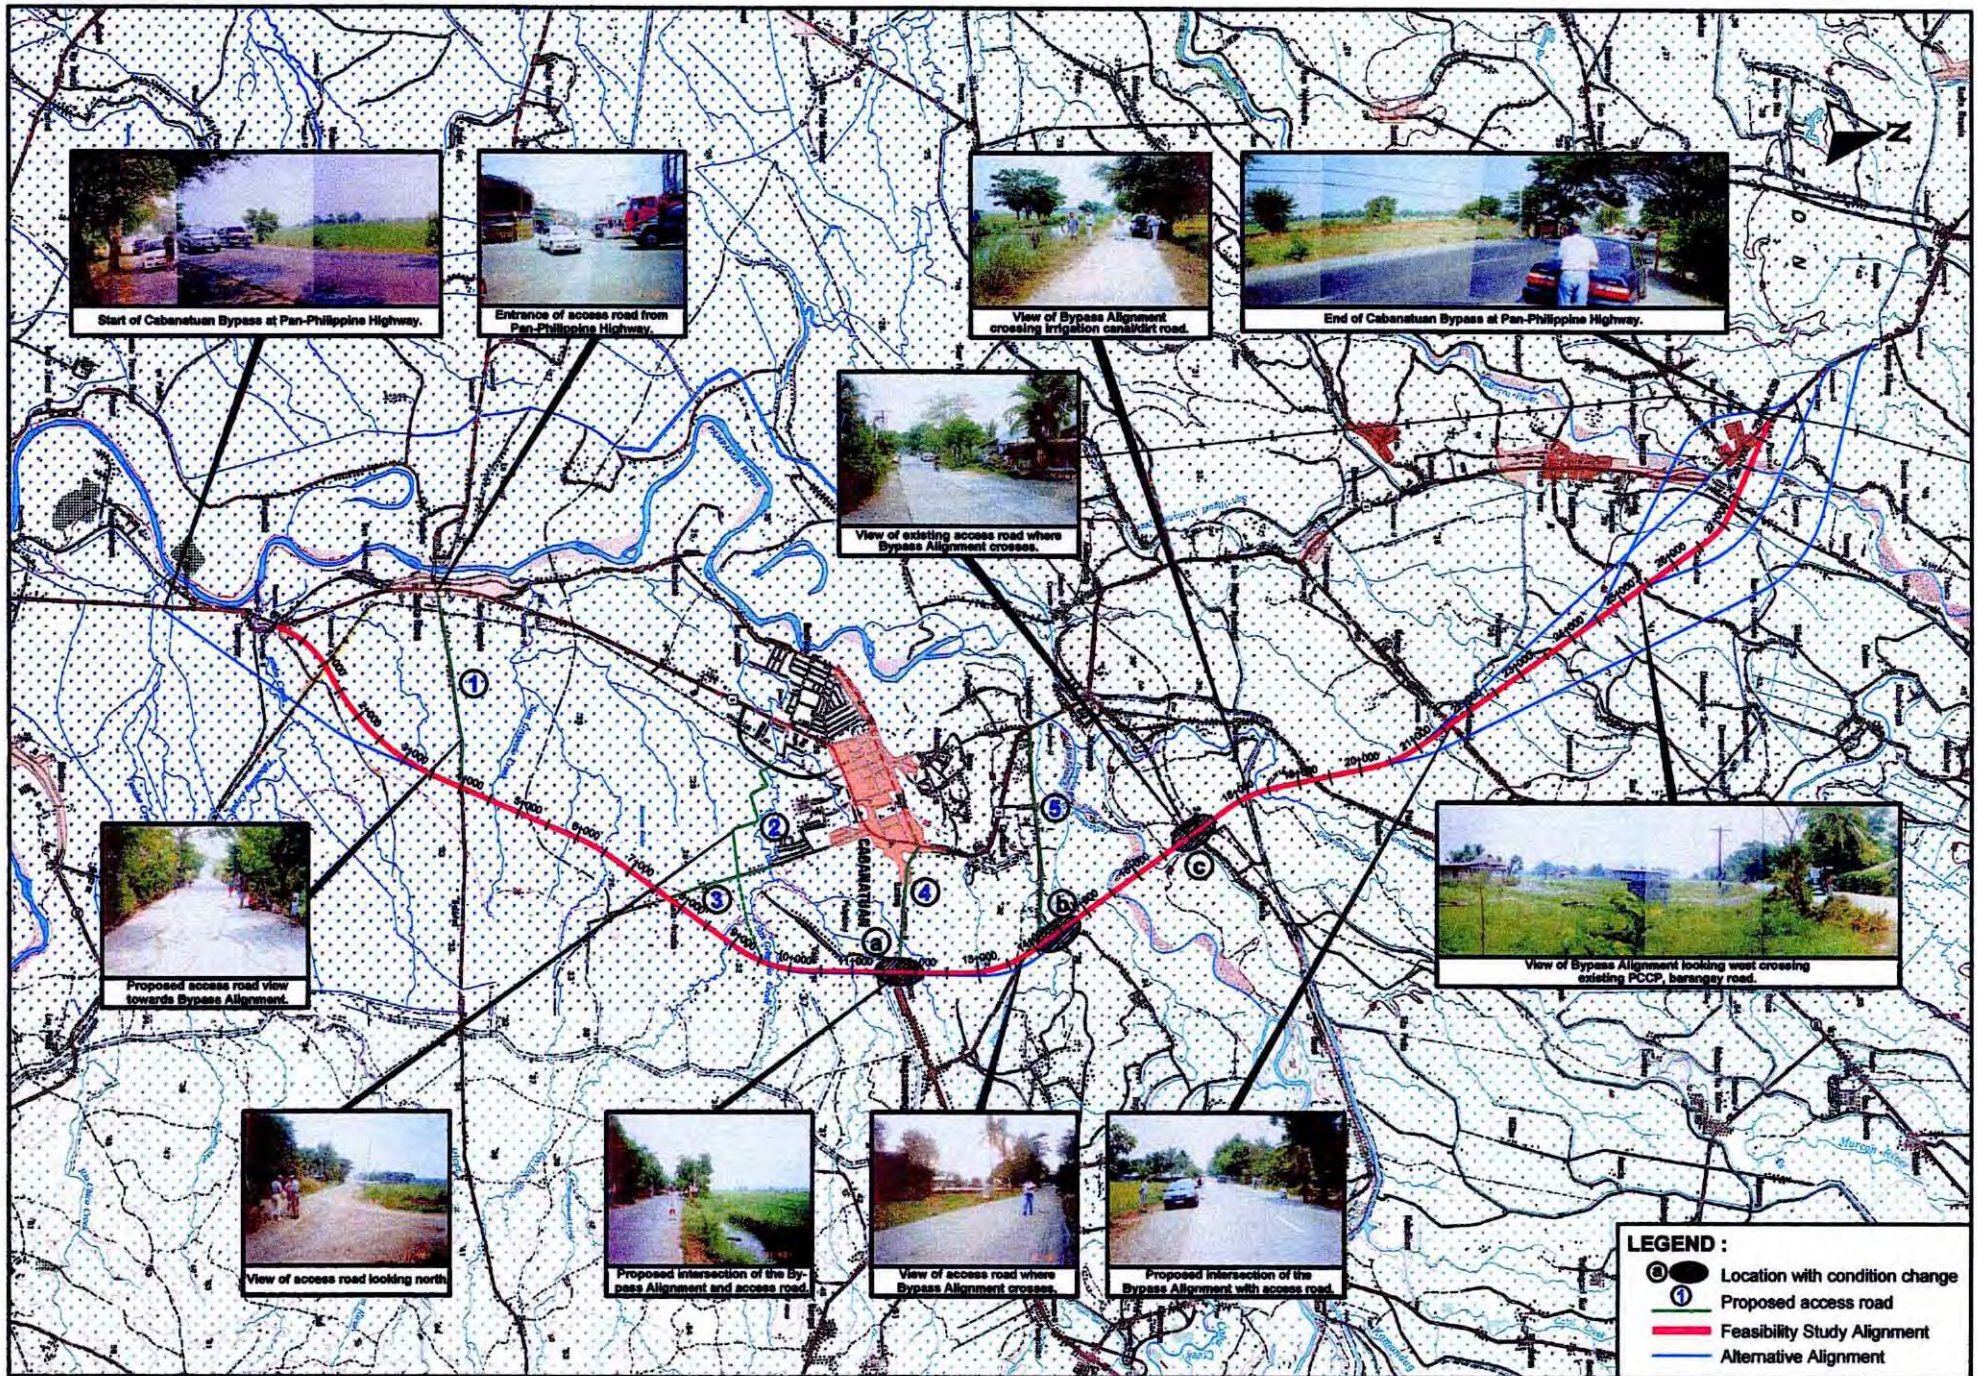
FIGURE 3.3-3 PRESENT CONDITION OF CABANATUAN BYPASS CORRIDOR

- a) At the intersection of proposed alignment with Nueva Ecija-Aurora Road at about Sta. 13+170, a permanent concrete house will be affected by the bypass corridor. The concerned structure can be avoided by shifting the alignment by about 30 meters towards east.

- b) At the intersection of the proposed alignment with a minor road just north of Valde Fuente-Fortaleza Road at about Sta. 15+970, six concrete houses will be affected by the bypass alignment. An alternative alignment needs to be studied to minimize structures to be affected.

- c) At the intersection of proposed alignment with a road at approximately Sta. 18+570, a small barangay chapel will be affected. An alternative alignment to avoid the chapel is not feasible because of the existing learning center located at the east and permanent concrete houses at the west side of the F/S alignment. The barangay chapel will be proposed for relocation.

- e) There were no changes to the condition of the proposed alignment at the beginning and end points as these locations were selected outside high density residential areas along the Pan-Philippine Highway. At the end section, the F/S alignment requires a long bridge to span over Talavera River, therefore, alternative alignments needs to be studied to select a more economical alignment.

- 1) *Magsaysay Road* - This 3.10km long provincial road consisted of 6.10m wide travelway with no identified shoulder, although 0.50m and 1.50m shoulders on both sides will be provided at built-up sections and at rice paddies, respectively. The existing PCCP pavement was fairly new but cracking and depression at several locations were rampant. This condition was seemed to be a clear indication of subgrade failure. No flooding was identified throughout the section.

- 2) *Cabanatuan-Papaya Road* - This 1.80km portion of a provincial road consisted of 6.10m wide travelway with 2.00m wide unmaintained shoulders. The existing pavement was in good condition but flooding to 0.30m deep at proposed intersection with the bypass alignment occurred during heavy rains.

- 3) *New Access Road* - This new road will directly connect the bypass road to the Circumferential Road in Cabanatuan City. The portion of the road from the bypass alignment to Cabanatuan-Papaya Road intersection which will traverse through rice paddies was still non-existent. From this intersection to the Circumferential Road, the existing road was 6.50m wide paved with gravel. Per interview with local residents, a knee deep flooding usually occurred during heavy rains.

- 4) *Nueva Ecija-Aurora Road* - This 2.05km portion of a national road consisted of 6.10m travelway with 1.80meter shoulders. Distresses such as potholes and crackings were observed in the section. No occurrence of flooding was recorded.

- 5) *Valde Fuerte-Fortaleza Road* - From Pan-Philippine Highway to approximately 2 km towards east, the road consisted of newly constructed pavement with sections still under construction. The new pavement was 6.10m PCC with 0.50m shoulder. The remaining 1.50km was still gravel paved.

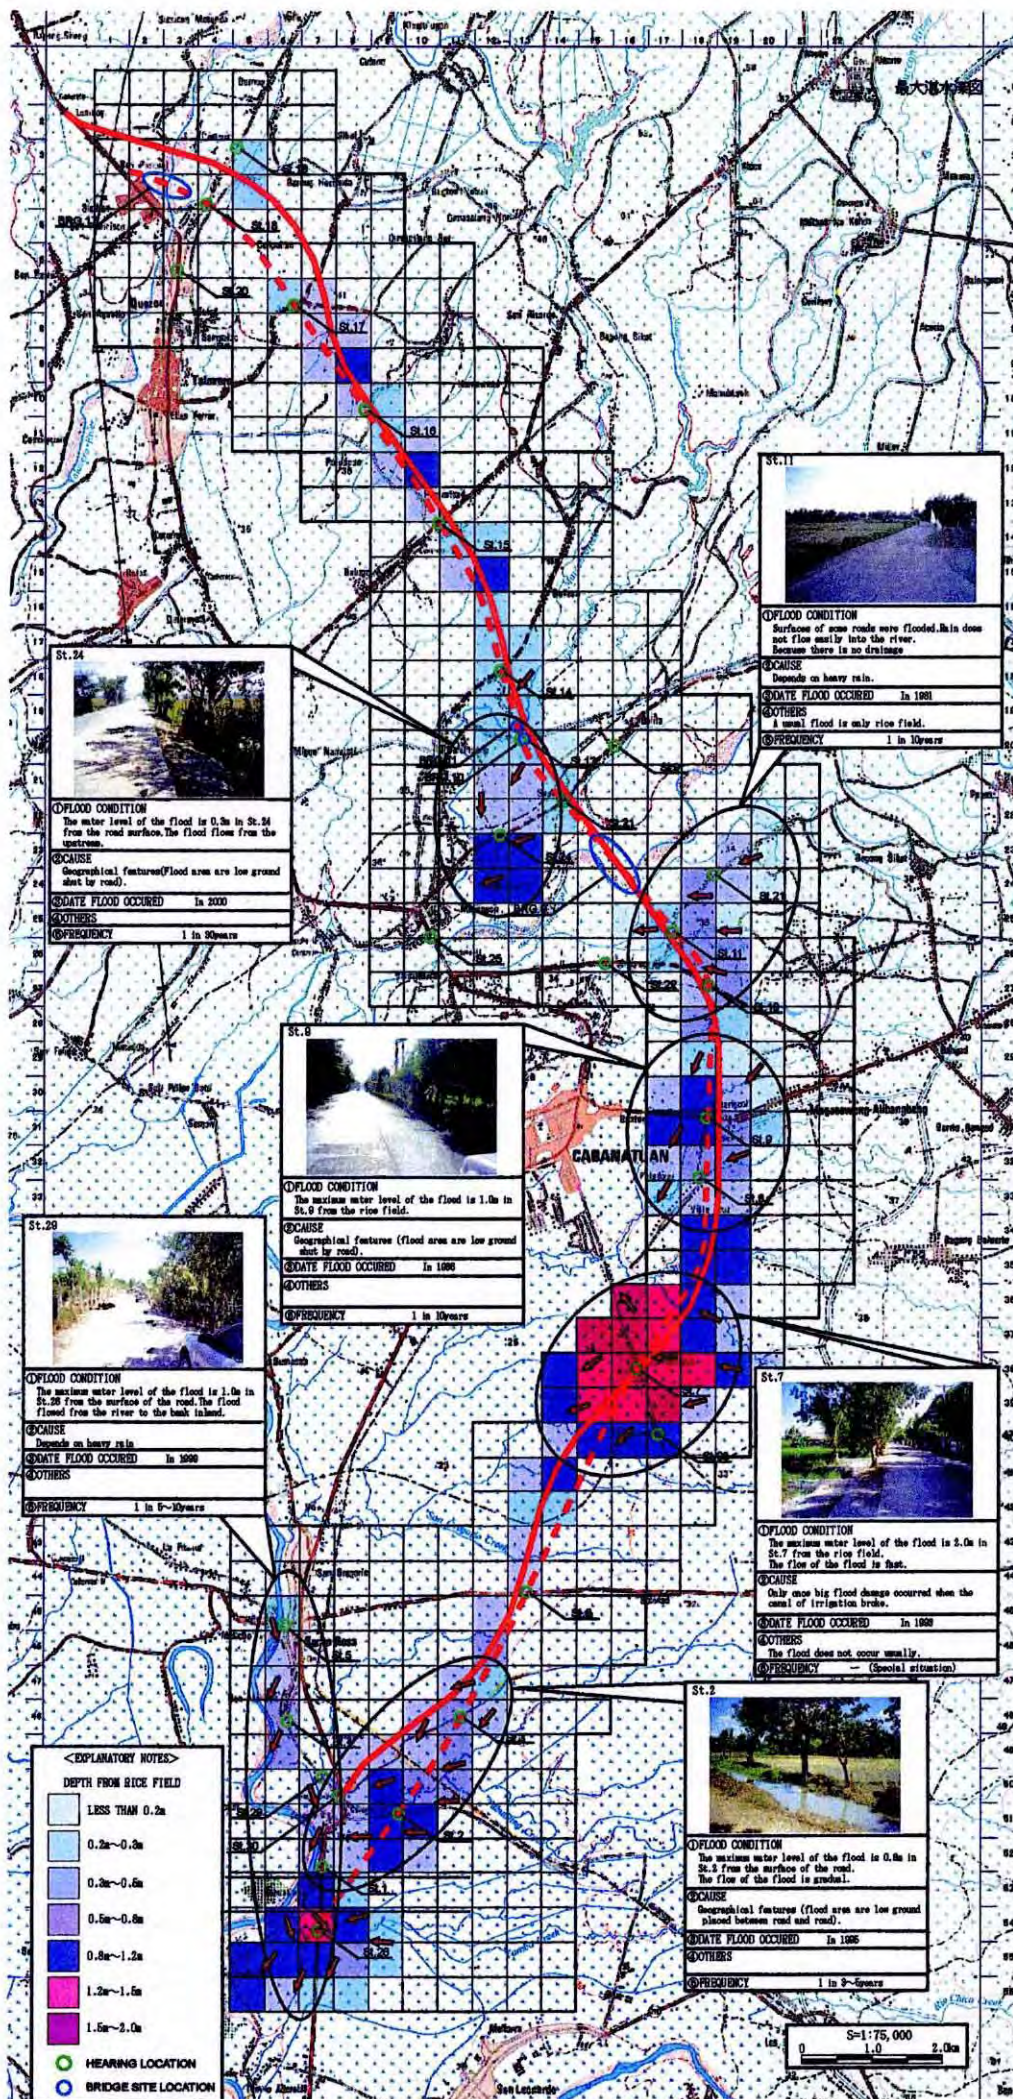
FIGURE 3.3-4 FLOOD AREA MAP (CABANATUAN BYPASS)

- d) Flood sections were identified as shown in Figure 3.3-4.
 - The beginning point of the alignment along Pan-Philippine Highway (km Post 102+650) up to Sta. 03+700 was identified as the flood section. This was confirmed during interview with local residents, that water from Pampanga River flows across Pan-Philippine Highway (Km Post 102 to Km Post 104) towards the direction of the bypass alignment.

- Half meter flooding has occurred at the intersection of the proposed alignment with Cabanatuan-Papaya Road during heavy rains. Different kinds of pavement distresses such as wide cracking and depression was evident at this location.

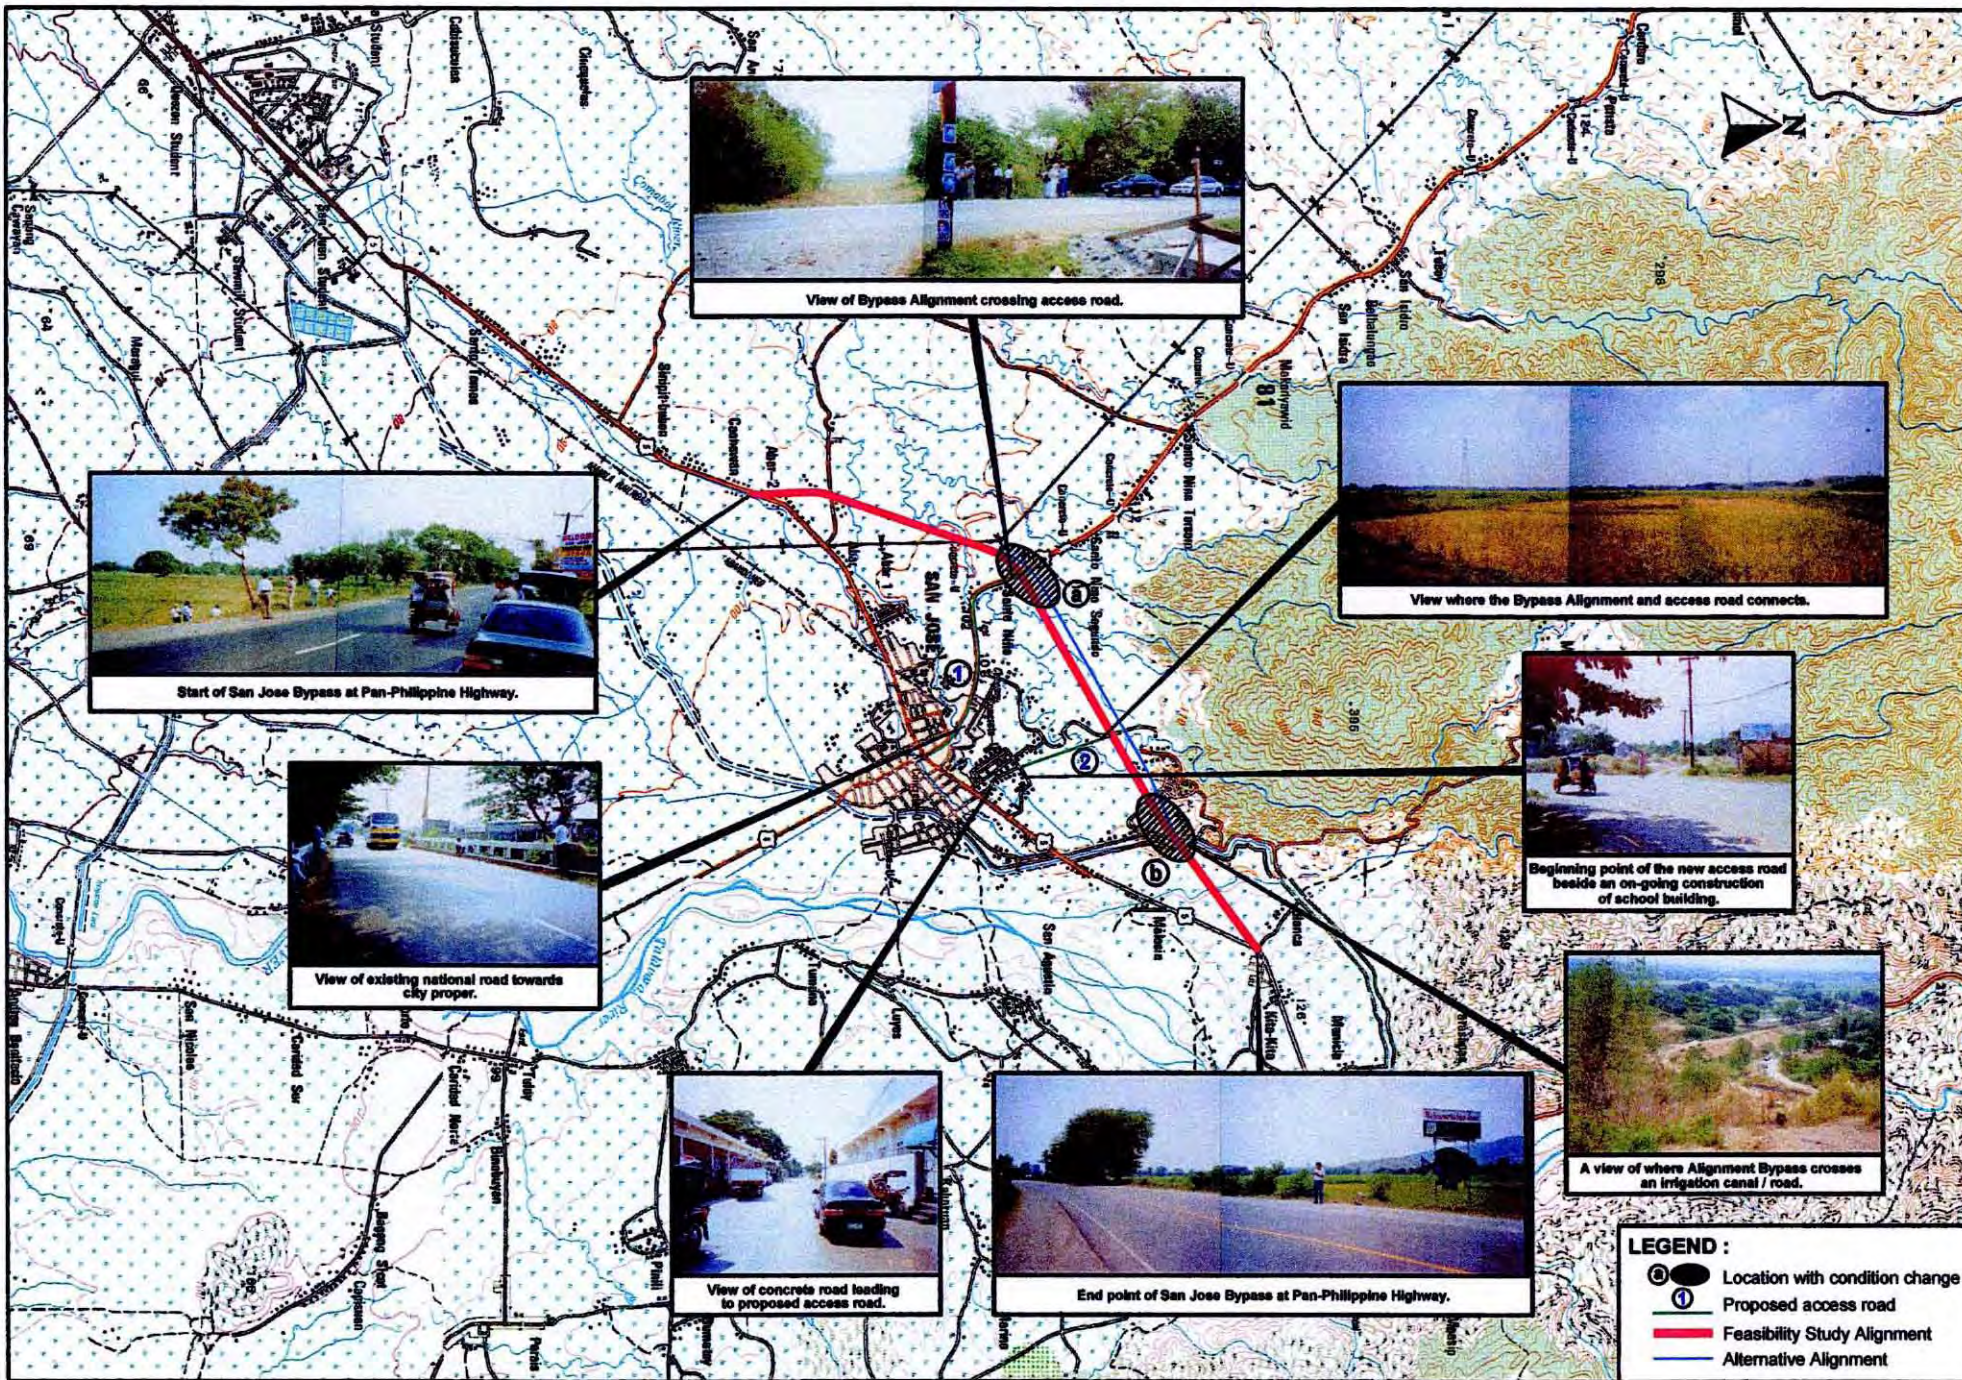
FIGURE 3.3-5 PRESENT CONDITION OF SAN JOSE BYPASS CORRIDOR

- a) At the intersection of proposed alignment with Nueva Ecija-Pangasinan Road at about Sta. 2+850, on-going construction and newly built concrete houses will be directly traversed by the bypass alignment.
- b) At about Sta. 05+100 to Sta. 05+400, the proposed alignment traverses on swampy area. An alternative alignment west of the F/S alignment needs to be studied to avoid this area.
- c) There were no changes to the condition of the proposed alignment at the beginning and end points as these locations were selected outside the high density residential areas along the Pan-Philippine Highway.
- d) Identified flood sections are shown in Figure 3.3-6.

- 1) *Nueva Ecija-Pangasinan Road* - This 2.25km long national road consisted of 6.10m wide travelway with 1.80m shoulders. The present PCCP and PCCP with AC overlay was in good to fair condition. No flooding occurred in the area.
- 2) *New Access Road* - The 1.67km of roadway was still non-existent but would be traversing through rice paddies. The proposed road will directly connect the proposed Bypass with the existing Pan-Philippine Highway. No flooding occurred in the end points of the access road.
