CHAPTER 5
SURVEY RESULT AND IDENTIFICATION OF
POTENTIAL SPOTS

5.1 NIC.1

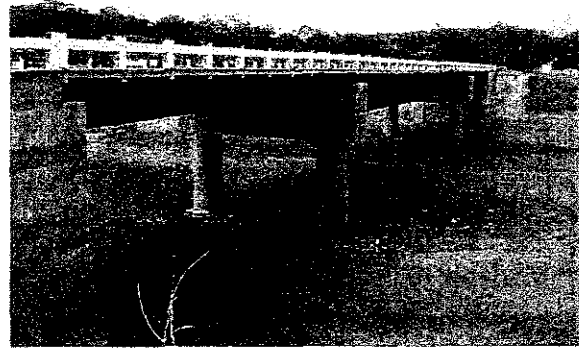
Photo 5.1.4 Los Encuentros Bridge

The lengths of the four new bridges on NIC.1 (Las Maderas, Sebaco, Ducuali and Los Encuentros), are all more than 50m. Las Maderas and Sebaco bridges were constructed as single spans in 1997 with aid from the Government of Japan, replacing old deteriorated bridges. Ducuali and Los Encuentros bridges were reconstructed with the help of BCIE. Ducuali Bridge is now a three-span construction with a rigid frame pier. Los Encuentros Bridge is a single span (shown as Photo5.1.4). The remaining bridges have the following characteristics:

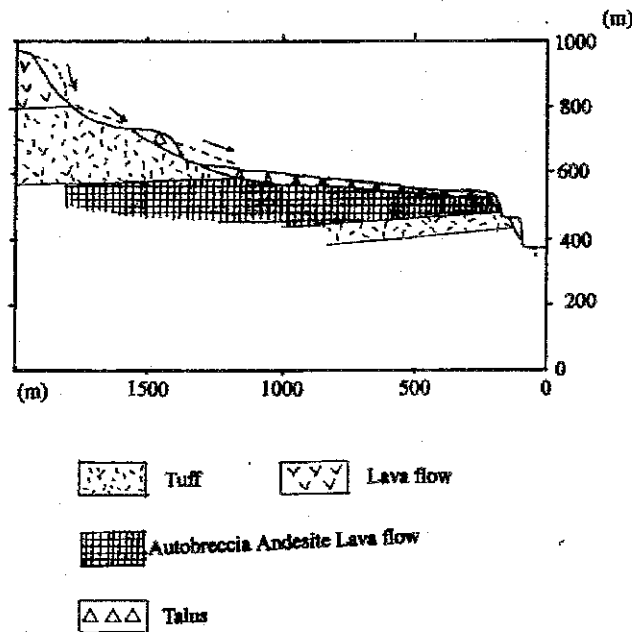
Figure 5.3.1 Schematic Profile of Collapse Site on NIC.5

As seen from the figure, it is presumed that the collapse occurred when the flat area on the upper part of the slope became catchment area and infiltrated into the talus deposits and the weathered zone of bedrock from near the boundary of talus deposits and pyroclastic lava flow which appeared on the slope by chance were engulfed. The tuff near the slope end and the bedrock thereupon are left as it is, and such deep landslide as passing under the national road of NIC.5 is not found. The angle of repose of the collapsed soil as left behind being 20-30°, it can be presumed that some parts of the collapsed soil fell down into the marsh over the road taking into account the water conditions at the time the collapse. The thickness of talus deposits is over 10 m even at the point going round in the direction of North, and clear collapsed topography is seen on the mountain above the slope. Therefore, it is judged that the whole ridge on the slope with 1.2 km width has problems as bedrock. Moreover, old cracks are found on the slope shoulder of NIC.5 in villages at El Tuma near 9.8 km point from Ladaria, therefore, any alteration should be checked in rainy season.

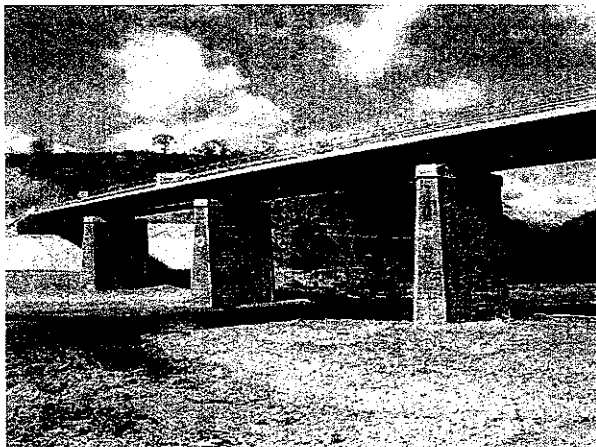
Photo 5.4.1 Ocotal Bridge

Ocotal Bridge (Photo5.4.1) crosses the Rio Coco and other bridges cross the Dipilot river, which is a tributary of Rio Coco. Road and bridges in this section are under rehabilitation and improvement work to damage caused by Hurricane Mitch (aided by the Government of

There were two plans for reconstruction of Ocotal Bridge. The first is to replace the superstructure on existing substructure, (capable of meeting 100 year demand) and the second one is the construction of a new bridge 30m downstream side that could deal with a disaster on the scale of Hurricane Mitch. The first plan seems to have been carried out, new bridge is observed to using the existing substructure with good protection for revetment around abutment. However traces of scouring around the pier we observed by this study team at the Ocotal Bridge site.

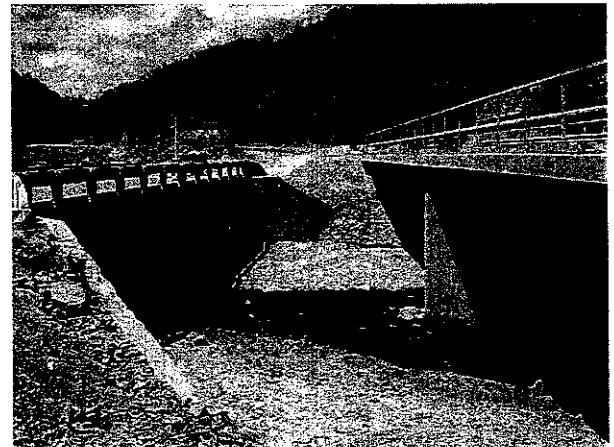
Photo 5.4.2 San Fabian Bridge

The improvement project reported four other bridges had some erosion damage at the feet of the stone masonry abutments and at the wingwalls. At San Fabian bridge, the road embankments were completely washed away during flood.

Traces of erosion damages can be seen at all wingwalls and the traces of scour problems are apparent in some places, with some these already repaired by Gabion (see Photos 5.4.2 to 5.4.5)

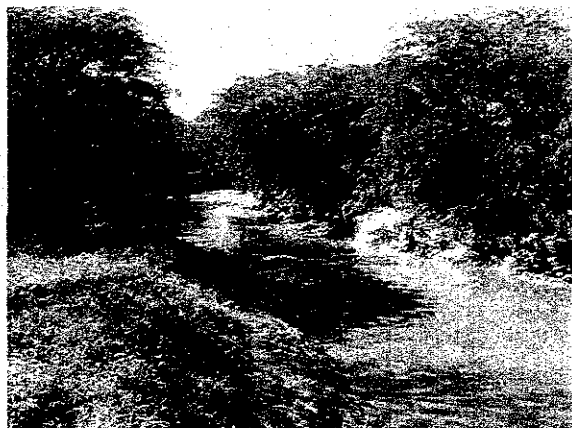
Photo 5.5.3 Estero Real

El Guarumo Bridge and Estero Real Bridge, located at the Western end of NIC.24, did not suffer much damage. However the area around Estero Real Bridge is very low lying and floods every three years. On average the water overflows the bridge every five years, owing to tidal influences (Photo 5.5.3).

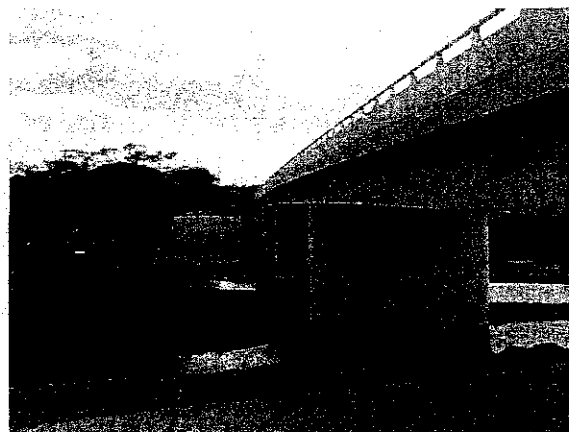
Photo 5.5.4 Rio Negro Bridge

sand riverbeds. There are thick layers of weak strata in and around Estero Real Bridge. Most scouring has already been repaired., but traces of scouring around the substructure on Rio Negro Bridge and La Culebara Bridge were found (Photos 5.5.4, 5.5.5).

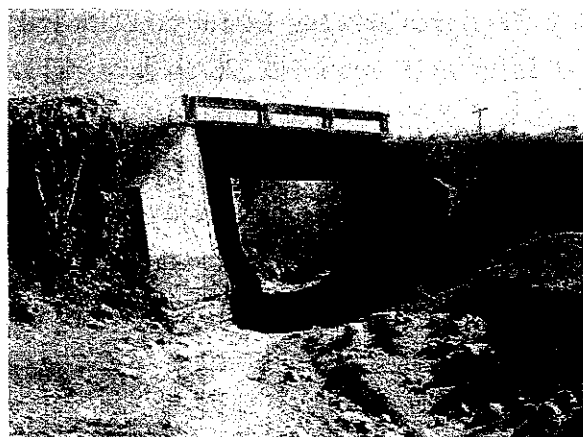
Photo 5.6.4 Solis Bridge

There a lot of short span bridges that length is less than 10m in lowland area, and we confirmed that abutment protrude into the river at some bridges. Quimera Bridge and La Milagrosa bridge already repaired, existing approach road replaced new arched bridge with three (3) spans. Furthermore in Los Pedrones Bridge, there is new barrage in downstream side for improvement riverbed grade. But some bridges haven't repaired as shown in Photo 5.6.4 and 5.6.5
