CHAPTER 8
NATURAL CONDITION SURVEY

8.1 General

8.1.1 Purpose of Survey

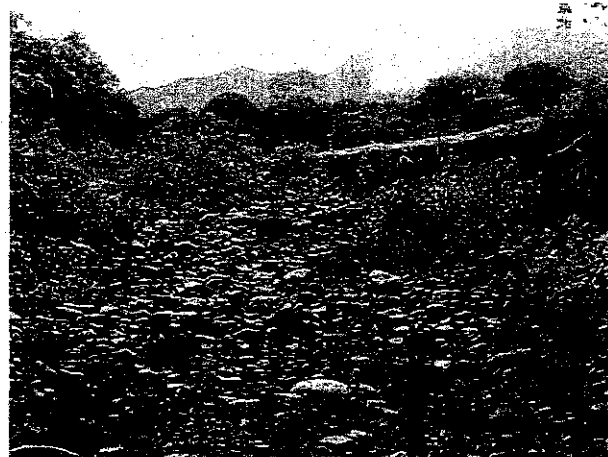
**El Guayacán Left Channel Upstream
the Bridge**
n= 0.027

- ii) **El Guayacán**: The channel is not capable at all to withdraw flows lower than 185.29 m³/s corresponding to 25 years return period flow. The bridge structure is composed by arcs, such shape produce higher resistance values by contracting the flow section. Therefore the flow resistance of the structure will increase the water levels values given. Considering this situation, a peak flow value supposed to reach the bridge line was estimated, corresponding to a value of 35 m³/s (<1.5 years return period). The value found could be lower if the bridge structure is considered in the analysis. Water levels for 25, 50 and 100 years return period given as results are not physically right, the reason in giving it is just to illustrate about the magnitude reached for these return periods. In the interview done to verify the result of the water supply analysis, overflow has been happened above bridge about 2-3 times a year.

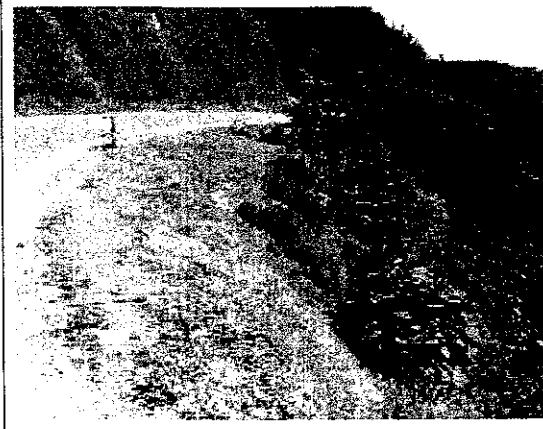
<p>Example of Type-B</p>	<p>Serial-No.32 (ID- No.003C150) It is in geographical features of the slope and there are weathering of tuffs, which influence easily and an argillation in a slope movement. And, there is small-scale movement (The flat terrain forms to the leg of the cliff like the belt) in the slope. And, the difference has been generated in the shoulder. The change in the geological features composition is understood by executing the bore in two or more.</p>

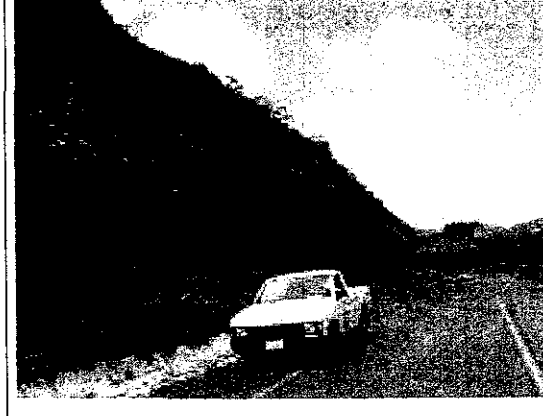
<p>Example of Type-C</p>	<p>Serial-No.35 (ID- No.005A010) Example of inclusion of face of slope collapse shown in NIC.5 of seepage water of stratum composition and lava plateau on back slope and influence on stability of the entire face of slope. Because height the face of slope and width require the examination of stability including the entire road long, plural bores are executed by arrangement to be able to do an overall evaluation.</p>

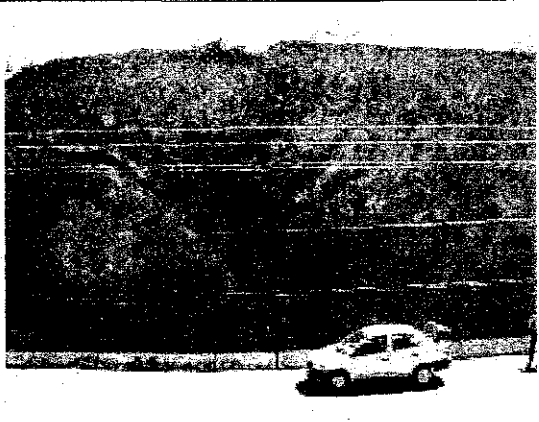
<p>Example of Type-D</p>	<p>Serial-No.22 (ID- No.001A010) There is no vegetation and it is a bedrock situation of the entire face of slope and the rock eyes are composed on the mass of agglomerate because of the andesite lava flow of the receiving board. The evaluation of the degree of weathering and stability is possible cases in watching enough.</p>

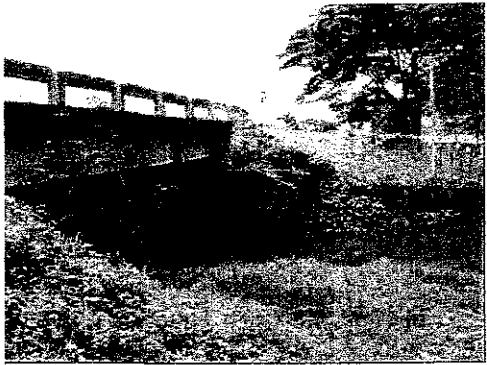
<p>Type- α</p>	<p>Serial-No.4 (ID- San Ramón) It is a bridge in the comparatively short length of bridge laid on geographical features in which the change does not exist in the plain part. As for the stratum composition, a big change need not be assumed in both banks, and a geological features composition and thickness, etc. boring singular average are appreciable.</p>

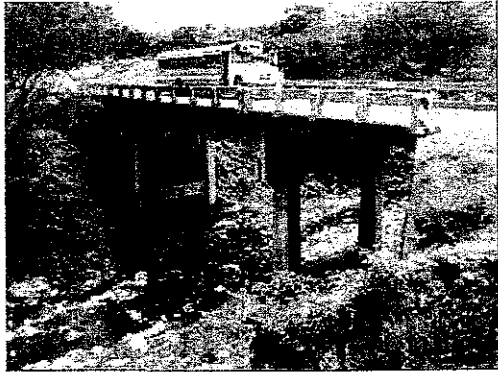
<p>Type- β</p>	<p>Serial-No.45 (ID- La Banderita) The bridge exists in sag vertical alignment in the valley of the mountainous area. There is a possibility that there is a change in the stratum composition in the right side shore and left bank in the river. It executes two or more bores and the geological features composition and thickness, etc. are evaluated by doing.</p>
