Table 17.2.5 Present Condition of Objective Bridges (1/3)

### 17.3 Preliminary Engineering Design of Slope Stability

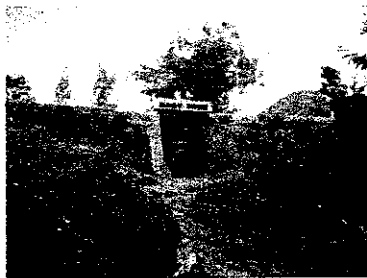
Papalón	<ul style="list-style-type: none"> <li>(i) The scouring of the bridge foundation is serious, and the level of the riverbed is 30-40 cm lower than the bottom of the abutment footing due to erosion.</li> <li>(ii) The level of the riverbed has become lower not only at the bridge but throughout the whole river channel as well. For that reason, there is no considerable change in vertical alignment at the bridge.</li> <li>(iii) The width of the river at the bridge is narrower than upstream and downstream. Because of the progress of erosion, the H.W.L and the free space under the beam are adequate.</li> <li>(iv) The riverbed is relatively solid, but it is covered by the powdered fine-gained soil about 10cm thick, which would be washed away easily if there were a strong water flow.</li> <li>(v) The back of the bridge wing on the upstream side has been eroded away largely.</li> <li>(vi) The slope of river is 2% and relatively steep, and there are a few obstructions. Therefore, the velocity of water flow is fast even if the total water volume is quite small.</li> </ul>

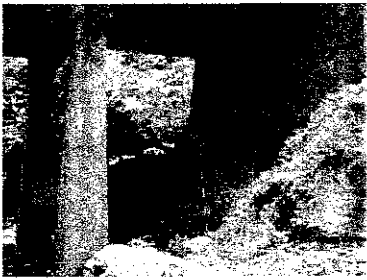
La Banderita	<p>(i) Although piers are rigid-framed, there is little scouring around the piers.</p> <p>(ii) Although the bottom of the abutment is about 3 meters higher than the riverbed, erosion has proceeded to the front of the abutment due to the small distance between the pier and the slope (about 2 meters).</p> <p>(iii) The abutment seems to be bedded on weathered tuff. Note that weathering is severe at the exposed part of the front of the abutment.</p>
