Appendix B1: Bridge Conditions (Chapter17)

Appendix B1 Bridge Conditions

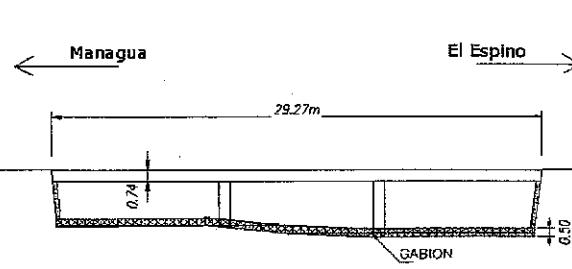
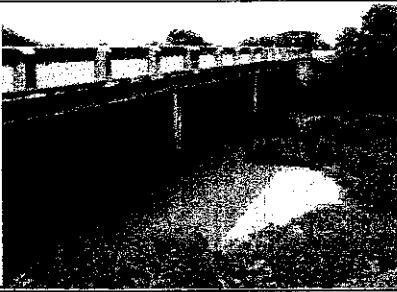
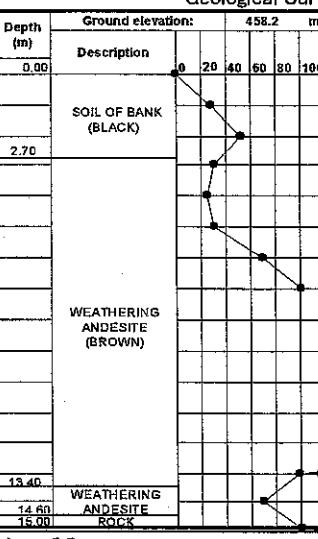
Table B1.1 Bridge Conditions (Junqillal)

Q for maximum velocity	m ³ /s	0.445		Description	0	20								
Analysis result	cathment area	km ²	49.8	0.00	40	60	80								
	Runoff Coefficient		0.46		100										
	Rainfall intensity (mm/h)	25years	38.7	2.70	SOIL OF BANK (BLACK)										
		50years	43.1												
		100years	48.1												
	Peak discharge (m ³ /s)	25years	246.28	13.40	WEATHERING ANDESITE (BROWN)										
		50years	274.28												
		100years	306.1												
	Velocity (m/s)	25years	1.86	14.50	WEATHERING ANDESITE ROCK										
		50years	1.89												
		100years	1.91												
Reflection of Countermeasure															
<p>(i) The lands are used as paddy fields both in upstream area and downstream area. Even in the dry season, water remains around the bridge.</p> <p>(ii) Although, even in the rainy season, the river doesn't seem to have water flow, the trace of river scouring is seen on the upstream side of bridge (the size of scouring is 5 meters from the pier to upstream channel).</p> <p>(iii) Because owing to the remaining water it is impossible to see through the bottom of scouring, the bottom of scouring seems to be deep, judging from the size of remaining water in upstream side</p> <p>(iv) The mad generated by scouring seems to be piled up in the downstream side.</p>

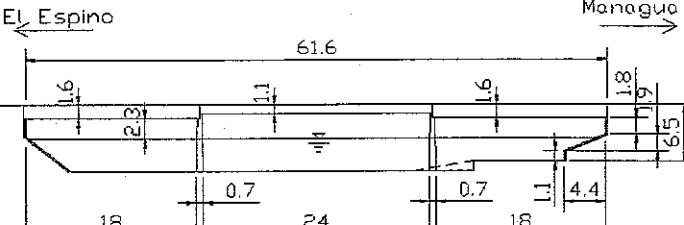
Table B1.3 Bridge Conditions (Las Chanillas)

(i) There is a large size of scouring around the piers. (ii) The vertical alignment of river channel is steep around bridge. The level of riverbed has descended because of the scouring of bridge foundation. (iii) No large abnormality is seen around abutments.

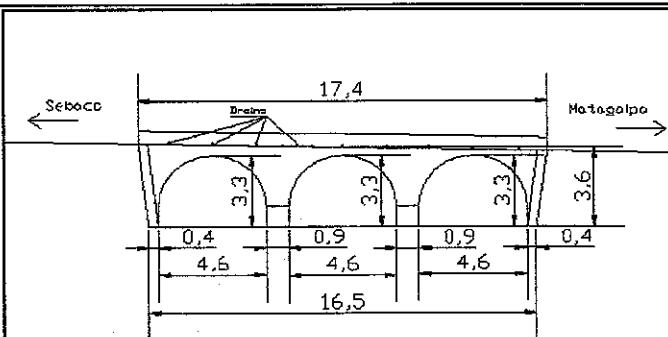
Table B1.7 Bridge Conditions (El Guayacan)

(i) The type of bridge is arched one, and the obstruction ratio is large (ii) Because the end side abutment subsided due to the scouring of bridge foundation, the wing of bridge was broken. (iii) The position of bridge does not correspond to that of river.

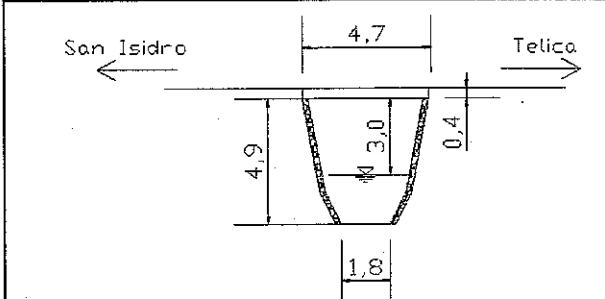
Table B1.9 Bridge Conditions (Papalon)

Runoff Coefficient		0.46								
	Rainfall intensity (mm/h)	25years	105.9								
		50years	114.7								
		100years	123.4								
		Peak discharge (m ³ /s)				WEATHERING TUFF (BLACK)					
		25years	8.12								
		50years	8.79								
		100years	9.46								
		Velocity (m/s)				ANDESITE (DARK BROWN)					
		25years	2.47								
		50years	2.61								
		100years	2.76			WEATHERING TUFF (LIGHT BROWN)					
		Clerance (m)									
		100years	3.00			WEATHERING ANDESITE					
Reflection of Countermeasure											
<p>(i) The scouring of bridge foundation is intense, and the level of riverbed is 30~40 cm lower than the bottom of footing of abutment due to the erosion.</p> <p>(ii) The level of riverbed has descended not only a to the part of bridge but also whole river channel. For that reason, there is no considerable change in vertical alignment at the part of bridge.</p> <p>(iii) The width of river at the bridge spot is narrower than in the upstream and downstream. Because of the progress of erosion, the H.W.L and the free space under the beam are adequate.</p> <p>(iv) The riverbed is relatively solid, but it is covered by the powdered fine-gained soil whose thickness is about 10cm. So that soil would be washed away easily if there were water flow.</p> <p>(v) The back of upstream side of wing was eroded largely</p> <p>(vi) The slope of river is 2% and relatively steep. And there is a few obstructions. So the velocity of water flow is fast even if the amount of water flow is quite small.</p>
