CHAPTER 5
IDENTIFICATION
OF DISASTER PREVENTION SPOTS

5.1 Natural Condition Survey

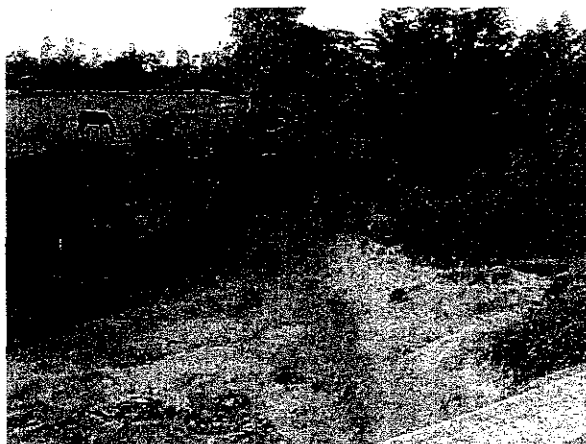
Solís main channel upstream the bridge $n = 0.016$

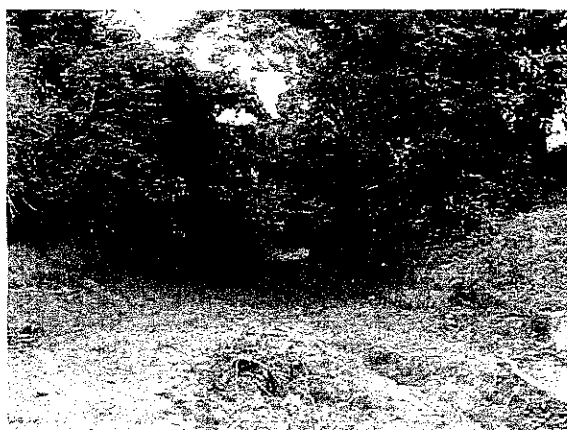
Papalón main channel upstream the bridge $n = 0.016$

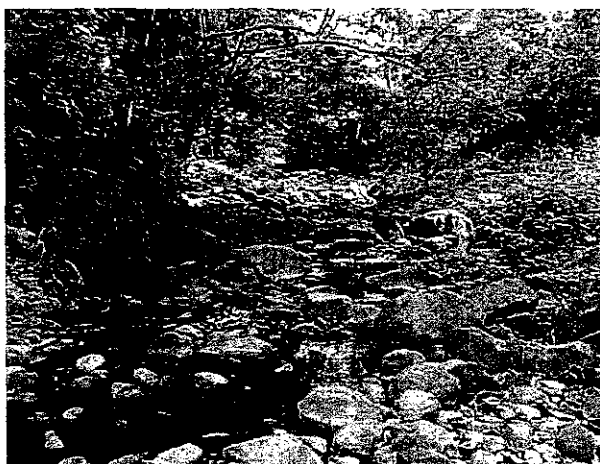
San Nicolás main channel upstream the bridge $n = 0.020$

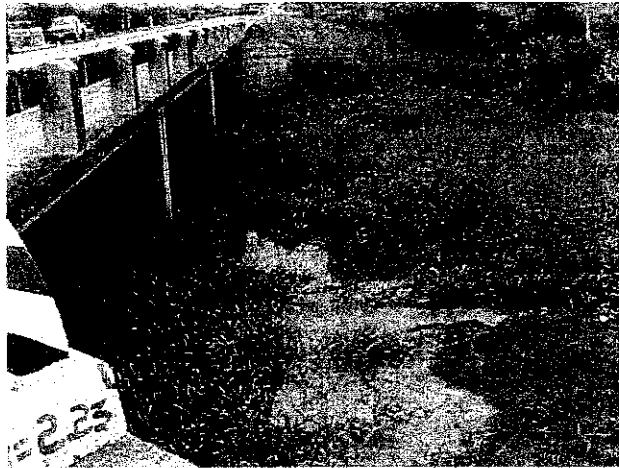
El Junquillal main channel upstream the bridge n = 0.027

3 Junquillal	The length of bridge is short and the surrounding area is flat. The geological alteration in right and left banks seems to be little. One (1) borehole shall be enough to evaluate.	According to the boring survey result, the weathered belt, most of which has already changed into soil, exists up to 3 meters depth. There is a weathered andesite belt with many cracks at the level deeper than 3 meters depth. Some part of the andeste has changed into soil, but those altered andesite cannot affect the bearing capacity, exsitting size of the bridge.

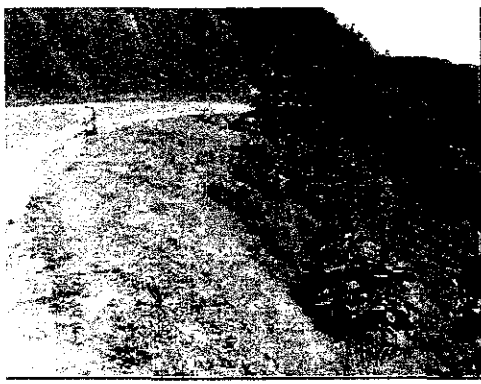
<p>Example of Type-B</p>	<p>Serial-No.32 (ID- No.003C150) It is in geographical features of the slope and there are weathering of tuffs, which influence easily and an argillation in a slope movement. And, there is small-scale movement (The flat terrain forms to the leg of the cliff like the belt) in the slope. And, the difference has been generated in the shoulder. The change in the geological features composition is understood by executing the bore in two or more.</p>

Serial No.	Site situation	Survey result
32 N003C150	The geographical change and decay are remarkable to some extent. In order to study the decay including the current road, 2 boreholes shall be selected.	As a result of boring, tuff are weathered and become soil to some extent at the fairly deep level. There is "water passage" at the level of 7 meters or deeper on this site, too. The road surface drainage and seepage water treatment in fill shall be required.
33 N003C140	A decay on the middle section of fill was caused by the penetrating water from mountain side. The decay is remarkable. In order to study the decay including the current road, 2 boreholes shall be selected.	The boring survey result shows that most of tuff has become soil and constitute weathered belt at the fairly deep level. The stability on the whole slope face shall be required.
34 N003B120	There is a face of steep slope consisted of black schist. And there is a dip slope on the schistosity face. The weathering and soundness of hard rocks shall be confirmed. one(1) borehole shall be selected.	The boring result shows that weathered black schist of rocks distribute on the lower part to same extent as on the slope face. There are many cracks. Almost of the schistosity forms are stable directions, but some part of face forms dip slope

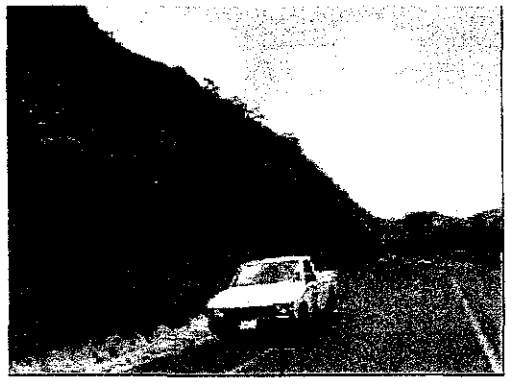
<p>Example of Type-C</p>	<p>Serial-No.35 (ID- No.005A010) Example of inclusion of face of slope collapse shown in Nic-5 of seepage water of stratum composition and lava plateau on back slope and influence on stability of the entire face of slope. Because height the face of slope and width require the examination of stability including the entire road long, plural bores are executed by arrangement to be able to do an overall evaluation.</p>

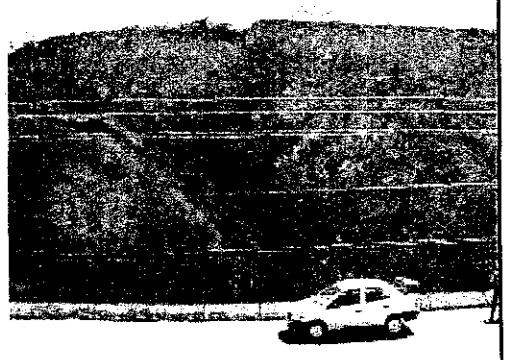
<p>Example of Type-D</p>	<p>Serial-No.22 (ID- No.001A010) There is no vegetation and it is a bedrock situation of the entire face of slope and the rock eyes are composed on the mass of agglomerate because of the andesite lava flow of the receiving board. The evaluation of the degree of weathering and stability is possible cases in watching enough.</p>

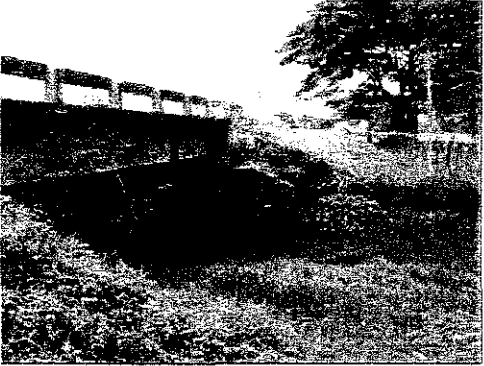
Type- α	<p>Serial-No.4 (ID- San Ramón)</p> <p>It is a bridge in the comparatively short length of bridge laid on geographical features in which the change does not exist in the plain part. As for the stratum composition, a big change need not be assumed in both banks, and a geological features composition and thickness, etc. boring singular average are appreciable.</p>

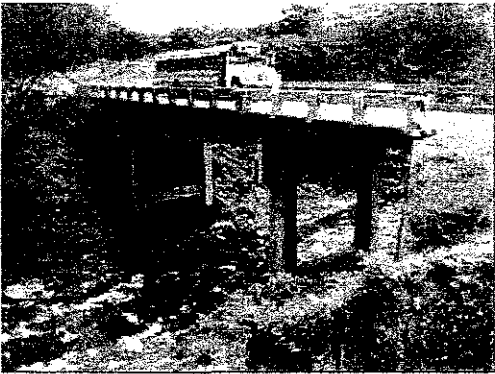
Type- β	<p>Serial-No.45 (ID- La Banderita)</p> <p>The bridge exists in sag vertical alignment in the valley of the mountainous area. There is a possibility that there is a change in the stratum composition in the right side shore and left bank in the river. It executes two or more bores and the geological features composition and thickness, etc. are evaluated by doing.</p>
