**BASIC DESIGN STUDY REPORT
ON
THE PROJECT
FOR
URGENT REHABILITATION OF
SINDHULI ROAD (SECTION IV)
IN
THE KINGDOM OF NEPAL**

FEBRUARY 2003

JAPAN INTERNATIONAL COOPERATION AGENCY

NIPPON KOEI CO., LTD.

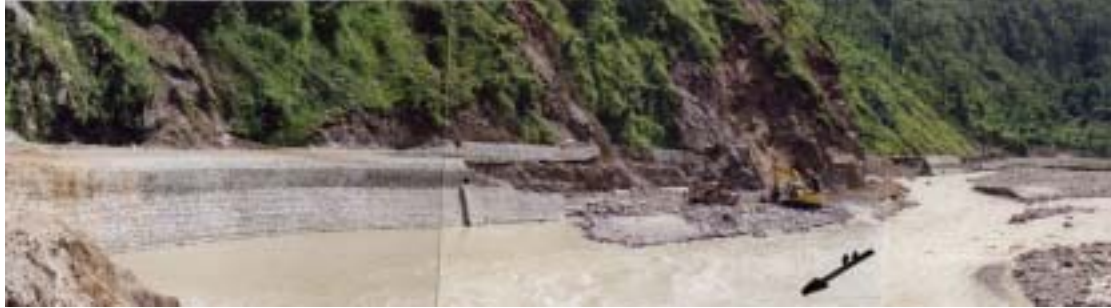
[No.16] STA.05+300 - 05+461 : Embankment washed away

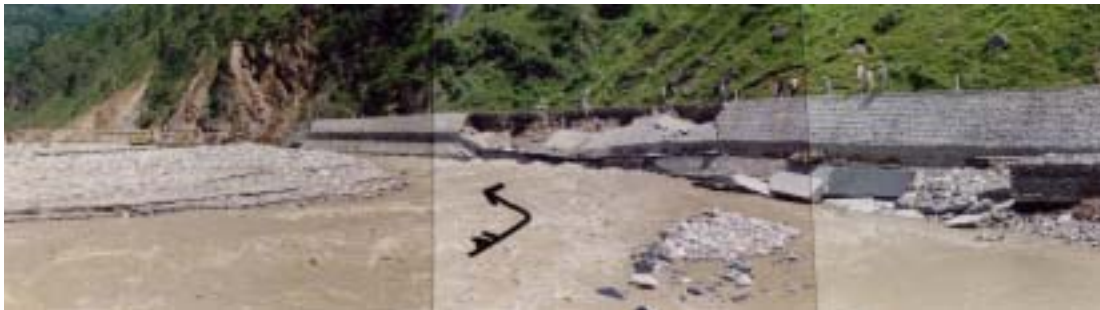
[No.17] STA.05+500 - 05+560 : Overturning of revetment

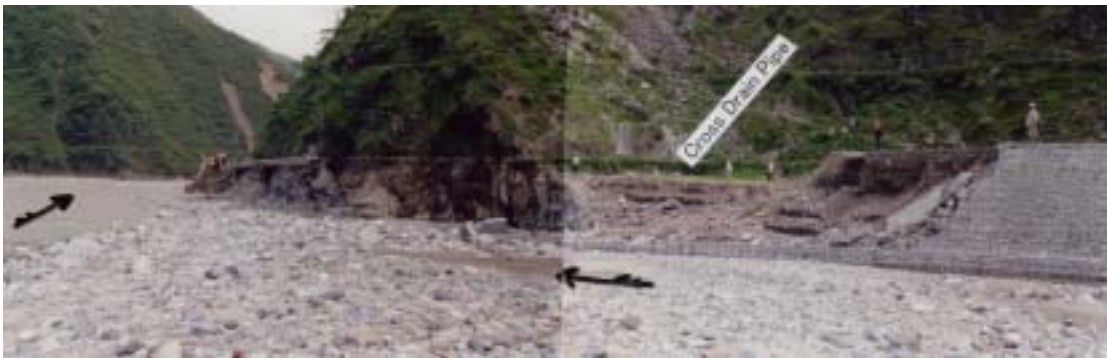
[No.18] STA.06+065 - 06+206 : Embankment washed away

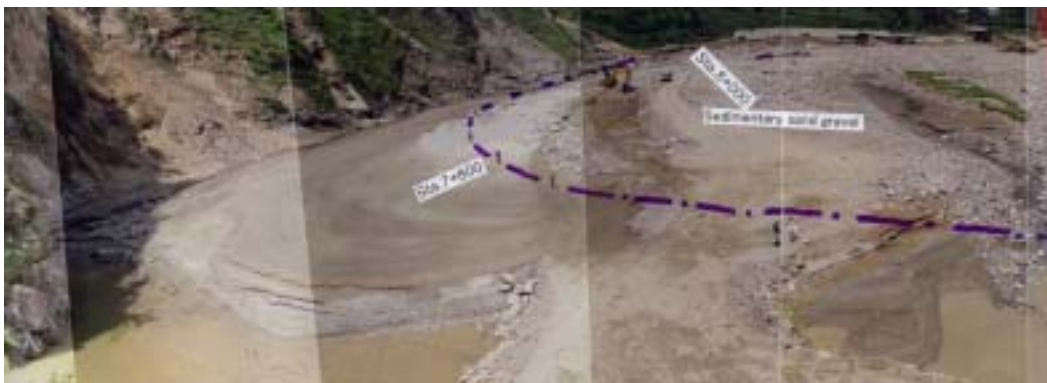
[No.24] STA.07+625 - 08+000 : Embankment washed away

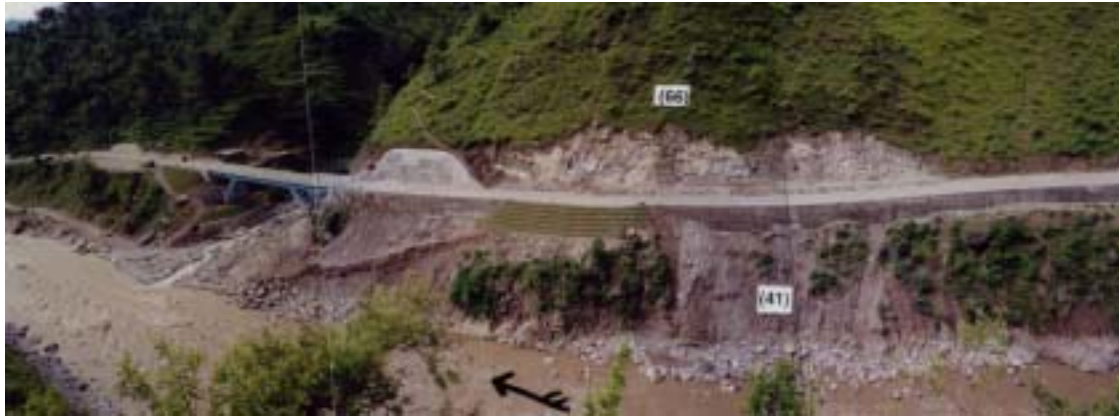
[No.41] STA.13+262 : Slope failure due to scouring

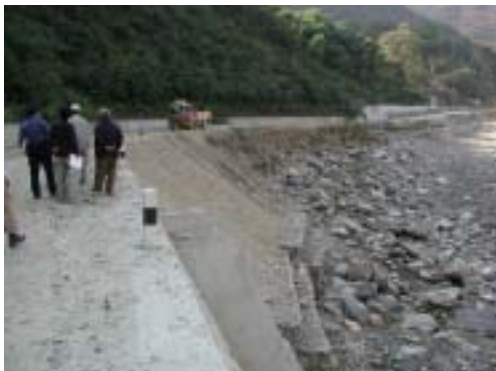
[No.44] STA.14+885 - 14+925 :
Erosion of riverbank
(Temporary work was done by DOR)

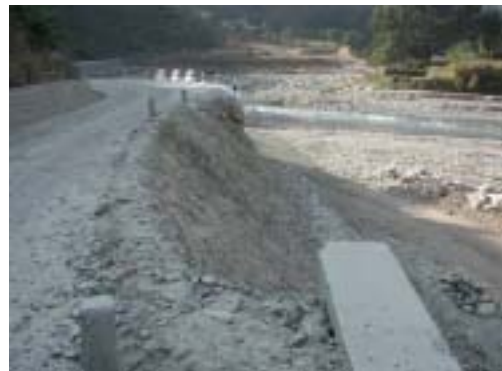
[No.50] STA.18+558 - 18+581 :
Embankment washed away
(Temporary work was done by DOR)

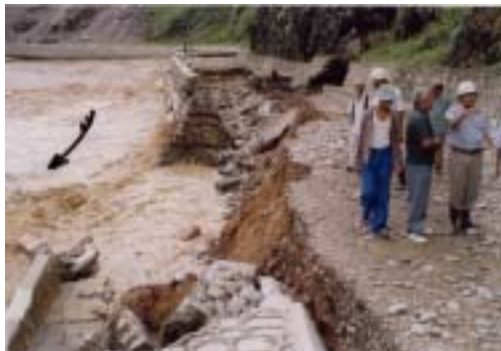
[No.65] STA.21+015 - 21+056 :
Embankment washed away

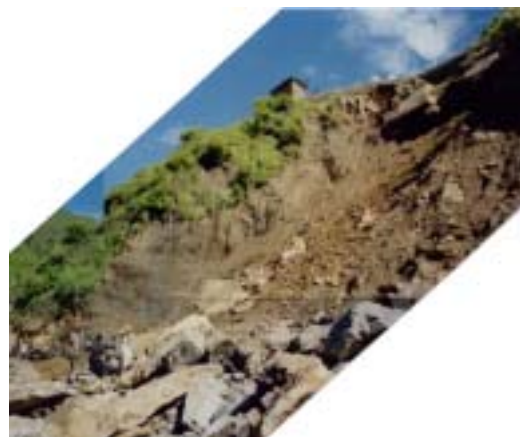
[No.66] STA.22+915 :
Slope failure due to scouring
