CHAPTER 3

CONTENTS OF THE PROJECT

3.1. Basic Concept of the Project

The Project (Urgent Rehabilitation of the Sindhuli Road Section IV) aims to restore the damage of the Project Road caused by the heavy rain during July 2002 to achieve the objectives of the Sindhuli Road Construction Project stated in Chapter 3.1.1.

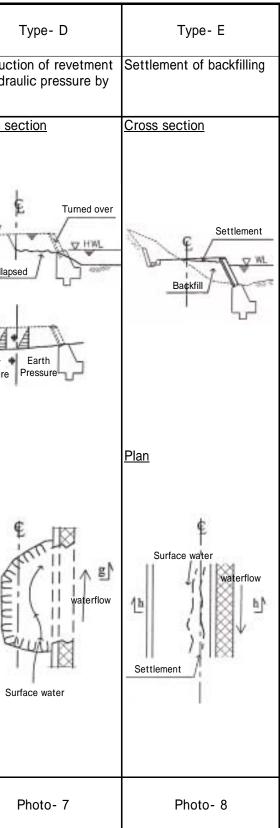
Figure 3-2 Types of Damages

- Type-A: Erosion of road surface by surface water
- Type-B: Scouring (can be further classified into following 4 types)
 - B-1: Crack and/or settlement of road surface
 - B-2: Depression of road surface
 - B-3: Overturning of revetment
 - B-4: Washing away of embankment
- Type-C: Washing away by overflow
- Type-D: Destruction of revetment due to excessive hydraulic pressure
- Type-E: Settlement of backfilling
- Damage of gabion box, concrete pavement, approach road and deposition of Debris at causeways

Тур	e- B			
Descriptions	Туре- А	B-1	B-2	B-3	B-4	Type- C	
	Erosion of road surface by surface water	Scouring: Crack and/or settlement of road surface	Scouring: Depression of road surface	Scouring: Overturning of revetment	Scouring: Washing away the embankment	Washing away by overflow	Destruct by hydra water
Improve of	Cross section	Cross section	Collapse Collapse Collapse Collapsed Eroded	Cross section	Cross section Missing Collapsed Eroded Eroded	Cross section Overflow Flood level Washed out Eroded	Cross se Collaps Water Presssure
Images of Destruction	<u>Plan</u>	<u>Plan</u>	<u>Plan</u>	<u>Plan</u>	<u>Plan</u>	<u>Plan</u>	<u>Plan</u>
	La Eroded	Settlement Settlement	Le Waterflow	1d Waterflow	Collapsed Missing	Waterflow Flood level Washed out Missing	18 CALLULUN SI
Photos	Photo- 1	Photo- 2	Photo- 3	Photo- 4	Photo- 5	Photo- 6

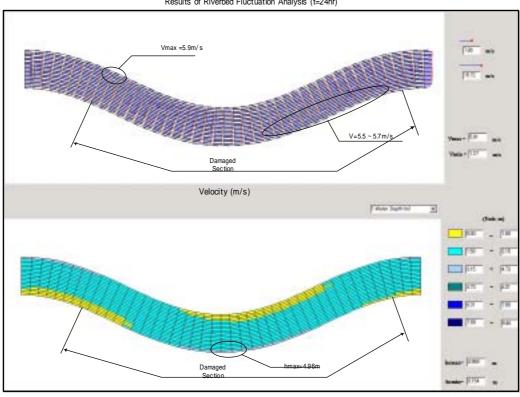
Figure 3-6 2.5 dimension riverbed fluctuation analysis (after 24hours)

A typical example of the simulated sequences of failure process of revetment based on a preliminary 2.5 dimension riverbed fluctuation analysis at the section between STA. 3+370 and STA. 3+730 as shown in Figure 3-5 through to Figure 3-8 and described below. The foundation of the revetment was set at 3 meter below the riverbed with foot protection blocks. The structures were designed for a 5.5 m/s of flow velocity.

- Just after the occurrence of the flood, the velocity and water depths are within the design conditions.
- After 24 hours of the continuous flood, maximum velocity is 5.7m/sec and maximum water depth is 5.0m almost equivalent to design level.
- After 48 hours of the continuous flood, maximum velocity and maximum water depth reached 6m/sec and 6.9m respectively. At this point, the revetment is very vulnerable to being washed away. It was observed that the actual failure of structures at the site only started after 48 hours from the beginning of the flood event justifying the results of the analysis.
- After 72 hours from the beginning of the flood, maximum velocity reaches 6.9m/sec and maximum water depth is 8.8m.

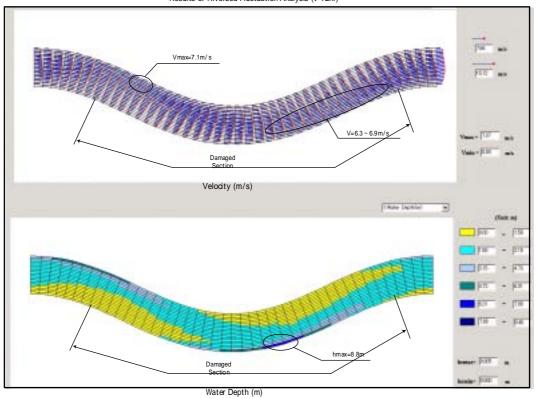
Figure 3-8 2.5 dimension riverbed fluctuation analysis (after 72hours)

The preliminary 2.5 dimension riverbed fluctuation thus justifies the assumption that the July 2002 event was a hydrologically unforeseen case, caused by the heavy rainfall lasting over a three day period.

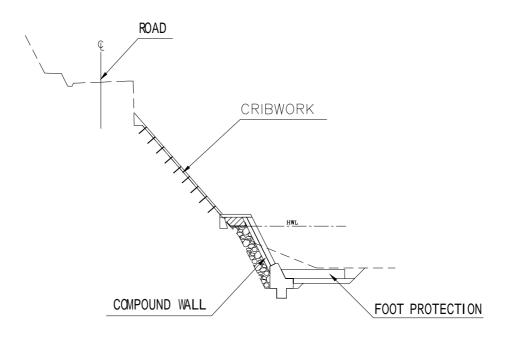
Figure 3-13 Countermeasure for slope failure due to scouring around Sta.13+300

Damages around STA.13+300 were due to scouring of the slope below the constructed wall foundations. These foundations now lack stability. Since the slope grade is not so steep (1:0.8) revetment and concrete crib works will be applied as a countermeasure to arrest further scouring as shown in Figure 3-13.

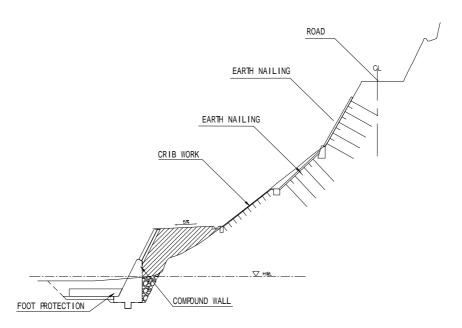
Figure 3-14 Countermeasures for slope failure due to scouring around STA.22+900

High water pressure during the flood has triggered a landslide on the natural slope below the road, destabilizing the riverside retaining wall. The size of slope failure is small and about 15m in width. Further extension of the failure will cause serious traffic disturbance since the road is located 25m above the riverbed.

- Construction of revetments as countermeasures against the erosion of deposit from flood and for further possible slope failure
- Slope protection work (crib work) as countermeasures against the erosion of deposit from surface water
- Against further slope failure just below the road

There are three options of countermeasure against the further slope failure just below the road. These are a retaining wall, anchor work or soil-nailing work. For the protection of the small size slope failures, the soil-nailing method is usually applied as the most

The soil-nailing work will be designed as per the design guideline "Design and Construction Guideline for Soil-nailing Work" Japan Highway Corporation, Oct. 1999. An outline of the countermeasure for the site is shown in Figure 3-14.
