## **C. STRUCTURE**

C-2. Inventory Sheet for the Structures

**NATIONAL ROAD NO.1**

**Structure Inventory**

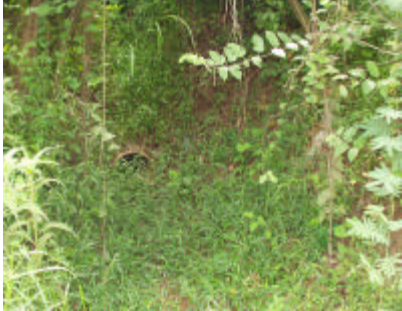
(21)	Foundation Type	Stone compaction for base of steel pipe only							
(22)	Foundation Condition	Settled							
	Comment	S=Settled, E=PILE EXPOSED - Height in meters, F=Foundation Scoured						Pavement cracking and settled. Shoulder both side settled	Evaluation

Comment	Damaged by water flow	Evaluation	C
<b>G. OVERALL EVLUATION</b>		Can serviceability, but need to rehabilitation		
H. OVERALL COMMENT				
	<p>1- This Pipe Culvert for drainage system in the raining season and protection of emergency flood.</p> <p>2- Position of steel pipe culvert is settled, because according to the appearance which pavement have cracking, base of steel pipe by crushed stone compaction only and it was scoured. Slope protection both side also scoured. So need to rehabilitation for availability.</p>

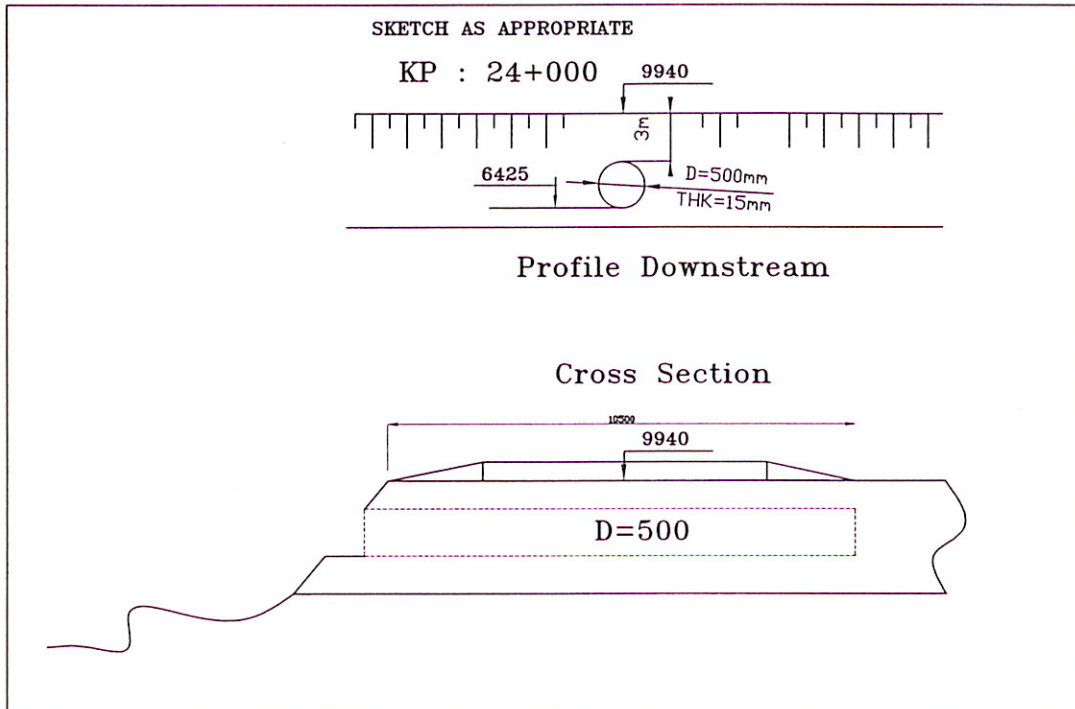
No.2 \_\_\_\_\_ KP : 24+000 (Prek Loung)

Steel pipe with D=0.5m and 3.5m below of road surface was constructed in the Sihanouk regime for irrigation

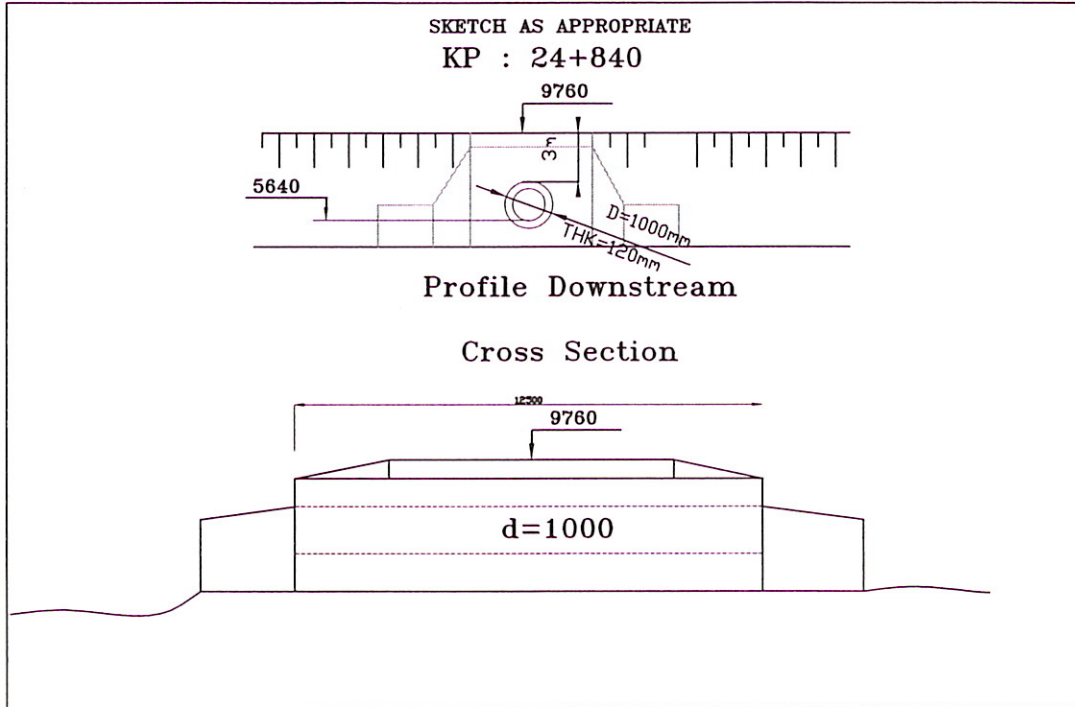
Concrete pipe with D=1m and 3m below of road surface was constructed in the Pol Pot regime for irrigation

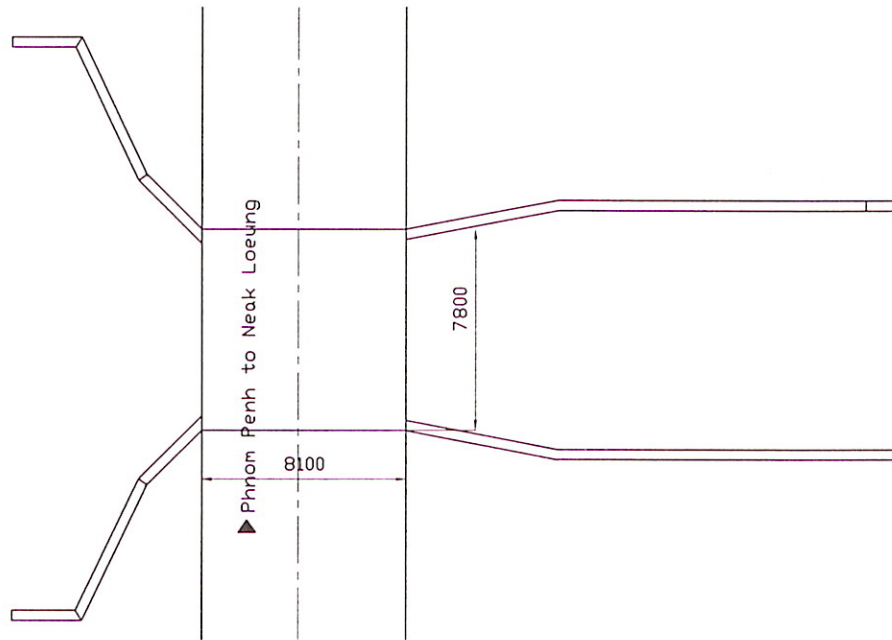
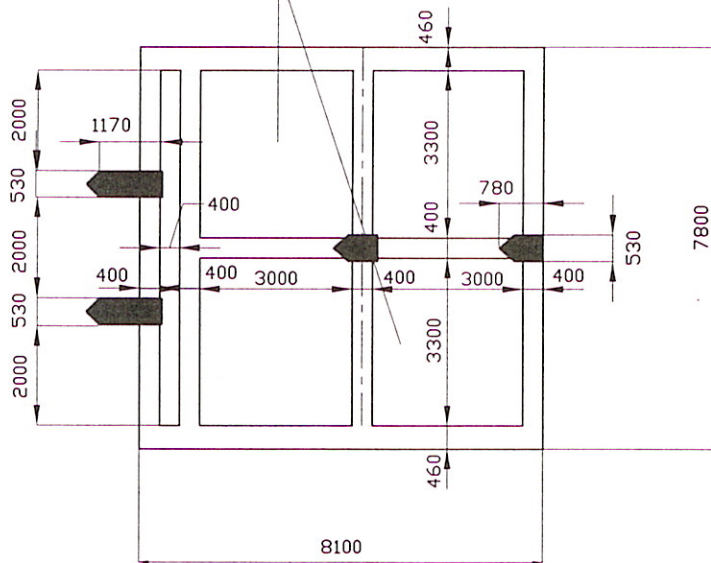
Sketch of Old Water gate (Prek Samrong Thom)

Comment	Protection required	Evaluation	B
G. OVERALL EVALUATION		D (Not enough on durability and serviceability)		
H. OVERALL COMMENT				
<p>1- This structure was built in 1977 in Pol Pot Regime, so everything became damaged</p> <p>2- There are some problem with local people, because downstream rice field can not job (Late job of farmer in the rainy season) 意味不明</p> <p>3- On the left bank (upstream), channel was filled for the factory. No flow.</p> <p>4- Downstream telephone cable on the slab.</p>

Scale and Exposed Re-Bar Under slab

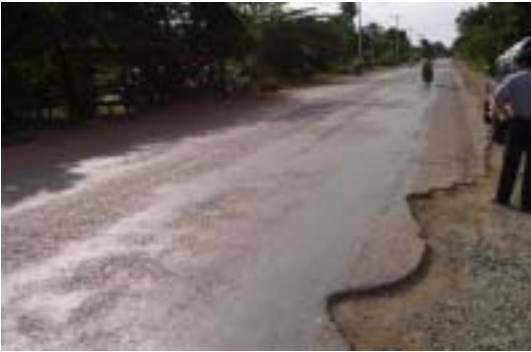
<p>Pk 9+100</p> <p>Damaged Pavement at Shoulder</p>

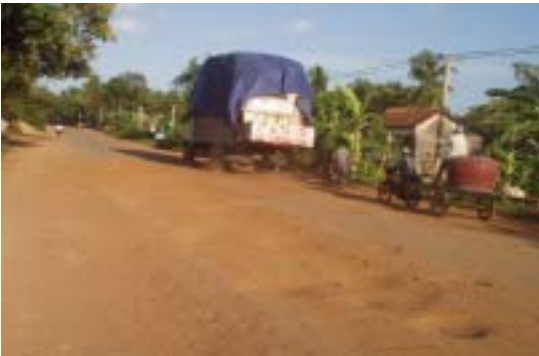
<p>Pk 18+000</p> <p>Critical Damaged Pavement Area and Heavy Vehicle</p>

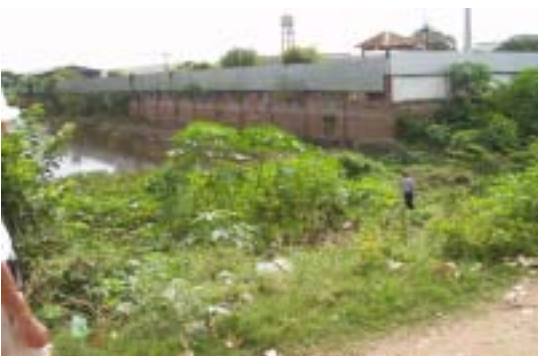
<p>Pk 20+640 Sdav anlaing</p> <p>Culvert Location from Interview Result</p> <p>There was pipe culvert in past time (Not Found)</p>

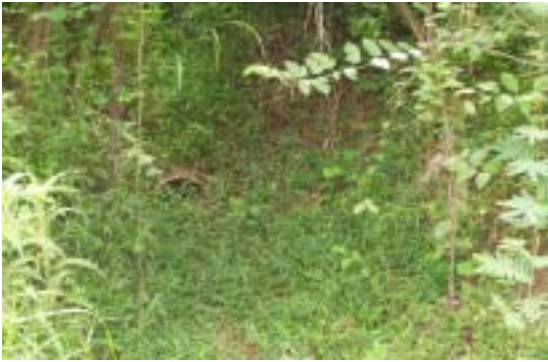
<p>Pk 24+000</p> <p>Pipe Culvert, Down-stream Side (Old, Sihanouk Regime)</p> <p>Pipe Length: 10.5m</p>

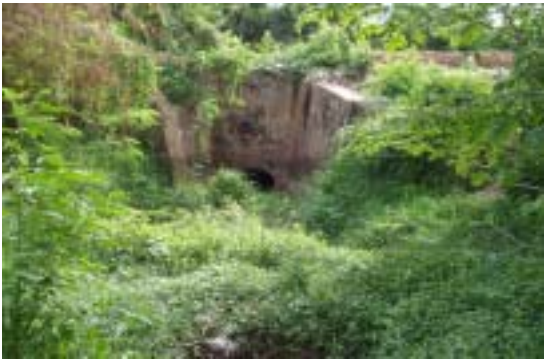
<p>Pk 24+840</p> <p>Pipe Culvert, Down-stream Side (Old, Pol Pot Regime, 1979)</p> <p>Pipe Length: 12.5m</p>

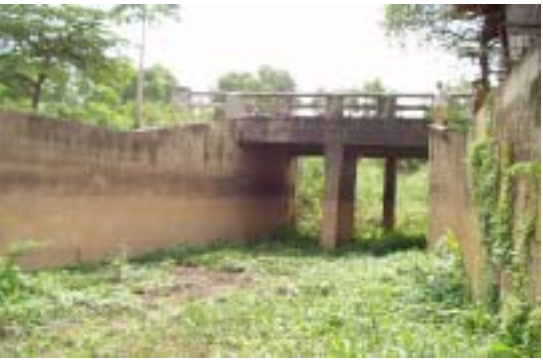
<p>Pk 41+040</p> <p>Water Gate, Pol Pot Regime, 1977</p> <p>Pavement Width 5m                  (Carriage Way Width 7.1m)                  Housing Site at Up-stream Side                  (No Function for Water way)</p>

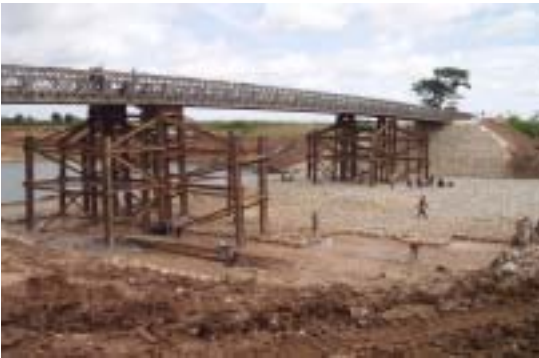
<p>Pk 42+850</p> <p>Bailey Bridge, Length 99m, Width 4m</p> <p>Under Improvement for Pier, River-bed (Traffic using Detour Road)</p> <p>Temporary Opened in year 2000</p>

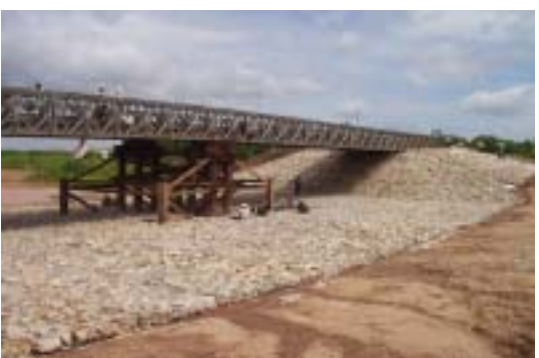
<p>Pk 47+967</p> <p>Bailey Bridge, Length 66m, Width 4m</p> <p>Under Improvement for Pier, River-bed (Traffic using Detour Road)</p> <p>Temporary Opened in year 2000</p>

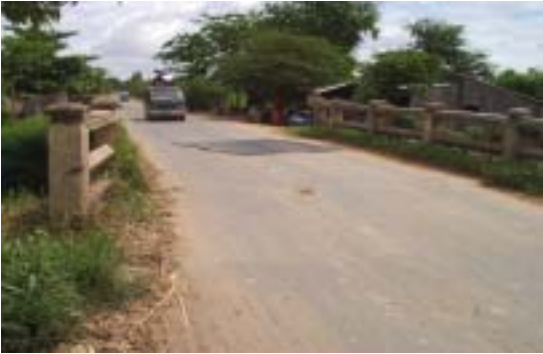
<p>Pk 50+015</p> <p>Water Gate, Pol Pot Regime, 1976 Pavement Width 5.8m (=Carriage Way)</p> <p>Defected, Damaged Concrete Structure Broken Surface and Concrete Slab, Placed Steel Plates on Road Surface</p>

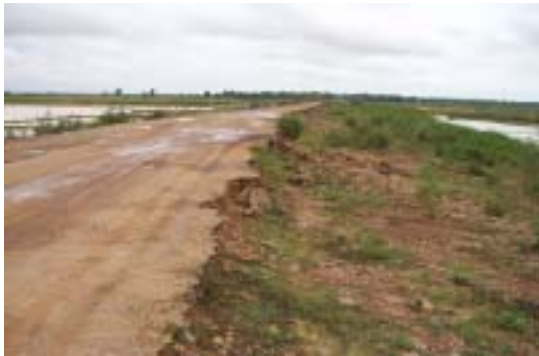
NR 11

Critical Eroded/ Damaged Paved Road

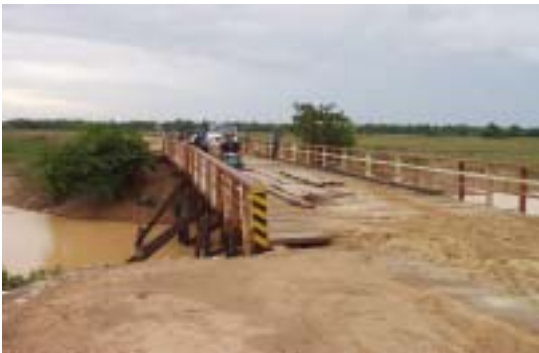
NR 11

Eroded Approach Embankment  
at Bridge
