**BASIC DESIGN STUDY REPORT
ON
THE PROJECT FOR REHABILITATION
OF
THE CHILDREN HOSPITAL ISLAMABAD
IN
THE ISLAMIC REPUBLIC OF PAKISTAN**

MARCH 2003

JAPAN INTERNATIONAL COOPERATION AGENCY

K.ITO ARCHITECTS & ENGINEERS INC.

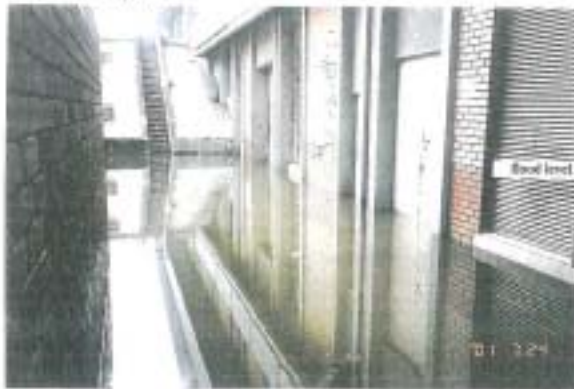
service yard

Damage after flood

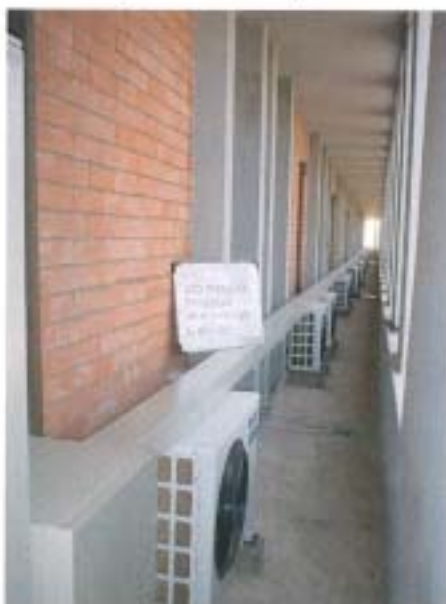
air conditioning units at balcony

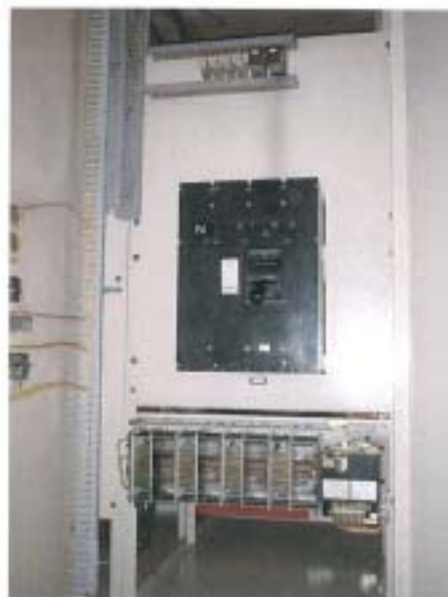
replacement of ACB on incoming panel
