ANNEX D. IRRIGATION CANAL

Through the workshop held on November 25 to 29 in 2002, farmers selected the issues of “Improvement of Irrigation Canal” as one of component of the Pilot Project. Name of the secondary canal to divert irrigation water for the Pilot Project area under the Laclo Irrigation System (LIS) is Inkeru.

THE STUDY ON INTEGRATED AGRICULTURALS DEVELOPMENT OF EAST TIMOR	TITLE OF DRAWING	IMPLEMENTATION OF THE PILOT PROJECT - CANAL MAINTENANCE -
JAPAN INTERNATIONAL COOPERATION AGENCY	DRAWING No.	D - 1

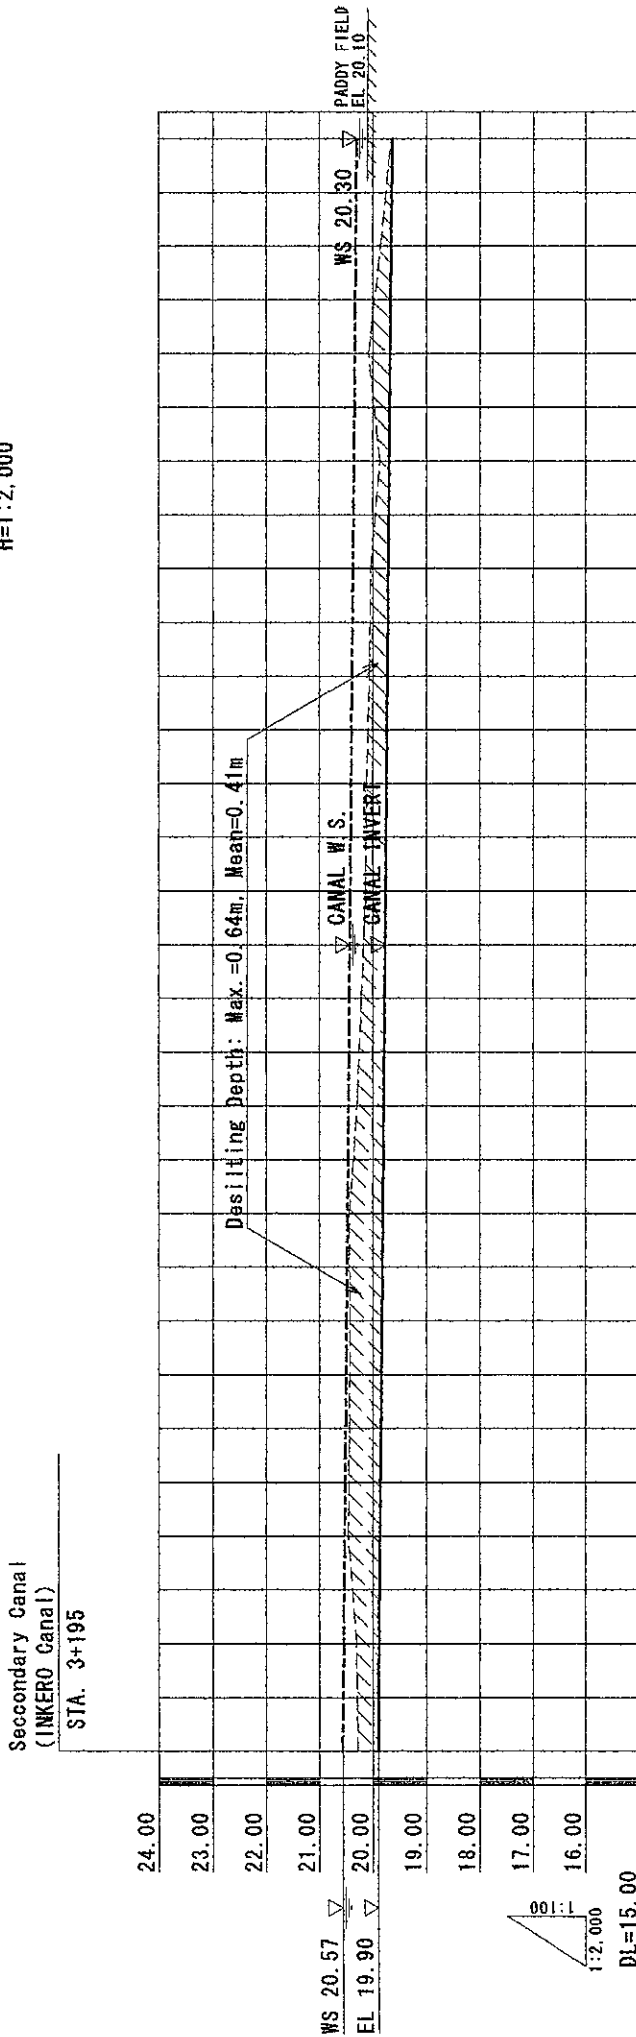
LONGITUDINAL PROFILE OF SECONDARY CANAL (INKERO)

The Study Team did the design work for canal improvement. The design indicates mainly the depth of digging the existing Inkeru secondary irrigation canal bed in order to divert irrigation water properly from main canal. The design drawings are referred to Drawing No. D-1 to D-4.

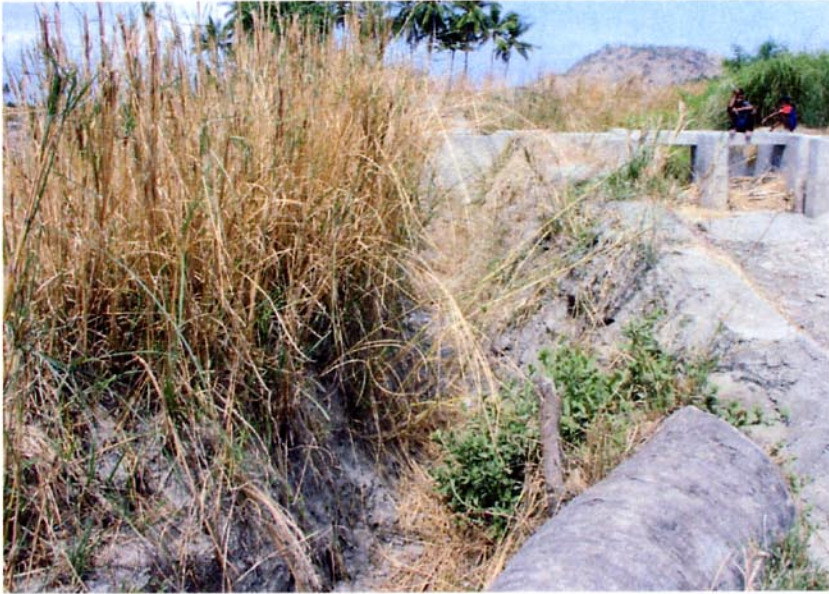
Secondary Canal condition

not in well conditions due to the sedimentation of soil, overgrow the grass in the canal and so on. It could be considered that these conditions are caused by lack of routine maintenance works by farmers. And also, the clayey and silty soils are accumulated in the secondary irrigation canal.

The secondary canal (*Inker* canal) is covered by grasses and sediments due to lack of maintenance work.

However, it is very difficult to prevent the secondary canal from sedimentation perfectly. Then, desilting works will be needed on secondary canal and on-farm facilities such as pipe culvert setting for crossing the road as routine/periodical maintenance work.

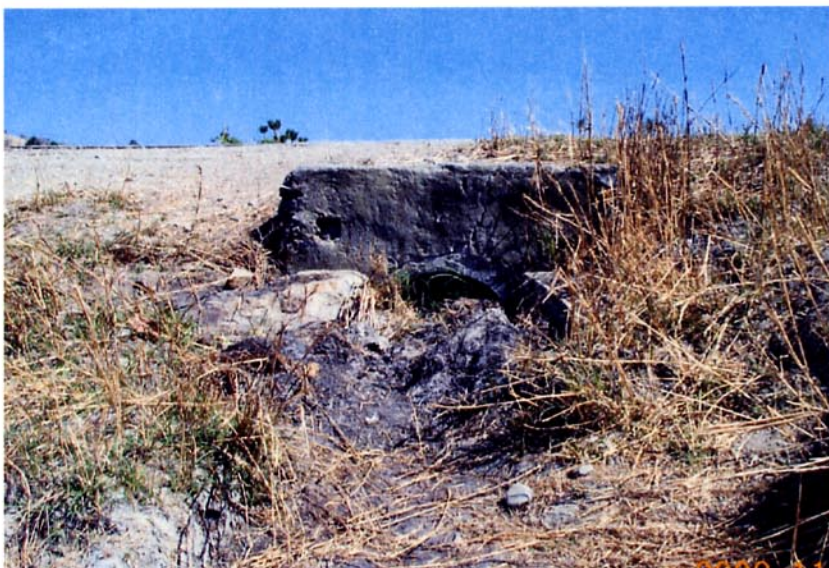
Ancillary Facilities

There are eight pipe culverts crossing the road in the Pilot Project area. These facilities collect the irrigation water that comes from paddy field located in upper portion by plot-to-plot irrigation and convey it to lower portion. Conditions of them are also poor. There exists much sediment in the pipe by debris and/or trash due to lack of maintenance works.

View of the pipe culvert for road crossing. The entire is plugged a lot of sedimentation and debris.
