Inspection Memo 3 Inspection of Hopin Small Hydropower Station in Hopin, Kachin

26.11.2002

Inspection Memo 4 Inspection of Zi Chaung Power Station during De-Watering

23 to 29 May 2003

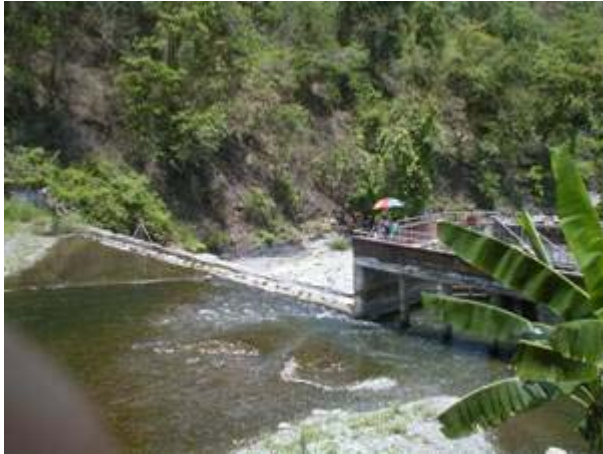
Intake weir site being surveyed

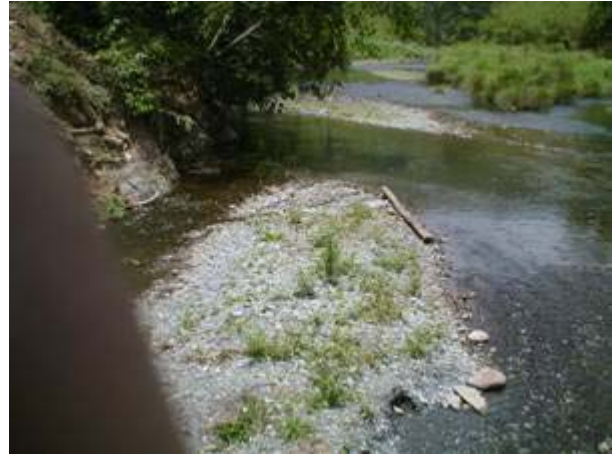
Gravel deposits upstream of the intake

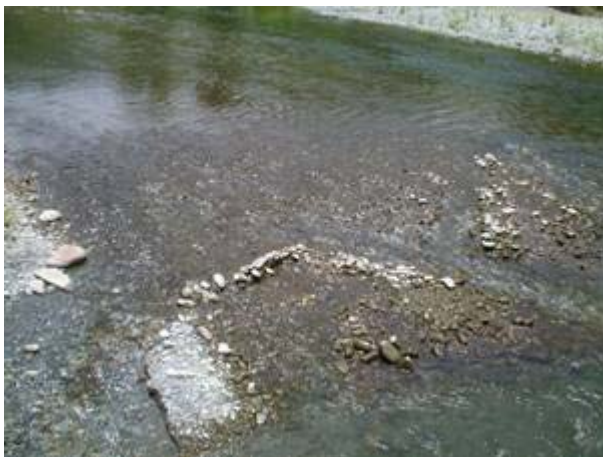
Gravel deposits in front of intake

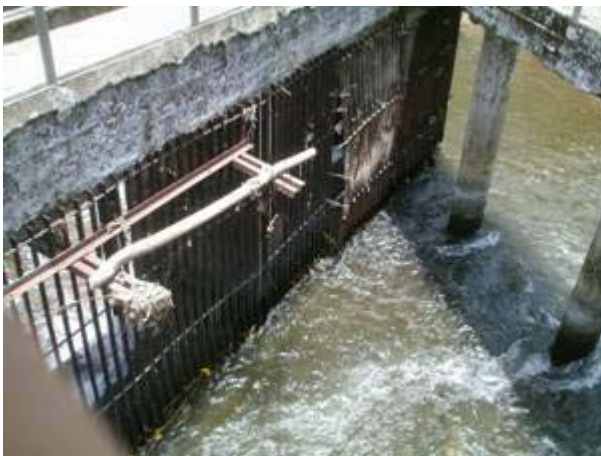
Intake trashrack and wreck of deck for operator to remove leaves etc.

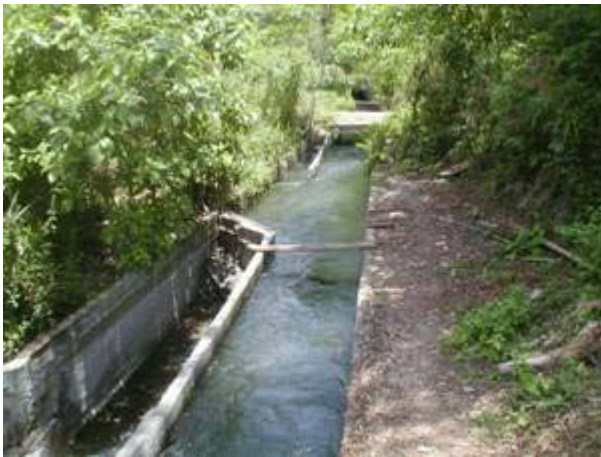
Side overflow spillway section, bow being Blocked with concrete to avoid leakage

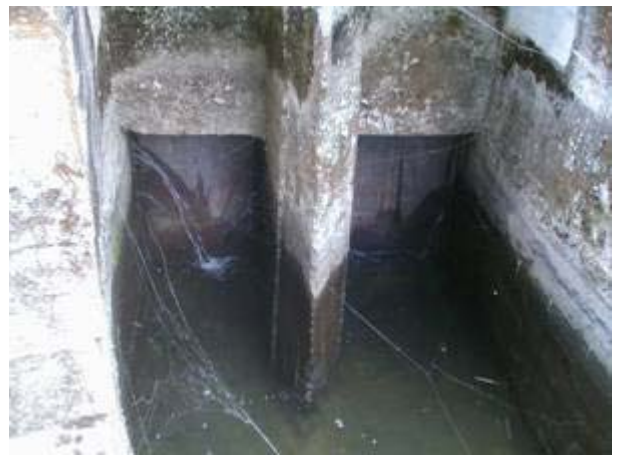
Intake gates fully closed for inspection
Water leakage is marginal.

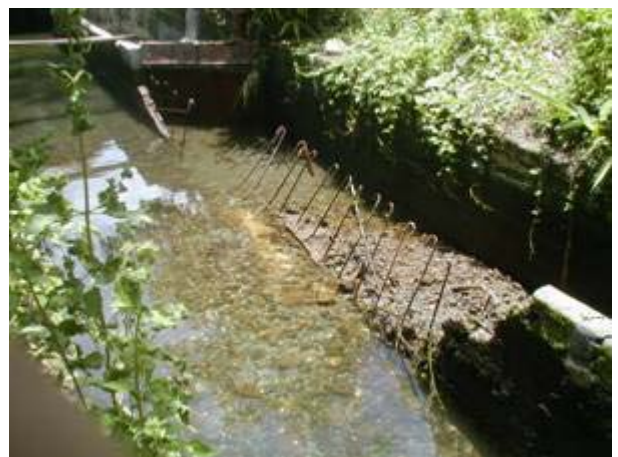
Sediments deposits in the same section.

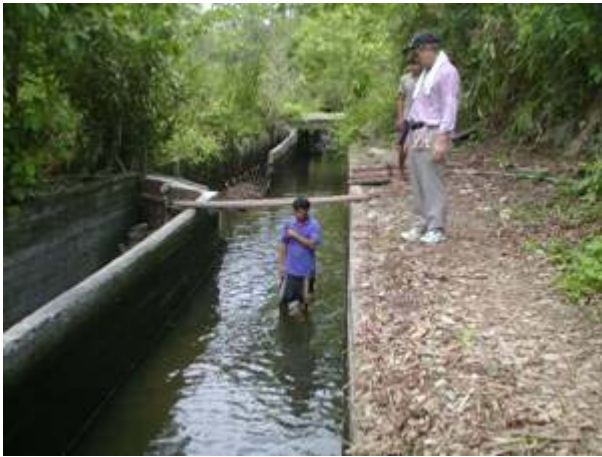
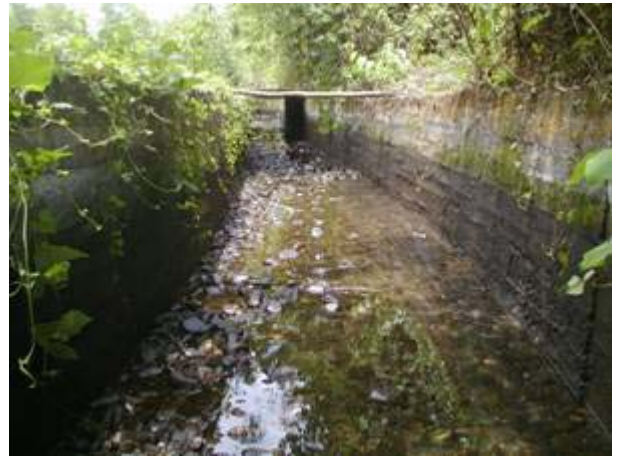
Water remains undrained in the spillway section (left) due to the thick sediments in the downstream section (right) from where water has been mostly drained.

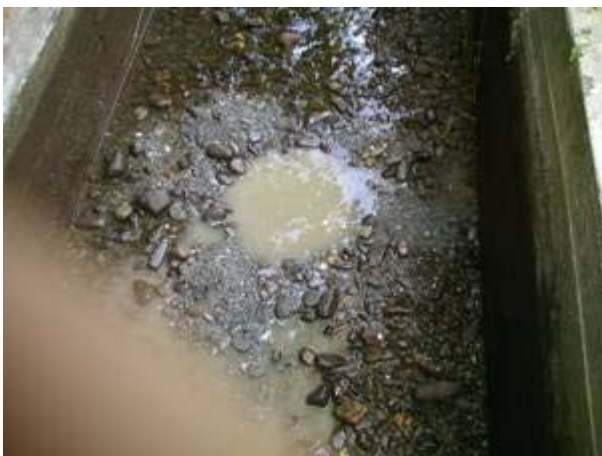
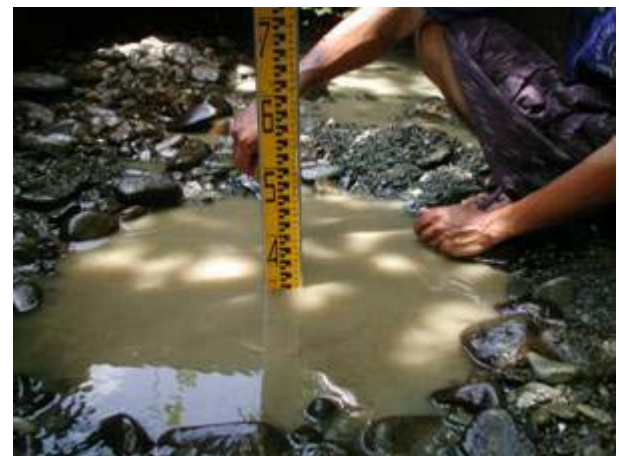
Sediments and test pit on the channel floor

Hole depth so far dug is 32 cm.

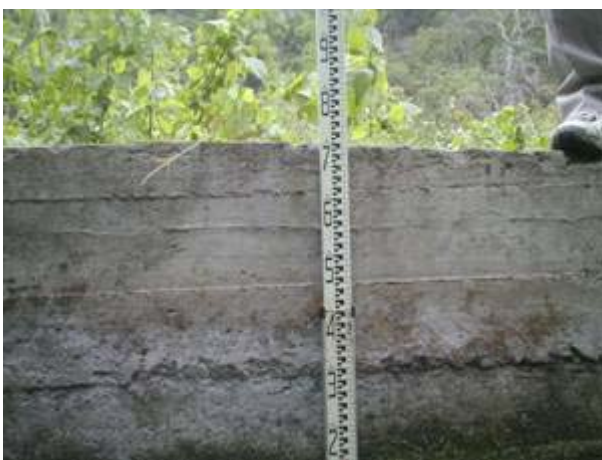
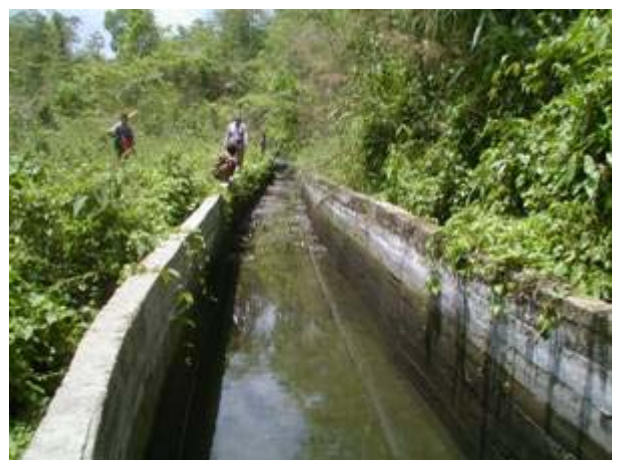
Side wall height at 1.70 m.

Water pond seen in the curved section is created by dam up effect of the sediments downstream, looking downstream

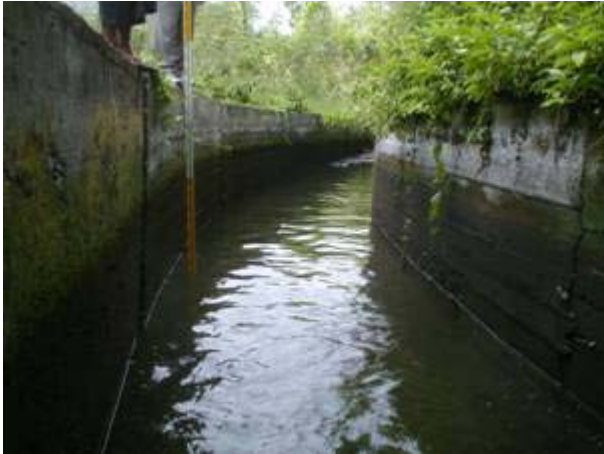
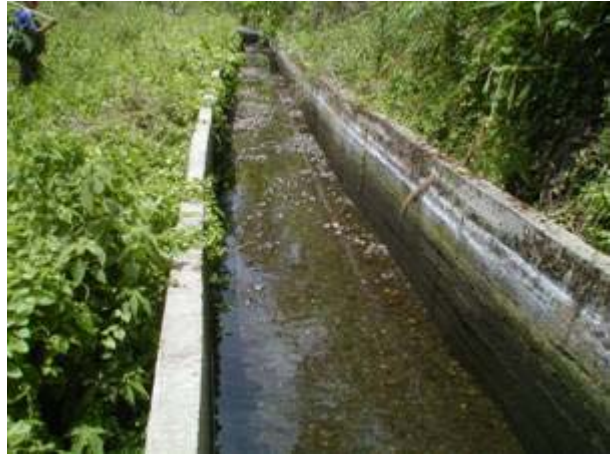
Water depth at this curved section was at 35 cm. Sediments observed mostly in straight sections

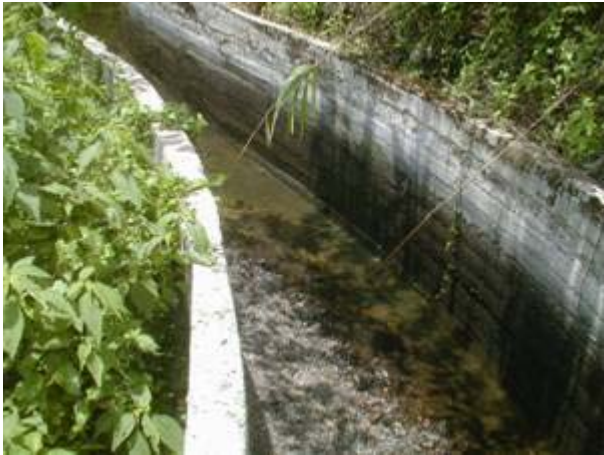
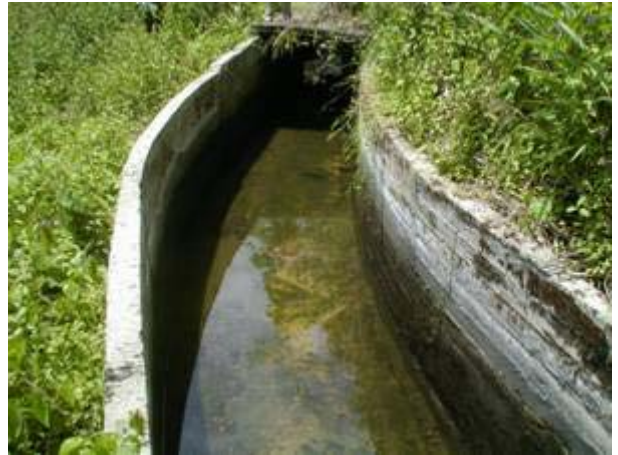
Sediments are limited in curved section (left) or nil in some section (right)

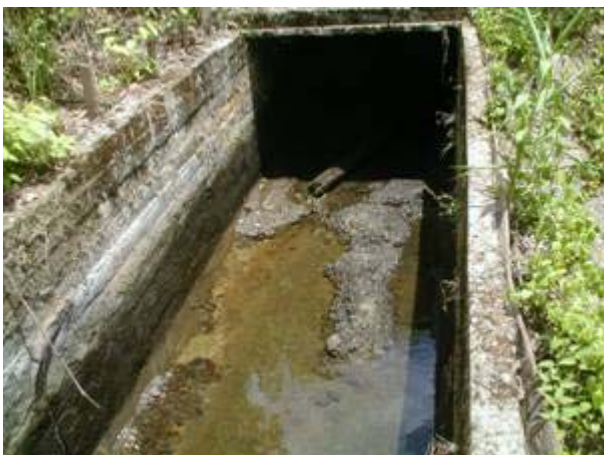
Erosion of channel floor

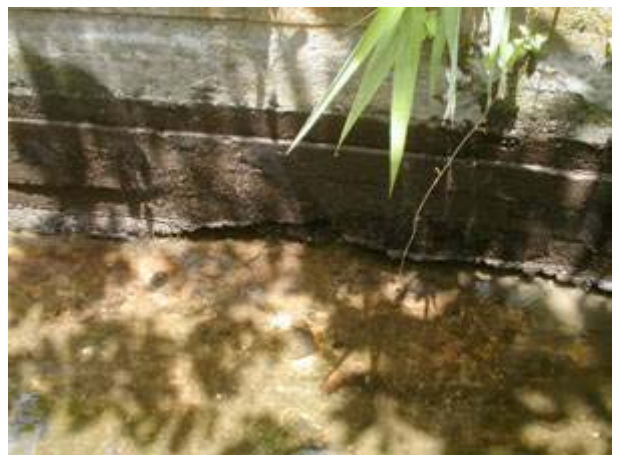
Erosion of side wall foot

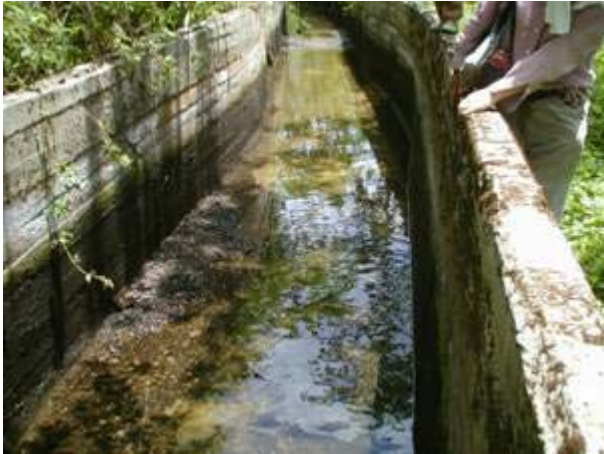
Channel floor in the leakage section right

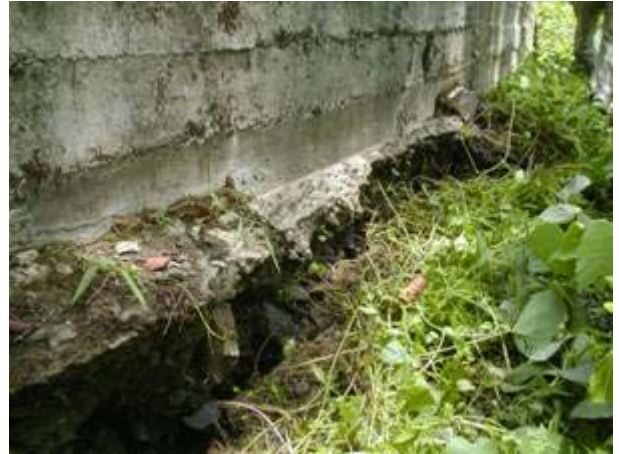
Outside foundation of leakage section (it seemed the foundation has been eroded by leakage water.)

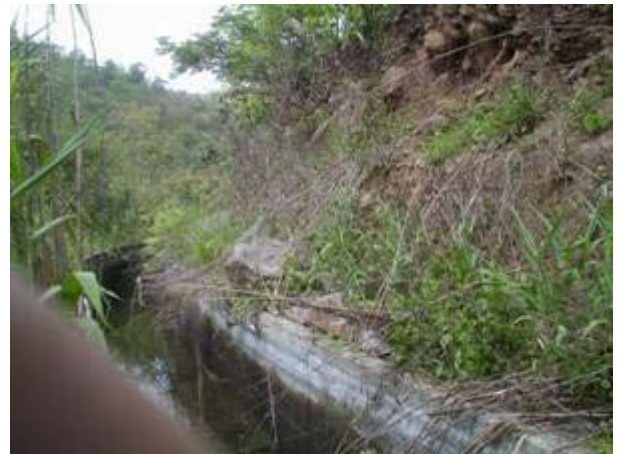
Rock from side slopes

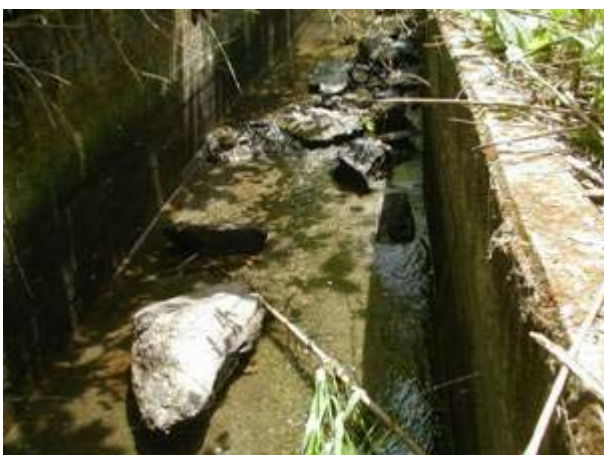
Rock fallen in the channel.

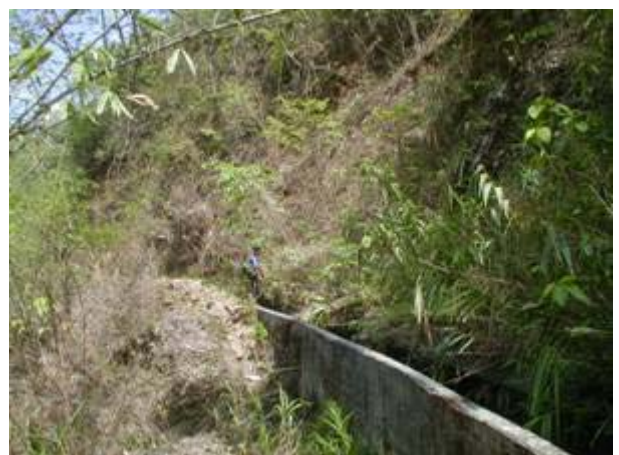
Debris once entered into and removed outside beside the channel. These channel sections should be placed with concrete cover.

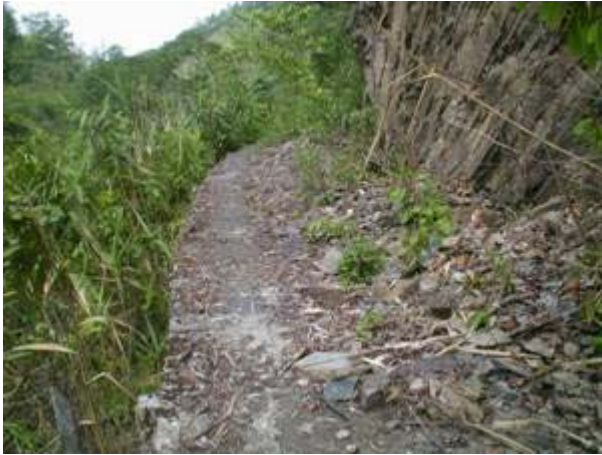
Debris on the channel cover, proving effectiveness of the cover.

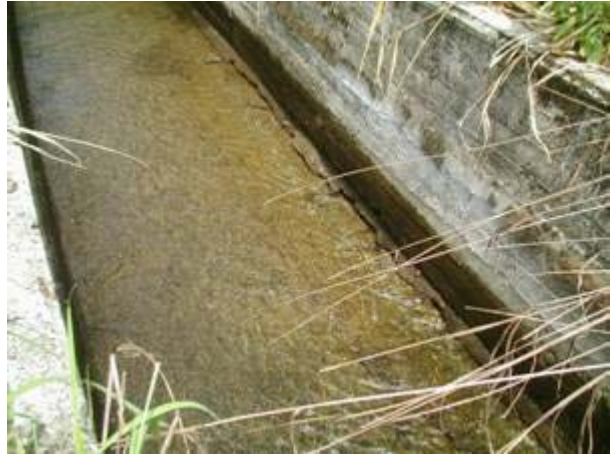
Channel floor at one of the leakage points

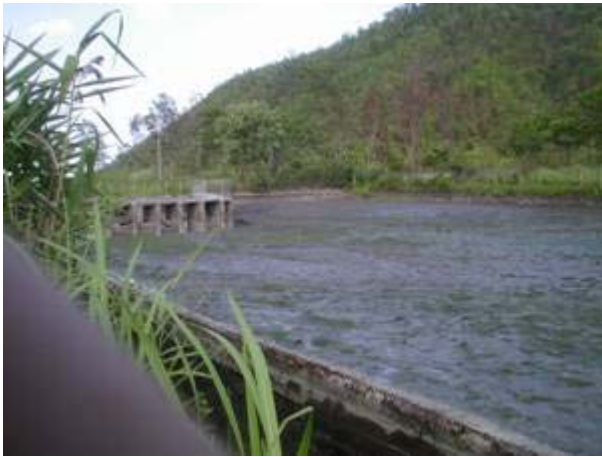
Sediments in the upper part of Regulating Pond, mainly consisting of silt

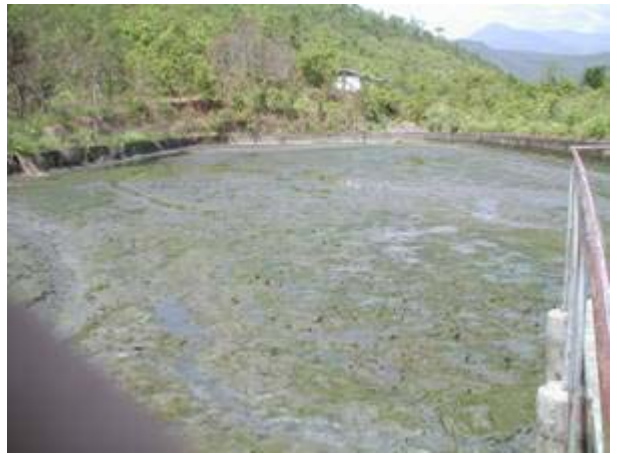
Sediment top covered with algae

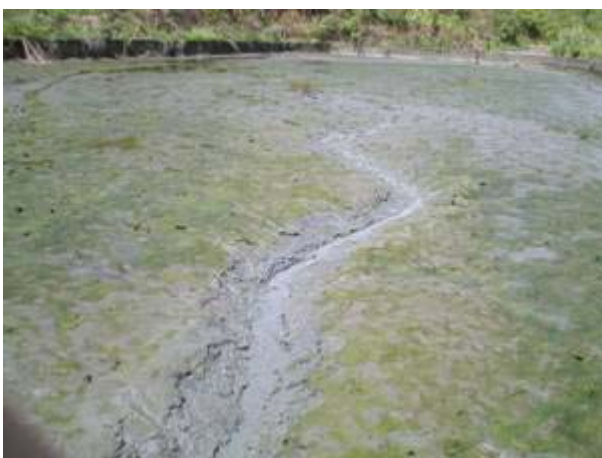
Sediment surface in the Regulating Pond
