THE GOVERNMENT OF THE PHILIPPINES
 THE DEPARTMENT OF PUBLIC WORKS AND HIGHWAYS
**The Study on Sabo and Flood Control for
 Western River Basins of Mount Pinatubo
 in the Republic of the Philippines**
 JAPAN INTERNATIONAL COOPERATION AGENCY

Figure 1.2.3
**Investigation Results of Sediment Delivery
 in 2002 in the Marella River**

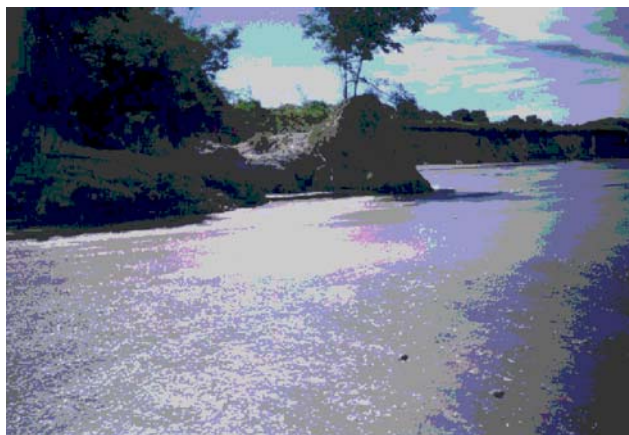
The river channel with 4 m depth was completely buried and the entire river terrace rose by 0.5 m due to sediment deposition after the flood in July 2002

Photo 4 Checkpoint No.2 (after Flood)

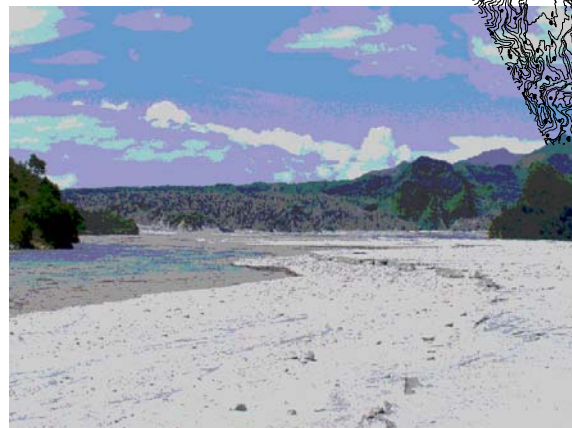
Photo 5 Upstream of Checkpoint No.2 (after Flood)

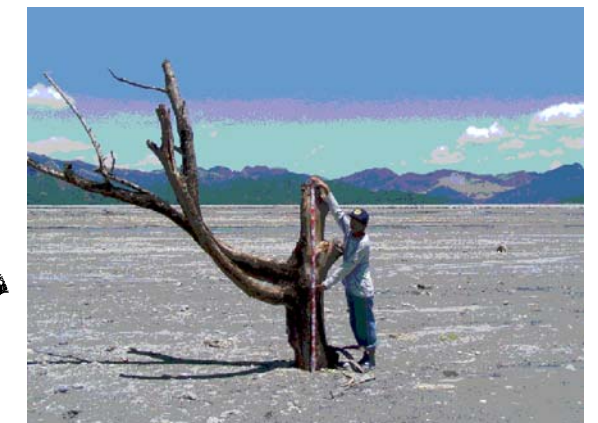
Sediment level at river terrace rose by 0.5 m, due to flood in July 2002 estimated by measurement of the tree height

Photo 2. Checkpoint No.1 (after Flood)

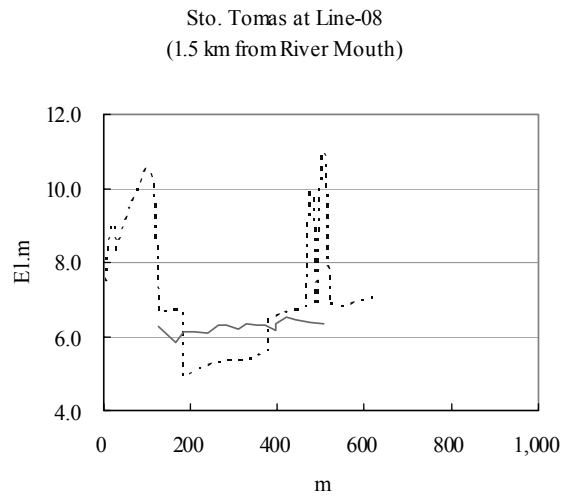
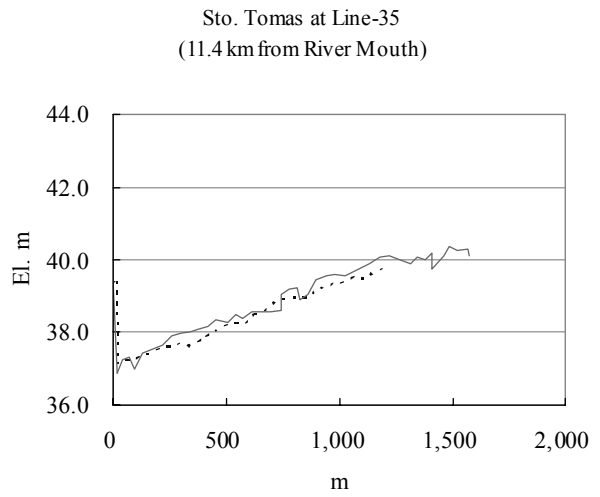
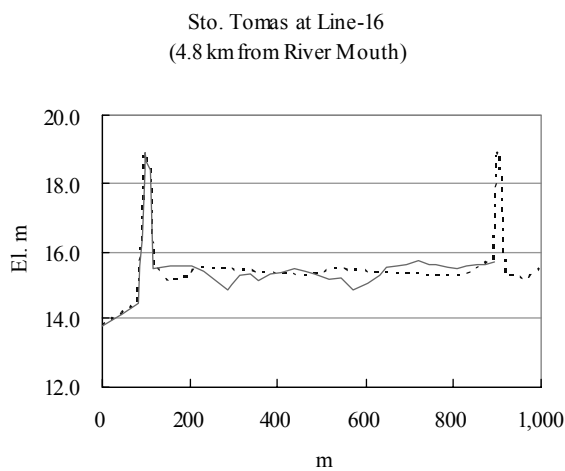
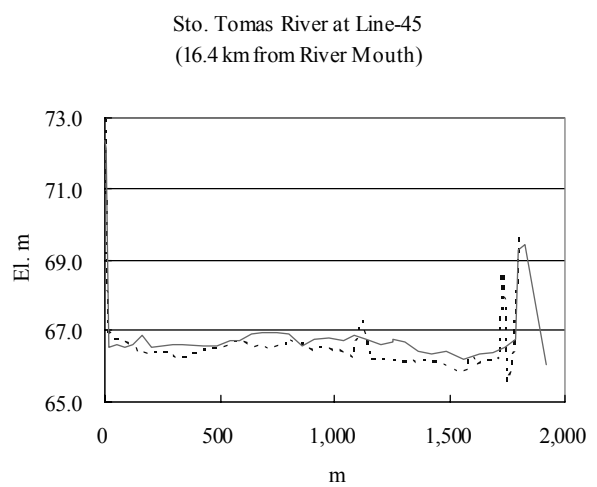
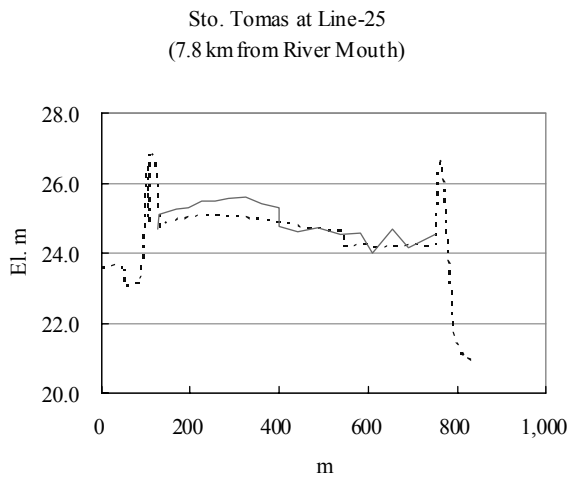
Figure 1.2.4

**Comparison of River Cross Sections before
and after the Flood in July 2002 in the Sto.
Tomas River**
