*The Study on Sabo and Flood Control for Western River Basins of Mount Pinatubo
in the Republic of the Philippines
Final Report
Supporting Report*

APPENDIX-V
Inundation and Damage

**THE STUDY ON SABO AND FLOOD CONTROL
FOR WESTERN RIVER BASINS OF MOUNT PINATUBO
IN THE REPUBLIC OF THE PHILIPPINES**

APPENDIX V INUNDATION AND DAMAGE

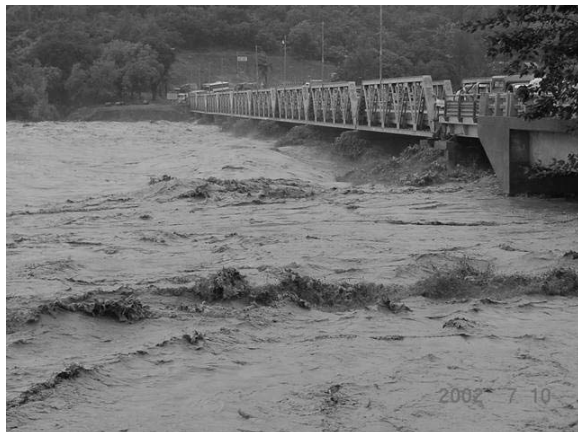
The lahar event observed in July 2002 was due to the collapse of the Maraunot Notch of the Pinatubo Crater Lake. The lake water level suddenly descended down with 23 m, and the flush flood with about 46 million m³ flew down to the downstream. Un-consolidated riverbed and banks along the Maraunot River were severely scoured/eroded, which was the source of lahar flow. The lahar occurrence in July 2002 was judged as the abnormal event considering the current basin condition in the upstream area, in which the natural vegetation on the slope gradually recovered as it were before the eruption. The study team then consider no more lahar event such as before 1995 would be expected without any abnormal phenomena such as July 2002.

Lahar in July 2002 (Bucao Bridge)

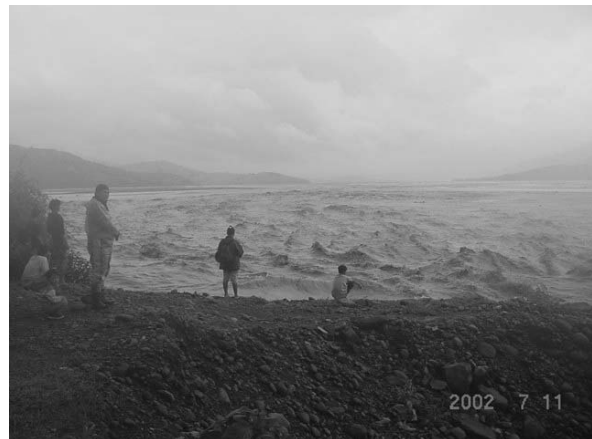
Lahar in July 2002 (Barangay San Juan)

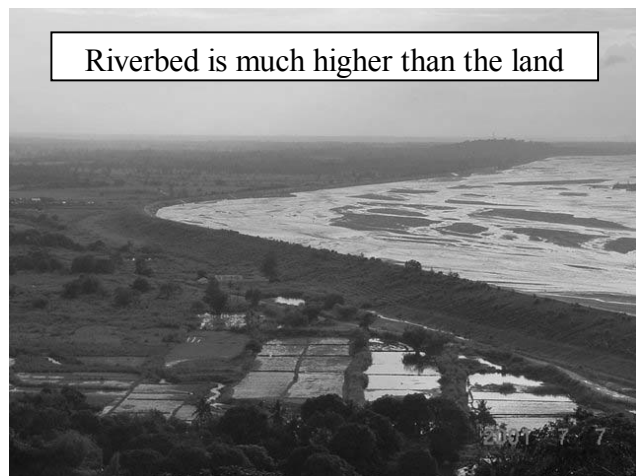
Riverbed excavation works have been performed every year in the short section immediately upstream and downstream of the Maculcol Bridge to secure the required clearance under the bridge girder to enable the flood discharge to pass. The volume of sand excavated in 2000 was recorded as 750,000 m³.

The excavated channel is, however, usually buried immediately after the first flood in rainy season under the current balance of the sediment transportation of the whole river stretch.

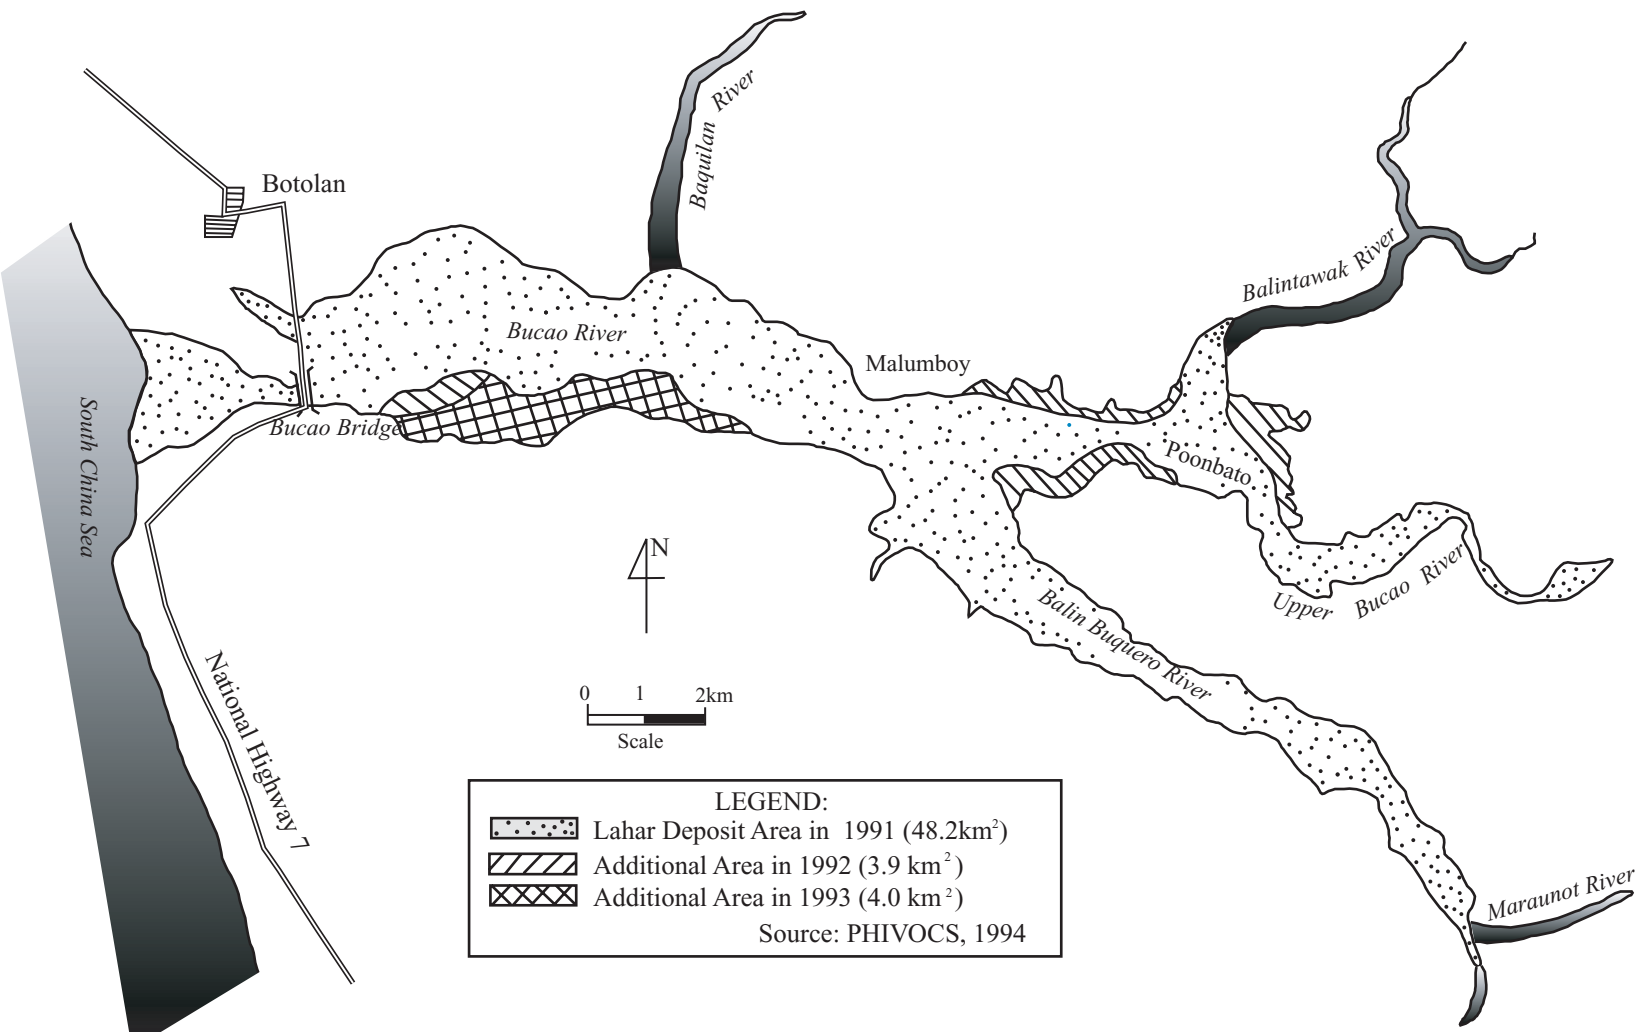
After the eruption of Mount Pinatubo in 1991, lahars (mudflow with high concentration of sediment) continued to flow until 1995, burying riparian villages along the Upper Bucao and the Balin Buquero River, namely, Malombo, Poonbato, Maguisguis, Nacolcol, Burgos, Villar, Moraza and other barangays. No lahars have been reported since 1996 except in July 2002, and diluted muddy water in the water course is observed at present. Figure 1.1.1 shows the lahar deposit area in the Bucao River system.

**Lahar Deposit Area in the Bucao River
System**

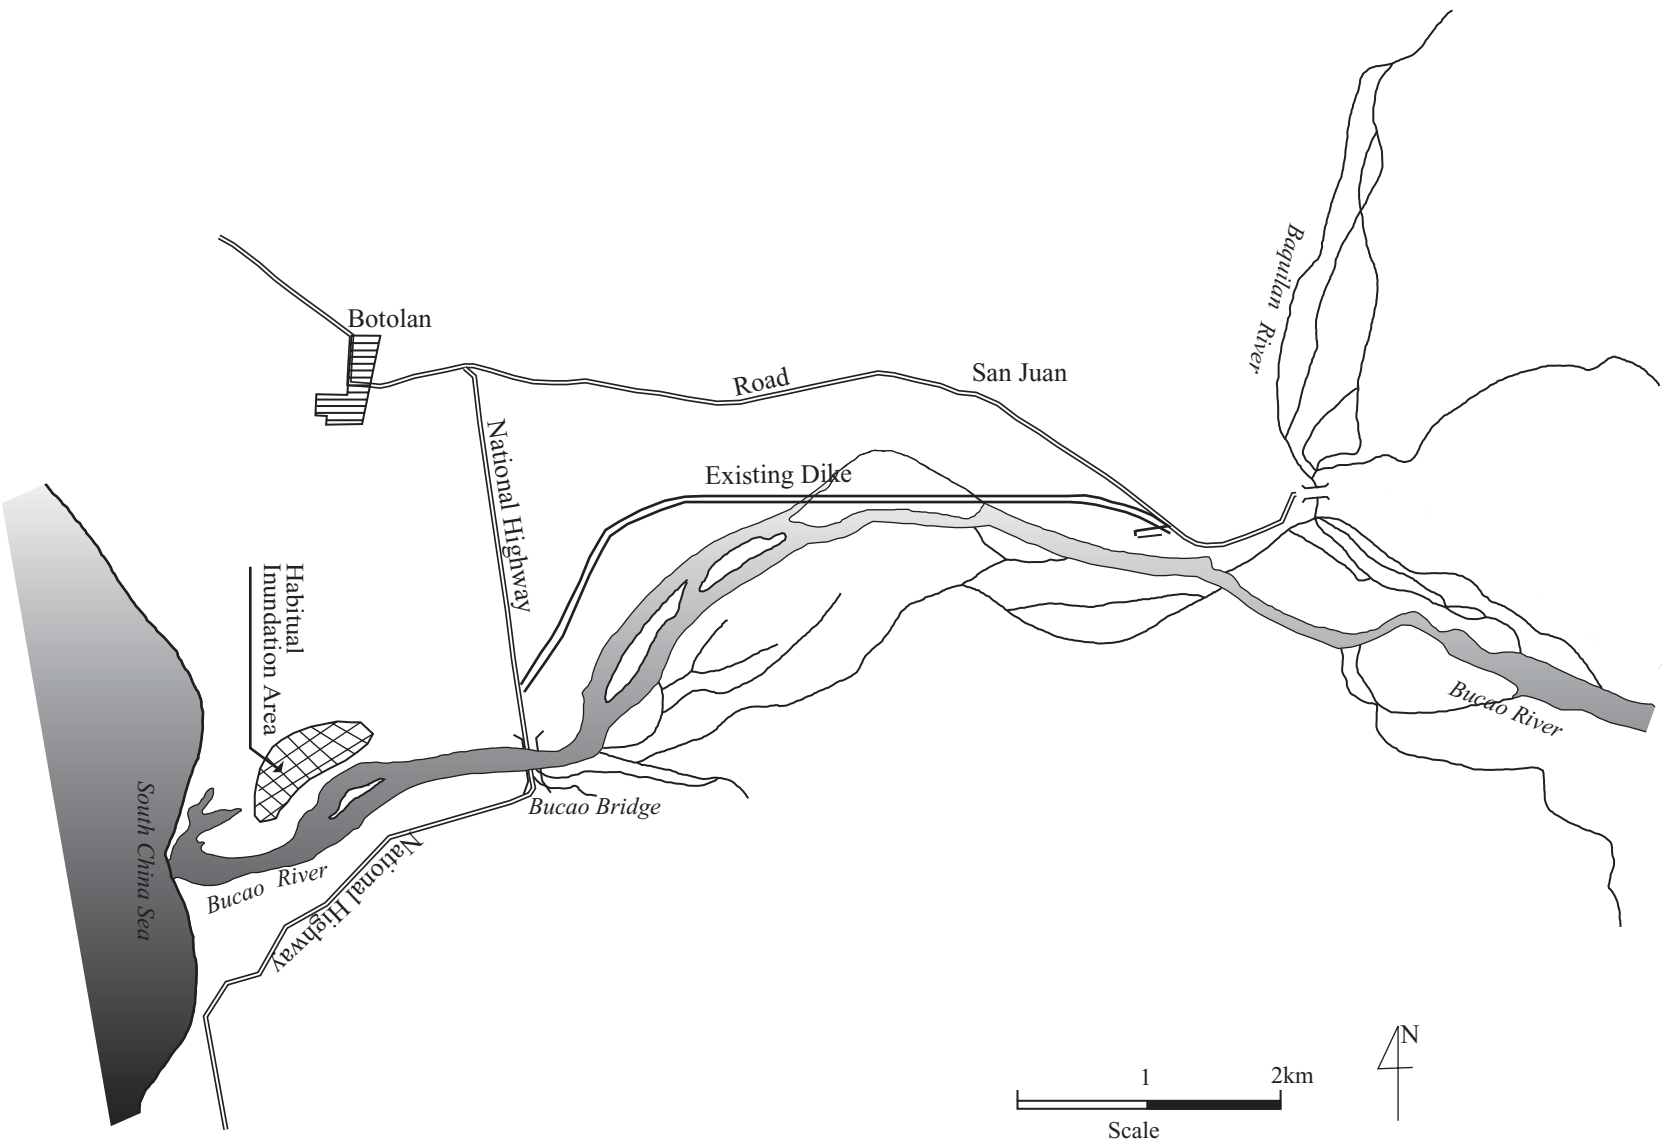
Figure 1.1.2

No dike has been constructed downstream from the Bucao Bridge, and flood water from the Bucao River overflows every year submerging part of a farmland (15 ha) and a few houses along the right bank between the river-mouth and the Bucao Bridge. The area of habitual inundation is shown in Figure 1.1.2.

Habitual Inundation Area along the Bucao River

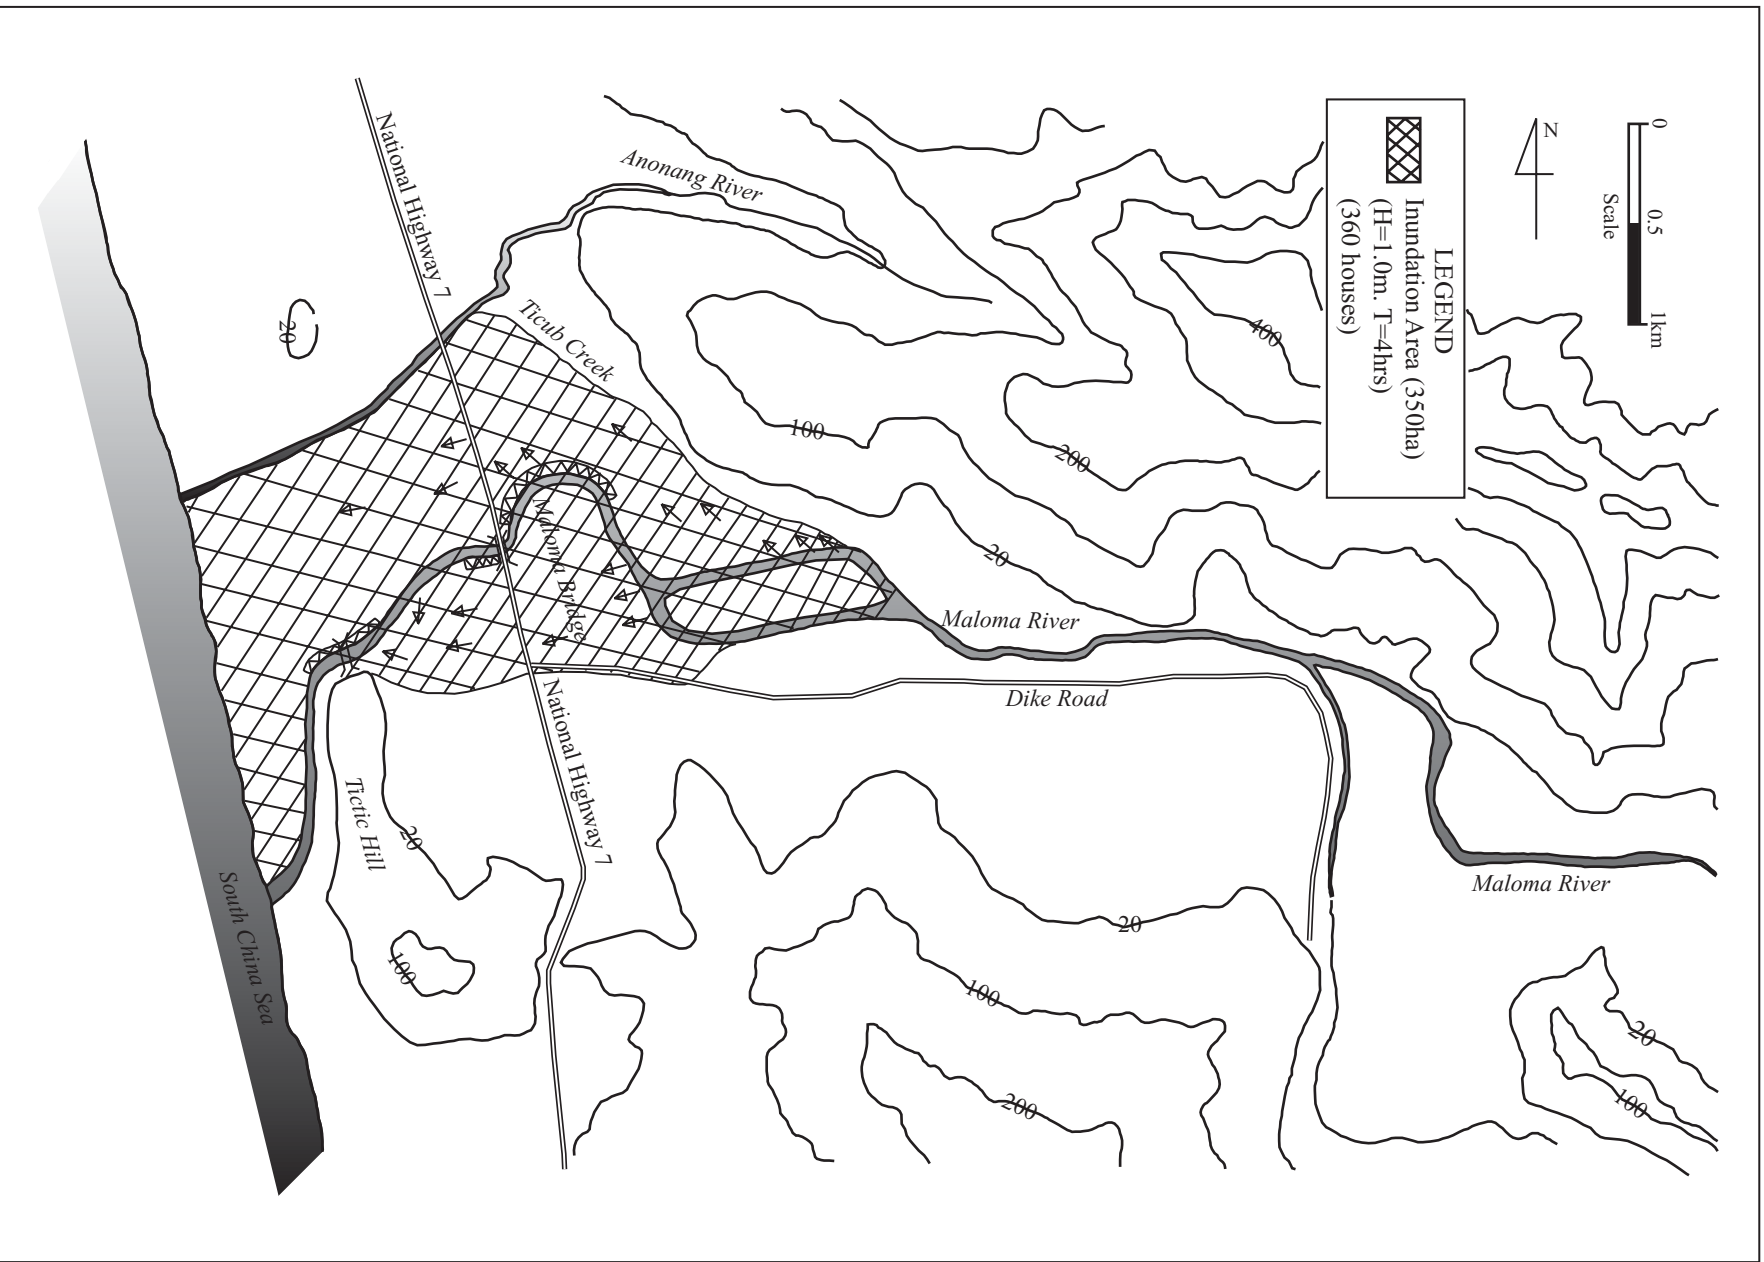
Figure 1.1.3
**Inundation Area along the Maloma River
 in August 2001**

In the flood in August 2001, extensive inundation damage occurred in and around Barangay Maloma in the vicinity of the Maloma Bridge. The flood inundation lasted for 4 hours with water depth of 1.0 m. A portion of the national highway on the right abutment of the Maloma Bridge was partially damaged due to flooding, and was then restored and raised by 1 m. The number of affected houses amounted to 360 (1,790 people) with 26 ha of damaged agricultural land. One high school and one elementary school with an enrollment of 709 and 410 respectively were also affected. The total inundation area amounted to 350 ha. The inundation area mentioned above is illustrated in Figure 1.1.3.

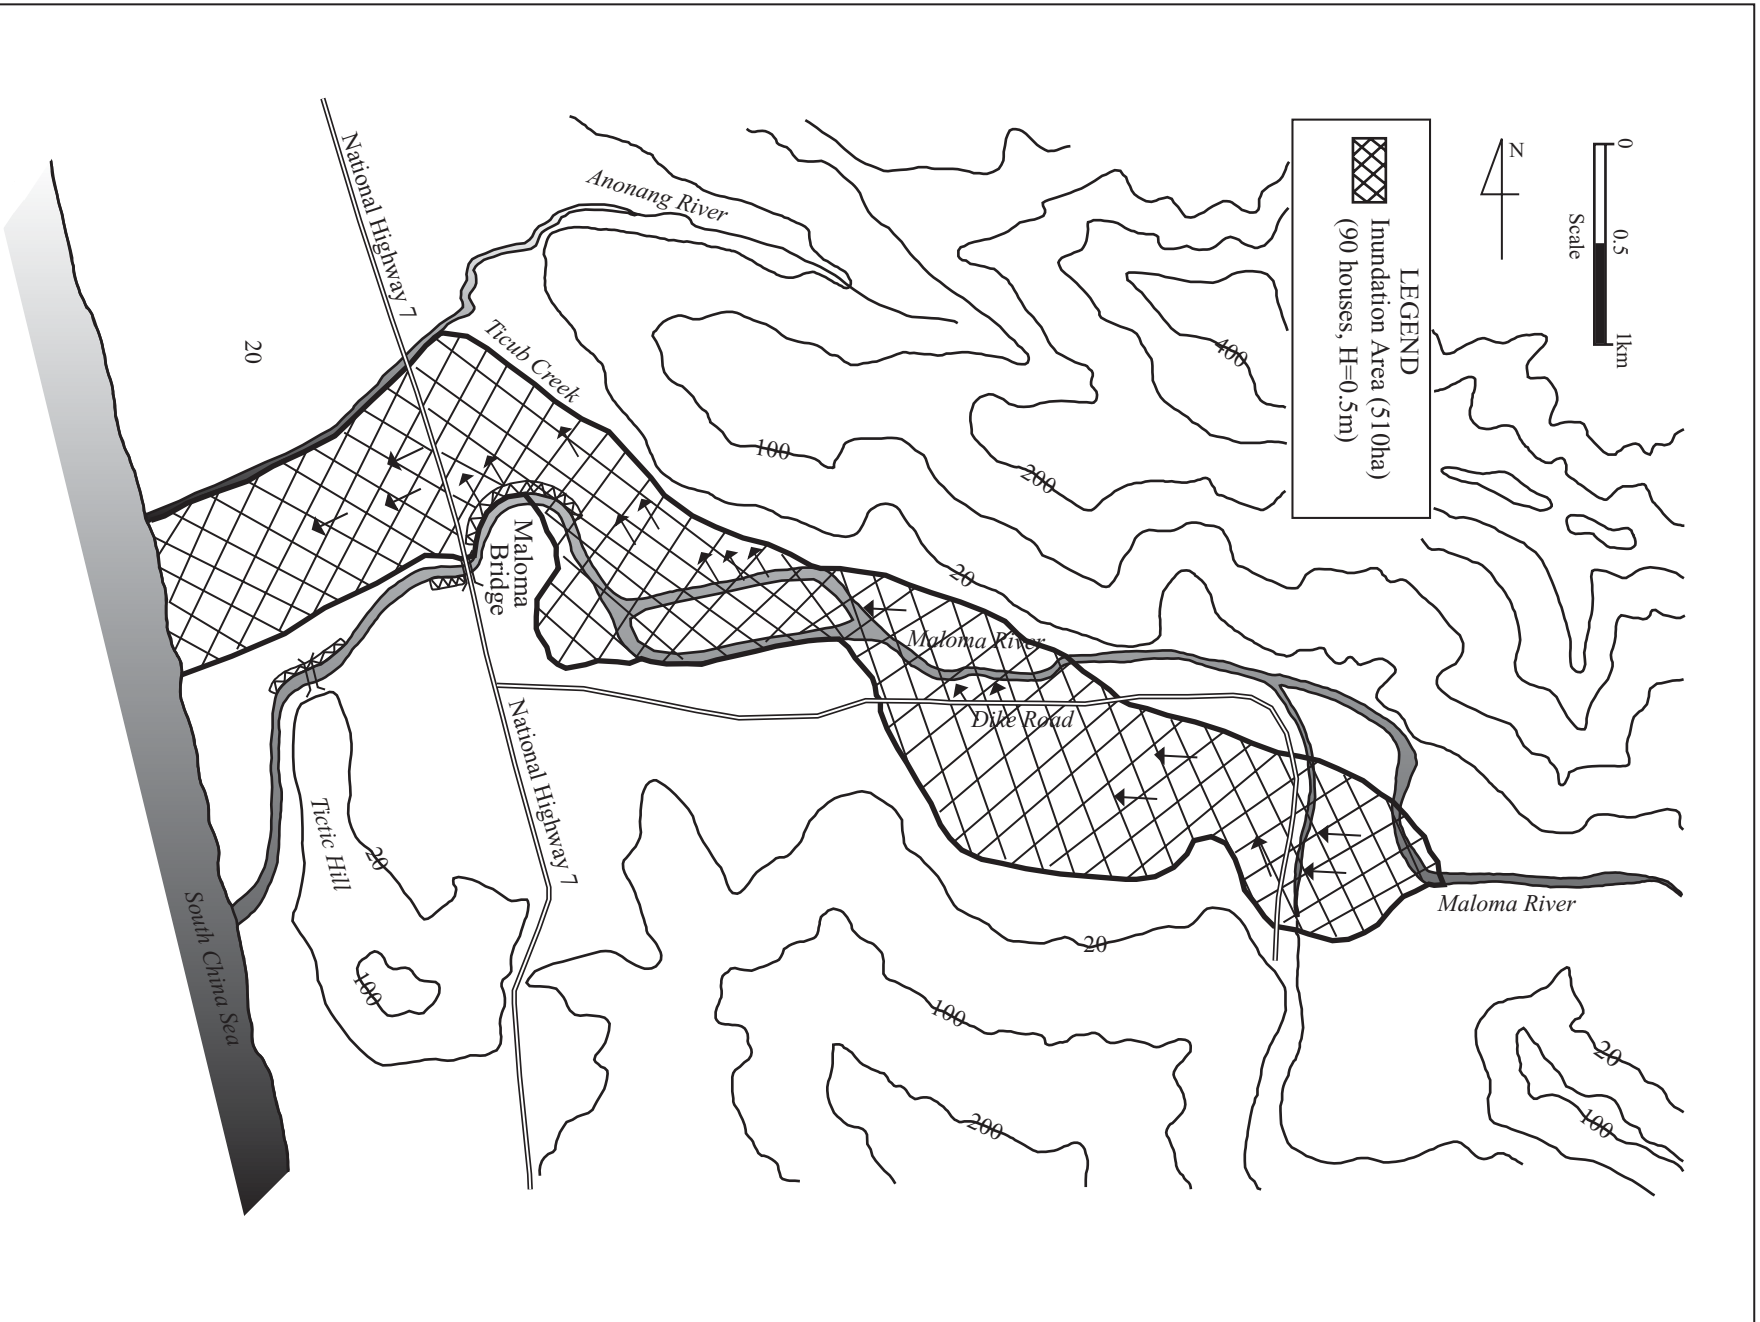
Figure 1.1.4
**Inundation Area along the Maloma River
 in July 2002**

In July 2002, another flood caused extensive inundation damage along the Maloma River. In this occasion, severe inundation took place only in the upstream portion of Barangay Maloma and submerged wide rice fields. The residential area of the barangay suffered again, although the inundation depth (0.5 m) was shallower compared with that in 2001 because of the attenuation effect of the peak flood discharge caused by the upstream inundation. 90 houses (460 persons) were affected and 120 ha of agricultural land was damaged. The inundation area from this flood in 2002 is illustrated in Figure 1.1.4.

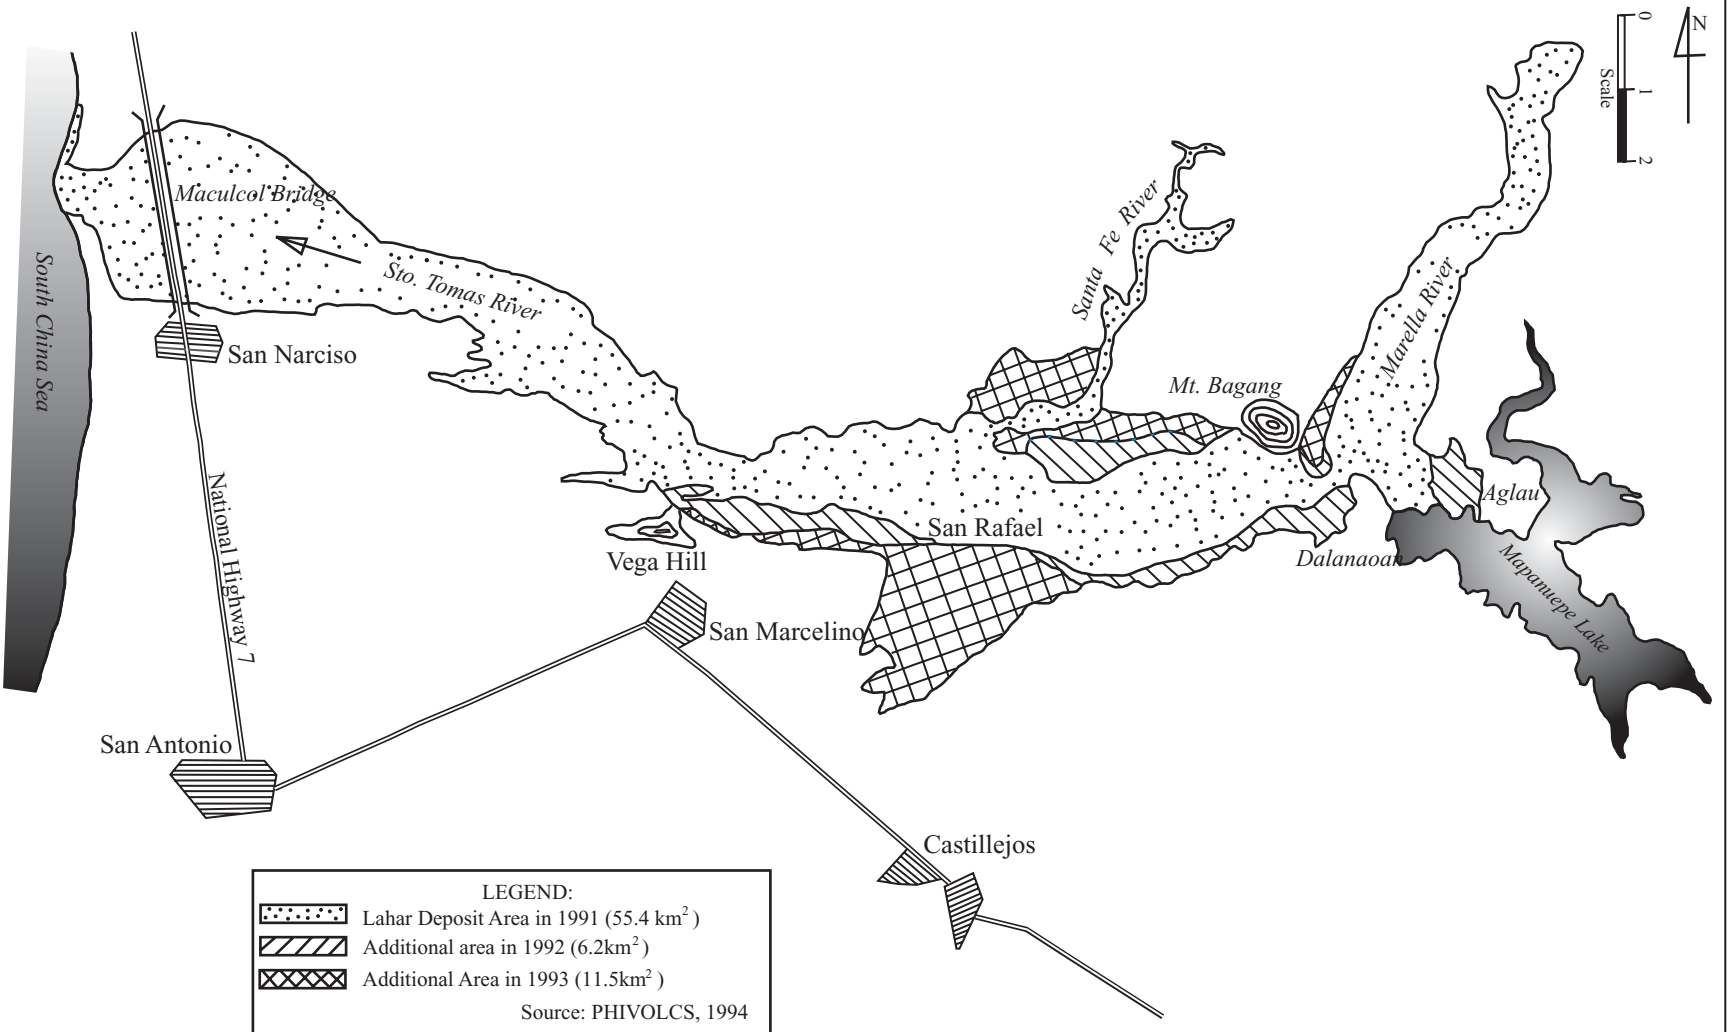
Figure 1.1.5

After the eruption in 1991, the Marella Valley and the Sto. Tomas River was buried by lahars, forming the Mapanuepe Lake in the largest left tributary. The lahars also ruined riparian villages along the Sto. Tomas River, namely, San Rafael, Santa Fe, Umayá, Maculcol and other barangays. A mining company and nearby villages along the Mapanuepe River were also ruined due to formation of the dammed up Mapanuepe Lake. No lahars have been reported since 1996, and flooding is now the main problem.

**Lahar Deposit Area in the Sto. Tomas River
System**

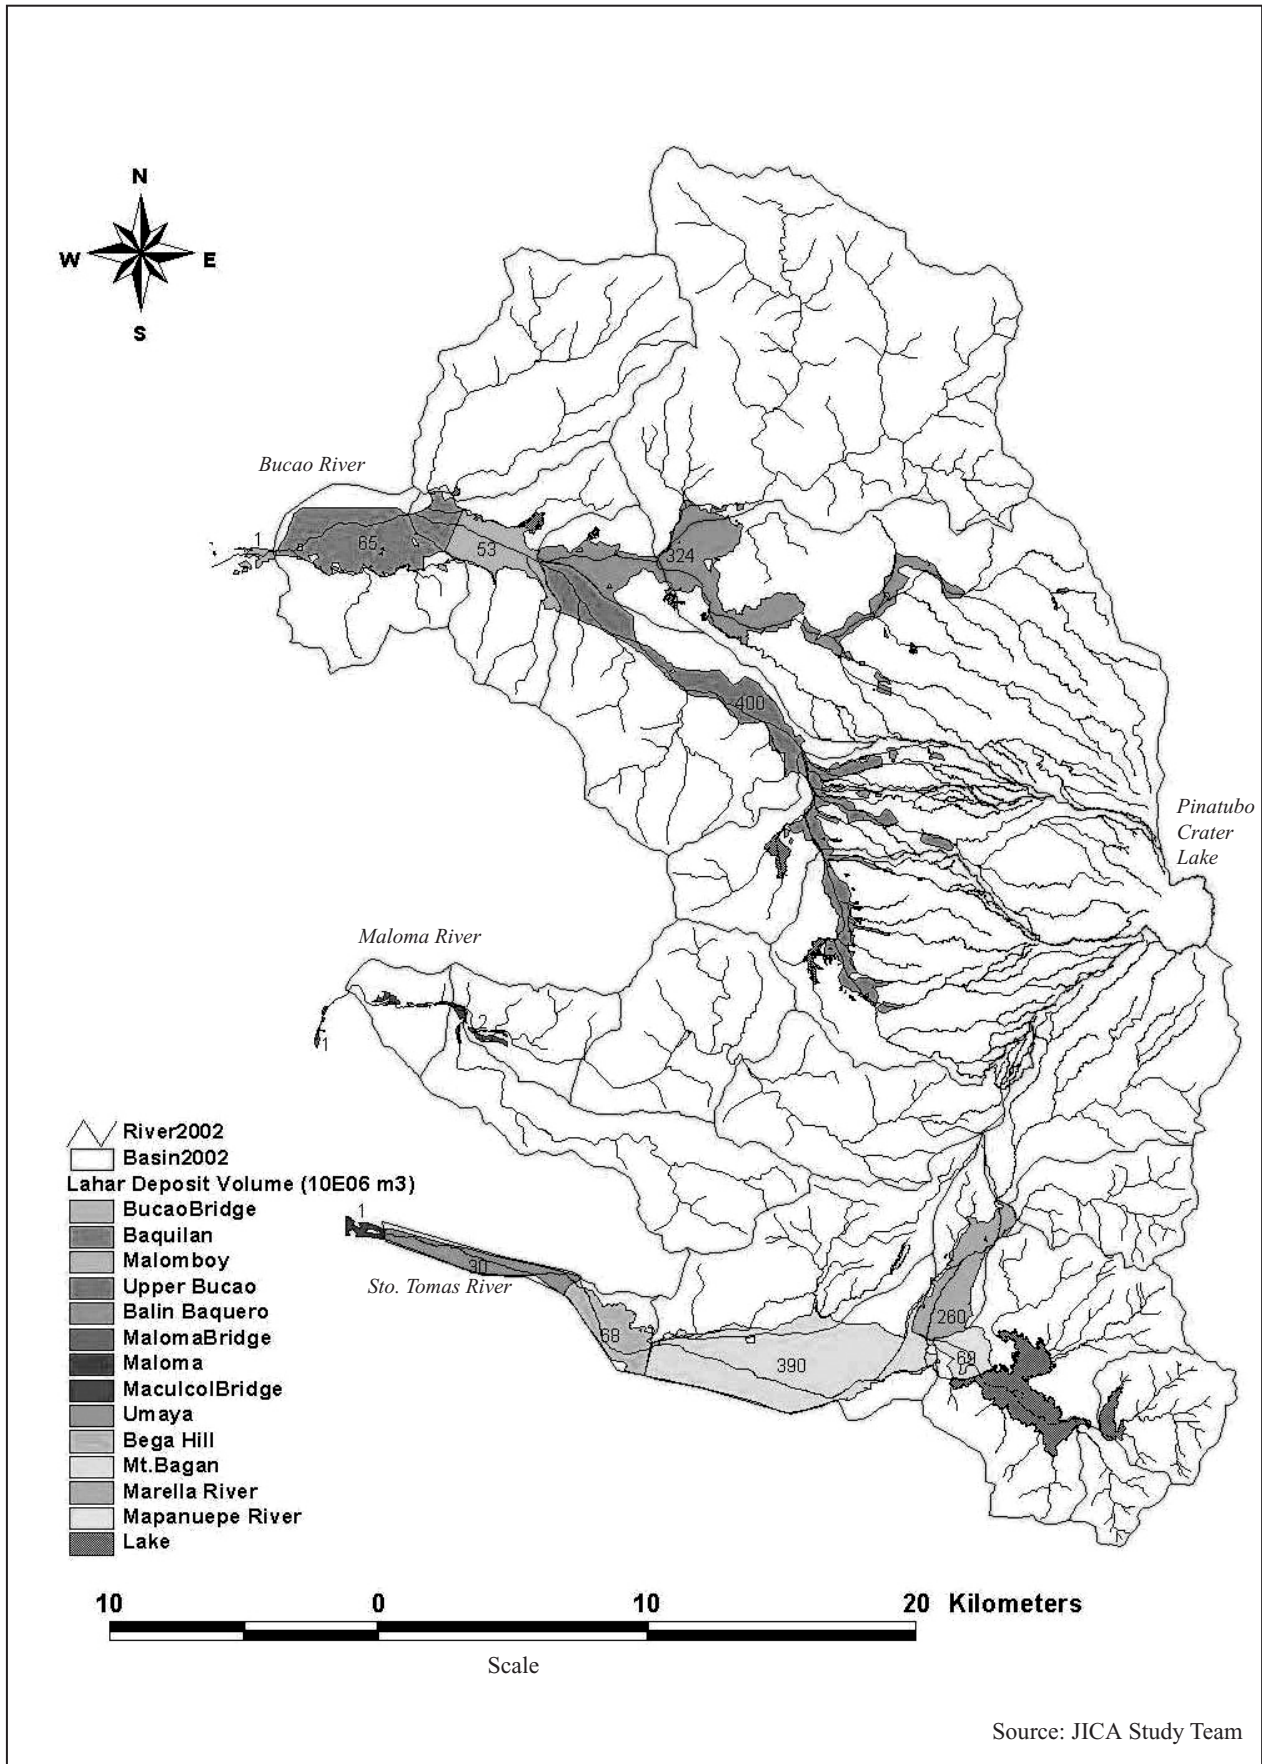
Figure 1.2.1
**Volume of Lahar Deposition along River
 Channels**

The volume of lahar deposition within the Bucao and the Sto. Tomas River areas is estimated at 843 and 818 million m³ respectively, as shown in Figure 1.2.1. The deposition depth is only a few meters in the lower stretches, however, the thickness increases to approximately 30 m in the upstream reaches. The huge volume of lahar deposition in the channel has significantly affected the surface run-off conditions. A considerable volume of the surface flow infiltrates into the lahar deposition area and the surface run-off ratio is dramatically decreased particularly during flooding periods.
