2.3.2 Existing Facilities of the Sewerage system

(1) Sewage Treatment Facility

2) Current Status of STP

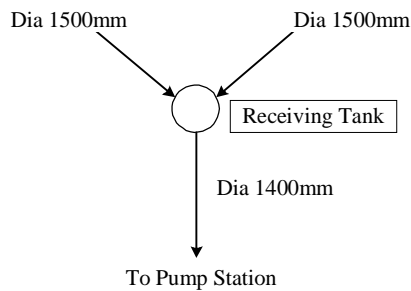
Figure 2.3.6 Receiving Tank Flow

Pipe capacity from receiving tank to the pump station is smaller than that installed upstream. Thus, pipe capacity from receiving tank to pump station is not sufficient. Furthermore, outlet pipe from the pump station is reduced to 1000mm dia. causing obstruction of sewage flow.

One pump station is under construction near the STP site 3km upstream, and its discharge pipe is planned to connect to this receiving tank one or two years later. In this regard, increase of the capacity for inlet pipe to the inlet pump station is an urgent need.
