*Appendix B-3*

*Result of Concrete Neutralization Test*

## APPENDIX B-3 Result of Concrete Neutralization Test

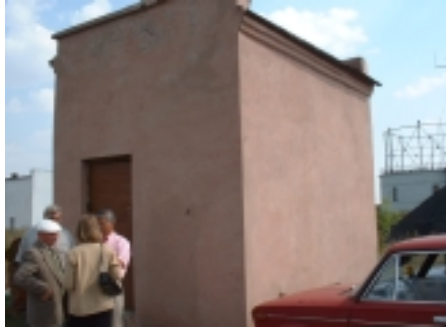
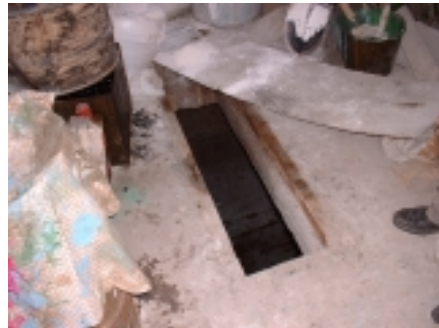
Figure B.3.1

No.	Facility	Remaining life	Description	Need for rehabilitation	Rehabilitation rank
1	Inlet Chamber	-	Test was not conducted because of safety measure, however from the observation condition of structure is deteriorated.	Necessary as soon as possible	Surface repairing
2	Inlet Pump Station screen room wall	4	From the chalking of the wall, urgent rehabilitation is necessary.	Necessary as soon as possible	Surface repairing
3	Inlet Pump Station superstructure wall	0	All the depth is already neutralized.	Necessary as soon as possible	Surface repairing
4	Grit Chamber	4	To be abolished with the new construction of grit chamber.	No need	No need
5	Primary Sedimentation Tank	128.44	The structures rehabilitated in 1998 are in good condition. Since, No.1 tank was off rehabilitation in 1998, 1 tank needs rehabilitation including reinforcement of the sub-	1 tank needs rehabilitation as soon as possible including sub-surface structure.	Surface repairing with reinforcement of the wall

1. Inlet chamber

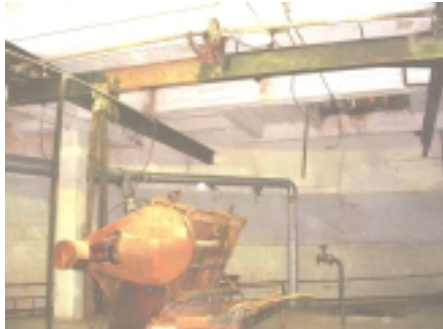
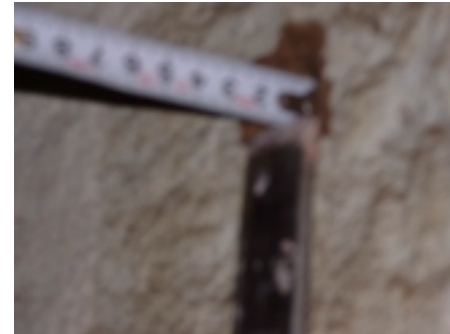
Figure B.3.2

2. Inlet pump station(1/2)

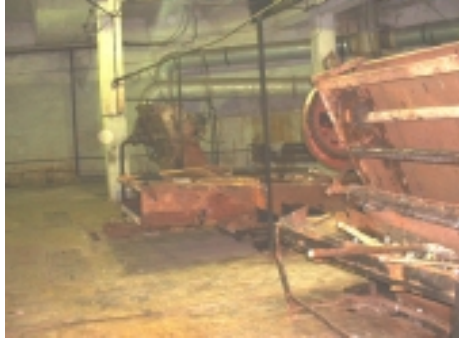
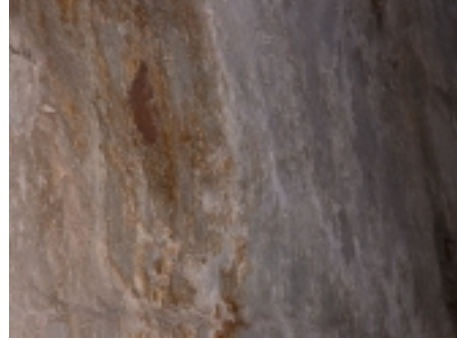
Figure B.3.3

2. Inlet pump station(2/2)  
The whole view

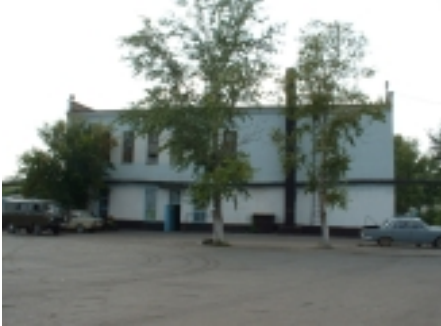
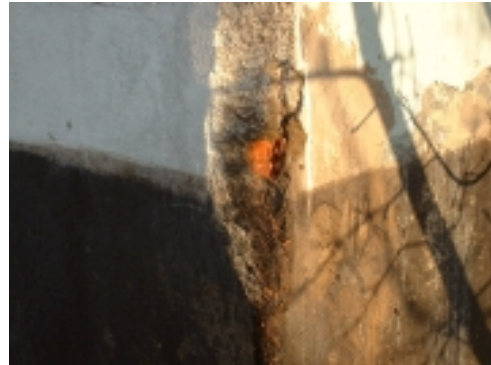
Figure B.3.4

3. Inlet pump station (External wall)  
The whole view

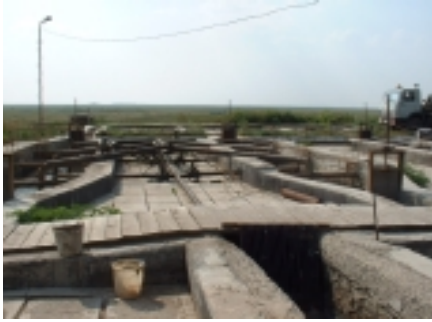
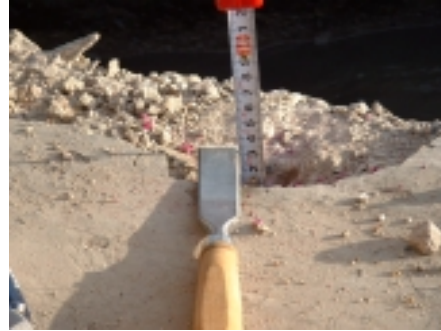
Figure B.3.5

4.Grit chamber

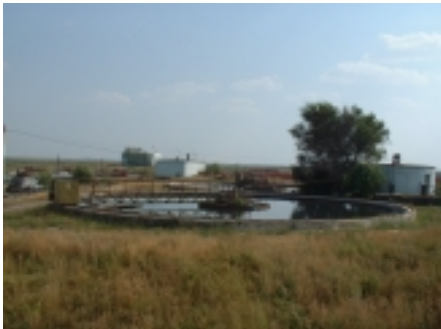
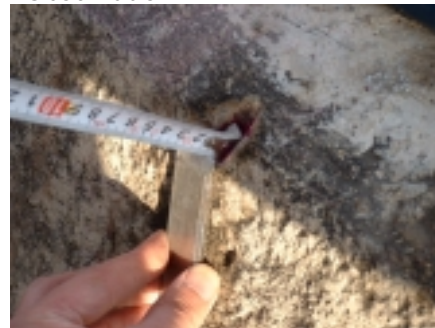
Figure B.3.6

5.Primary sedimentation tank

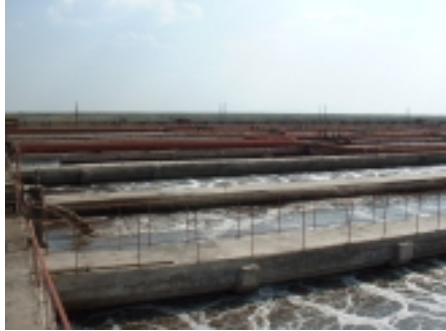
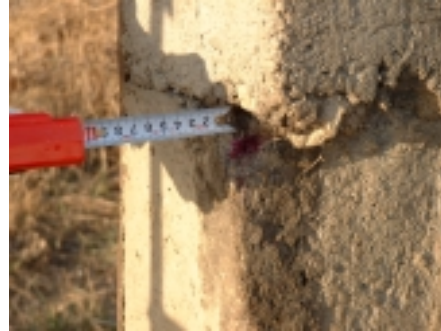
Figure B.3.7

6	Aeration Tank	11.11	This structure was rehabilitated in 1998, condition is not so good compared with sedimentation tank. Prolonging measure is necessary for further use.	Necessary as soon as possible	Surface repairing
7	Secondary Sedimentation Tank	128.44	The structures rehabilitated in 1998 are in good condition. Since, No.1,2 tanks were off rehabilitation in 1998, 2 of them need rehabilitation including reinforcement of the sub-surface wall.	2 tanks needs rehabilitation as soon as possible including sub-surface structure.	Surface repairing with reinforcement of the wall
8	Distribution Chamber	0.08	Although this was rehabilitated in 1998, surface condition is rather bad. Intense weathering is observed.	Necessary as soon as possible	Surface repairing
9	Sludge Thickener	128.44	The structures rehabilitated in 1998 are in good condition.	No need	No need
10	Digestion tank	503.75	Since the outer cover is thick, long remaining life is calculated. But from the viewpoint of heat retaining function, rehabilitation is necessary. Condition of the	Necessary as soon as possible	Surface repairing with reinforcement of the inside wall

6. Aeration tank

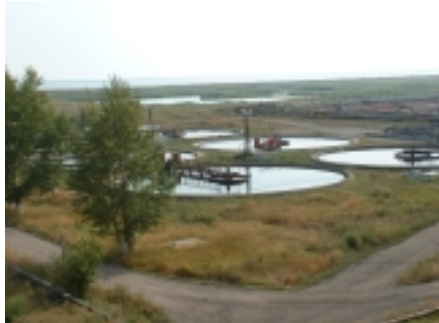
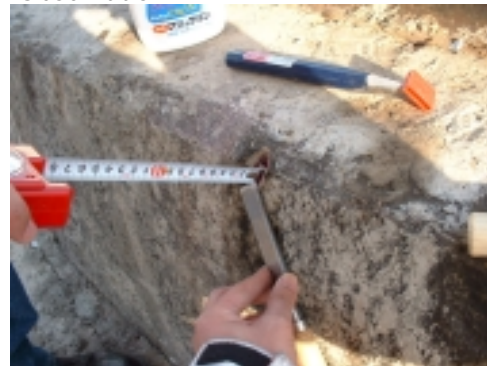
Figure B.3.8

7. Secondary sedimentation tank

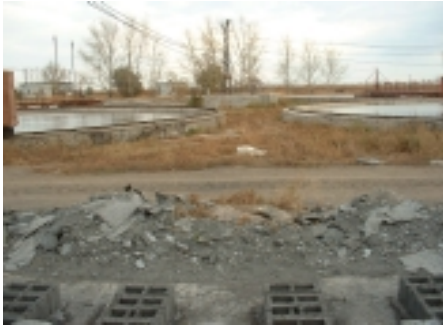
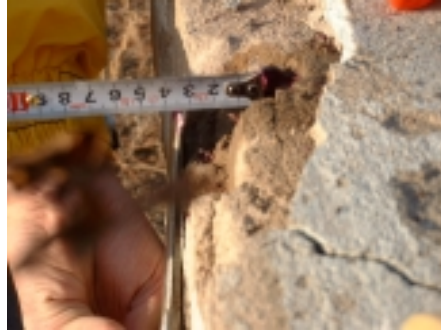
Figure B.3.9

8. Distribution tank (secondary sedimentation tank)  
The whole view

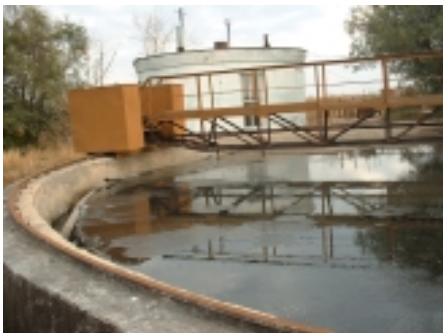
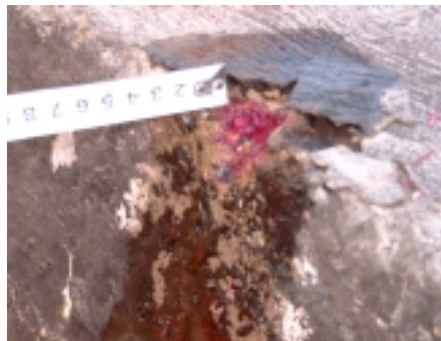
Figure B.3.10

No.	Facility	Location of inspection point	Observation	Period of operation (years)	Concrete cover (mm)	Depth of neutralization (mm)	Coefficient " a "	Remaining life
1	Inlet Chamber	Inside the cover (observation only)	Dirt, rust, humidity.	36	40	-	-	-
2	Inlet Pump Station	Internal wall of screen room	Chalking was confirmed on the surface broadly.	36	40	30	5	4
3	-ditto	External superstructure wall	Brick inside the finish mortar	36	40	40	6.7	0
4	Grit Chamber	External wall of channel	Calcification. Cracks.	36	40	30	5	4
5	Primary Sedimentation	Outer wall of tank	Dirt. (1998, rehabilitation made)	4	40	6	3	128.44
6	Aeration Tank	Wall of tank	Dirt. (1998, rehabilitation made)	4	40	15	7.5	11.11
7	Secondary Sedimentation	Outer wall of tank	Dirt. (1998, rehabilitation made)	4	40	6	3	128.44
8	Distribution Chamber	External wall of chamber	Dirt. (1998, rehabilitation made)	4	40	35	17.5	0.08
9	Sludge Thickener	Outer wall of tank	Dirt. (1998, rehabilitation made)	4	40	6	3	128.44

9. Sludge Thickener  
The whole view

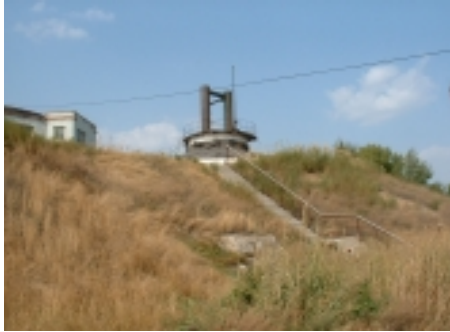
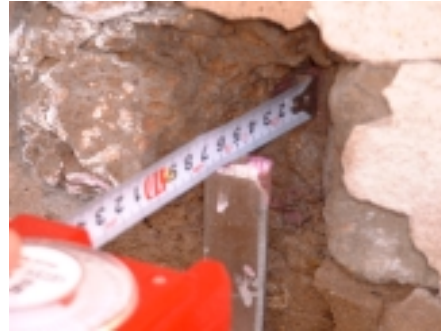
Figure B.3.11

10	Digestion tank	External wall of tank	Dirt. (1998, rehabilitation made)	4	550	45	22.5	503.75
Average						13.9

10. Digestion tank
