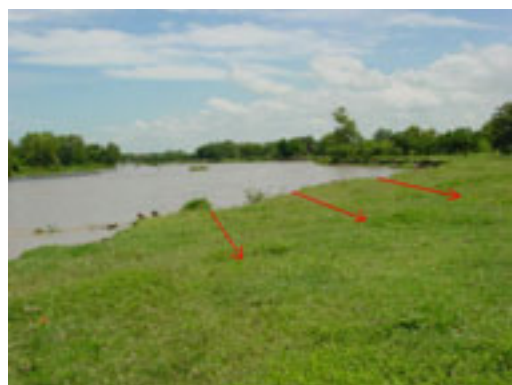
Photo 2.3.4-4 Undercut slope of the Samalá River

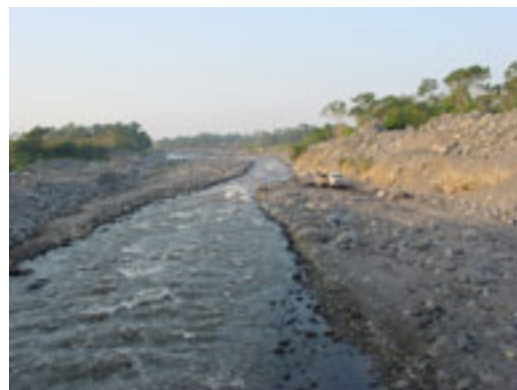
For the Samalá River, gravel on the riverbed near San Sebastián is dug using heavy equipment in order to prevent the riverbed from rising and maintain the river course. However, an overwhelming volume of sediments is coming down from the upper reaches, making the riverbed

Photo 2.3.5-1 Status of excavation on the riverbed

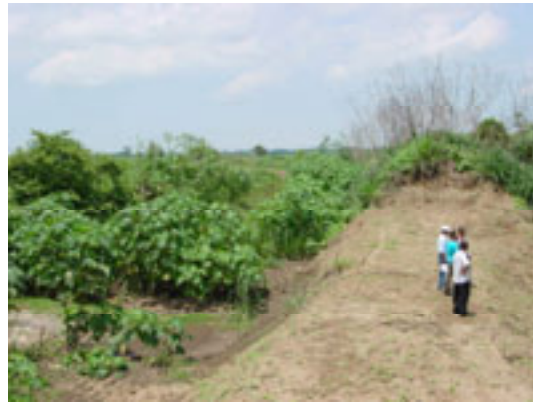
continue to rise. In San Sebastián where damage often occur due to floodings, an embankment made of gabions has been built on the left bank. After this embankment had been built, no flood damage occurred in San Sebastián, according to the inhabitants. Downstream from the diversion point with the Ixpatx River, another embankment was built on the curve of the river.

Photo 2.3.5-2 Gabions for prevention of erosion

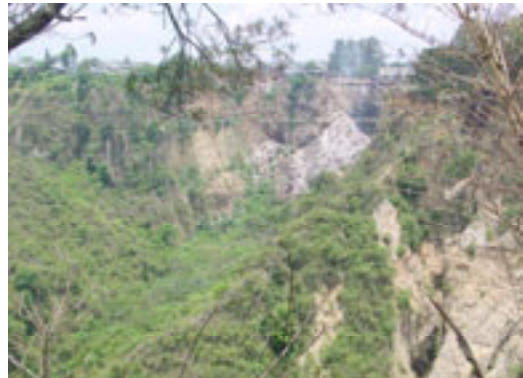
Several areas of landslides were visited along the Salaya, Tzalja, Sapote, and Guacamaya rivers in zona 19. The largest landslide at the area has a depth of 80 m (from 1500m at the start of Guacamaya river bed to 1580m at the top of plateau). Its geology is tephra interbedded with pumiceous diamictons and fluvio-lacustrine sediments. This is the characteristic of the ravines (*barrancos*) in Guatemala City which stand in depths between 25 and 150 m. In this site during the 1976 earthquake many slope failures (18) were observed. Also before these earthquake many clues of old slope failures are shown. Along 7th Avenue in the Primero de Julio neighborhood, a crack or a fault was observed with obvious cracks in the road and an offset gate. This area would be highly vulnerable to earthquake and landslide damages.

Photo 2.3.7-1 Landslide at the valley head of Guacamaya River

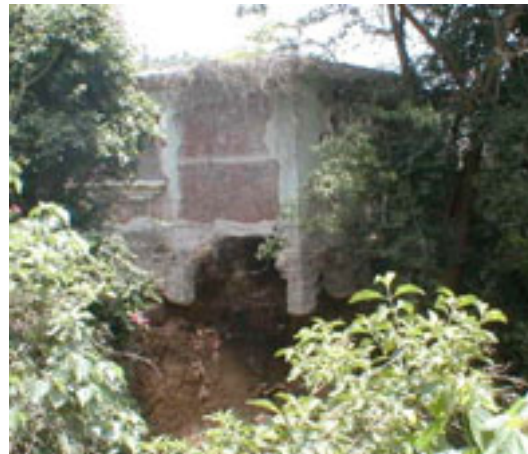
Ciudad Nueva is a residential area of better economic level but intense land usage near the edge of the ravine was observed. Further investigation showed buildings perched on the edge of nearly vertical slopes of the ravines. Some of them were reinforced to compensate for erosion and gradual slope movement but obviously slope failure will result in total destruction of many of these structures.

Photo 2.3.7-2 Base ground was eroded and subject to failure

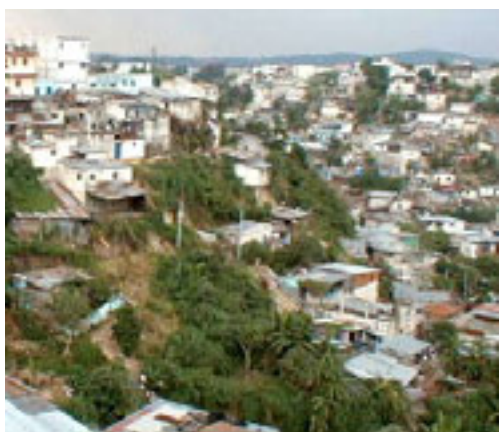
Photo 2.3.7-3 The settlement of La Limonada

The oldest settlement (pre 1976), La Limonada, was visited to observe general construction and social conditions. Most of the homes and structures are built from scrap materials along the slopes of the valley. Narrow networks of footpaths wind through the settlement. Some of the more recently constructed buildings were constructed with cement blocks. The poor construction and extremely limited access within this hillside settlement make it highly vulnerable to natural disasters.

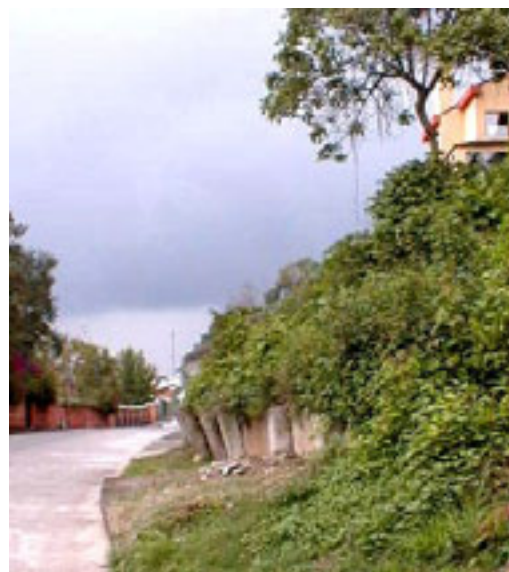
The area of San Rafael and La Mirada are affluent neighborhoods with many grand houses constructed on the hillside. The streets have cracks and depressions from slumping and movement of the slope. These areas are very unstable and will continue to move, and could result in severe destruction if triggered by heavy rains or an earthquake.

Photo 2.3.7-4 Landslide at San Rafael (the wall is sticking out)

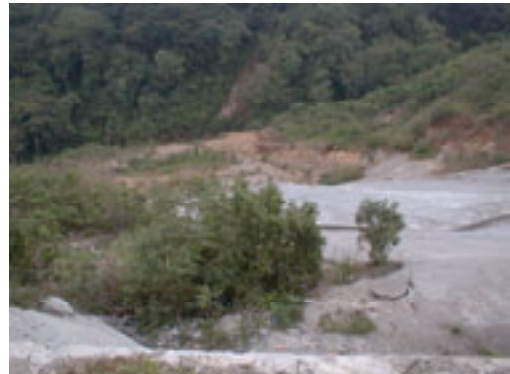
This landslide appeared on October/1993. It is known the rainy season of 1993 up to October gave about 1,150 mm of rain and 676 mm accumulated in the previous three months. Although until now it was not possible to know final report (if exists) or details about further study or countermeasures for stabilizing this landslide, in a visit to the field (14/6/2001) it could be observed stabilizing structures such as a bridge platform, piles driven and some erosion control mortar carpet were already installed. However, the erosion control structure is not protected against gully erosion below it where the lack of vegetation threat to undermine the base of the slope of 62° inclination at the lower side of the road.

Photo 2.3.7-5 Landslide at km. 11.5 Road to El Salvador (erosion control mortar carpet were already installed)

Although until now it was not possible to know final report (if exists) or details about further study or countermeasures, in a visit to the field (June 14, 2001) it could be observed that stabilizing structures such as a bridge platform, piles driven and some erosion control mortar carpet were already installed. In the case the abutments of the bridge are fixed to bedrock and that enough number of piles were driven well beyond the sliding surface, this method would work effectively even when expensive. Carelessness of this matter may induce new troubles in the future, thus actions for slope protection at the base are highly recommended.

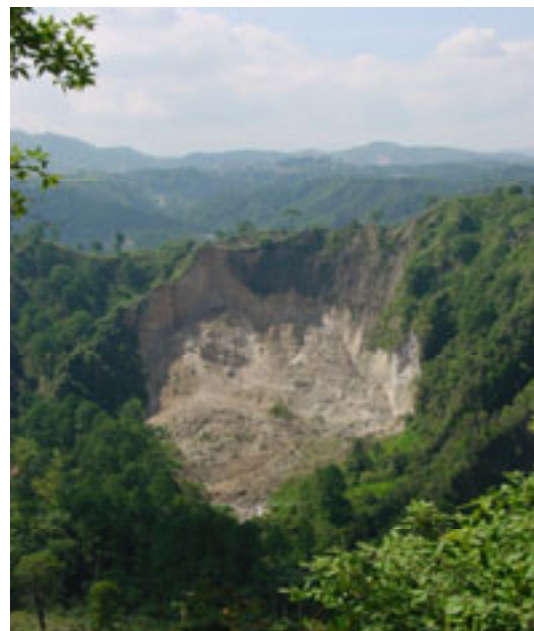
Because there were no houses below this no damage was reported. The end of landslide tongue seems to have reached the river stream, but no report of damming was found. However in future slides it may produce the temporary damming of the river or it may become the source of flow out debris to down stream.

Photo 2.3.7-6 Landslide at Tzajá River side

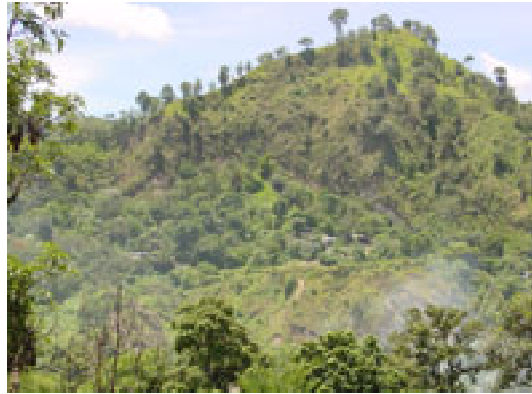
Photo 2.3.7-7 Landslide at Cantón Amatitlancito

Although technically there are many solutions to these type of landslides, from the economic ones of improving the surface and subsurface drainage, as well as the sealing of all the cracks and scarps in order to recover shear strength and avoid infiltration of water, to the expensive ones of piling deep into the bedrock to retain the sliding (retaining wall at the foot would be ineffective), considering the few families affected (about 10-12) and the value of property, it is more economical the withdrawal and resettlement of this people in other safe place, and use this area for forest protection purposes. However, it seems people inside is not well aware of the danger, because one family has recently constructed very nice house with concrete blocks and steeled roof frame, to substitute the older cracked one of adobe. This matter has to be undertaken by responsible institutions like CONRED in order to get the necessary awareness and avoid useless expectations of the people.

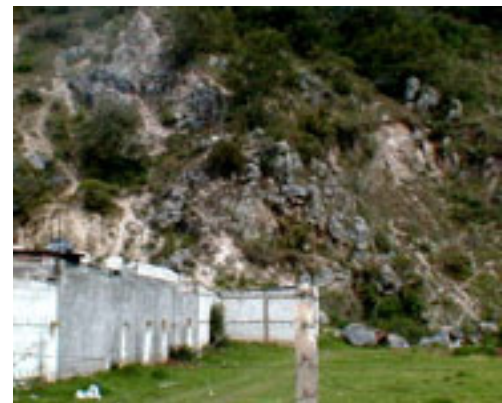
Photo 2.3.7-11 Dangerous cliff at La Pedrera

falls during earthquakes or rainfalls. The hazard is permanent due to fractured rock at the top of the cliff. There are about 40 houses of the Barrio Santa Ana in danger of damages by rock falls. An earthquake in 1998 caused damage and cracks in several houses.

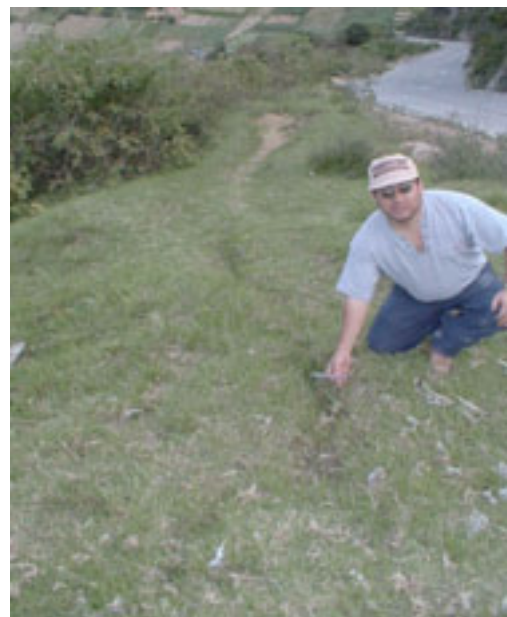
Photo 2.3.7-12 Chuicaracoj road cracking

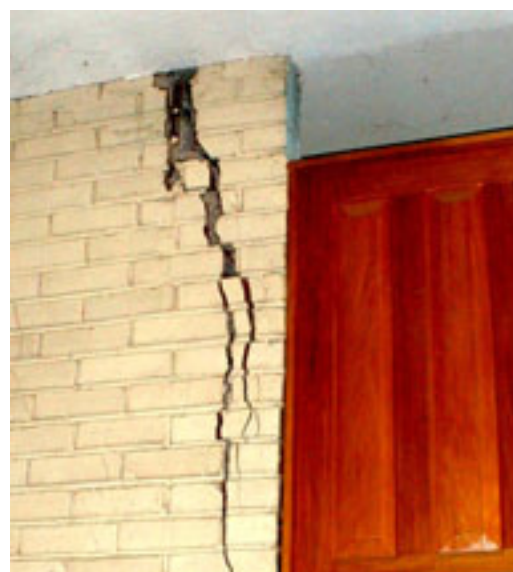
Photo 2.3.7-17 The damage of 1999 earthquake at Customs building, Puerto Barrios
