Section 3 Bukhara to Gazachak via dam crossing - Kms 344

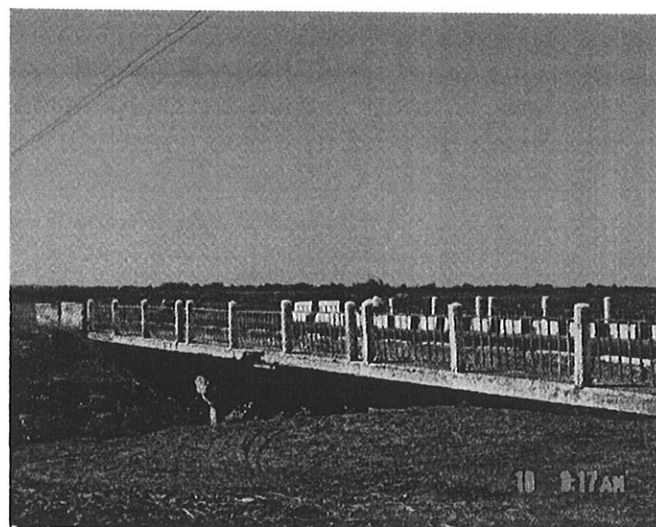
Km 4.5 Bridge 2 x 9m section.
Possible repair required due to
some cracking of bridge beam.

Km4.5 2枚構造一枚9mの橋。
はりにひびが入っているため、修繕が必要かもしれない。

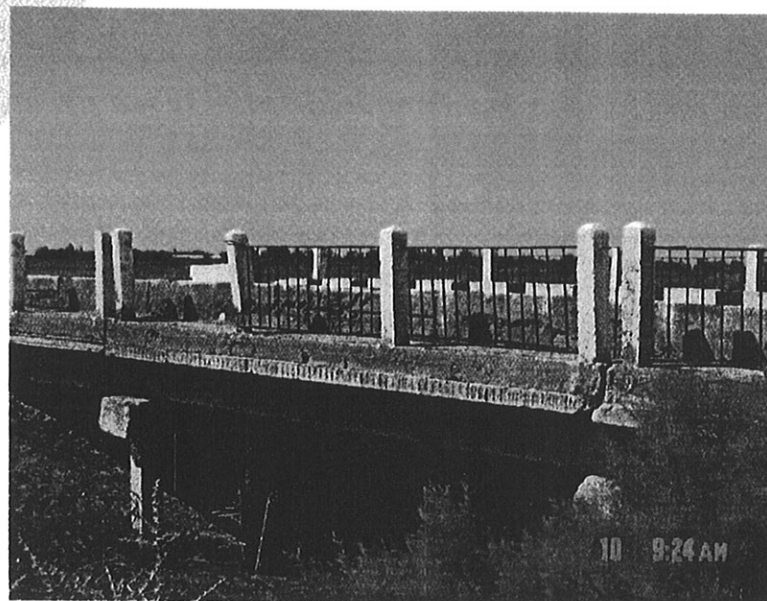
Km 11 Bridge 3 x 9m section
This bridge previously repaired but needs more attention.

Km11.0 3 x 9 m の橋。この橋は以前修繕された :

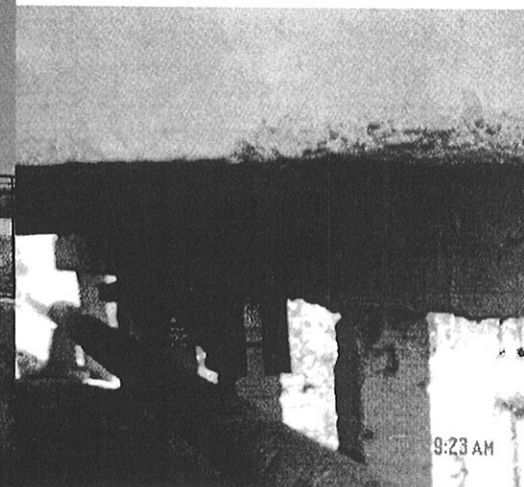
Km 13 Bridge 3 x 9m section
Similar to above and needs attention.

Km13.0 3 x 9 m の橋。 上記と同じく注意が必要

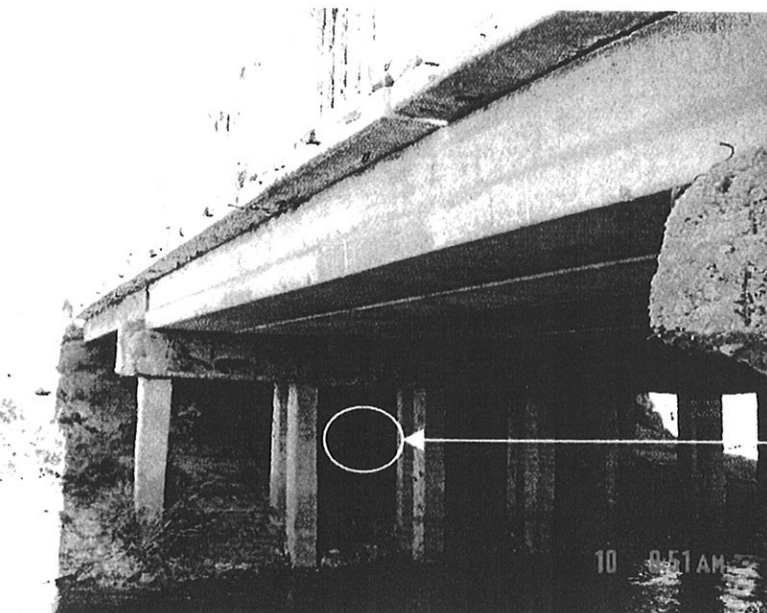
Km 37 Bridge 3 x 9m section
considered suspect as there were concrete block placed under approach and exit sections as reinforcement although not touching.

Km37.0 3 x 9 m の橋。橋入り口及び出口の橋げた
があるため、橋の強度に疑問があり。
