PANALPINA

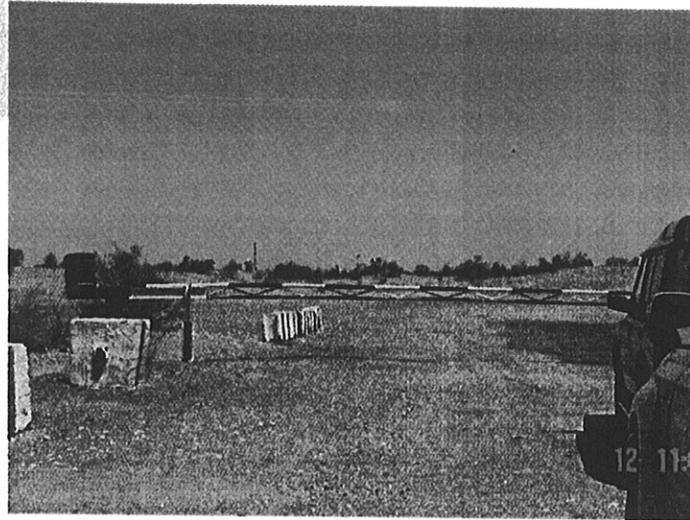
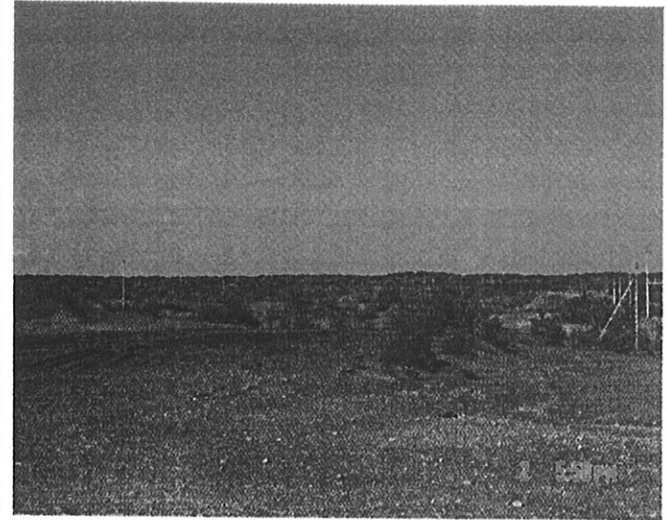
Km351.0

Km 351 Police check point
Passing under 35kv at 7m.
At this point turn right.
Road is potholed and edge
eroded.

警察の検問所があります。

3 5KV 電線が頭上7 mにあります。

道路は所々穴があり、道路脇は状態がよくありません。

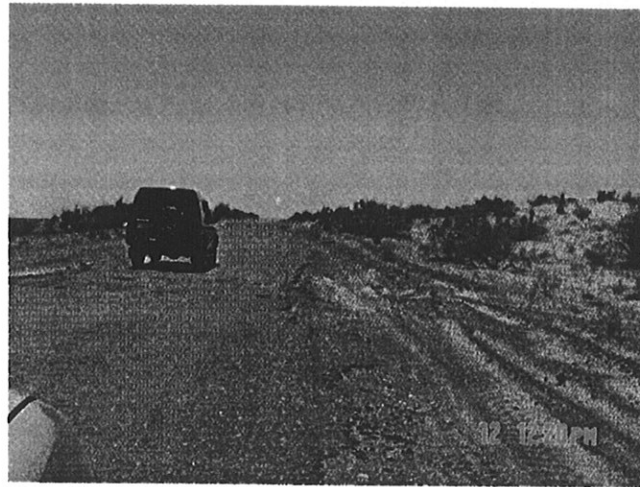
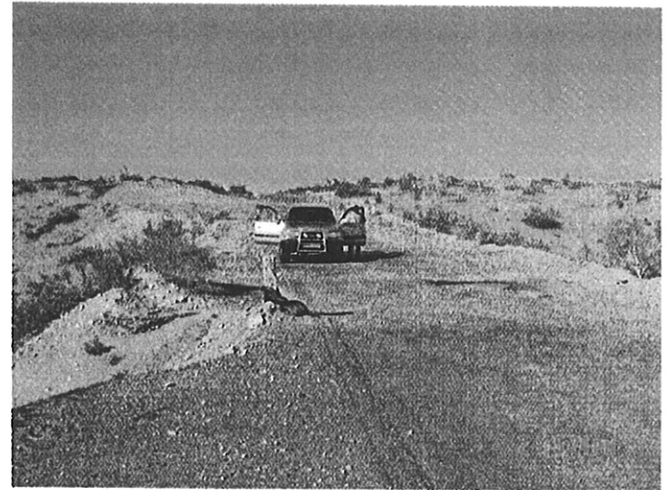
Km361.0

From **Km 361** road
deteriorates with potholing
and edge erosion.

ここから穴があいて、道路脇の状態がよくない道路になります。
