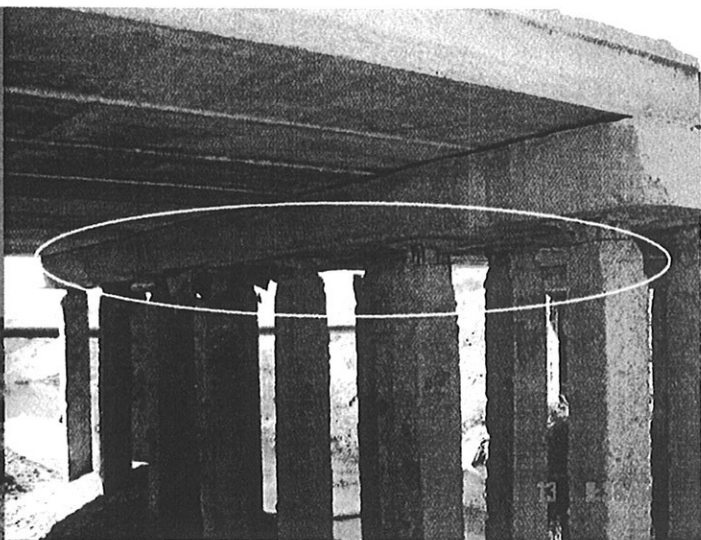
Km 91 Bridge 5 x 9m section
This bridge looks in very bad condition due to collapsed walkways. Deck beams are solid concrete and piers are with double columns support. Top of columns have bad spalling but can be repaired easily.

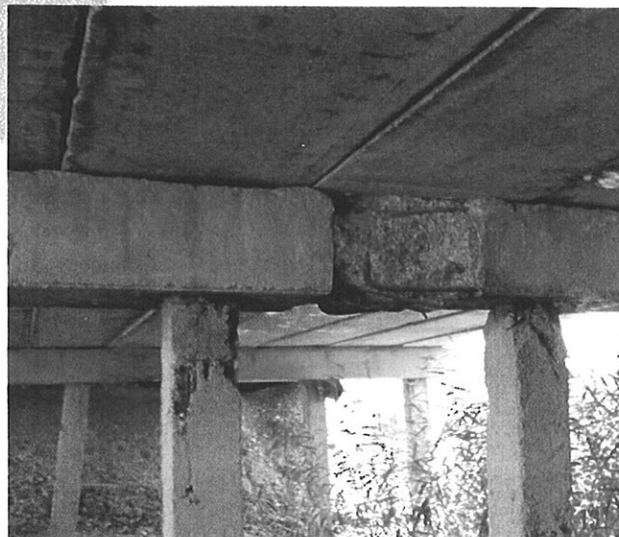
Km 92 Bridge 3 x 9m section
Some column tops to be
repaired.

Km92.0 3 x 9 m の橋。橋げたの上の方は修繕必要。

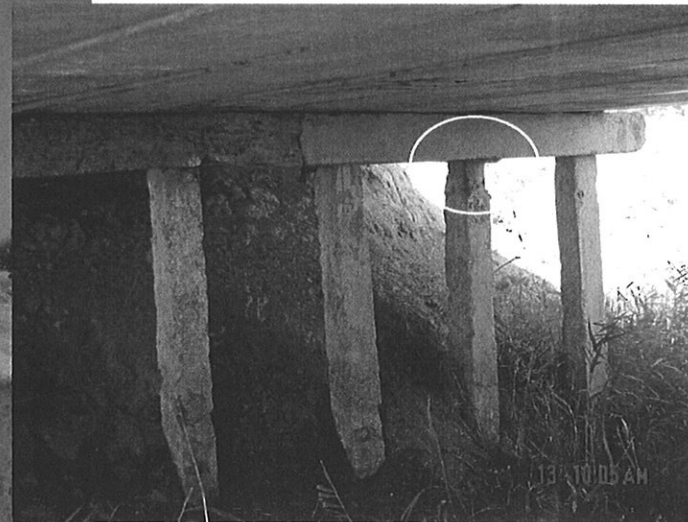
Km 100 Bridge 3 x 9m section
requires some repair to three
column tops.

Km100.0 3 x 9 m の橋。橋げたの上の方は修繕必要。
