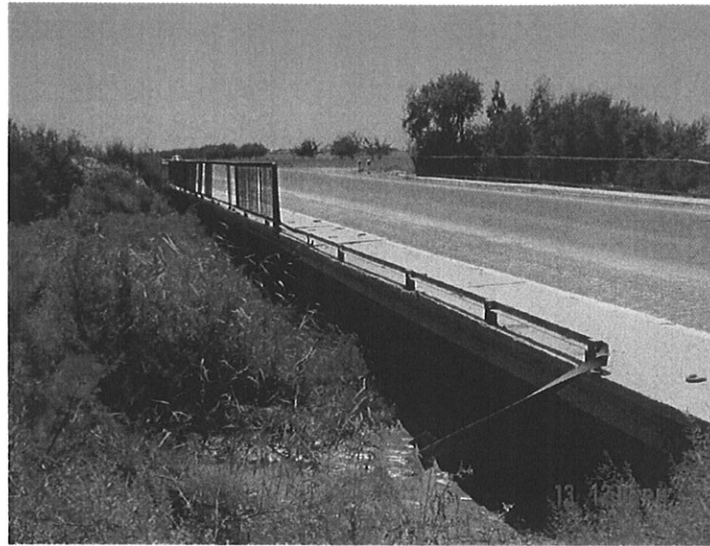
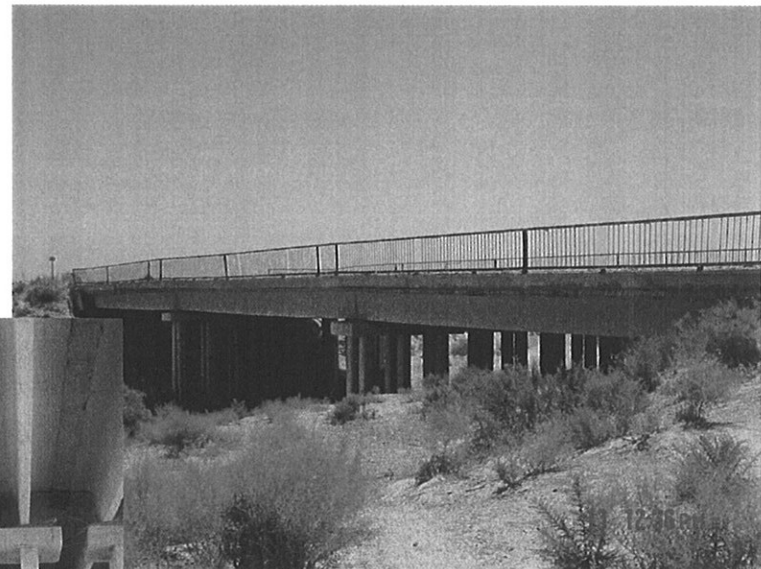
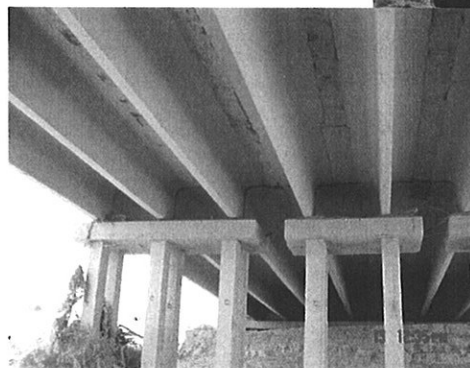
**Km 252** Bridge 3 x 14 m section  
with support columns split as  
shown. Transports to keep to  
right of centre.

Km252.0 3 x 1 4 m の橋。橋げたは写真の通りわかれています。輸送は橋の真中をさけ右による。

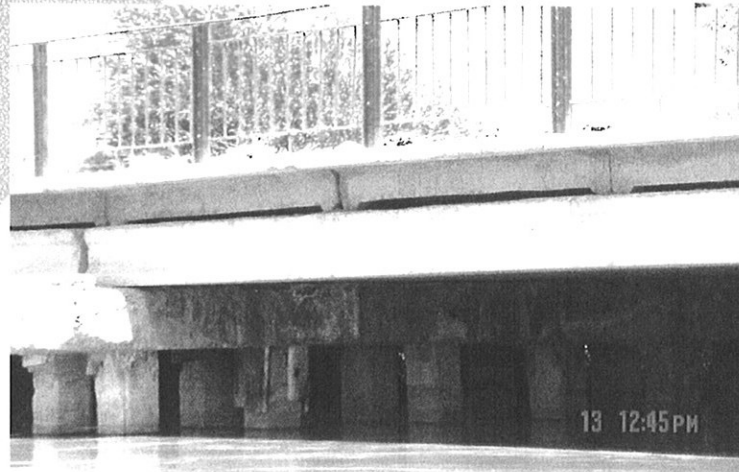
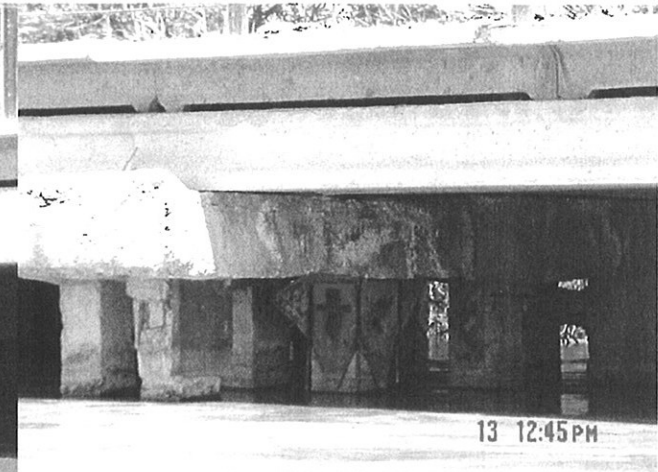
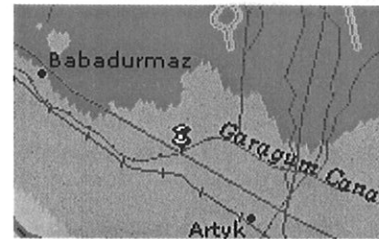
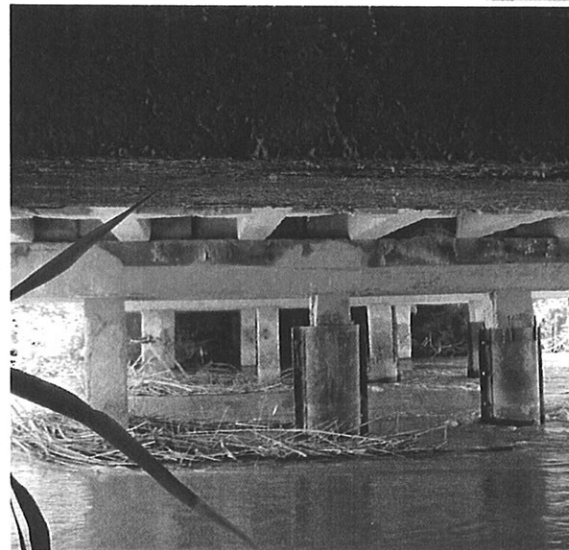
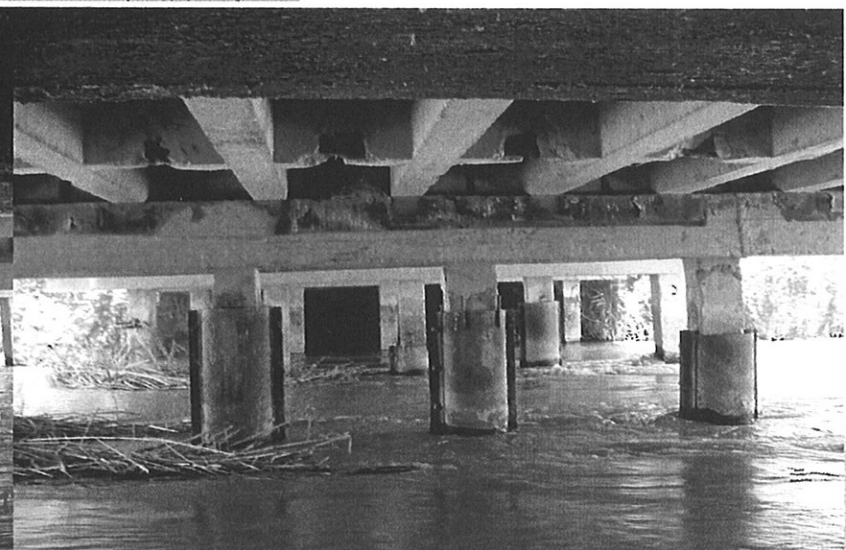
Km259.0

**Km 259** there are two bridges at this point which are having a high water level at all times. First bridge is 7 x 9m sections which could not be closely inspected due to the water level however it was observed that some column repairs have been made for previous heavy lift transports in 1999. Most columns are repair free. Second bridge following about 300m is 6 x 6m section and has been extensively repaired as shown. These bridges are only repaired at water level. There is no guarantee as to below water level condition.

ここには2つ橋があり、水かさがふたつとも常時高い。

1つ目の橋は7 x 9 m。水かさがあるため橋げたはチェックできなかったが、1999の重量物輸送で橋げたを補強したあとがみれた。ほとんどの橋げたが補修不要である。

2つ目の橋は一つ目から300mいったところにあり、6 x 6 mである。写真で見て取れるように集中的に補修がされている。水面より上しか見れないので、水面下の状態は保証できない。
