Km 300 Bridge 8 x 14m section with surface cracks on some bridge piers.
Routing to take right of centre when crossing.
Bridge has been repaired with additional steel plates at bridge beam end supports.

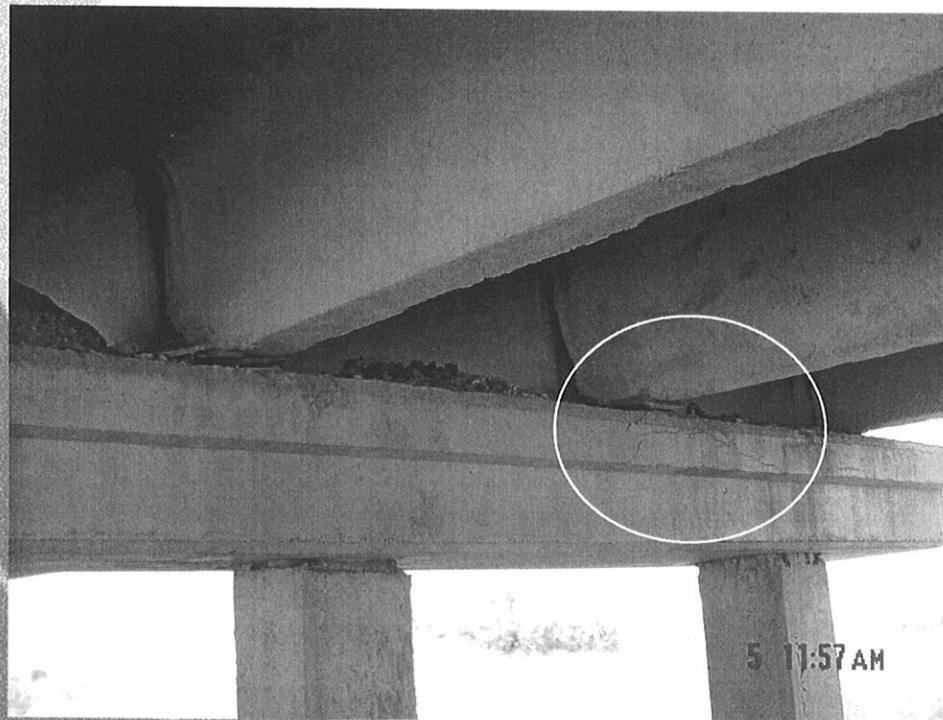
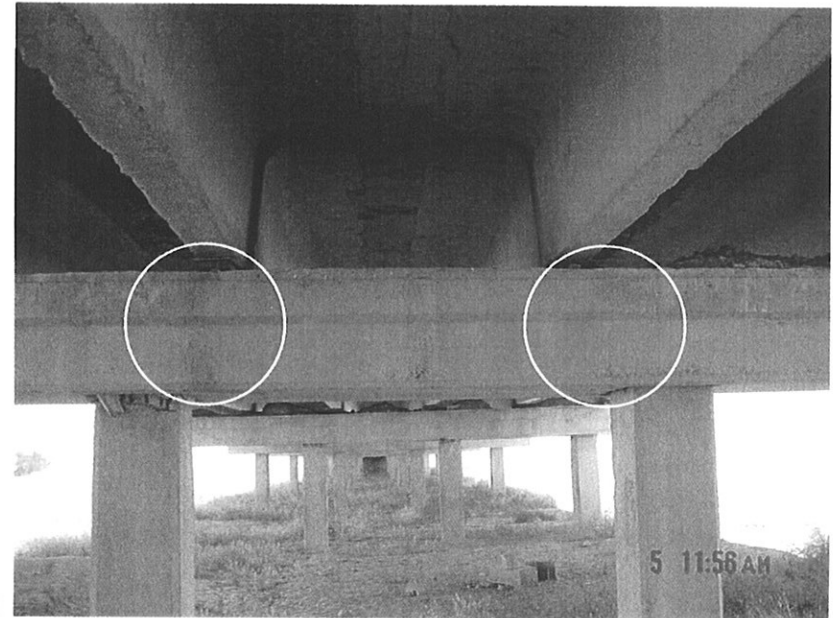
Km300.0

8 x 1 4 m の橋。はりの表面にひびあり。
使用の時は橋の右を通ること。
鉄板を使った修繕がしてある。

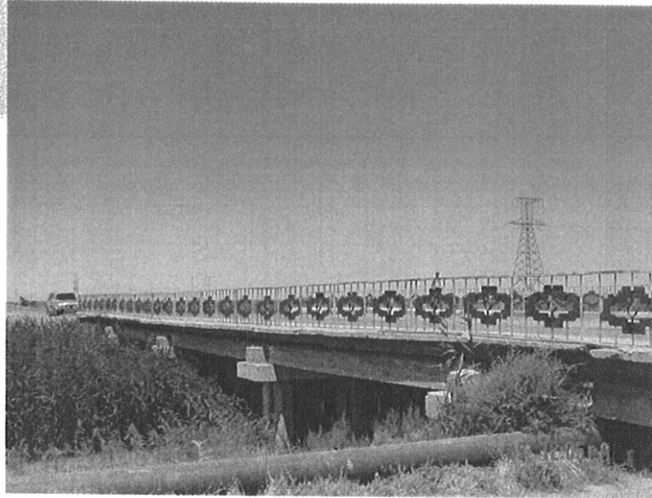
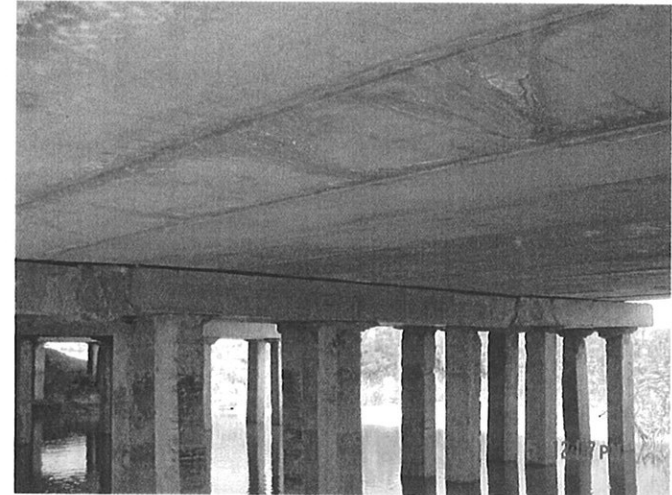
Km302 Bridge 5 x 9m section.

Km302.0 5 x 9 m の橋。

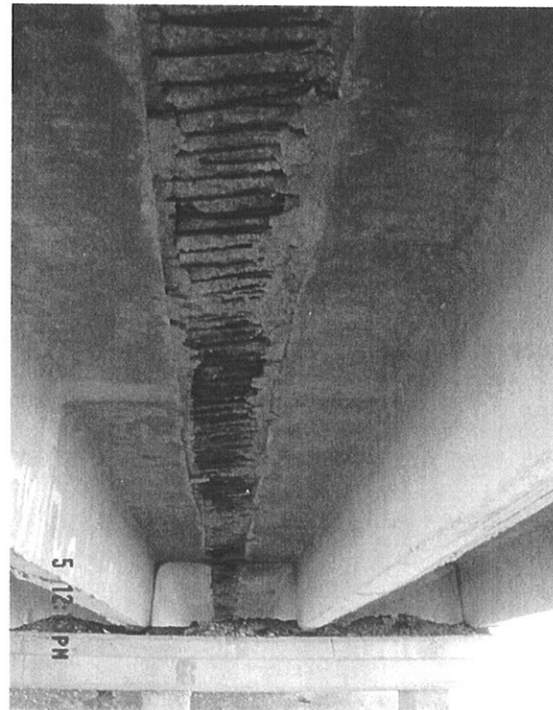
Km 305 Bridge 3 x 14 section
Which has a defect between
bridge beams which may
affect strength.
Passage should be made left
of centre.

Km305.0 3 x 1 4 m の橋。
橋の裏にほころびたところあり。強度に影響あるかもしれない。
使用するときは左側によること。
