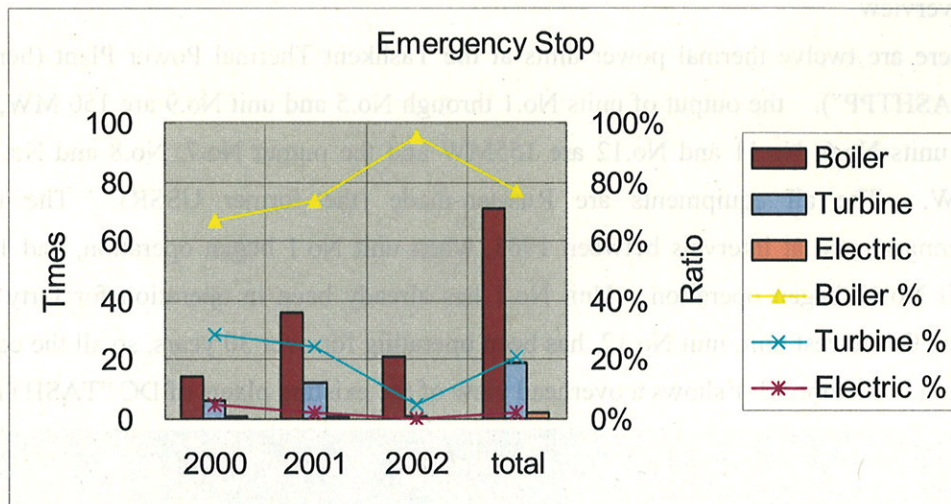
Figure 5.1-1 Causes of Unit Shutdowns by Facility

Figure 5.1-1 shows the causes of unit shutdowns for each facility between 2000 and 2002. In particular, it must be noted that over 75% of the problems leading to unit shutdowns are related to boiler equipment.

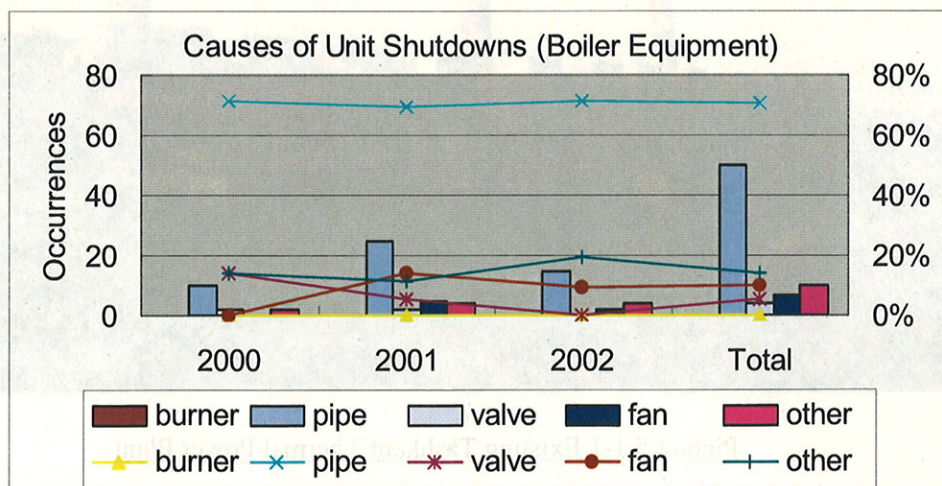
Figure 5.1-2 Boiler Equipment Causes of Unit Shutdowns

As shown in Figure 5.1-2, breakages of boiler tubes are the biggest boiler problem related to unit shutdowns, at 70%. The problems with the next highest significance are damaged bearings and vibration in pumps and fans. This indicates that broken boiler tubes are the biggest cause of unit shutdowns, at over 50%.

As a means of preventing these failures, a highly accurate inspection should be implemented at the time of periodical maintenance, in order to detect any problems in the early stages. All

problems detected should be repaired during the periodical maintenance work, and places where tube breakage is likely to occur should be tracked, so that planned reinforcement and updating of equipment can be performed.

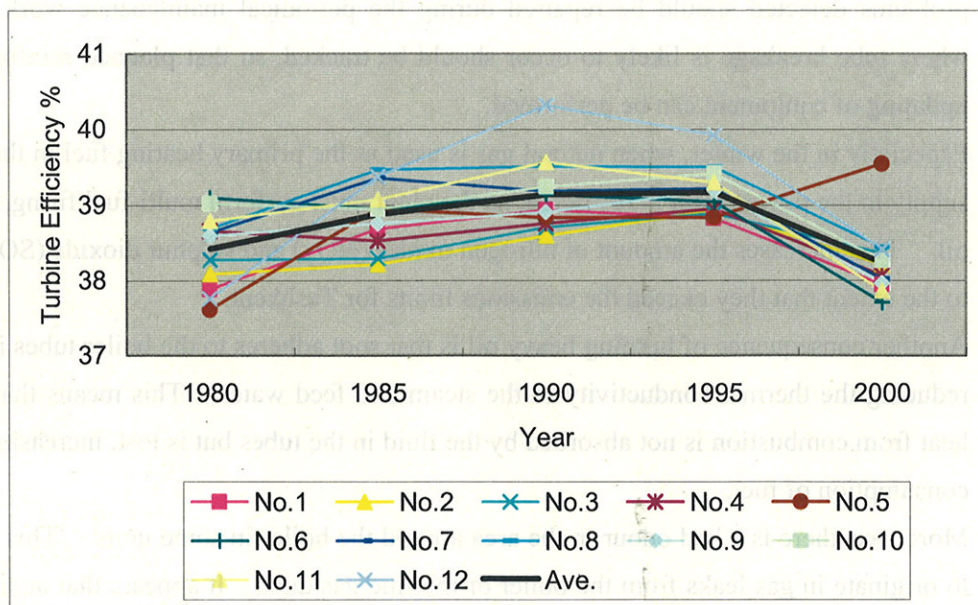
Figure 5.1-3 Trend of Turbine Efficiency

As in Figure 5.1-3, turbine efficiency has been declining in recent years.

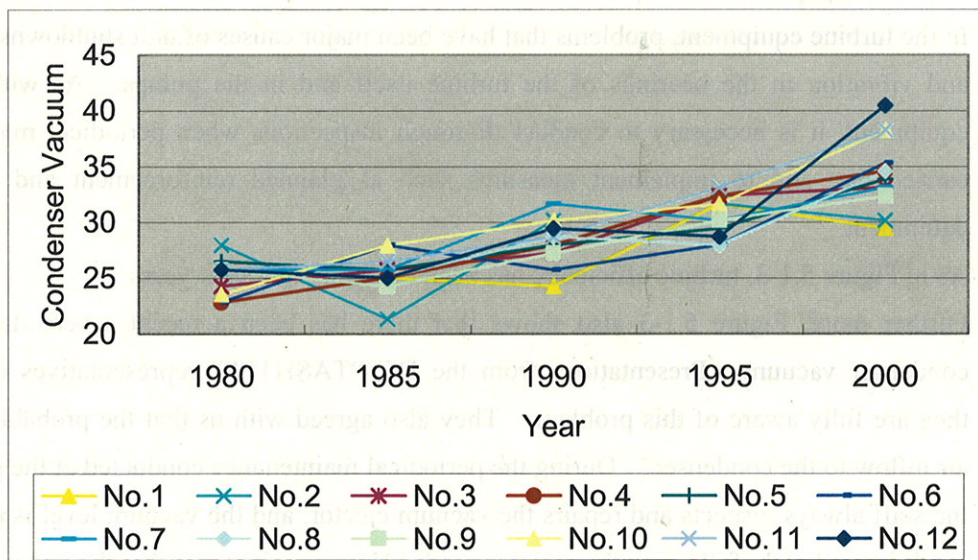
Figure 5.1-4 Trend of Condenser Vacuum

Further more, Figure 5.1-3 also shows that there has been a recent severe decline in the condenser vacuum. Presentations from the DC "TASHTPP" representatives indicate that they are fully aware of this problem. They also agreed with us that the probable cause was air inflow to the condenser. During the periodical maintenance conducted at the power plant, the staff always inspects and repairs the vacuum ejector, and the vacuum level is restored as a result immediately following the maintenance. However, it seems that the vacuum decreases again during operation shortly thereafter. This loss of condenser vacuum diminishes turbine efficiency, which in turn has the direct effect of reducing unit efficiency. Therefore, urgent measures such as those described below are required.

By updating this equipment, its efficiency can be improved.

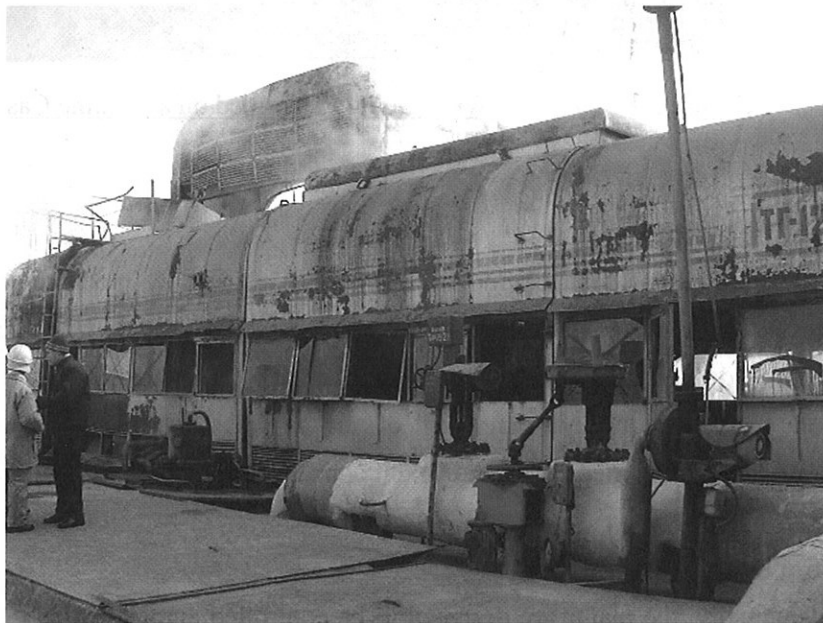
Picture 5.1-2 Turbine Cover

As Picture 5.1-3 shows, the turbine equipment is not indoor type, as is not common in Japan. The cover that covers the whole turbine has not been maintained, so the turbine casing is virtually exposed to the rain. The outdoor type of equipment has the merit of keeping construction costs down, but it is also susceptible to corrosion caused by rain during operation. There is also the possibility that foreign matter such as dust, which must be kept out of the turbine, may get into the equipment. This type of installation is too harsh for precision equipment such as turbines. Because the equipment is taken apart during scheduled maintenance, if this work is performed outdoors more stringent procedures than usual must be followed. As can be seen from Picture 5.1-3, the turbine, one of the most important facilities, is wet from the rain. The problem of rust is naturally a concern.
