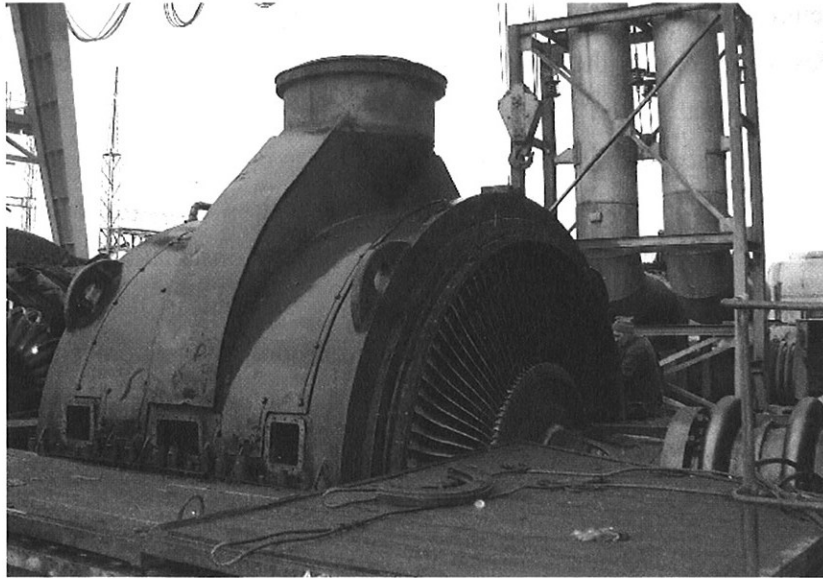
Picture 5.1-3 Outdoor Work Being Performed on a Turbine Casing

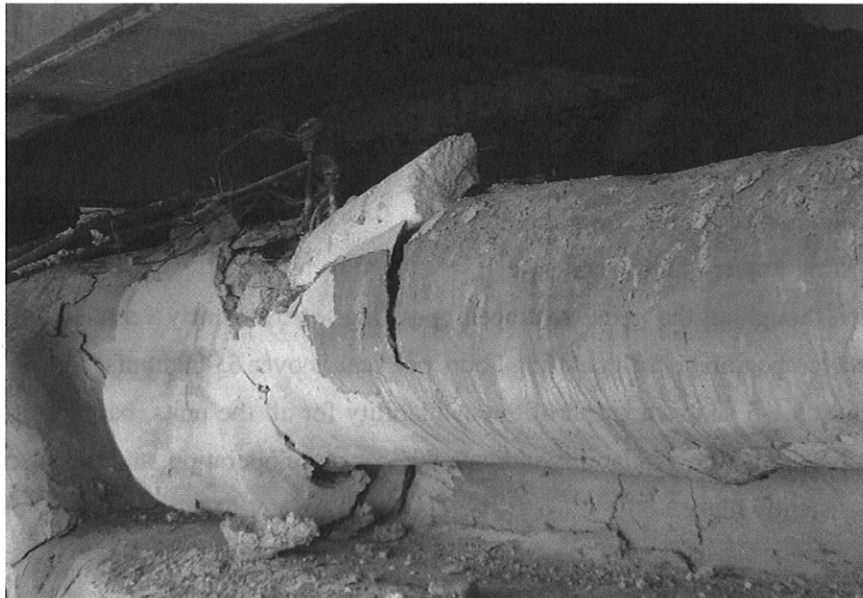
Within the grounds of the DC “TASHTPP”, there are many places where the covers have been removed from the pipes, exposing the insulating material. Among these, there are some places where the insulation has also fallen away, and the hot pipes are directly in contact with the atmosphere. This means that not only is the heat held by the fluid in the pipes lost to the atmosphere; there is also the danger that staff members could be burned. Remedial measures are urgently needed. Picture 5.1-4 shows a pipe where the insulation has been lost.

Picture 5.1-4 Pipe Missing Insulation

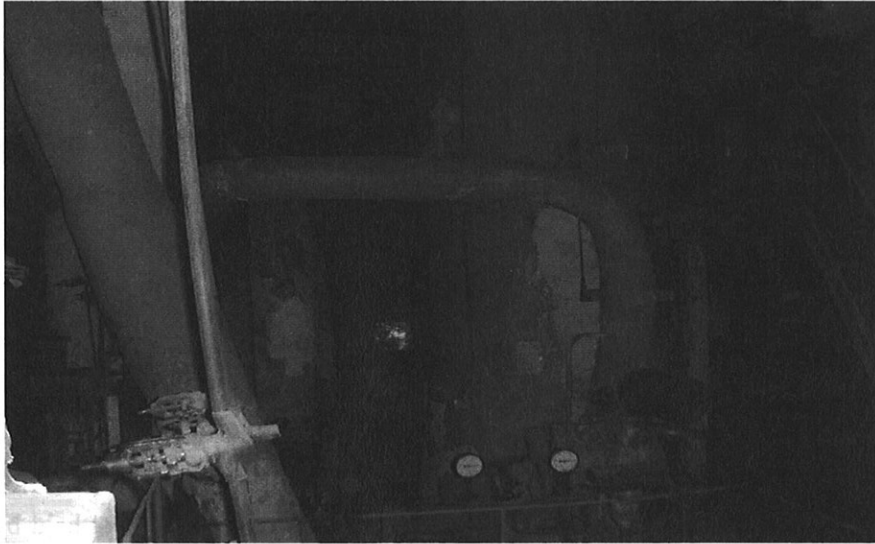
As shown in Picture 5.1-5, the inside of the turbine auxiliaries building is dimly lit, even during the day on sunny days. There are many places where the lighting is insufficient especially in the turbine auxiliaries building. There are even places where it is impossible to see one's feet for the pitch darkness, even in the daytime. It is very dangerous, as one must walk without being able to see what is at one's feet, and urgent improvement is needed.

Picture 5.1-5 Inside the Turbine Auxiliaries Building
