a. Important Inspection Unit

In discussions with DC "TASHTPP" representatives, it was decided that we would emphasize unit No.6 in our study. From 2000 to 2002, there were seven emergency shutdowns (none in 2000), which are broken down as follows.

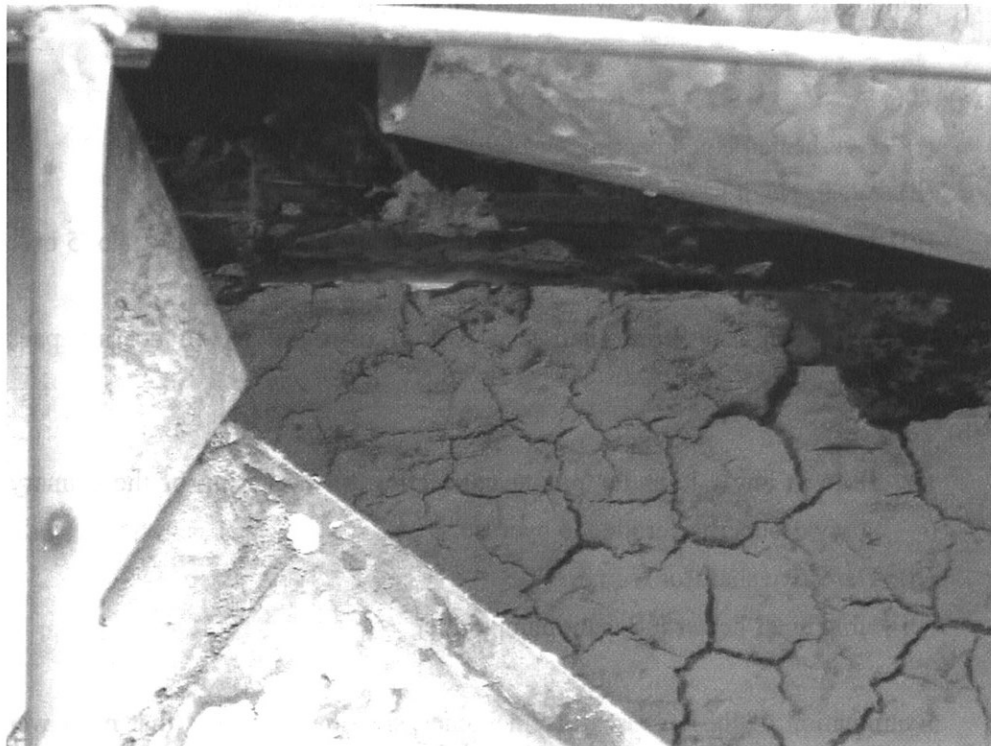
Picture 5.1-6 Cracks in Unit No.6 Boiler Ceiling

(The red heat of the furnace is visible.)

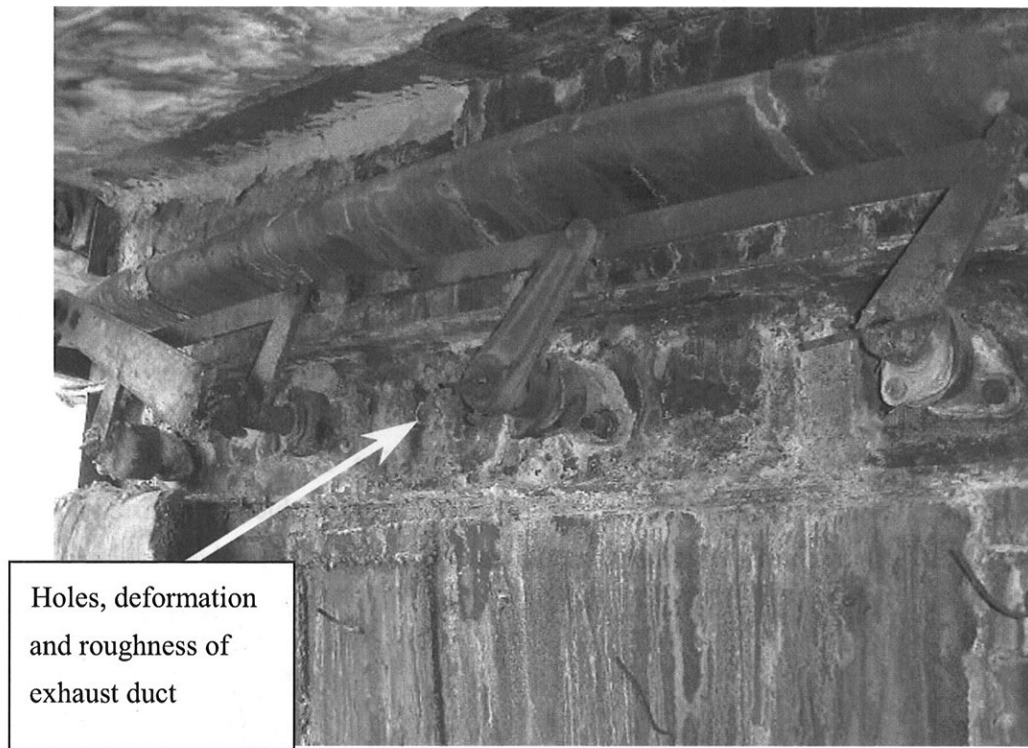
Picture 5.1-7 Unit No.1 Exhaust Duct

(With the insulation is removed, there is significant deterioration and many holes due to corrosion.)
