5.2 Proposal for Maintaining and Managing the Existing Plants

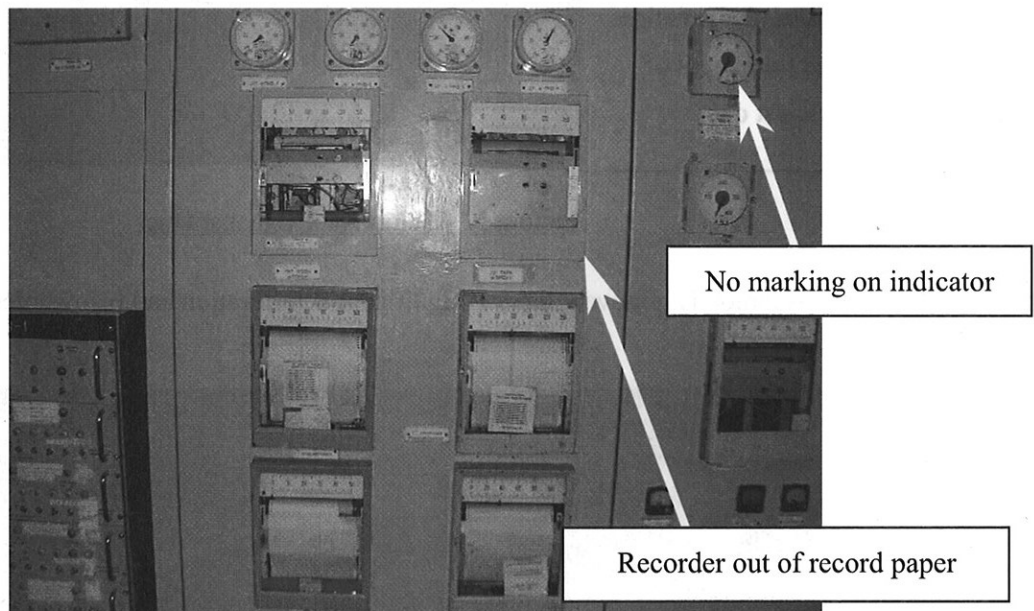
There are many places in which the control equipment is aging and faulty, and there are few parts of the equipment that actually fulfill their control functions. In actual practice, operation is performed manually. There is serious deterioration of the cable tray, such that it no longer has its original shape. In addition, due to cable deterioration, there is a great possibility of a ground fault or short circuit. If a cable fire occurred due to a ground fault or short circuit, it is likely that the damage would be extensive.

Picture 5.1-9 Unit 6 Central Control Room Indicating and Recording Instruments

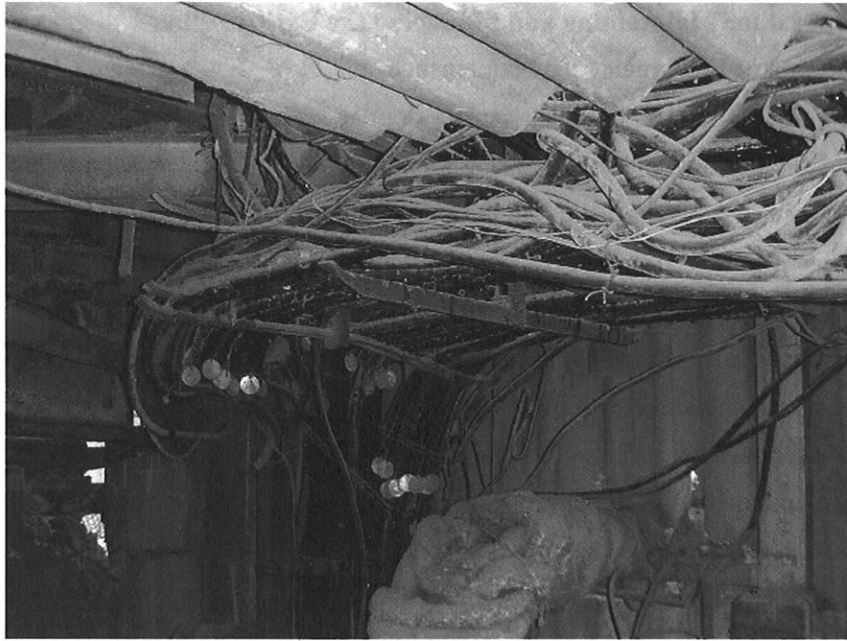
Picture 5.1-10 Cables Near Unit 6 Burner

(The cables are dusty and deterioration is evident on the outer covering.)
