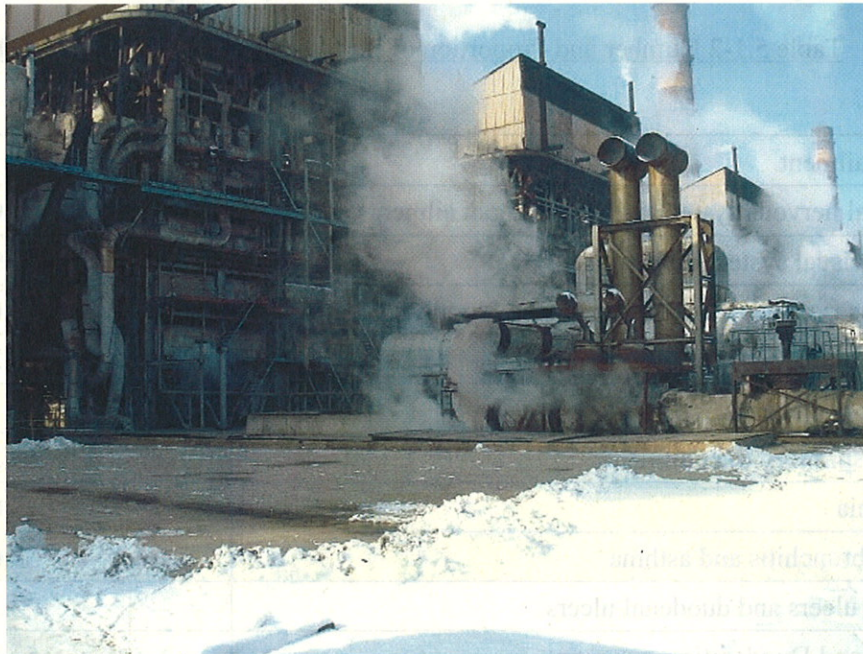
Picture 5.1-2 View of Boiler from Turbine Side

The oldest facilities at the DC “TASHTPP” were constructed more than 40 years ago. The boilers employ two-stage combustion, and gas recirculation to reduce the nitrogen oxides in

the exhaust gases.

At the time, these facilities were environmentally advanced, but the environmental effectiveness has decreased as the equipment has aged. Especially in the winter, when natural gas is used as the primary heating fuel in the region, the supply to the power plant is restricted, so the plant must perform multi-fuel firing, using heavy oil. This increases the amount of nitrogen oxides (NO_x) and sulphur dioxide (SO₂) emissions to the extent that they exceed the emissions limits for Tashkent. As a result, the DC "TASHTPP" is paying fines.

Another consequence of burning heavy oil is that soot adheres to the boiler tubes in the boiler, reducing the thermal conductivity to the steam and feed water. This means that the radiant heat from combustion is not absorbed by the fluid in the tubes but is lost, increasing the plant's consumption of fuel.

Moreover, there is a bad odour in the area around the boiler in some units. This would seem to originate in gas leaks from the boiler or the flue. Even briefly inhaling these gases brings a feeling of strong irritation to the throat that remains for some time thereafter. Although it is impossible to measure these gas leaks quantitatively, it appears that auxiliary fans to the boilers are forced to consume more power due to the increased leaks. (This increased consumption is impossible to confirm, as there are no records of the current to the auxiliary equipment.) As a result of this increase, the house consumption (rate) of the plant is also increasing, which is one cause of the reduced efficiency of the plant.

From the above, it would seem that there is an urgent necessity to urgently implement measures to prevent leaks from the boilers and flues, not only to maintain the equipment and improve its reliability, but also to improve industrial health.

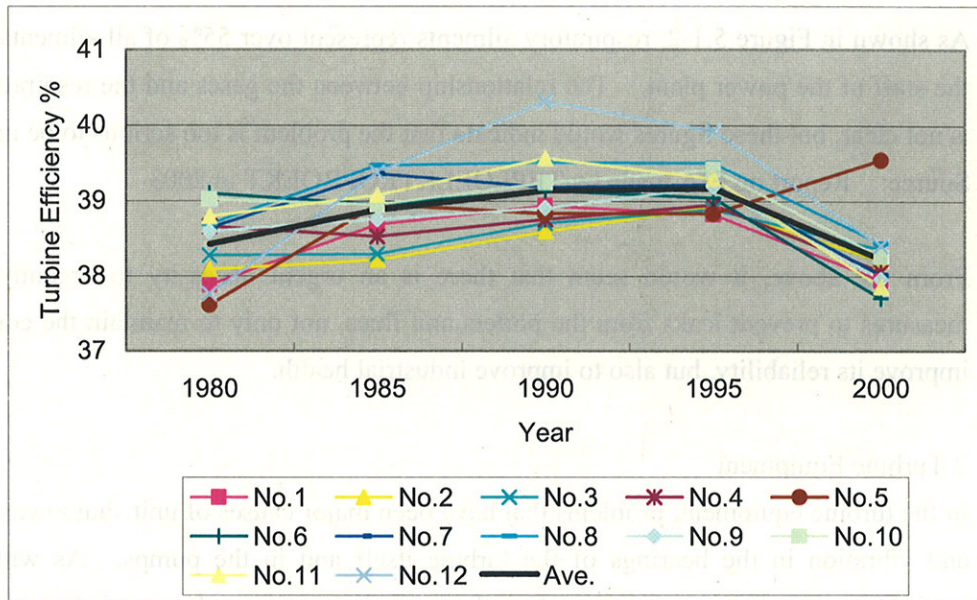
Figure 5.1-5 Turbine Efficiency over Time

Data obtained from the DC "TASHTPP" did not include recent efficiency data for the turbine units, so we calculated turbine efficiency from the unit efficiency and boiler efficiency data. The results are shown in Figure 5.1-5. These results show that turbine efficiency has been declining in recent years.

Further, Figure 5.1-5 also shows that there has been a recent severe decline in the condenser vacuum. Presentations from the DC "TASHTPP" representatives indicate that they are fully aware of this problem. They also agreed with us that the probable cause was air inflow to the condenser. During the periodic maintenance conducted at the power plant, the staff always inspects and repairs the vacuum ejector, and the vacuum level is restored as a result immediately following the maintenance. However, it seems that the vacuum decreases again during operation shortly thereafter. This loss of condenser vacuum diminishes turbine efficiency, which in turn has the direct effect of reducing unit efficiency. Therefore, urgent measures such as those described below are required.
