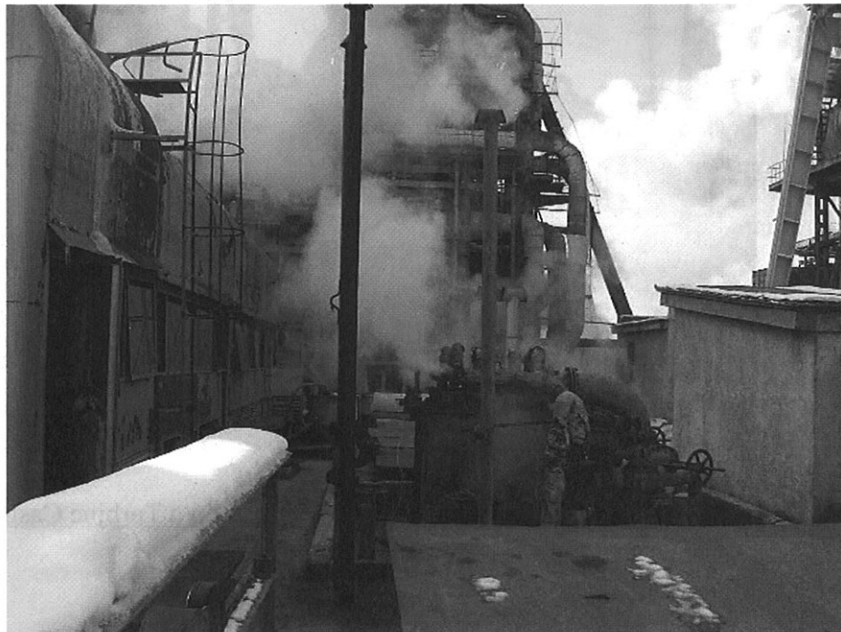
Additionally, there are holes in the condenser and heater tubes, due to aging and the lack of materials, which cause problems such as allowing the internal fluid to leak out. The staff of the DC "TASHTPP" plugs at both ends of these tubes when this occurs. The ratio of the plugged tubes to the total number of tubes is known as the plugging ratio, and when the plugging ratio exceeds the allowable value for the equipment, the heat exchange rate declines, causing a decrease in the condenser's vacuum level. Therefore, it is necessary to manage the plugging ratio and replace tubes as necessary so that the plugging ratio does not exceed the appropriate level. To prevent further decreased efficiency, it is very important that data is collected and analyzed during the next scheduled maintenance and that a planned replacement of tubes is carried out.

Picture 5.1-3 Condenser Vacuum Ejector

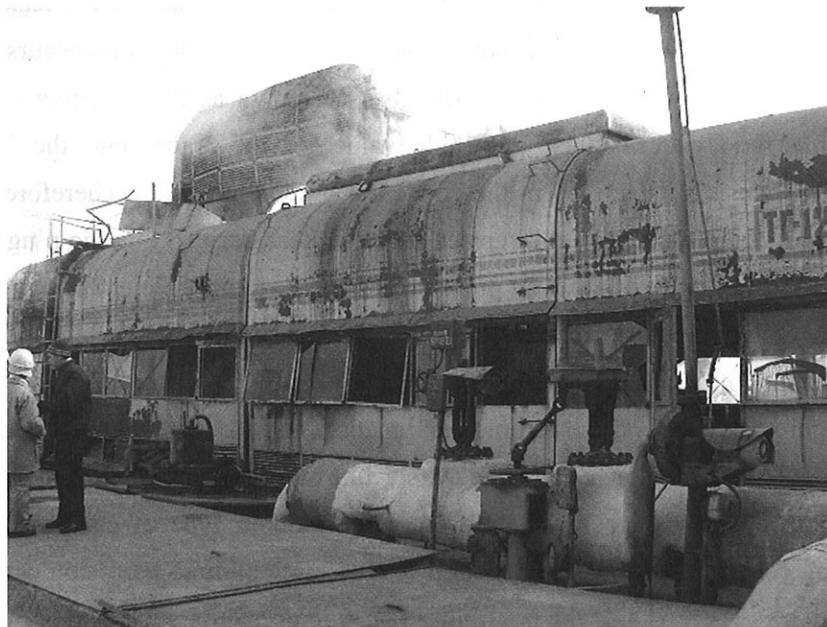
As Figure 5.1-5 shows, the turbine equipment is not indoor equipment, as is not common in Japan. The cover that covers the whole turbine has not been maintained, so the turbine casing is virtually exposed to the rain. The outdoor type of equipment has the merit of keeping construction costs down, but it is also susceptible to corrosion caused by rain during operation. There is also the possibility that foreign matter such as dust, which must be kept out of the turbine, may get into the equipment. This type of installation is too harsh for precision equipment such as turbines. Because the equipment is taken apart during scheduled maintenance, if this work is performed outdoors more stringent procedures than usual must be followed. As can be seen from Picture 5.1-5, the turbine, one of the most important facilities, is wet from the rain. The problem of rust is naturally a concern.

Picture 5.1-4 Turbine Cover

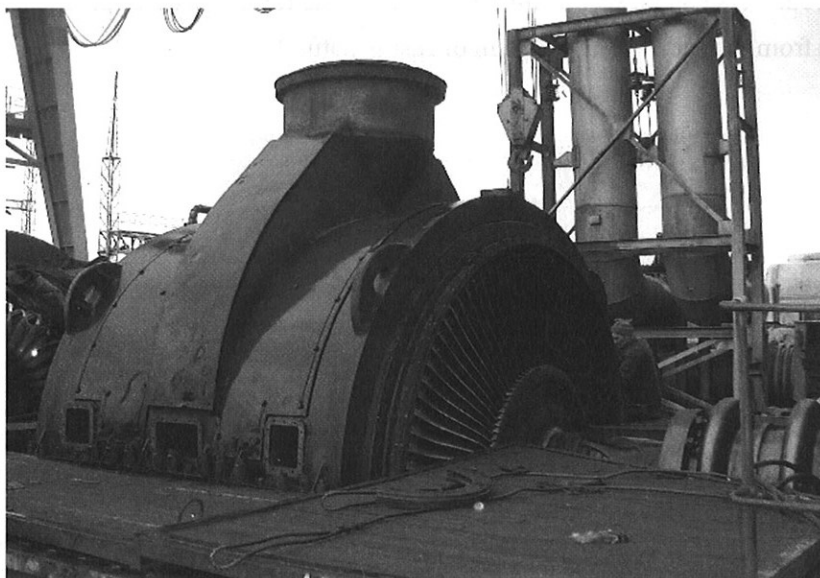
Picture 5.1-5 Outdoor Work Being Performed on a Turbine Casing

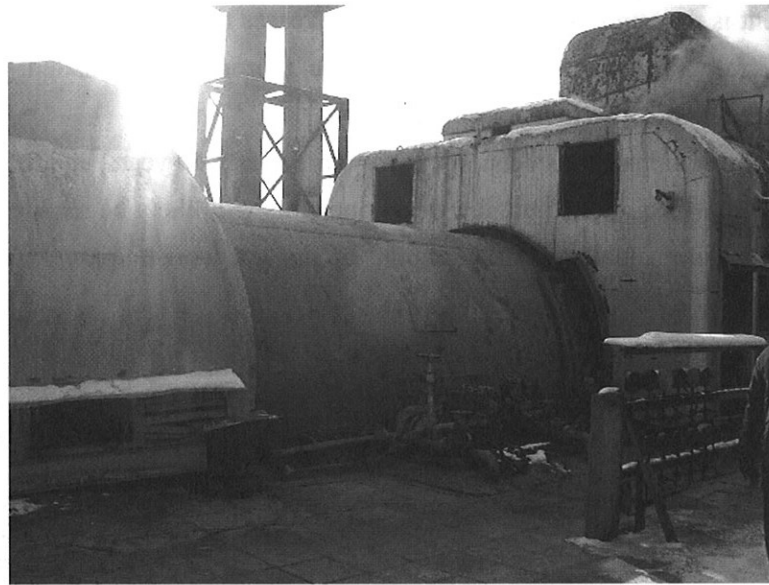
caused by electrical equipment is far lower than the number caused by mechanical equipment. Like the other facilities, the external appearance of the electrical equipment indicates that it is not being properly maintained. Even so, the equipment is functioning well overall, and there do not appear to be any problems requiring immediate attention. Picture 5.1-6 shows the external appearance of a generator. The 220 kV switchgear is an outdoor switching station that is primarily composed of an air blast circuit breaker. This is being appropriately maintained, and there do not appear to be any operational problems.

Picture 5.1-6 External Appearance of Generator
