b. Important Inspection Unit

In discussions with DC "TASHTPP" representatives, it was decided that we would emphasize unit 6 in our inspection. According to the DC "TASHTPP" representatives, unit 6 does not have any particularly pressing problems; it is a very average facility. This can be confirmed by the number of emergency shutdowns shown in Figure 5.1-3. From 2000 to 2002, there were seven emergency shutdowns (none in 2000), which are broken down as follows.

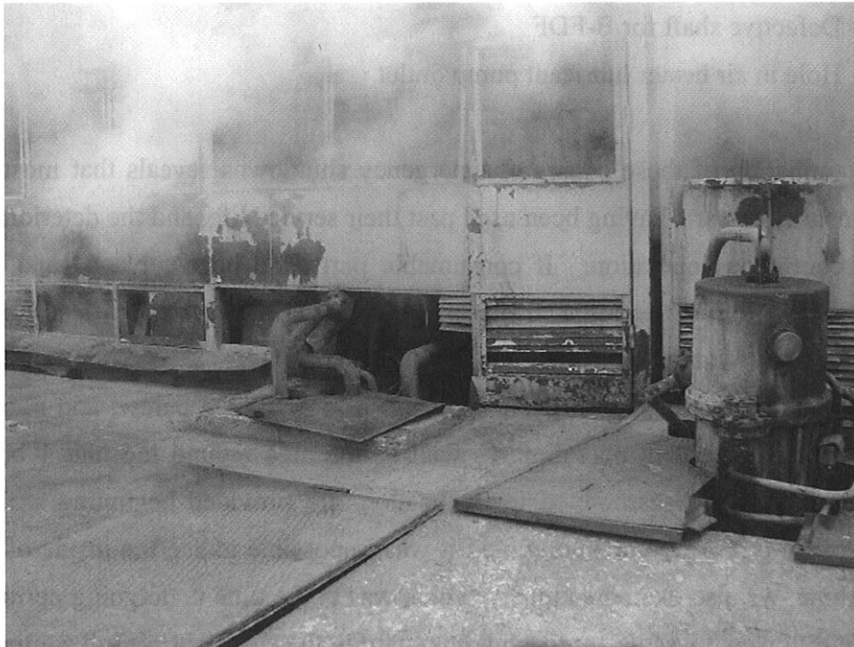
As shown in Picture 5.1-13 up to Picture 5.1-24, when the outside temperature is low, there are many opportunities to visually confirm in the area of the turbines that a large quantity of steam is leaking. By addressing these leaks, the house consumption can be decreased and it is highly possible that the units' efficiency can be improved.

Picture 5.1-13 Steam Leaking from Turbine Area

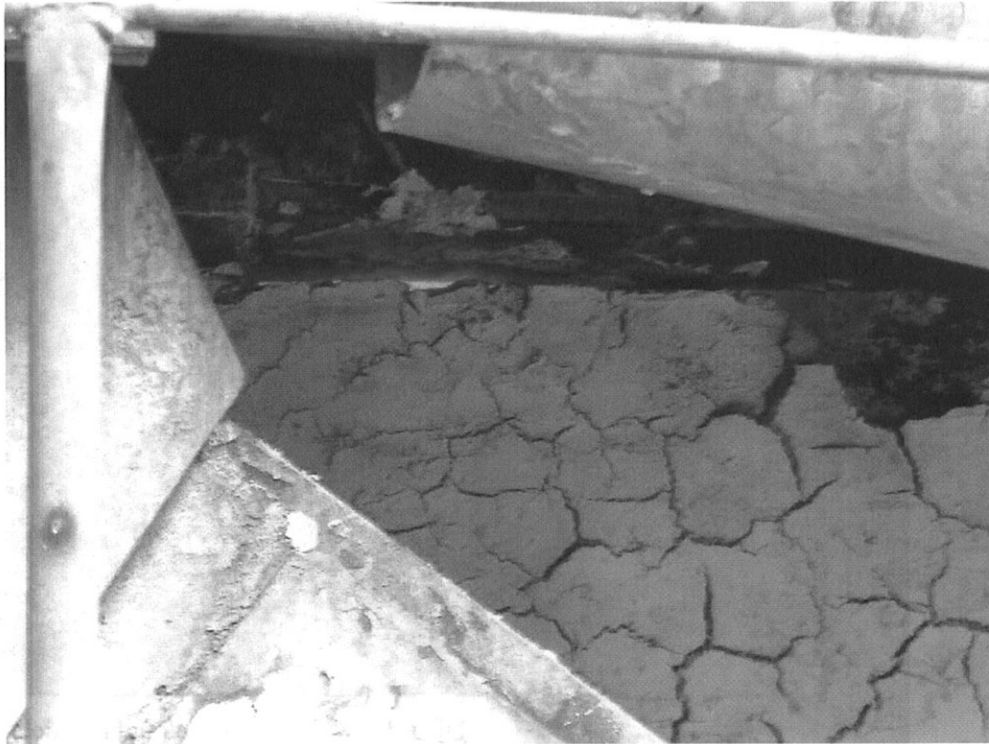
Picture 5.1-14 Cracks in Unit 6 Boiler Ceiling

(The red heat of the furnace is visible.)
