Japan International Cooperation Agency (JICA)

**Ministry of Settlement and Regional Infrastructure (MOSRI)
The Republic of Indonesia**

**THE STUDY
ON
COMPREHENSIVE RECOVERY PROGRAM
OF
IRRIGATION AGRICULTURE**

**Priority List
of
Irrigation Schemes
for
Rehabilitation
(North Sumatra Province)**

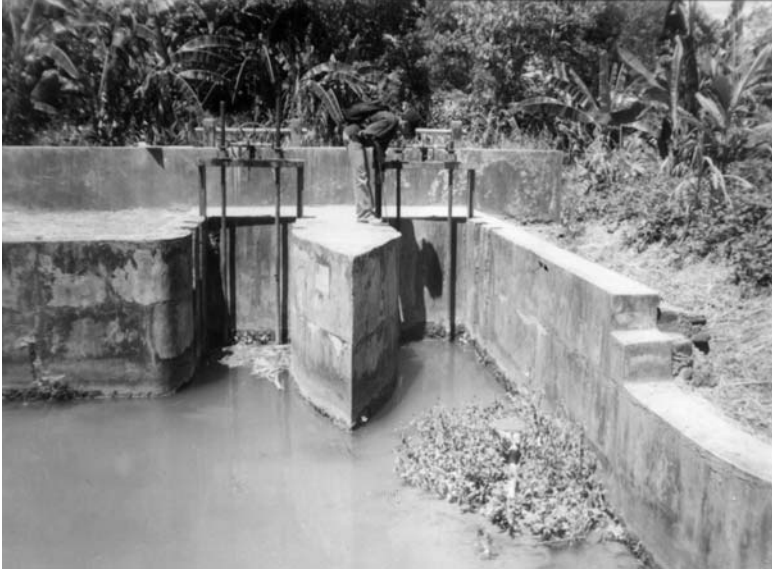
<i>Category</i> Irrigation (Main Canal)			
				<i>Structure</i> Division Structure			
				<i>Condition</i> <input type="checkbox"/> A <input type="checkbox"/> B <input checked="" type="checkbox"/> C <input type="checkbox"/> D			
				<i>Problems</i> Lower function of structure; physical operation problem; sedimentation.

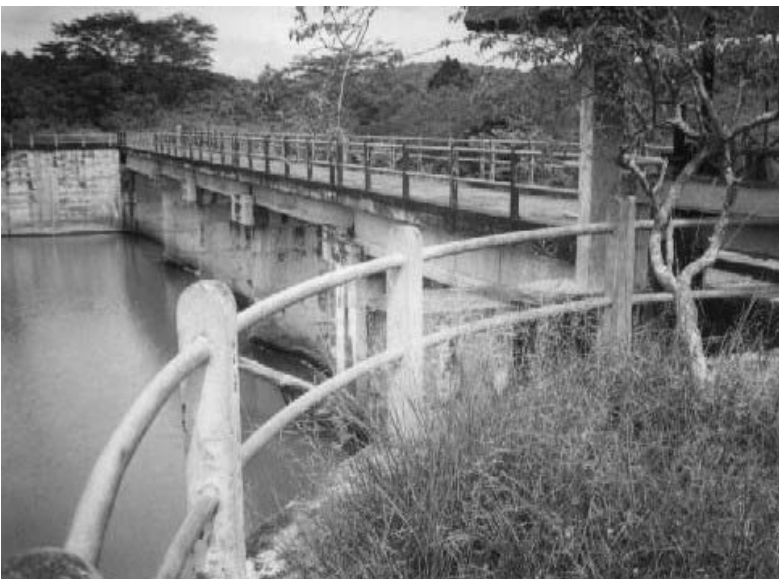
<p><u>Structure</u> Irrigation (Headworks)</p>			
		<p><u>Structure</u> Fixed Weir</p>			
		<p><u>Condition</u> <input type="checkbox"/> A <input checked="" type="checkbox"/> B <input type="checkbox"/> C <input type="checkbox"/> D</p>

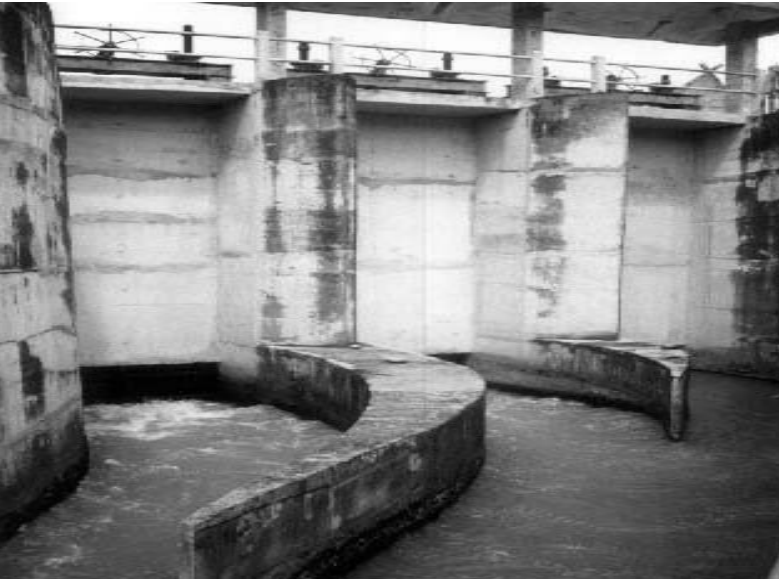
<p><u>Category</u> Irrigation (Headworks)</p>			
		<p><u>Structure</u> Intake Gate</p>			
		<p><u>Condition</u> <input type="checkbox"/> A <input checked="" type="checkbox"/> B <input type="checkbox"/> C <input type="checkbox"/> D</p>

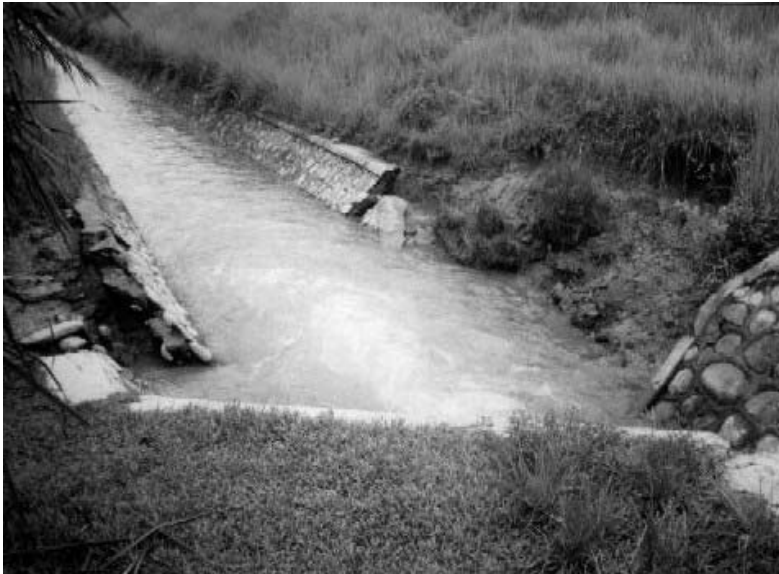
<p><u>Category</u> Irrigation (Main Canal)</p>		
		<p><u>Structure</u> Masonry Lined Canal</p>		
		<p><u>Condition</u> <input type="checkbox"/> A <input type="checkbox"/> B <input checked="" type="checkbox"/> C <input type="checkbox"/> D</p>		
		<p><u>Problems</u> Cracks or partial damage on lined canal; leakage from lined canal; deflection of lining toward inside of canal; sedimentation; and no inspection road.</p>

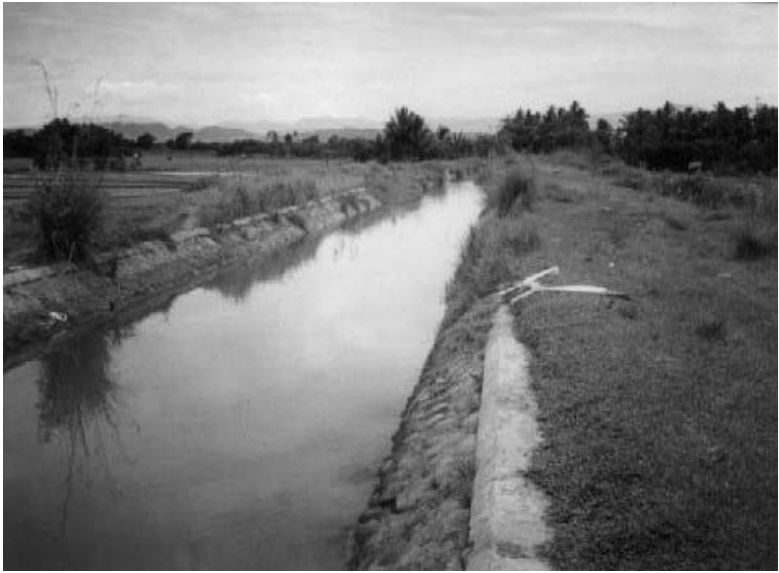
<p><u>Category</u> Irrigation (Main Canal)</p>		
		<p><u>Structure</u> Masonry Lined Canal</p>		
		<p><u>Condition</u> <input type="checkbox"/> A <input type="checkbox"/> B <input checked="" type="checkbox"/> C <input type="checkbox"/> D</p>		
		<p><u>Problems</u> Lower strength of lined canal; leakage from lined canal; sedimentation; and no maintenance of inspection road.</p>

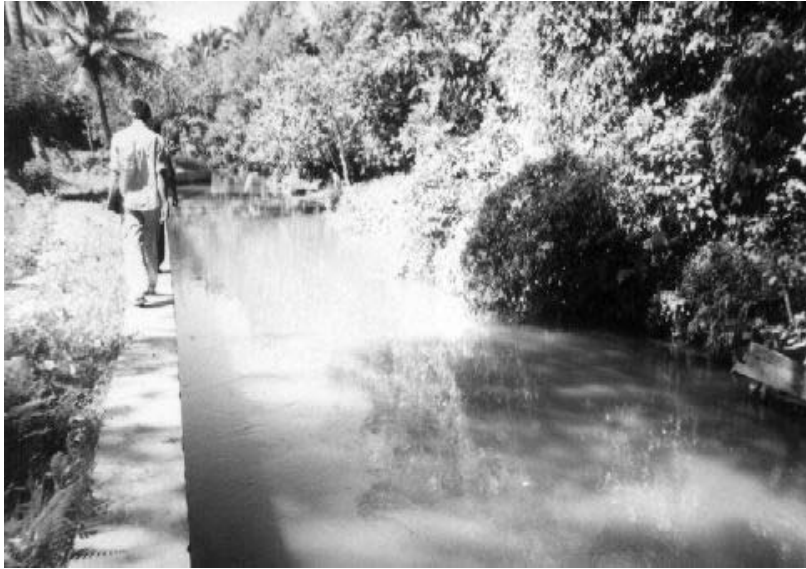
<u>Category</u> Irrigation (Main Canal)		
		<u>Structure</u> Concrete Lined Canal		
		<u>Condition</u> <input type="checkbox"/> A <input type="checkbox"/> B <input type="checkbox"/> C <input checked="" type="checkbox"/> D		
		<u>Problems</u> Sedimentation; leakage from lined canal; crack or damage on lined canal; and no inspection road.

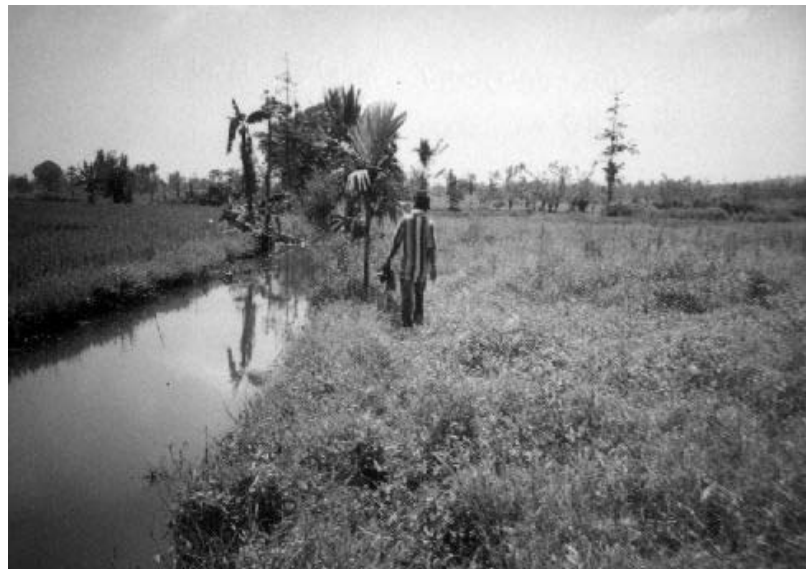
<u>Category</u> Irrigation (Secondary Canal)		
		<u>Structure</u> Earth Canal		
		<u>Condition</u> <input type="checkbox"/> A <input type="checkbox"/> B <input type="checkbox"/> C <input checked="" type="checkbox"/> D		
		<u>Problems</u> Sedimentation; leakage from canal; collapse of canal; difficulty on maintenance of earth canal; and no inspection road.

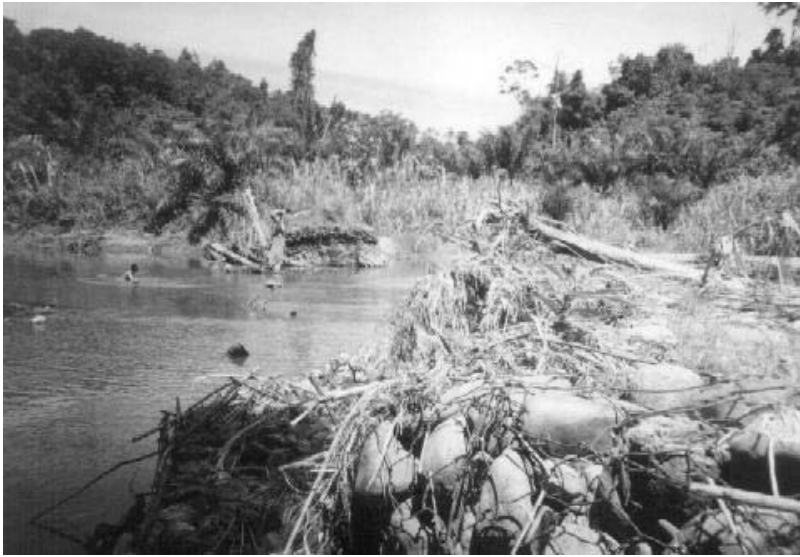
<p><u>Category</u> Irrigation (Headworks)</p>			
		<p><u>Structure</u> Fixed Weir (Gabion)</p>			
		<p><u>Condition</u> <input type="checkbox"/> A <input type="checkbox"/> B <input type="checkbox"/> C <input checked="" type="checkbox"/> D</p>			
		<p><u>Problems</u> Weir is totally damaged, urgent measures are required.</p>

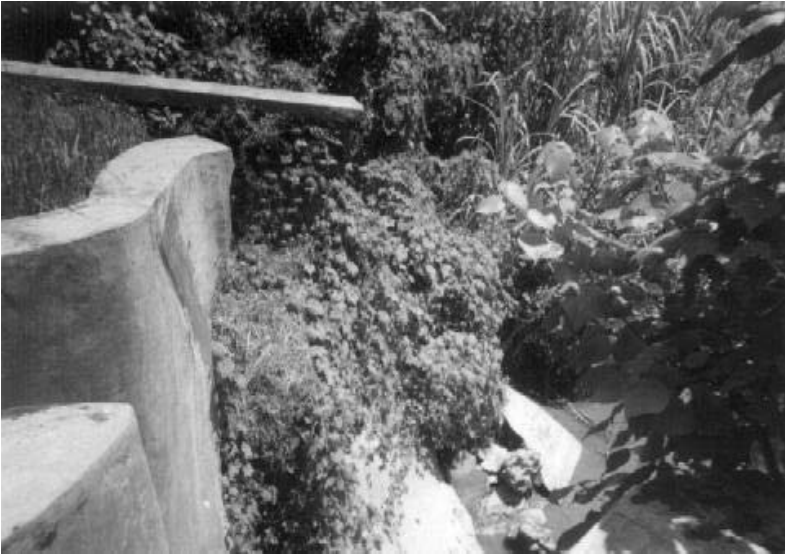
<p><u>Category</u> Irrigation (Headworks)</p>			
		<p><u>Structure</u> Retaining Wall</p>			
		<p><u>Condition</u> <input type="checkbox"/> A <input type="checkbox"/> B <input type="checkbox"/> C <input checked="" type="checkbox"/> D</p>			
		<p><u>Problems</u> Retaining wall is totally damaged.</p>

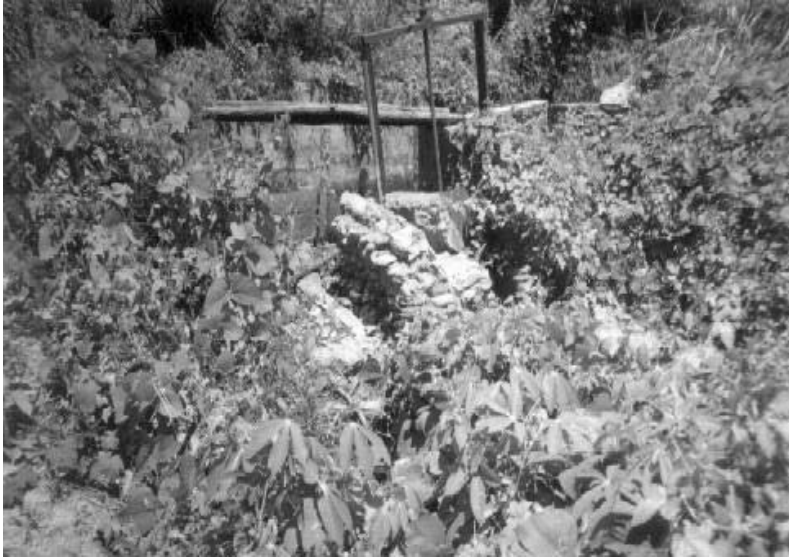
<u>Category</u> Irrigation (Main Canal)		
		<u>Structure</u> Division Structure		
		<u>Condition</u> <input type="checkbox"/> A <input type="checkbox"/> B <input type="checkbox"/> C <input checked="" type="checkbox"/> D		
		<u>Problems</u> Not in use

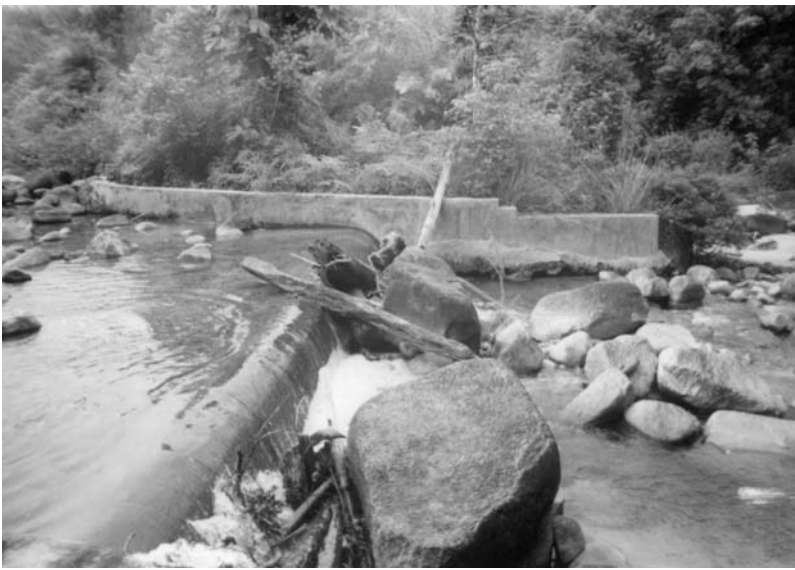
<p><u>Category</u> Irrigation (Headworks)</p>		
		<p><u>Structure</u> Fixed Weir</p>		
		<p><u>Condition</u> <input type="checkbox"/> A <input type="checkbox"/> B <input type="checkbox"/> C <input checked="" type="checkbox"/> D</p>		
		<p><u>Problems</u> Crack or damage on weir crest; settlement of weir body; sedimentation at weir; settlement or breakage of apron;</p>

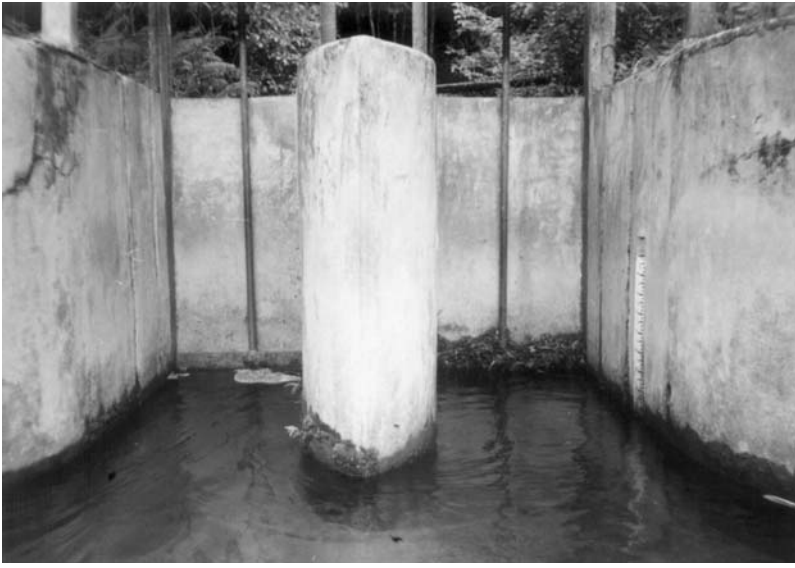
<p><u>Category</u> Irrigation (Headworks)</p>		
		<p><u>Structure</u> Intake Gate</p>		
		<p><u>Condition</u> <input type="checkbox"/> A <input type="checkbox"/> B <input type="checkbox"/> C <input checked="" type="checkbox"/> D</p>		
		<p><u>Problems</u> Insufficient diversion water due to sedimentation in front of intake; problem on management due to lack of periodically maintenance; and low function of gates.</p>

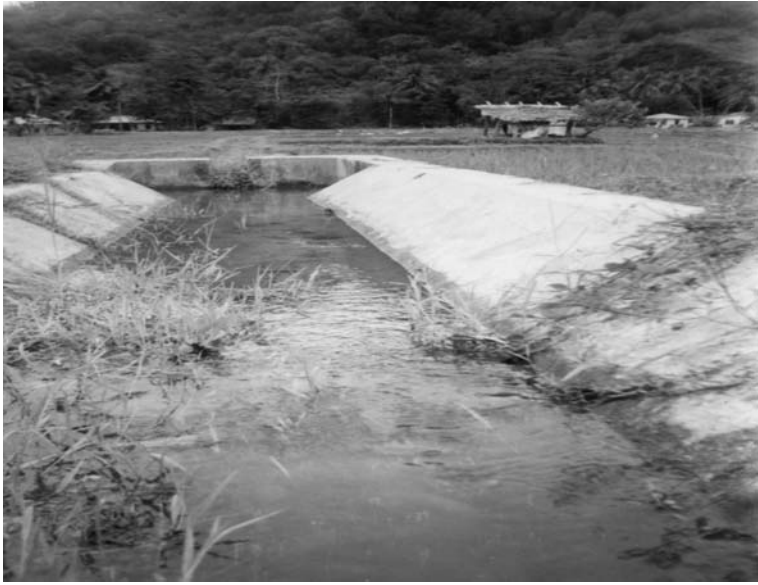
<p><u>Category</u> Irrigation (Main Canal)</p>		
		<p><u>Structure</u> Concrete Lined Canal</p>		
		<p><u>Condition</u> <input type="checkbox"/> A <input type="checkbox"/> B <input type="checkbox"/> C <input checked="" type="checkbox"/> D</p>		
		<p><u>Problems</u> Crack on lined canal; leakage from lined canal; sedimentation in canal; and no inspection road.</p>

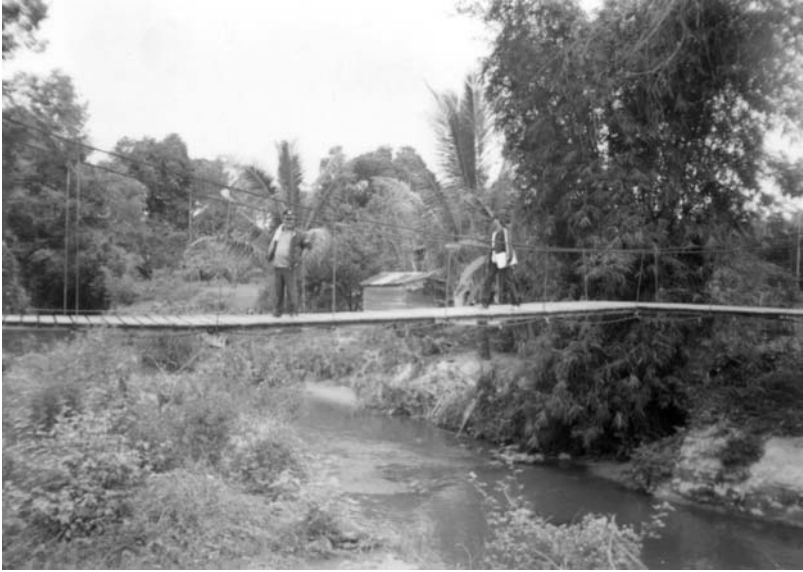
<p><u>Category</u> Irrigation (Secondary Canal)</p>		
		<p><u>Structure</u> Canal and Foot Bridge</p>		
		<p><u>Condition</u> <input type="checkbox"/> A <input type="checkbox"/> B <input checked="" type="checkbox"/> C <input type="checkbox"/> D</p>		
		<p><u>Problems</u> Leakage from canal; sedimentation in canal; collapse on canal; difficulty on maintenance of earth canal; and no inspection road.</p>

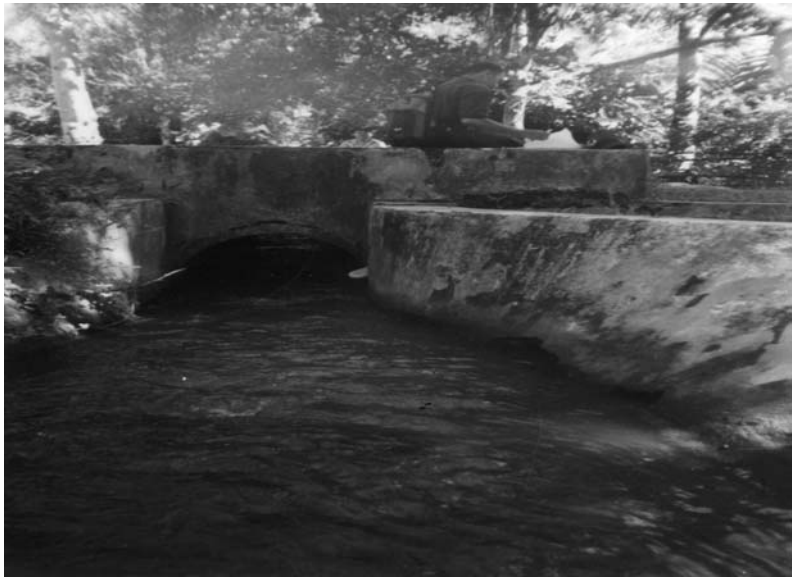
<p><u>Category</u> Irrigation (Main Canal)</p>			
		<p><u>Structure</u> Concrete Culvert</p>			
		<p><u>Condition</u> <input type="checkbox"/> A <input type="checkbox"/> B <input type="checkbox"/> C <input checked="" type="checkbox"/> D</p>			
		<p><u>Problems</u> Sedimentation; crack on culvert.</p>

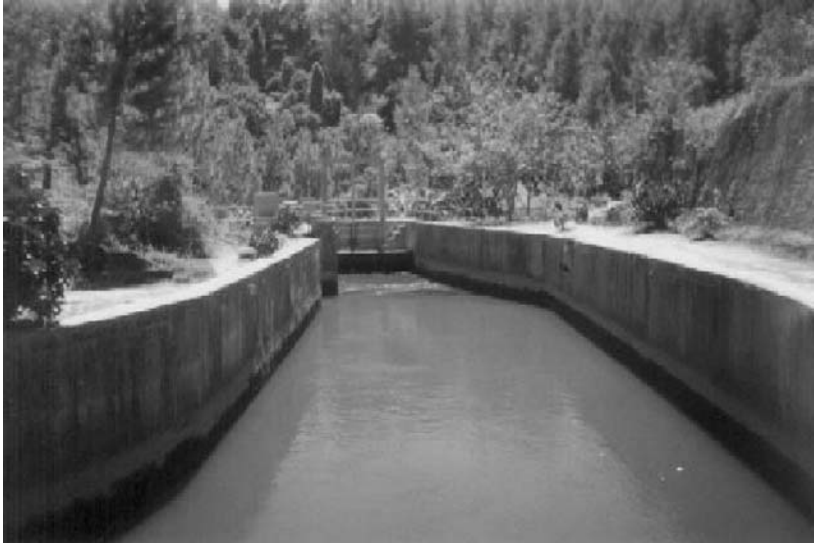
<p><u>Category</u> Irrigation (Free Intake)</p>		
		<p><u>Structure</u> Intake Gate</p>		
		<p><u>Condition</u> <input type="checkbox"/> A <input type="checkbox"/> B <input checked="" type="checkbox"/> C <input type="checkbox"/> D</p>		
		<p><u>Problems</u> Insufficient diversion water due to river bed degradation; insufficient diversion water due to sedimentation in front of intake</p>

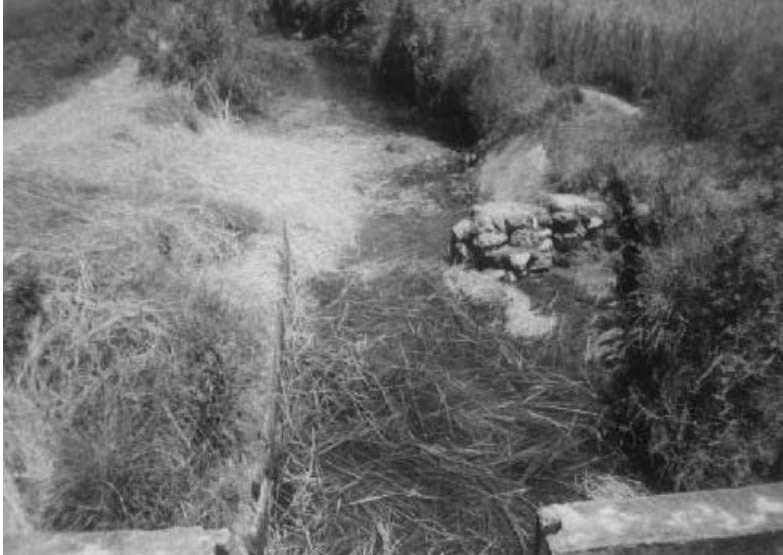
<p><u>Category</u> Irrigation (Secondary Canal)</p>		
		<p><u>Structure</u> Division Structure</p>		
		<p><u>Condition</u> <input type="checkbox"/> A <input type="checkbox"/> B <input type="checkbox"/> C <input checked="" type="checkbox"/> D</p>		
		<p><u>Problems</u> Totally damaged and no function.</p>

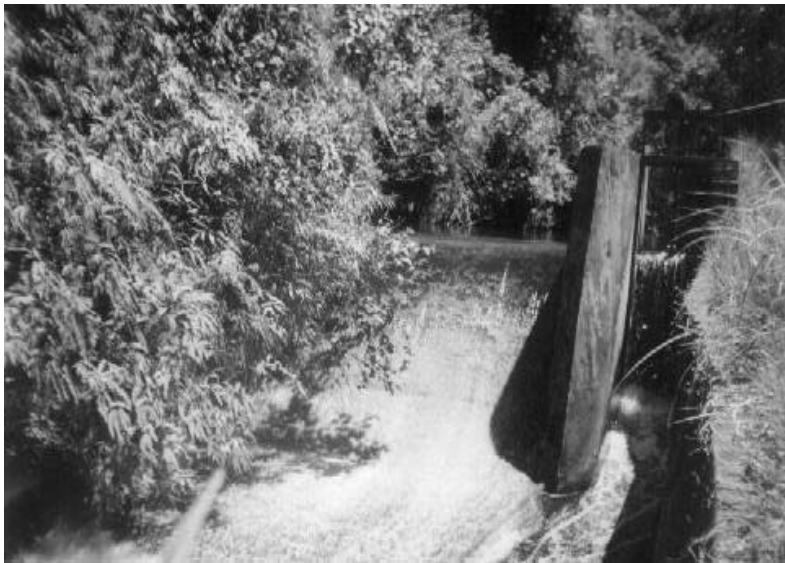
<p><u>Category</u> Irrigation (Headworks)</p>		
		<p><u>Structure</u> Fixed Weir</p>		
		<p><u>Condition</u> <input type="checkbox"/> A <input checked="" type="checkbox"/> B <input type="checkbox"/> C <input type="checkbox"/> D</p>		
		<p><u>Problems</u> Leakage from foundation or settlement of weir body; settlement or washed away of stilling basin; washed away of retaining wall of weir</p>		
 		<p><u>Category</u> Irrigation (Headworks)</p>		
		<p><u>Structure</u> Intake Gate</p>		
		<p><u>Condition</u> <input type="checkbox"/> A <input checked="" type="checkbox"/> B <input type="checkbox"/> C <input type="checkbox"/> D</p>		
		<p><u>Problems</u> Insufficient diversion water due to sedimentation in front of intake; leakage from gate leaf; insufficient strength against design load due to rust, decay of steel material</p>

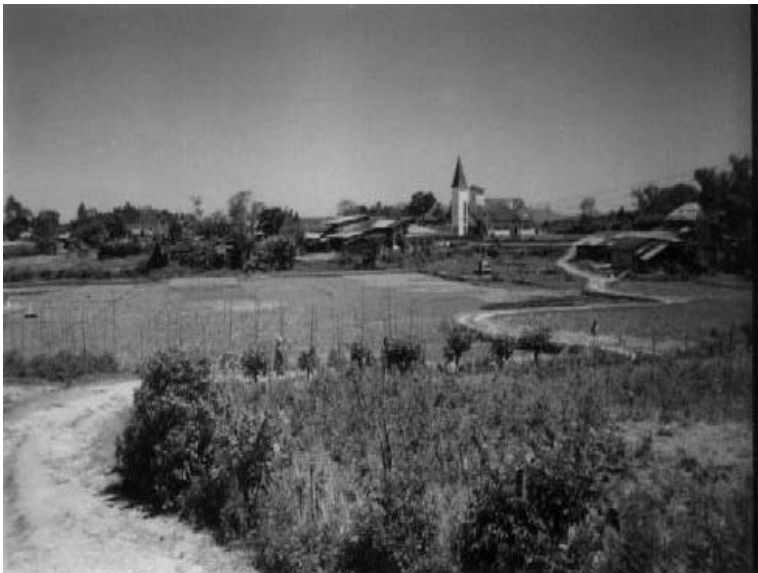
<p><u>Category</u> Agriculture, On-Farm</p>		
		<p><u>Activity</u> Paddy Cultivation</p>		
		<p><u>Condition</u> <input type="checkbox"/> A <input type="checkbox"/> B <input type="checkbox"/> C <input checked="" type="checkbox"/> D</p>		
		<p><u>Problems</u> Low density of on-farm canal and farm roads.</p>

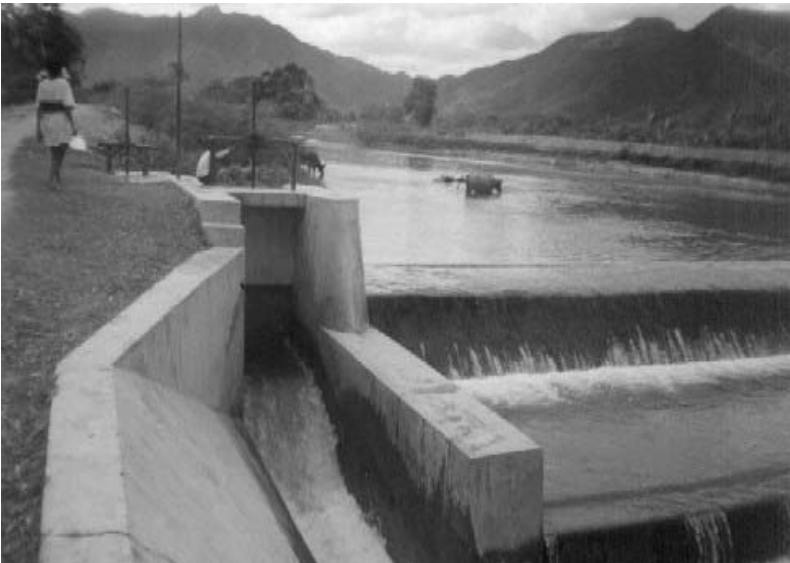
<p><u>Category</u> Irrigation (Headworks)</p>		
		<p><u>Structure</u> Fixed Weir</p>		
		<p><u>Condition</u> <input type="checkbox"/> A <input type="checkbox"/> B <input checked="" type="checkbox"/> C <input type="checkbox"/> D</p>		
		<p><u>Problems</u> Sediment in front of weir; damage of retaining wall.</p>

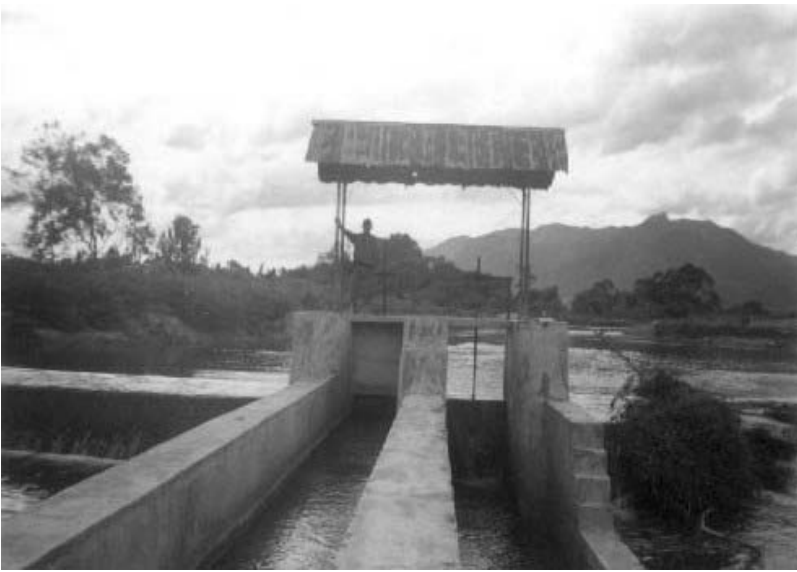
<p><u>Category</u> Irrigation (Headworks)</p>		
		<p><u>Structure</u> Intake Gate</p>		
		<p><u>Condition</u> <input type="checkbox"/> A <input type="checkbox"/> B <input type="checkbox"/> C <input checked="" type="checkbox"/> D</p>		
		<p><u>Problems</u> Leakage from gate leaf; insufficient strength against design load due to rust, decay of steel material</p>

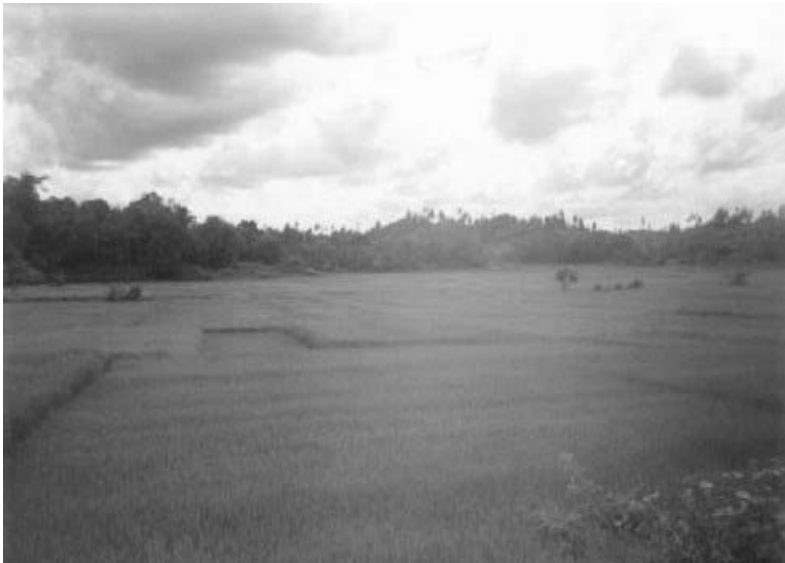
<u>Category</u> Agriculture, On-Farm		
		<u>Activity</u> Paddy Cultivation		
		<u>Condition</u> <input type="checkbox"/> A <input type="checkbox"/> B <input type="checkbox"/> C <input checked="" type="checkbox"/> D		
		<u>Problems</u> Low density of on-farm canal and farm roads.

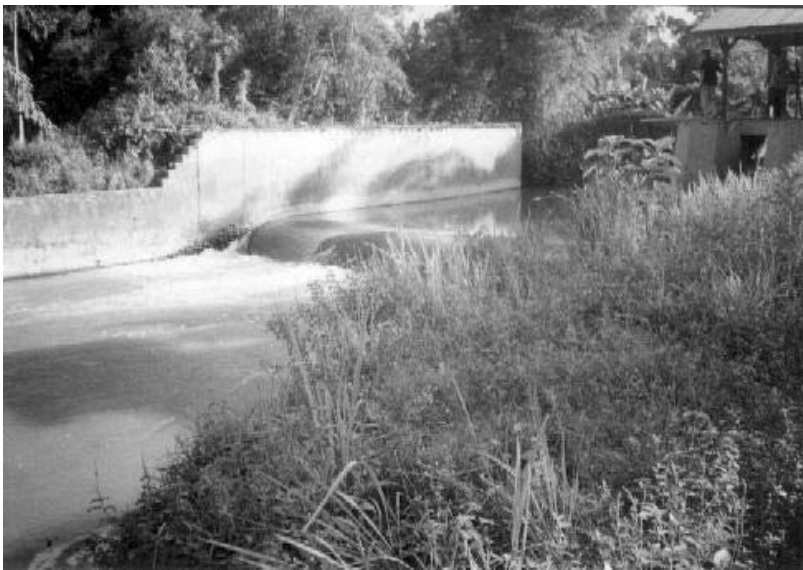
<i>Category</i> Irrigation (Headworks)		
		<i>Structure</i> Fixed Weir		
		<i>Condition</i> <input type="checkbox"/> A <input checked="" type="checkbox"/> B <input type="checkbox"/> C <input type="checkbox"/> D		
		<i>Problems</i> Damage or collapse of side wall at up and downstream of weir.

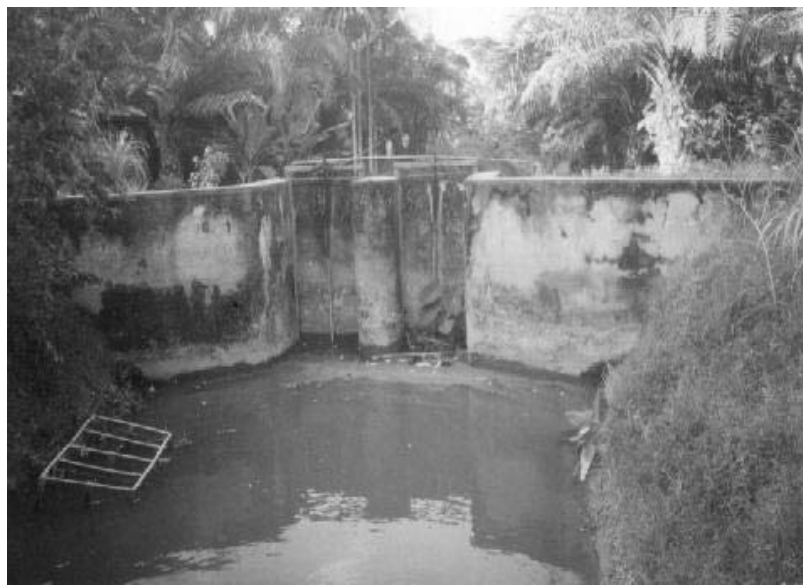
<i>Category</i> Irrigation (Headworks)		
		<i>Structure</i> Intake Gate		
		<i>Condition</i> <input type="checkbox"/> A <input type="checkbox"/> B <input checked="" type="checkbox"/> C <input type="checkbox"/> D		
		<i>Problems</i> Insufficient diversion water due to sedimentation in front of intake; settlement or deflection of intake structure; physical operation problem due to deflection; problem on management due to lack of periodically maintenance.

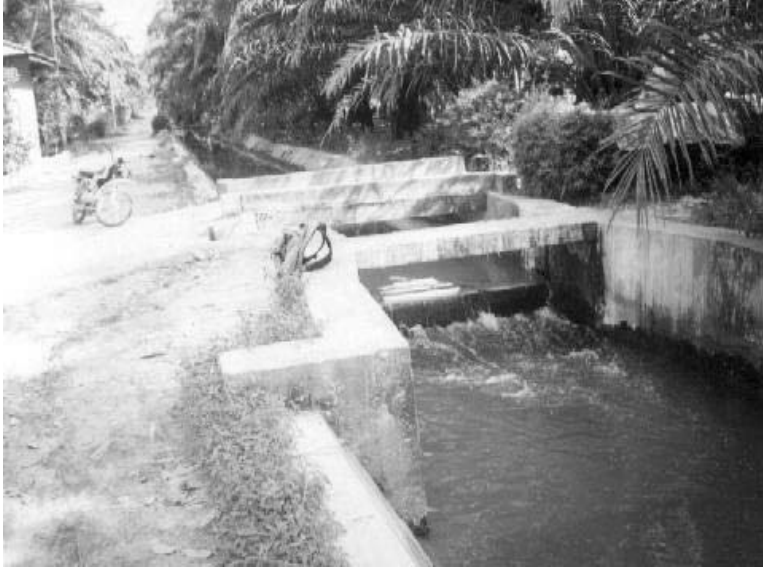
<p><u>Category</u> Irrigation (Secondary Canal)</p>			
		<p><u>Structure</u> Masonry Lined Canal</p>			
		<p><u>Condition</u> <input type="checkbox"/> A <input type="checkbox"/> B <input type="checkbox"/> C <input checked="" type="checkbox"/> D</p>			
		<p><u>Problems</u> Sedimentation, crack or damage on lined canal; leakage from lined canal; deflection of lining toward inside of canal; and less control facility.</p>

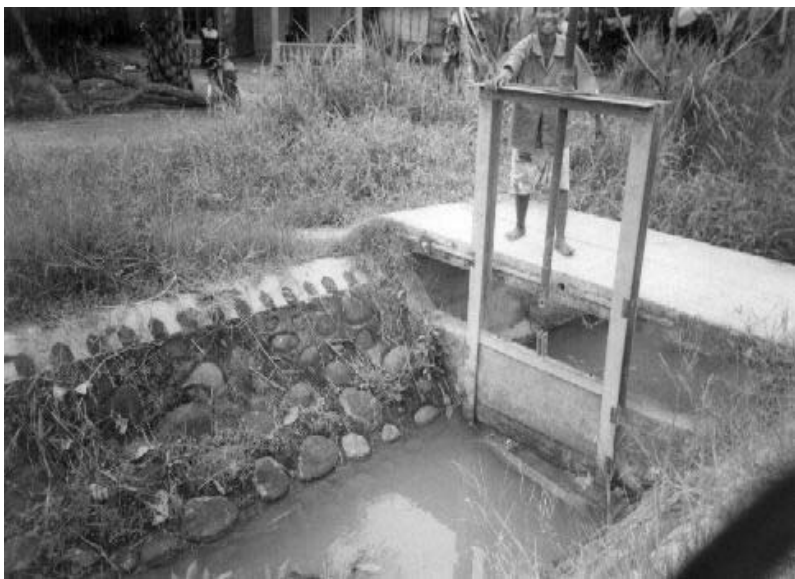
<i>Category</i> Irrigation (Main Canal)		
		<i>Structure</i> Check Structure		
		<i>Condition</i> <input type="checkbox"/> A <input type="checkbox"/> B <input checked="" type="checkbox"/> C <input type="checkbox"/> D		
		<i>Problems</i> Lower function of structure; physical operation problem on structure, both structure and gate work

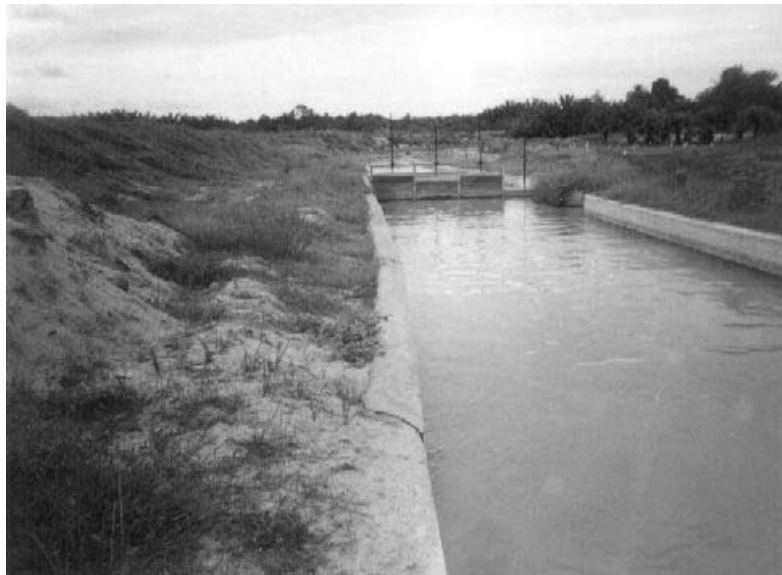
<i>Category</i> Irrigation (Main Canal)		
		<i>Structure</i> Concrete Lined Canal		
		<i>Condition</i> <input type="checkbox"/> A <input type="checkbox"/> B <input checked="" type="checkbox"/> C <input type="checkbox"/> D		
		<i>Problems</i> Sedimentation; crack or damage on lined canal; leakage from lined canal; deflection of lining toward inside of canal;

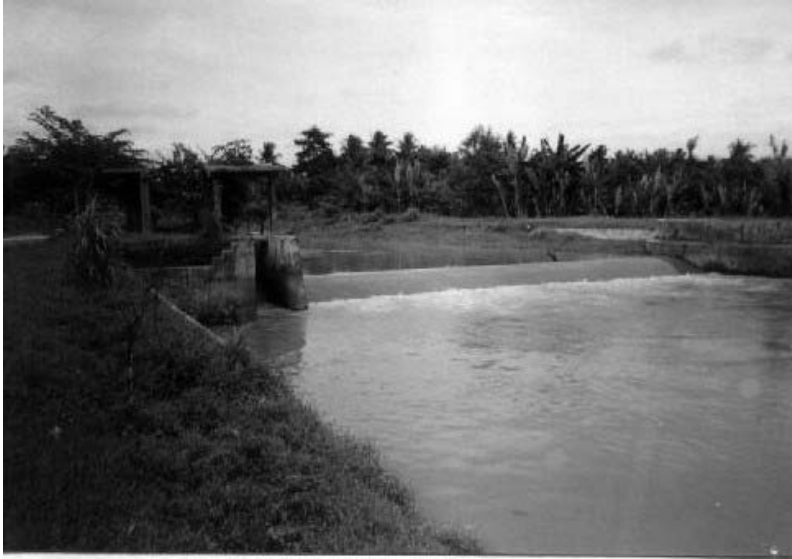
<i>Category</i> Irrigation (Headworks)		
		<i>Structure</i> Fixed Weir		
		<i>Condition</i> <input type="checkbox"/> A <input type="checkbox"/> B <input checked="" type="checkbox"/> C <input type="checkbox"/> D		
		<i>Problems</i> Fallen down, incline or washed away of retaining wall of weir; washed away of ripraps or blocks at downstream of stilling basin

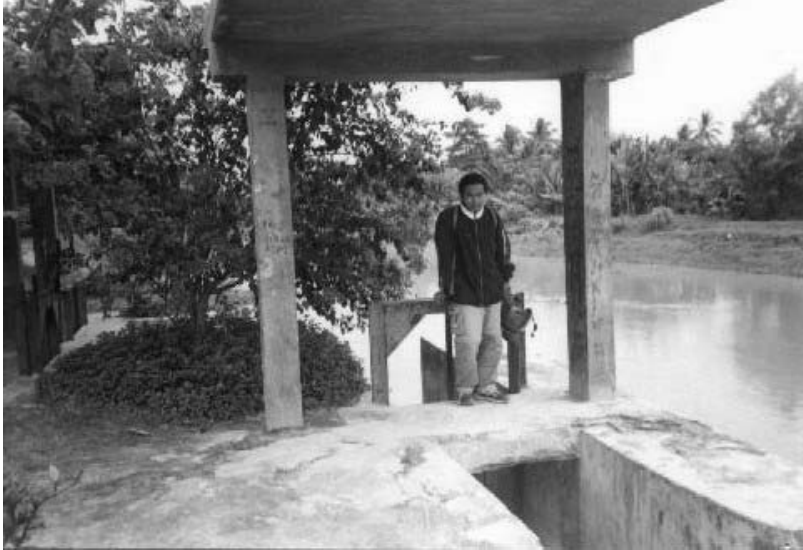
<i>Category</i> Intake Gate		
		<i>Condition</i> <input type="checkbox"/> A <input type="checkbox"/> B <input checked="" type="checkbox"/> C <input type="checkbox"/> D		
		<i>Problems</i> Insufficient diversion water due to sedimentation in front of intake; leakage from gate leaf; insufficient strength against design load due to rust, decay of steel material

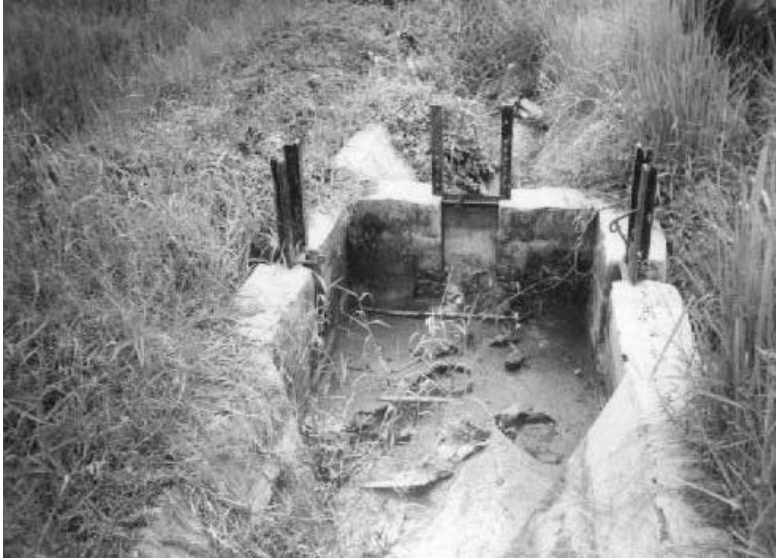
<p><u>Category</u> Irrigation (Secondary Canal)</p>		
		<p><u>Structure</u> Division structure</p>		
		<p><u>Condition</u> <input type="checkbox"/> A <input type="checkbox"/> B <input type="checkbox"/> C <input checked="" type="checkbox"/> D</p>

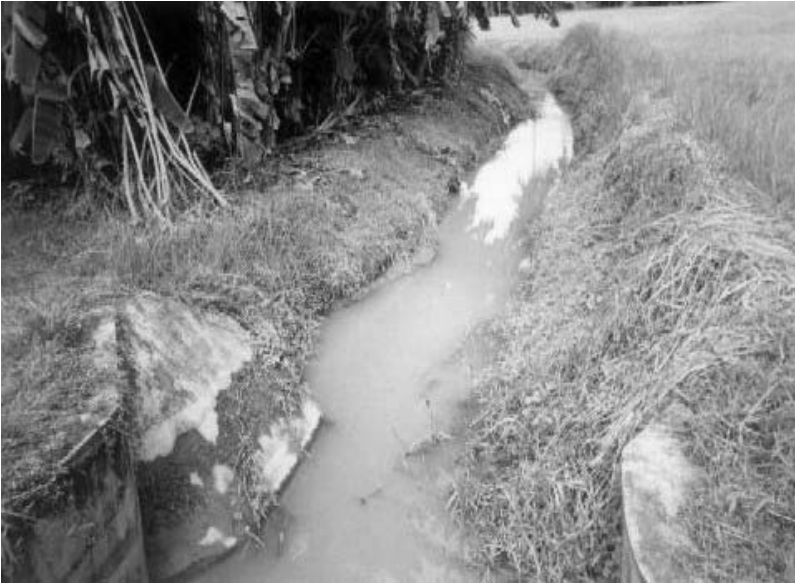
<p><u>Category</u> Irrigation (Secondary Canal)</p>		
		<p><u>Structure</u> Canal</p>		
		<p><u>Condition</u> <input type="checkbox"/> A <input type="checkbox"/> B <input type="checkbox"/> C <input checked="" type="checkbox"/> D</p>		
		<p><u>Problems</u> Damaged and no function.</p>		
		<p><u>Category</u> Irrigation (Secondary Canal)</p>		
		<p><u>Structure</u> Canal</p>		
		<p><u>Condition</u> <input type="checkbox"/> A <input type="checkbox"/> B <input type="checkbox"/> C <input checked="" type="checkbox"/> D</p>		
		<p><u>Problems</u> Sedimentation; collapse of canal; leakage from canal; difficulty on maintenance of earth canal; and no inspection road.</p>

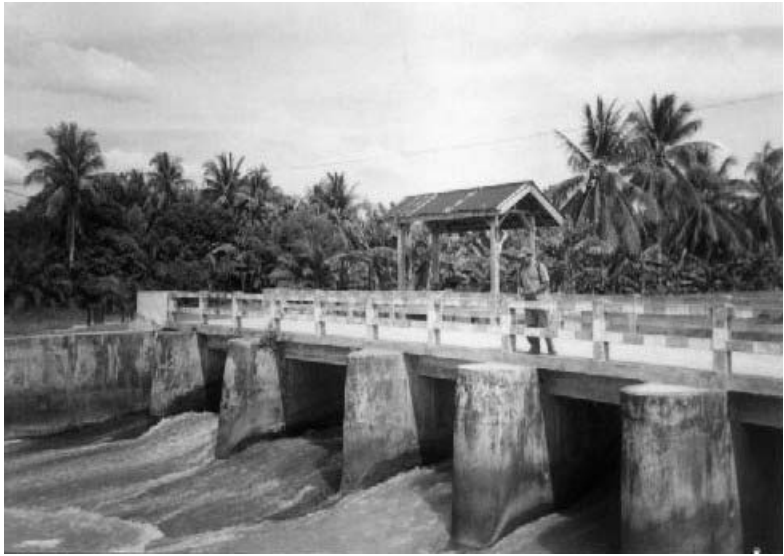
<p><u>Category</u> Irrigation (Headworks)</p>		
		<p><u>Structure</u> Fixed Weir</p>		
		<p><u>Condition</u> <input type="checkbox"/> A <input type="checkbox"/> B <input checked="" type="checkbox"/> C <input type="checkbox"/> D</p>		
		<p><u>Problems</u> Washed away of stilling basin</p>

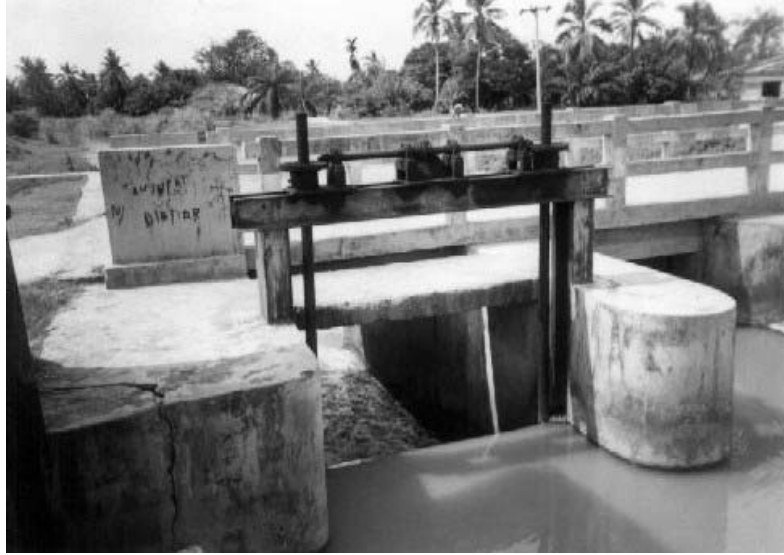
<p><u>Category</u> Irrigation (Headworks)</p>		
		<p><u>Structure</u> Scouring Sluice Gate</p>		
		<p><u>Condition</u> <input type="checkbox"/> A <input type="checkbox"/> B <input checked="" type="checkbox"/> C <input type="checkbox"/> D</p>		
		<p><u>Problems</u> Leakage from gate leaf; insufficient strength against design load due to rust, decay of steel material; problem on management due to lack of periodically maintenance; and insufficient diversion water due to sedimentation in front of intake.</p>

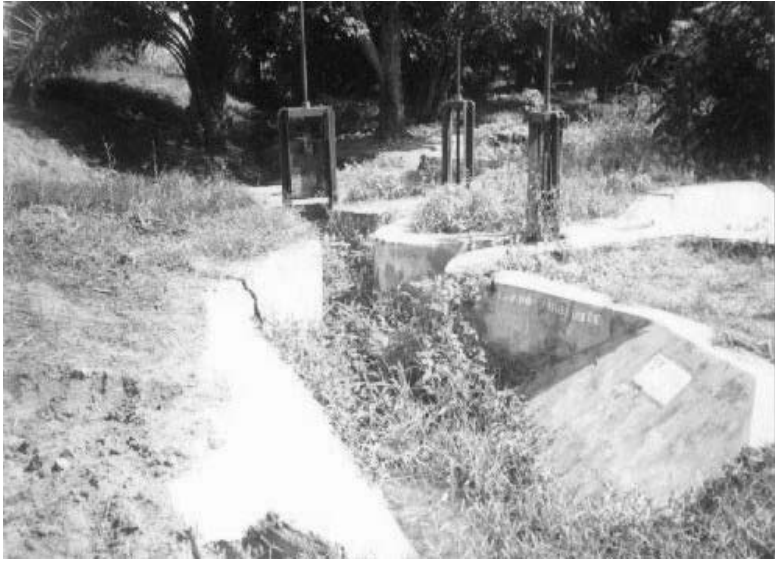
<i>Category</i> Irrigation (Main Canal)		
		<i>Structure</i> Division Structure		
		<i>Condition</i> <input type="checkbox"/> A <input type="checkbox"/> B <input type="checkbox"/> C <input checked="" type="checkbox"/> D		
		<i>Problems</i> Lower function of division structure due to sedimentation in front of division structure; settlement or damage on division structure; physical operation problem on division structure.

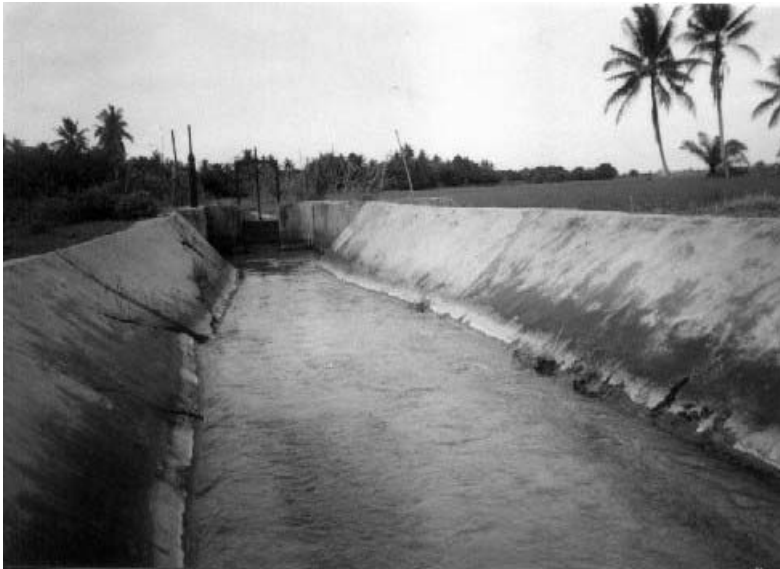
<i>Category</i> Irrigation (Main Canal)		
		<i>Structure</i> Concrete Lined Canal		
		<i>Condition</i> <input type="checkbox"/> A <input type="checkbox"/> B <input type="checkbox"/> C <input checked="" type="checkbox"/> D		
		<i>Problems</i> Sedimentation; crack or damage on lined canal; leakage from lined canal; deflection of lining toward inside of canal; and no inspection road.

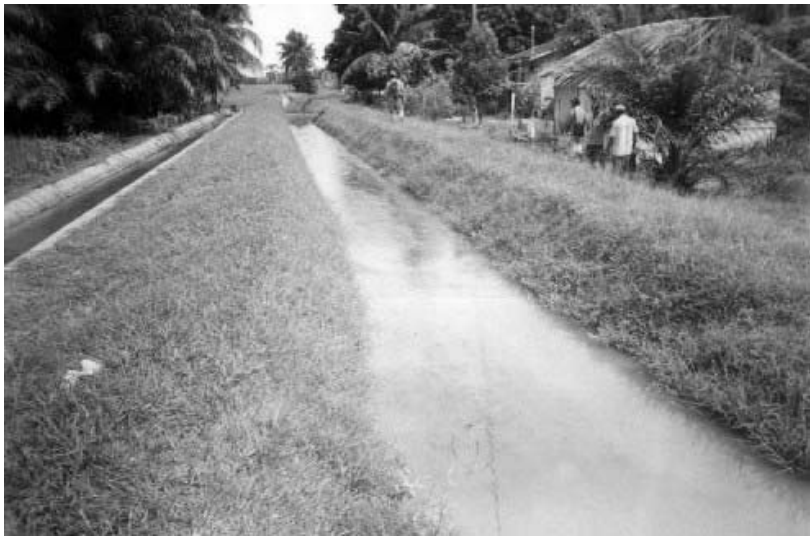
<i>Category</i> Irrigation (Secondary Canal)		
		<i>Structure</i> Earth Canal		
		<i>Condition</i> <input type="checkbox"/> A <input type="checkbox"/> B <input type="checkbox"/> C <input checked="" type="checkbox"/> D		
		<i>Problems</i> Sedimentation; collapse of canal; leakage from canal; difficulty on maintenance of earth canal; and no inspection road.

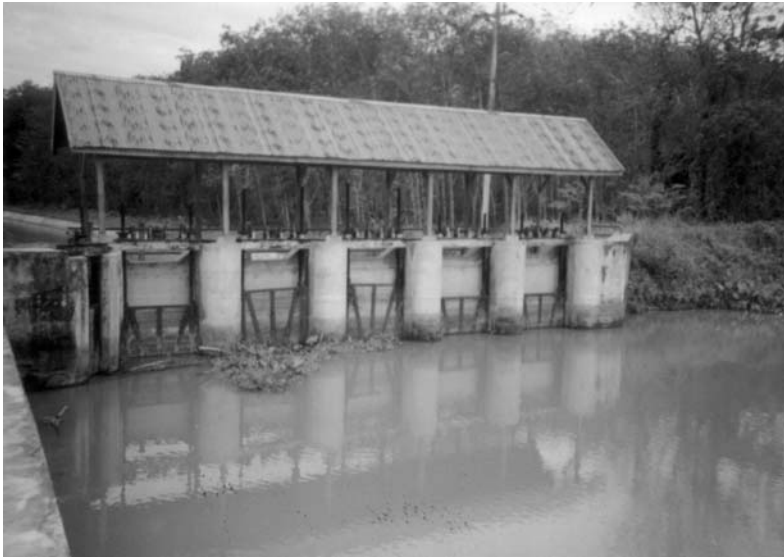
<i>Category</i> Irrigation (Headworks)		
		<i>Structure</i> Movable Weir (Rear View)		
		<i>Condition</i> <input type="checkbox"/> A <input type="checkbox"/> B <input checked="" type="checkbox"/> C <input type="checkbox"/> D		
		<i>Problems</i> Leakage from gate leaf; insufficient strength against design load due to decay of wood (wooden gate); insufficient diversion water due to sedimentation in front of intake

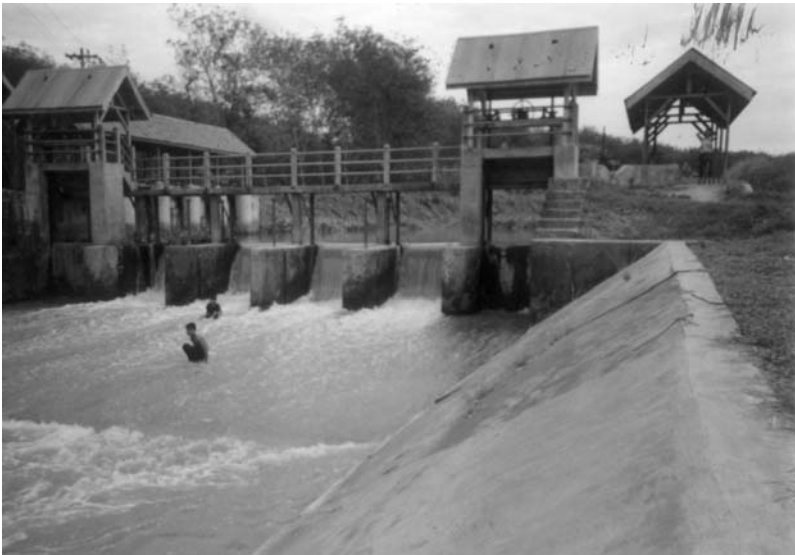
<i>Category</i> Irrigation (Headworks)		
		<i>Structure</i> Movable Weir (Front View)		
		<i>Condition</i> <input type="checkbox"/> A <input type="checkbox"/> B <input checked="" type="checkbox"/> C <input type="checkbox"/> D		
		<i>Problems</i> Cracks and incline of walls.

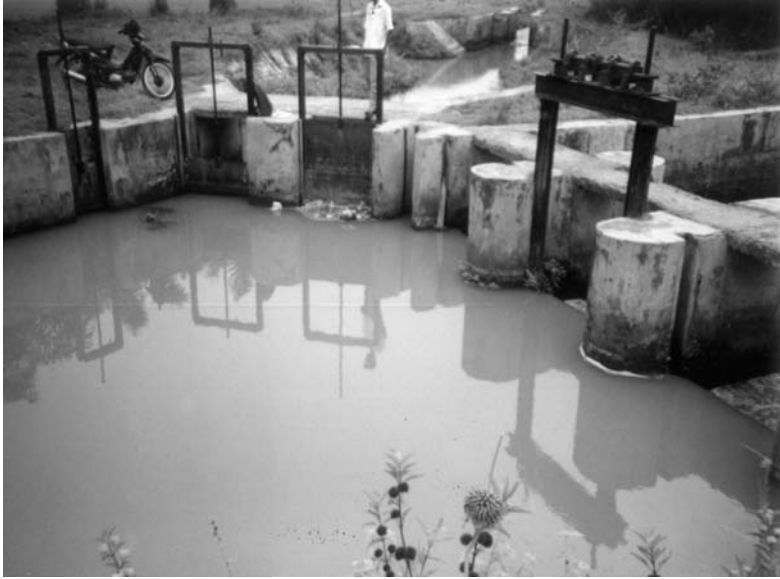
<p><u>Category</u> Irrigation (Main Canal)</p>		
		<p><u>Structure</u> Division structure</p>		
		<p><u>Condition</u> <input type="checkbox"/> A <input type="checkbox"/> B <input type="checkbox"/> C <input checked="" type="checkbox"/> D</p>		
		<p><u>Problems</u> Sedimentation in canal; low function of steel gates; and no water measuring structure.</p>
