The Study on Comprehensive Recovery Program of Irrigation Agriculture

Japan International Cooperation Agency

I. PROJECT FUNDAMENTALS									
I.1 General									
(1) Code Number	:	120123000	(7)	Number of Farmers	:	Not available			
(2) Name of Irrigation Scheme	:	Bah Korah II	(8)	Water Resource River	:	Bah Biak, Bah Korah, Bah Binoman

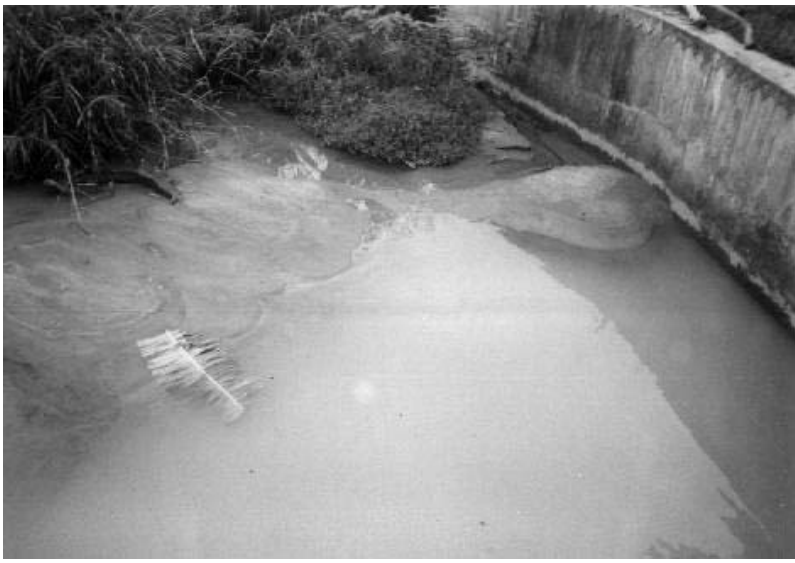
<i>Category</i> Irrigation (Headworks)		
		<i>Structure</i> Fixed Weir		
		<i>Condition</i> <input type="checkbox"/> A <input checked="" type="checkbox"/> B <input type="checkbox"/> C <input type="checkbox"/> D		
		<i>Problems</i> Settlement or washed away of stilling basin; washed away of ripraps or blocks at downstream of stilling basin; sediment in front of intake.

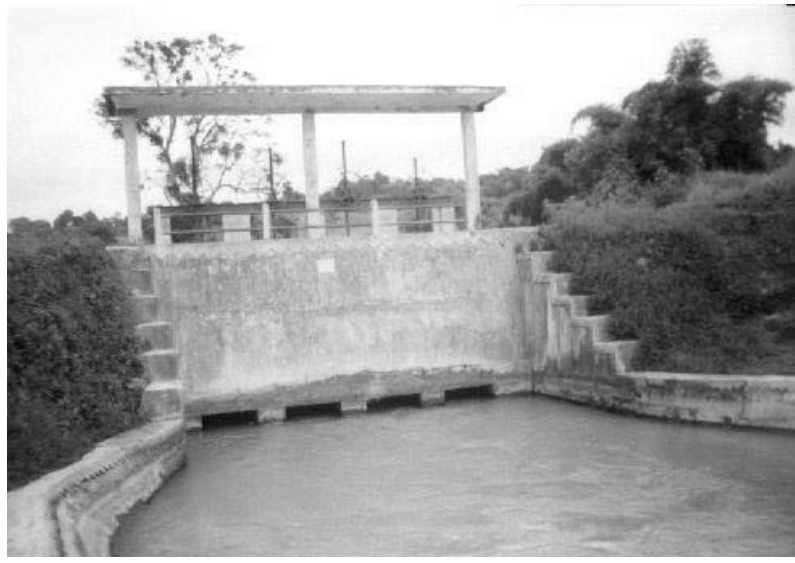
<i>Category</i> Irrigation (Headworks)		
		<i>Structure</i> Intake Gate		
		<i>Condition</i> <input type="checkbox"/> A <input checked="" type="checkbox"/> B <input type="checkbox"/> C <input type="checkbox"/> D		
		<i>Problems</i> Leakage from gate leaf; insufficient strength against design load due to rust, decay of steel material; problem on management due to lack of periodically maintenance

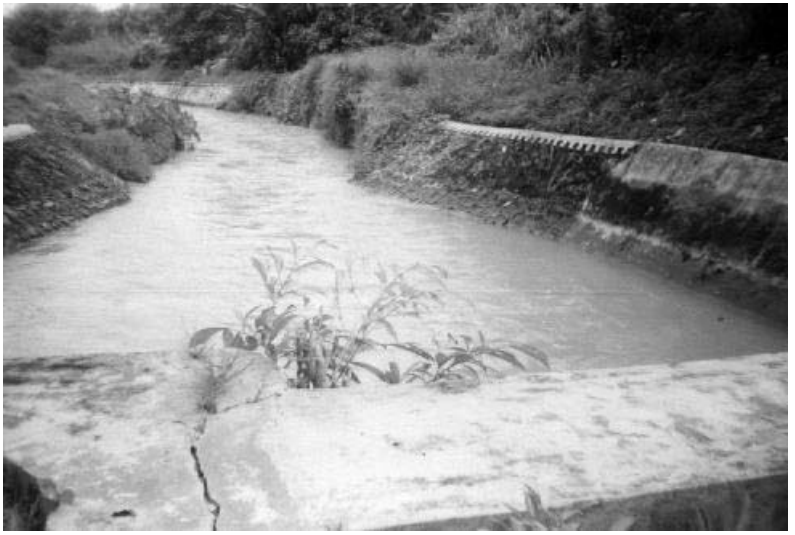
<i>Category</i> Irrigation (Main Canal)

<i>Structure</i> Masonry Lined Canal		
		<i>Condition</i> <input type="checkbox"/> A <input type="checkbox"/> B <input checked="" type="checkbox"/> C <input type="checkbox"/> D		
		<i>Problems</i> Sedimentation; leakage from lined canal; deflection of lining toward inside of canal; crack or damage on lined canal

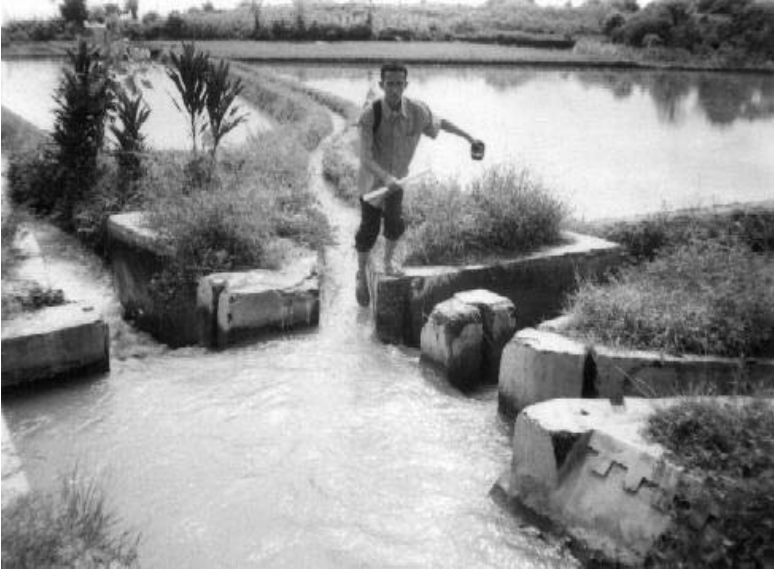
<p><u>Category</u> Irrigation (Secondary Canal)</p>			
		<p><u>Structure</u> Division structure</p>			
		<p><u>Condition</u> <input type="checkbox"/> A <input checked="" type="checkbox"/> B <input type="checkbox"/> C <input type="checkbox"/> D</p>			
		<p><u>Problems</u> No control gate is provided; difficulty on water management.</p>

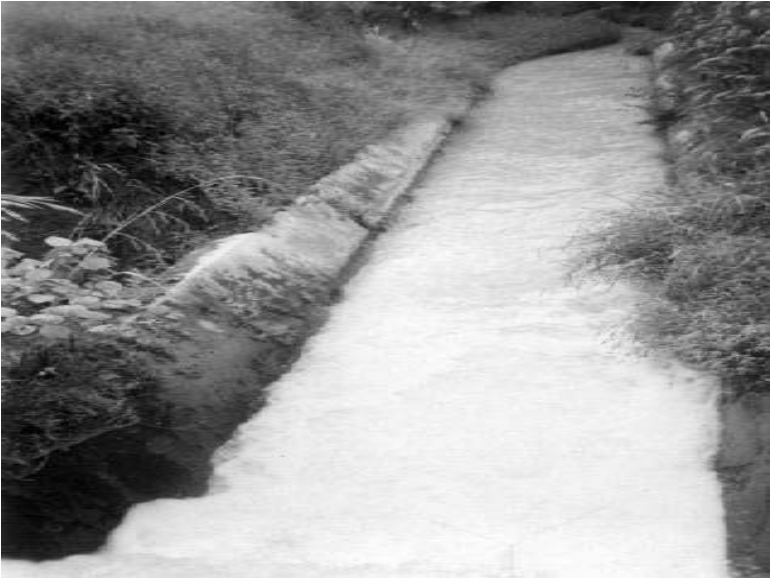
<p><u>Category</u> Irrigation (Secondary Canal)</p>			
		<p><u>Structure</u> Masonry Lined Canal</p>			
		<p><u>Condition</u> <input type="checkbox"/> A <input type="checkbox"/> B <input type="checkbox"/> C <input checked="" type="checkbox"/> D</p>			
		<p><u>Problems</u> Sedimentation; leakage from lined canal; deflection of lining toward inside of canal; crack or damage on lined canal; and no inspection road.</p>

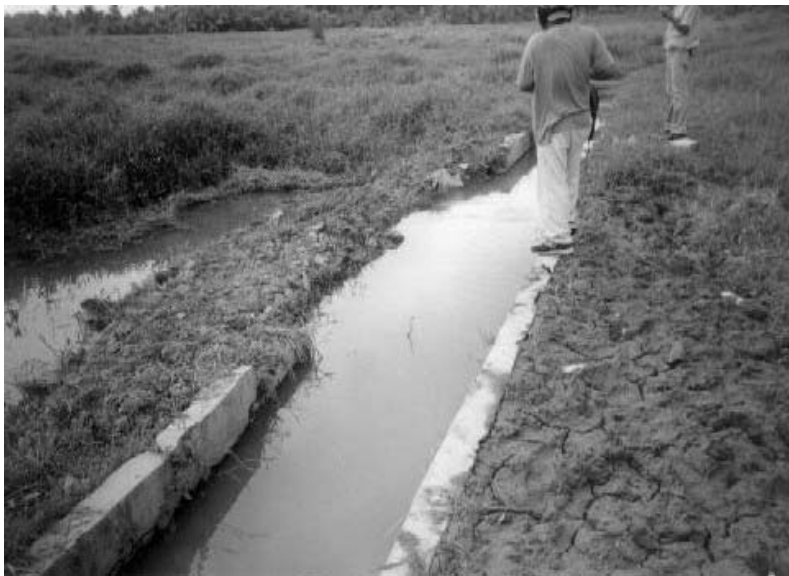
<p><u>Category</u> Irrigation (Secondary Canal)</p>			
		<p><u>Structure</u> Concrete Lined Canal</p>			
		<p><u>Condition</u> <input type="checkbox"/> A <input type="checkbox"/> B <input type="checkbox"/> C <input checked="" type="checkbox"/> D</p>

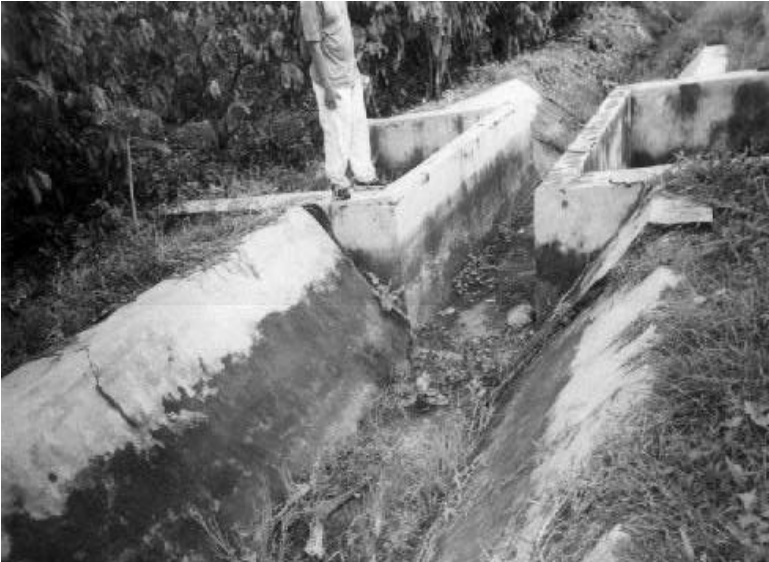
<p><u>Category</u> Irrigation (Secondary Canal)</p>			
		<p><u>Structure</u> Canal Crossing</p>			
		<p><u>Condition</u> <input type="checkbox"/> A <input type="checkbox"/> B <input type="checkbox"/> C <input checked="" type="checkbox"/> D</p>

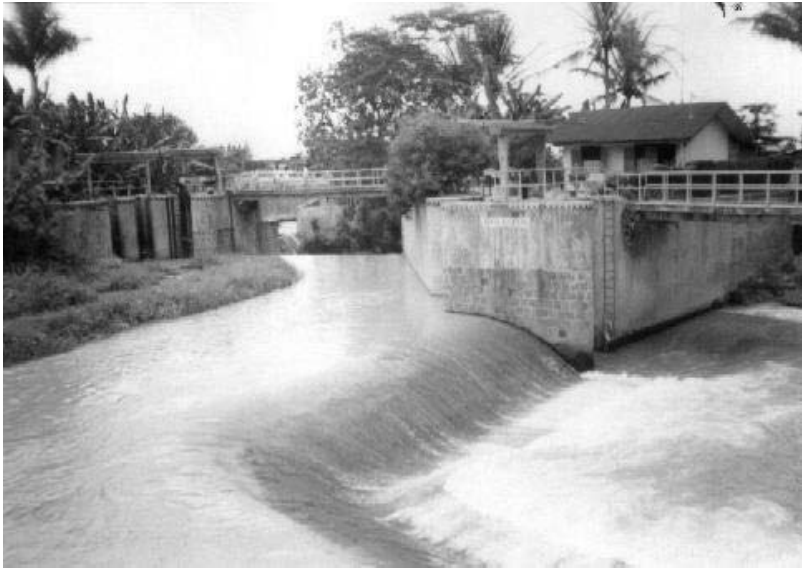
<i>Category</i> Irrigation (Headworks)		
		<i>Structure</i> Fixed Weir		
		<i>Condition</i> <input type="checkbox"/> A <input checked="" type="checkbox"/> B <input type="checkbox"/> C <input type="checkbox"/> D		
		<i>Problems</i> Crack or damage on weir crest; settlement of weir body; deflection of pier of weir

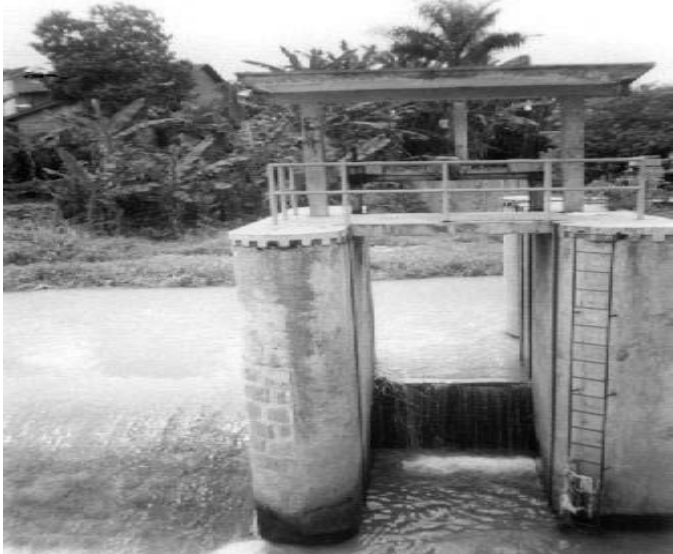
<i>Category</i> Irrigation (Headworks)		
		<i>Structure</i> Intake Gate		
		<i>Condition</i> <input type="checkbox"/> A <input checked="" type="checkbox"/> B <input type="checkbox"/> C <input type="checkbox"/> D		
		<i>Problems</i> Leakage from gate leaf; insufficient strength against design load due to rust, decay of steel material; problem on management due to lack of periodically maintenance

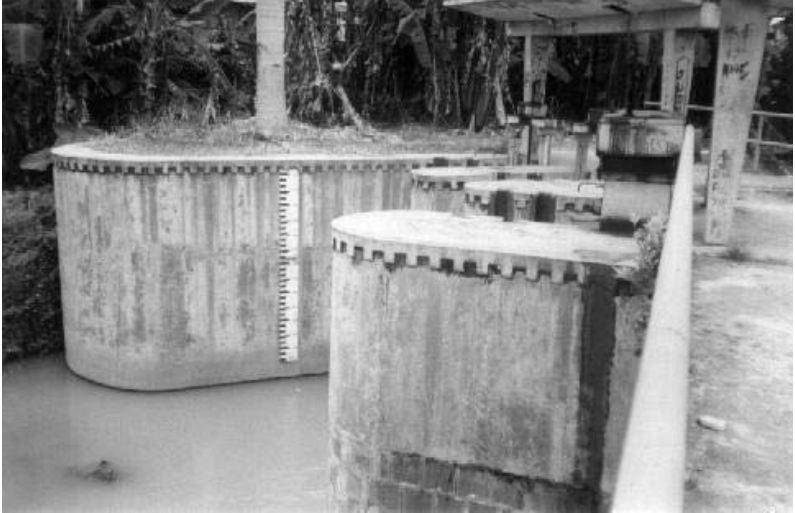
<i>Category</i> Irrigation (Headworks)		
		<i>Structure</i> Intake and Gauging Staff

<i>Condition</i> <input type="checkbox"/> A <input checked="" type="checkbox"/> B <input type="checkbox"/> C <input type="checkbox"/> D		
		<i>Problems</i> Sedimentation in front of intake.

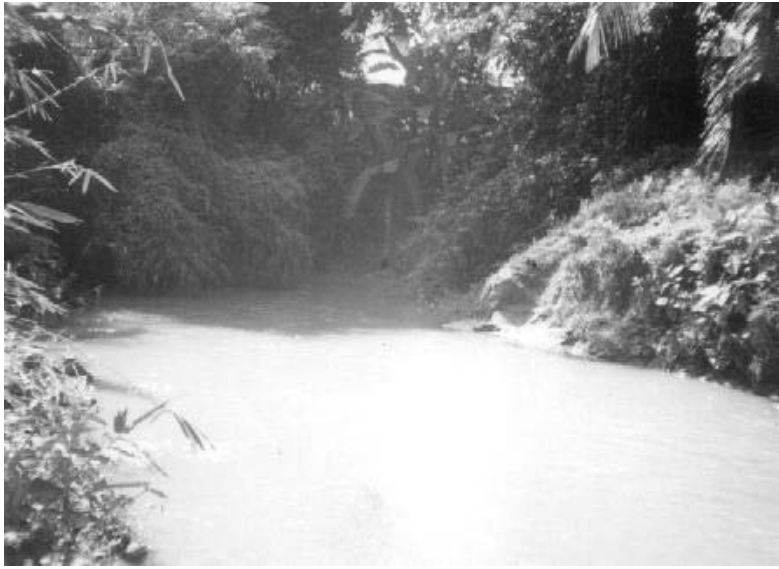
<u>Category</u>	Irrigation (Main Canal)		
		<u>Structure</u>	Earth Canal		
		<u>Condition</u>	<input type="checkbox"/> A <input type="checkbox"/> B <input type="checkbox"/> C <input checked="" type="checkbox"/> D		
		<u>Problems</u>	Sedimentation; leakage from canal; collapse of canal; difficulty on maintenance of earth canal; no inspection road.

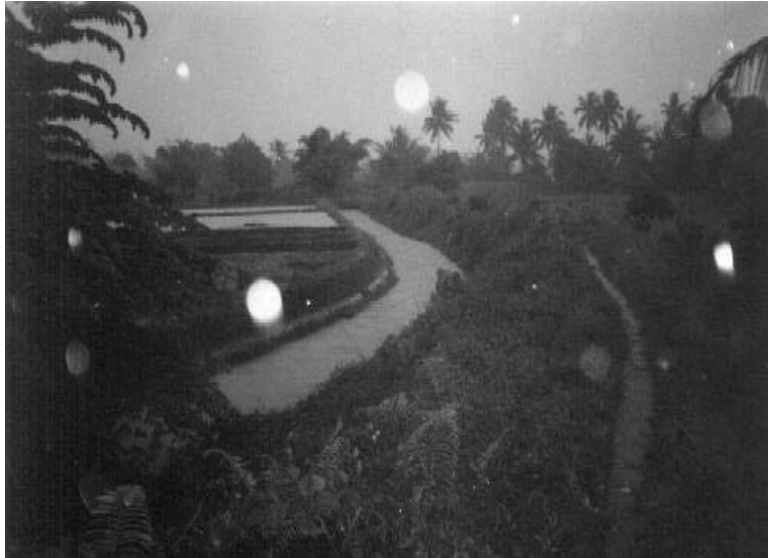
<u>Category</u>	Irrigation (Secondary Canal)		
		<u>Structure</u>	Canal		
		<u>Condition</u>	<input type="checkbox"/> A <input type="checkbox"/> B <input type="checkbox"/> C <input checked="" type="checkbox"/> D		
		<u>Problems</u>	Sedimentation; leakage from canal; collapse of canal; difficulty on maintenance of earth canal

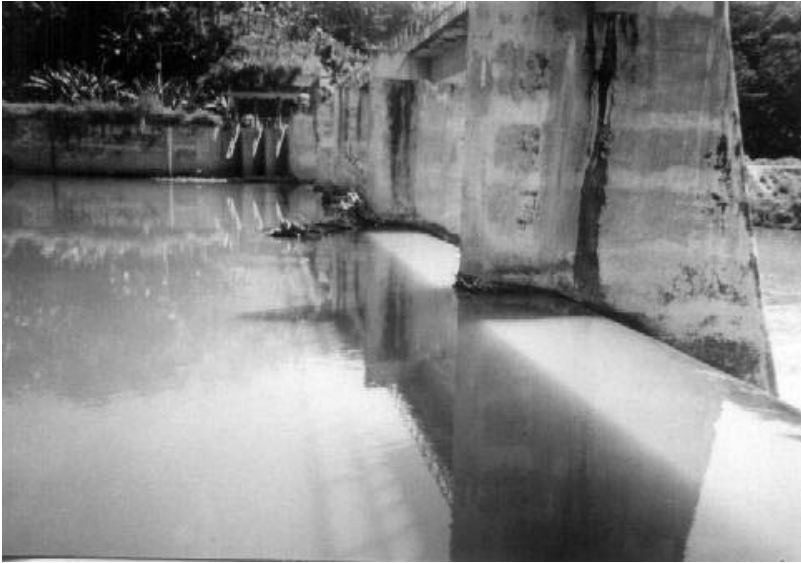
<p><u>Category</u> Irrigation (Headworks)</p>			
		<p><u>Structure</u> Fixed Weir</p>			
		<p><u>Condition</u> <input type="checkbox"/> A <input checked="" type="checkbox"/> B <input type="checkbox"/> C <input type="checkbox"/> D</p>			
		<p><u>Problems</u> Crack or damage on weir crest; settlement of weir body; deflection of pier of weir; sediments in front of intake</p>

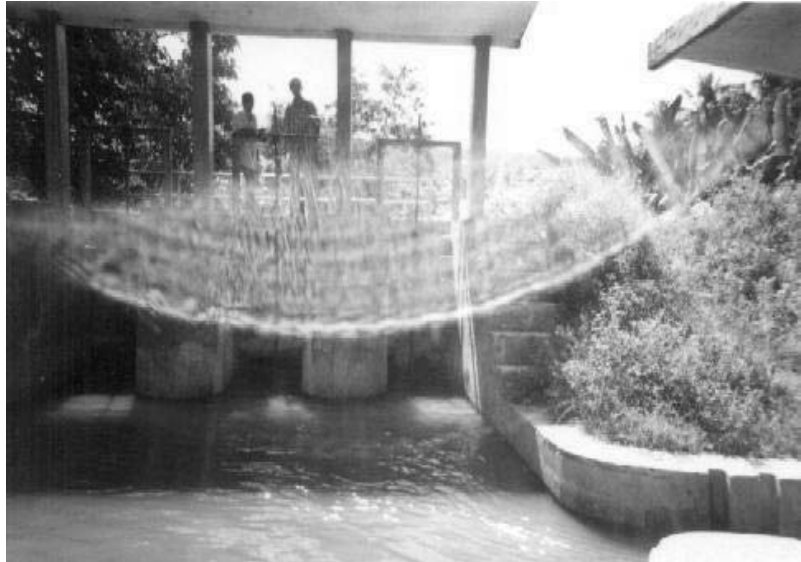
<p><u>Category</u> Irrigation (Headworks)</p>			
		<p><u>Structure</u> Intake Gate (Rear View)</p>			
		<p><u>Condition</u> <input type="checkbox"/> A <input checked="" type="checkbox"/> B <input type="checkbox"/> C <input type="checkbox"/> D</p>			
		<p><u>Problems</u> Leakage from gate leaf; insufficient strength against design load due to rust, decay of steel material; problem on management due to lack of periodically maintenance</p>

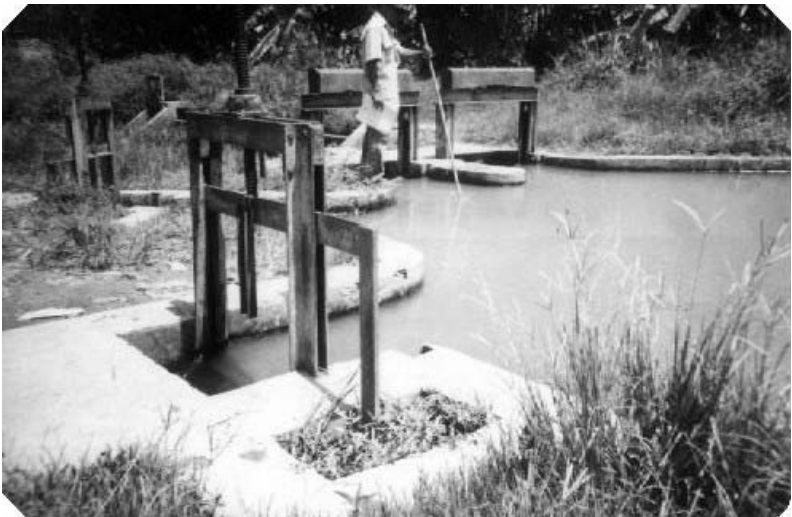
<p><u>Category</u> Irrigation (Main Canal)</p>			
		<p><u>Structure</u> Division structure</p>			
		<p><u>Condition</u> <input type="checkbox"/> A <input type="checkbox"/> B <input checked="" type="checkbox"/> C <input type="checkbox"/> D</p>			
		<p><u>Problems</u> Lower function of division structure; physical operation problem on structure; less maintenance; and sedimentation in canal</p>

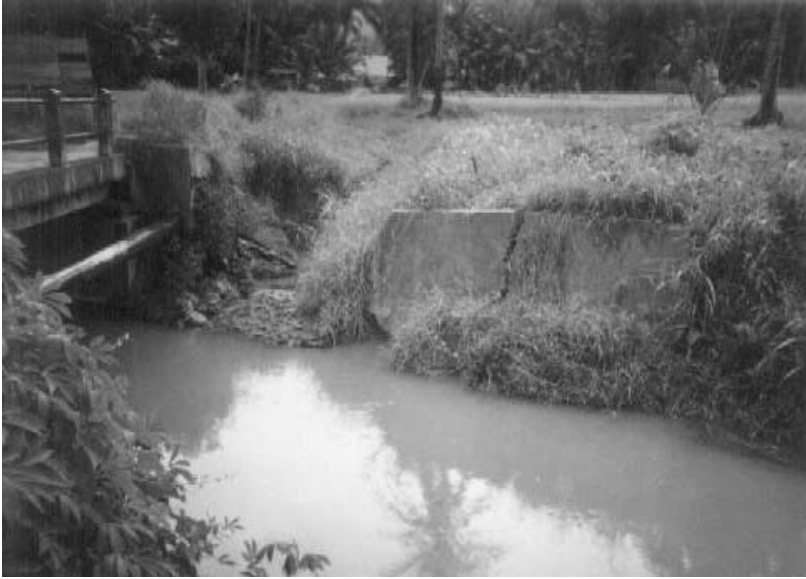
<p><u>Category</u> Irrigation (Main Canal)</p>		
		<p><u>Structure</u> Masonry Lined Canal</p>		
		<p><u>Condition</u> <input type="checkbox"/> A <input type="checkbox"/> B <input checked="" type="checkbox"/> C <input type="checkbox"/> D</p>		
		<p><u>Problems</u> Sedimentation; leakage from lined canal; deflection of lining toward inside of canal; crack or damage on lined canal; and no inspection road.</p>

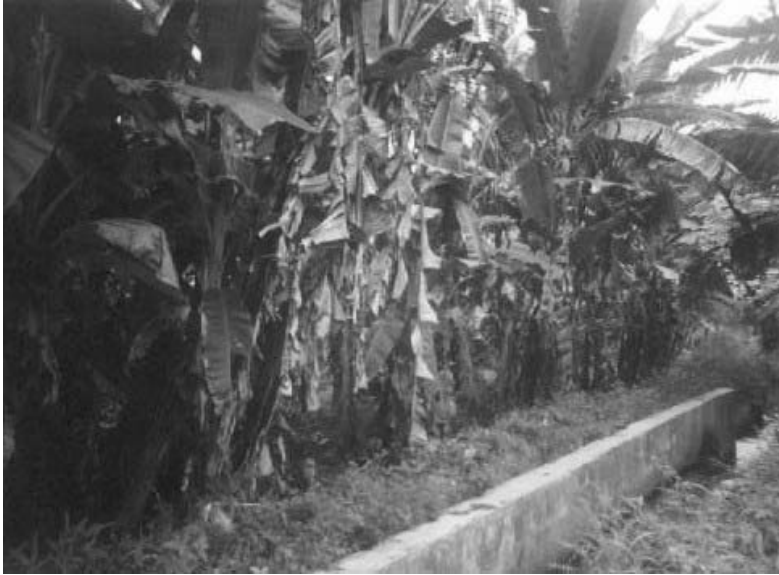
<p><u>Category</u> Irrigation (Secondary Canal)</p>		
		<p><u>Structure</u> Concrete Lined Canal</p>		
		<p><u>Condition</u> <input type="checkbox"/> A <input type="checkbox"/> B <input type="checkbox"/> C <input checked="" type="checkbox"/> D</p>		
		<p><u>Problems</u> Sedimentation; leakage from lined canal; damage on lined canal; and no inspection road.</p>

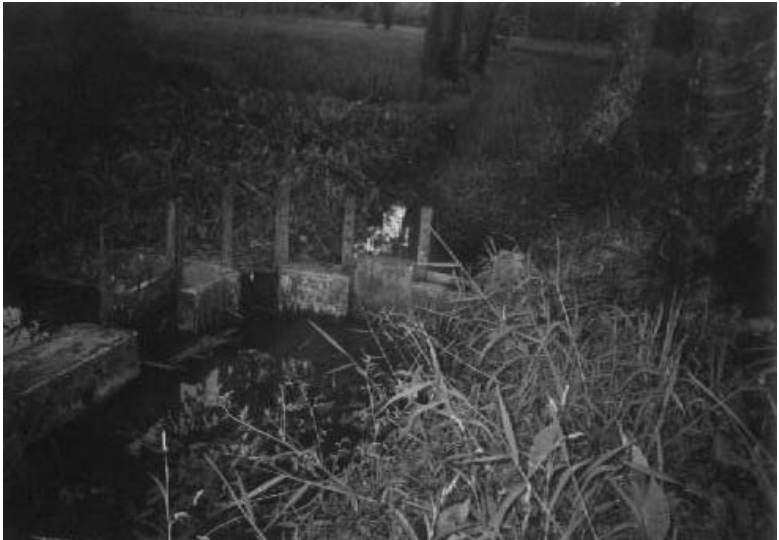
<p><u>Category</u> Irrigation (Secondary Canal)</p>		
		<p><u>Structure</u> Division structure</p>		
		<p><u>Condition</u> <input type="checkbox"/> A <input type="checkbox"/> B <input type="checkbox"/> C <input checked="" type="checkbox"/> D</p>		
		<p><u>Problems</u> Sediment in front of gate and damaged gates.</p>
