**THE STUDY  
ON  
COMPREHENSIVE RECOVERY PROGRAM  
OF  
IRRIGATION AGRICULTURE**

**Priority List  
of  
Irrigation Schemes  
for  
Rehabilitation  
(Central Java Province)**

**February 2004**

**Nippon Koei Co., Ltd.**

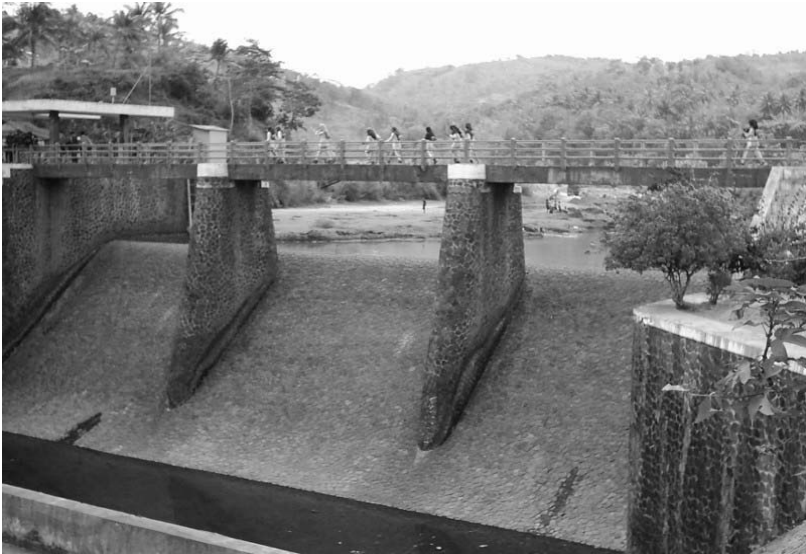
| Scheme | Cijalu | District | Cilacap |
|---|---|---|---|
| | | <u>Structure</u><br>Fixed Weir | |
| | | <u>Condition</u><br><input type="checkbox"/> A <input checked="" type="checkbox"/> B <input type="checkbox"/> C <input type="checkbox"/> D | |
| | | <u>Problems</u><br>Minor repairs for weir body and gates are required | |

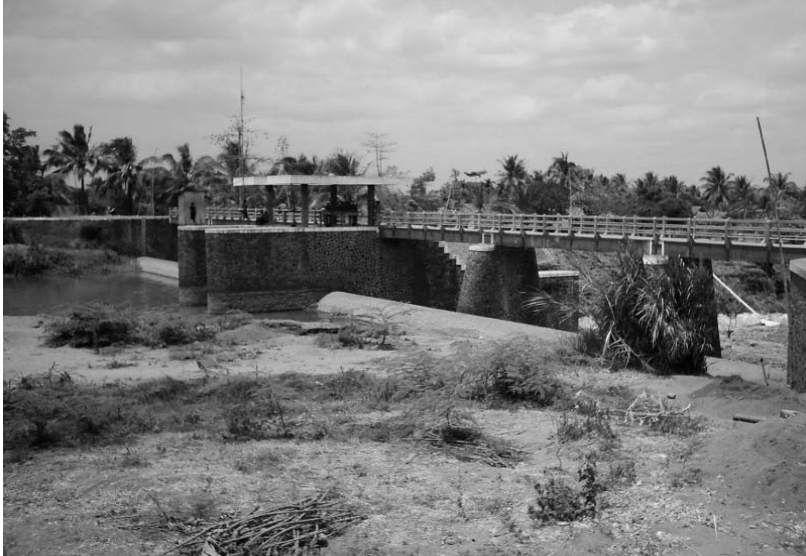
| Scheme | Cijalu | District | Cilacap |
|---|---|---|---|
| | | <u>Structure</u><br>Fixed Weir | |
| | | <u>Condition</u><br><input type="checkbox"/> A <input checked="" type="checkbox"/> B <input type="checkbox"/> C <input type="checkbox"/> D | |
| | | <u>Problems</u><br>Minor repairs for weir body and gates are required | |

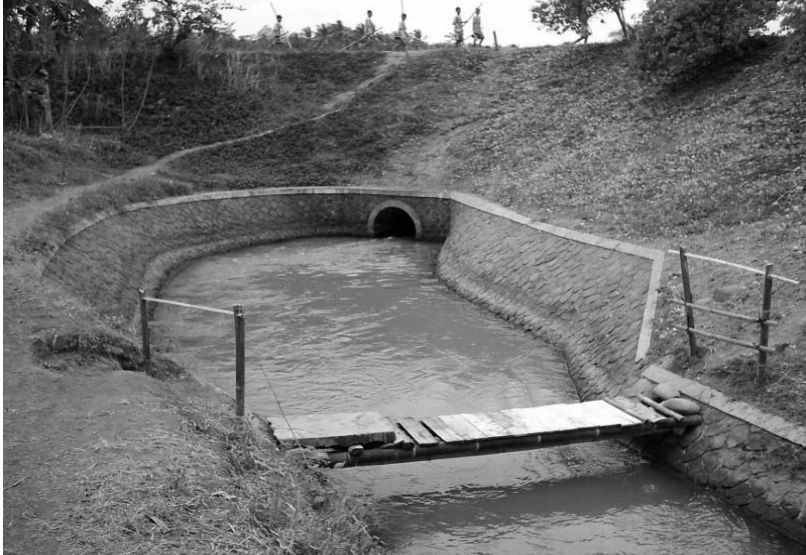
| Scheme | Cijalu | District | Cilacap |
|---|---|---|---|
| | | <u>Structure</u><br>Intake | |
| | | <u>Condition</u><br><input type="checkbox"/> A <input type="checkbox"/> B <input checked="" type="checkbox"/> C <input type="checkbox"/> D | |

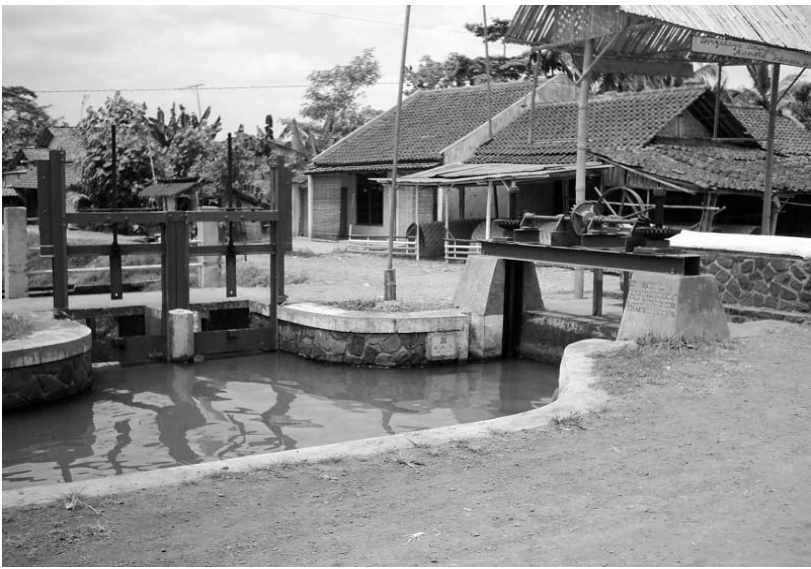
| Scheme | Cijalu | District | Cilacap |
|---|---|---|---|
| | | <b>Structure</b><br>Division Structure | |
| | | <b>Condition</b><br><input type="checkbox"/> A <input checked="" type="checkbox"/> B <input type="checkbox"/> C <input type="checkbox"/> D | |
| | | <b>Problems</b><br>Gates are required repair / replace | |

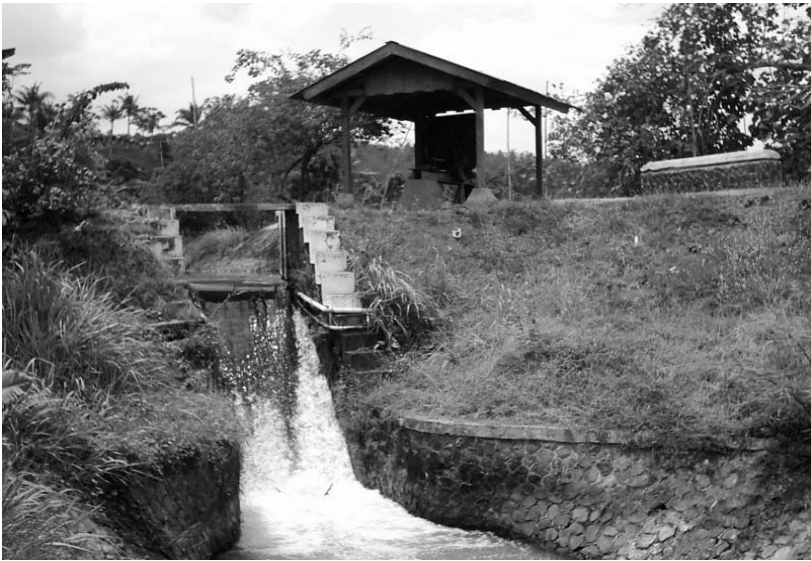
| Scheme | Cijalu | District | Cilacap |
|---|---|---|---|
| | | <b>Structure</b><br>Division Structure | |
| | | <b>Condition</b><br><input type="checkbox"/> A <input type="checkbox"/> B <input checked="" type="checkbox"/> C <input type="checkbox"/> D | |
| | | <b>Problems</b><br>Require minor repair | |

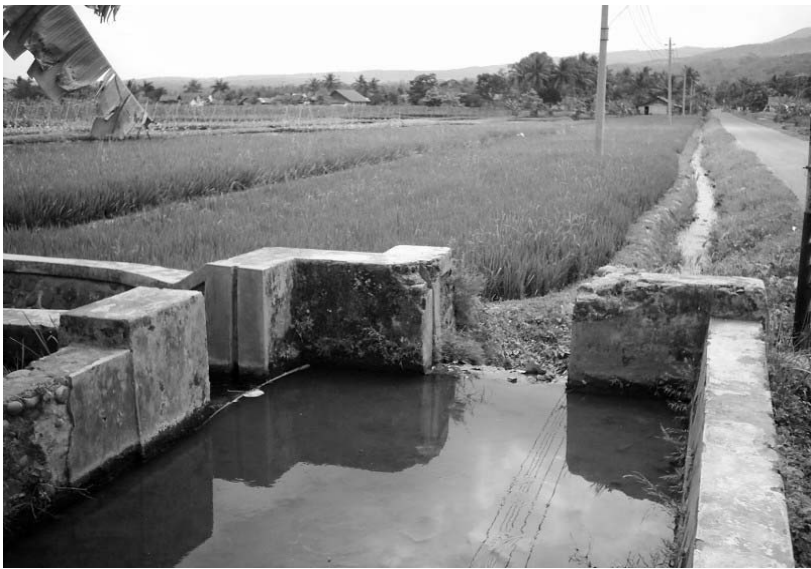
| Scheme | Cijalu | District | Cilacap |
|---|---|---|---|
| | | <b>Structure</b><br>Canal and Division Box | |
| | | <b>Condition</b><br><input type="checkbox"/> A <input type="checkbox"/> B <input type="checkbox"/> C <input checked="" type="checkbox"/> D | |

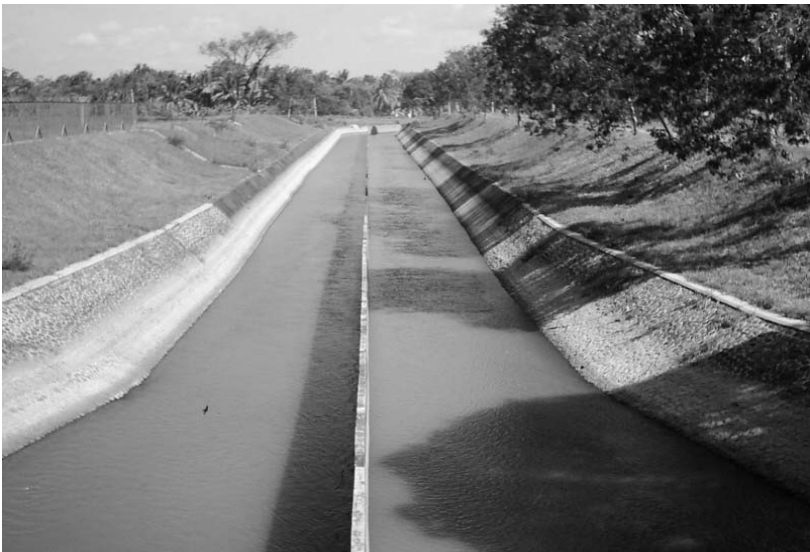
| Scheme | Mangganti | District | Cilacap |
|---|---|---|---|
| | | <u>Structure</u><br>Settling Basin | |
| | | <u>Condition</u><br><input type="checkbox"/> A <input checked="" type="checkbox"/> B <input type="checkbox"/> C <input type="checkbox"/> D | |
| | | <u>Problems</u><br>Inspection road is not provided | |

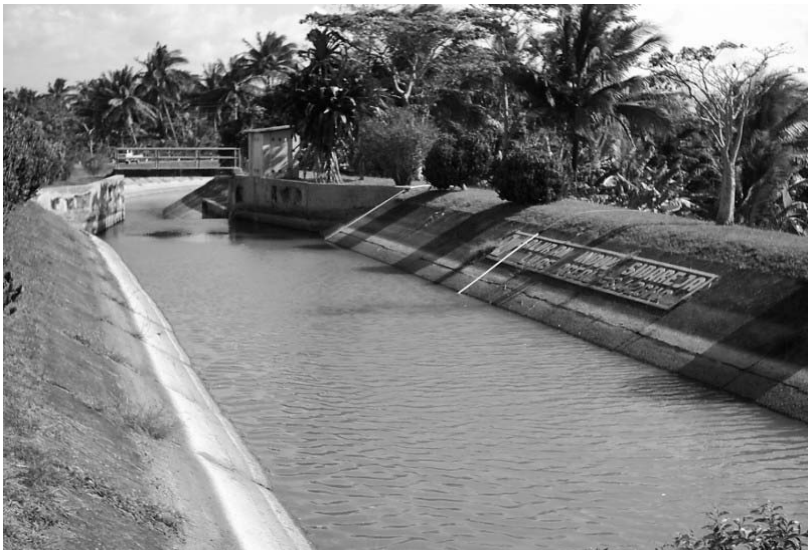
| Scheme | Mangganti | District | Cilacap |
|---|---|---|---|
| | | <u>Structure</u><br>Lined Canal | |
| | | <u>Condition</u><br><input type="checkbox"/> A <input checked="" type="checkbox"/> B <input type="checkbox"/> C <input type="checkbox"/> D | |
| | | <u>Problems</u><br>Require sediment removal | |

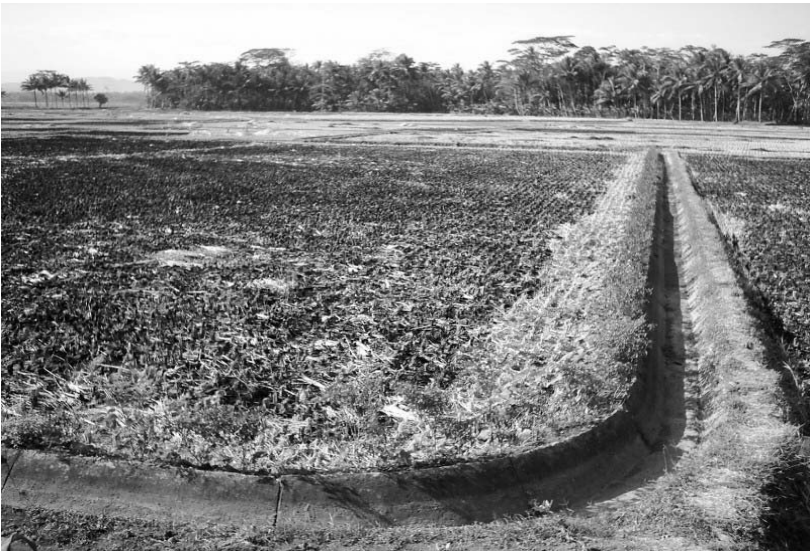
| Scheme | Mangganti | District | Cilacap |
|---|---|---|---|
| | | <u>Structure</u><br>Tertiary System | |
| | | <u>Condition</u><br><input type="checkbox"/> A <input type="checkbox"/> B <input checked="" type="checkbox"/> C <input type="checkbox"/> D | |

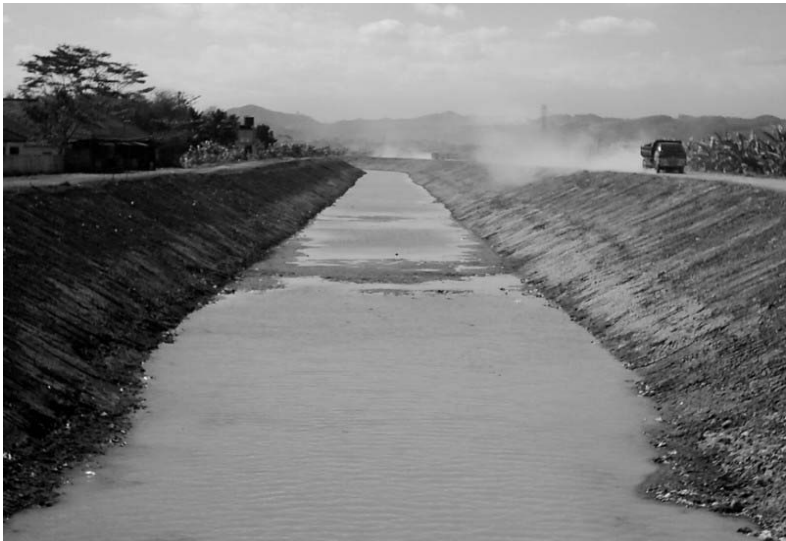
| Scheme | Serayu | District | Cilacap |
|---|---|---|---|
| | | <u>Structure</u><br>Canal | |
| | | <u>Condition</u><br><input type="checkbox"/> A <input type="checkbox"/> B <input checked="" type="checkbox"/> C <input type="checkbox"/> D | |
| | | <u>Problems</u><br>Require canal lining | |

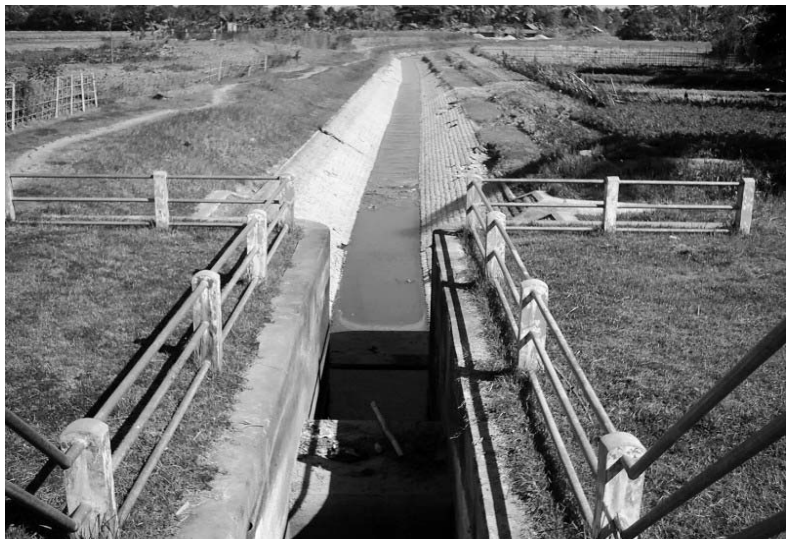
| Scheme | Serayu | District | Cilacap |
|---|---|---|---|
| | | <u>Structure</u><br>Canal lining | |
| | | <u>Condition</u><br><input type="checkbox"/> A <input checked="" type="checkbox"/> B <input type="checkbox"/> C <input type="checkbox"/> D | |

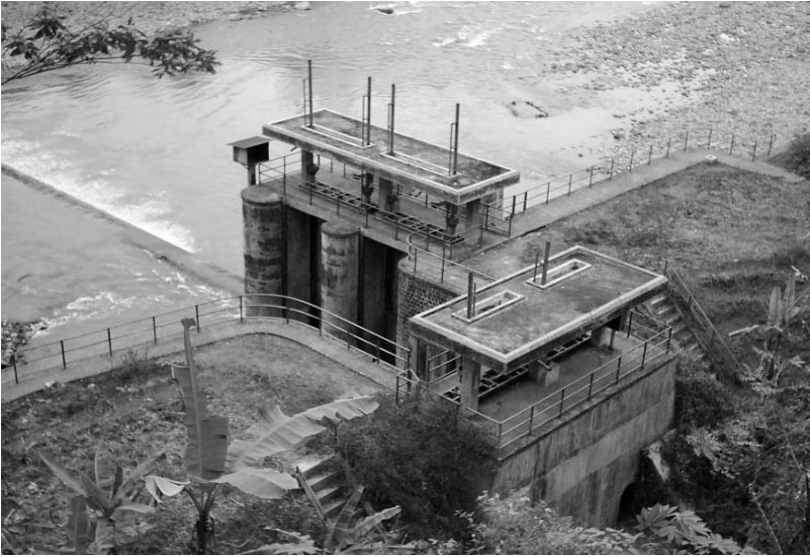
| Scheme | Banjarcayana | District | Banjarnegara |
|---|---|---|---|
| | | <u>Structure</u><br>Fixed Weir | |
| | | <u>Condition</u><br><input type="checkbox"/> A <input checked="" type="checkbox"/> B <input type="checkbox"/> C <input type="checkbox"/> D | |
| | | <u>Problems</u><br>Sediment in front of intake | |

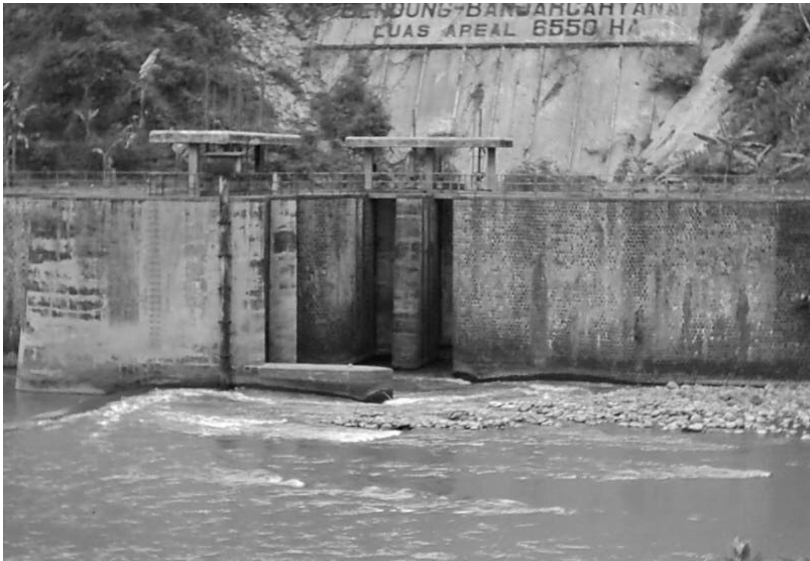
| Scheme | Banjarcayana | District | Banjarnegara |
|---|---|---|---|
| | | <u>Structure</u><br>Scouring Sluice and Intake | |
| | | <u>Condition</u><br><input type="checkbox"/> A <input checked="" type="checkbox"/> B <input type="checkbox"/> C <input type="checkbox"/> D | |
| | | <u>Problems</u><br>Sediment in front of intake | |

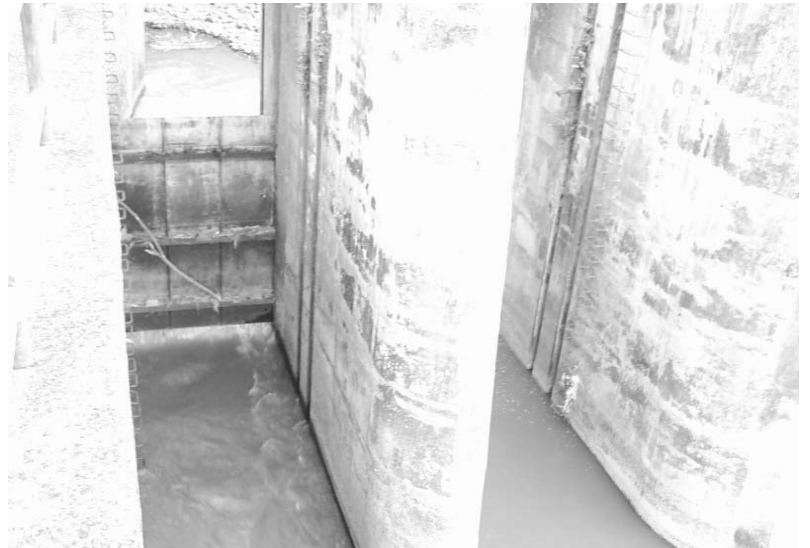
| Scheme | Banjarcayana | District | Banjarnegara |
|---|---|---|---|
| | | <u>Structure</u><br>Scouring Sluice Gate | |
| | | <u>Condition</u><br><input type="checkbox"/> A <input type="checkbox"/> B <input checked="" type="checkbox"/> C <input type="checkbox"/> D | |

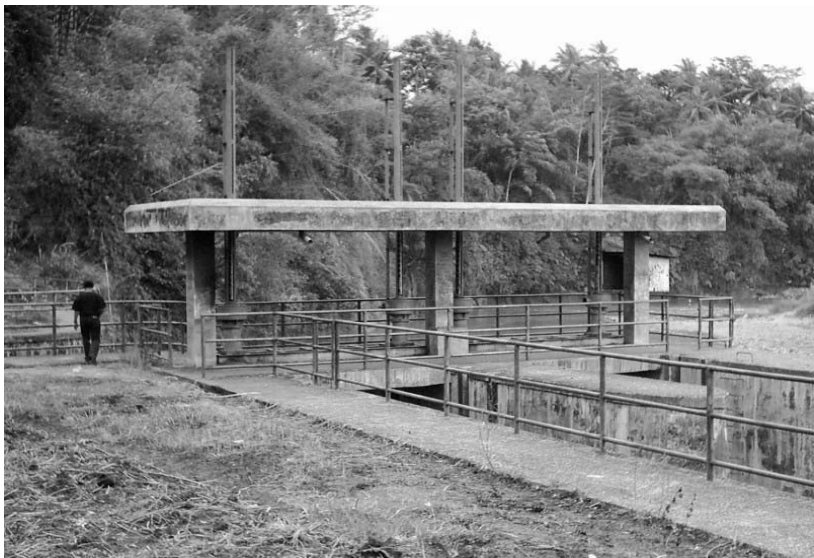
| Scheme | Banjarcayana | District | Banjarnegara |
|---|---|---|---|
| | | <u>Structure</u><br>Intake | |
| | | <u>Condition</u><br><input type="checkbox"/> A <input checked="" type="checkbox"/> B <input type="checkbox"/> C <input type="checkbox"/> D | |
| | | <u>Problems</u><br>Require minor repair | |

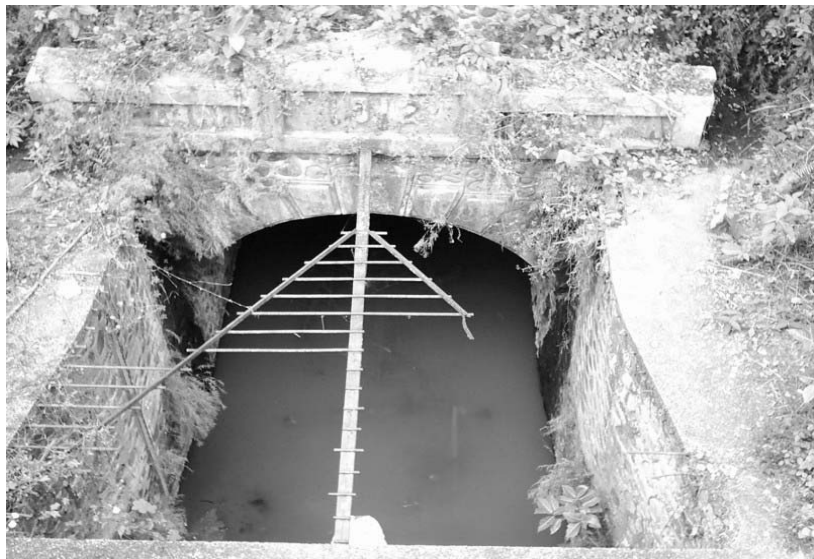
| Scheme | Banjarcayana | District | Banjarnegara |
|---|---|---|---|
| | | <u>Structure</u><br>Culvert | |
| | | <u>Condition</u><br><input type="checkbox"/> A <input type="checkbox"/> B <input checked="" type="checkbox"/> C <input type="checkbox"/> D | |

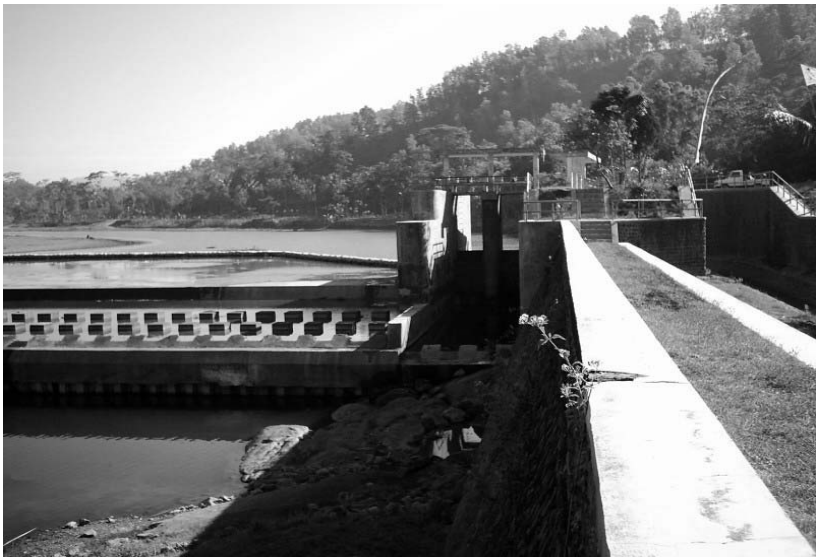
| Scheme | Kaligending | District | Kebumen |
|---|---|---|---|
| | | <u>Structure</u><br>Fixed Weir | |
| | | <u>Condition</u><br><input type="checkbox"/> A <input type="checkbox"/> B <input checked="" type="checkbox"/> C <input type="checkbox"/> D | |
| | | <u>Problems</u><br>Problem of water intake due to miss match of river and river water level | |

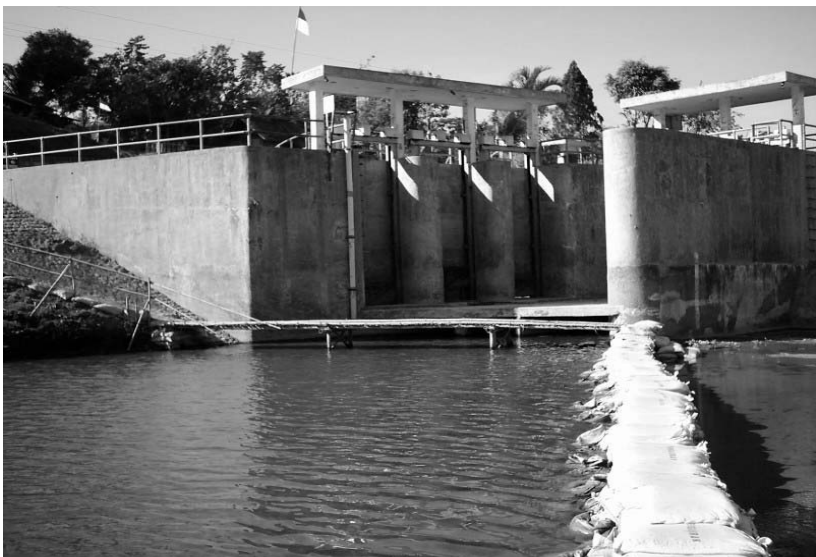
| Scheme | Kaligending | District | Kebumen |
|---|---|---|---|
| | | <u>Structure</u><br>Fixed Weir | |
| | | <u>Condition</u><br><input type="checkbox"/> A <input type="checkbox"/> B <input checked="" type="checkbox"/> C <input type="checkbox"/> D | |
| | | <u>Problems</u><br>Problem of water intake due to miss match of river and river water level | |

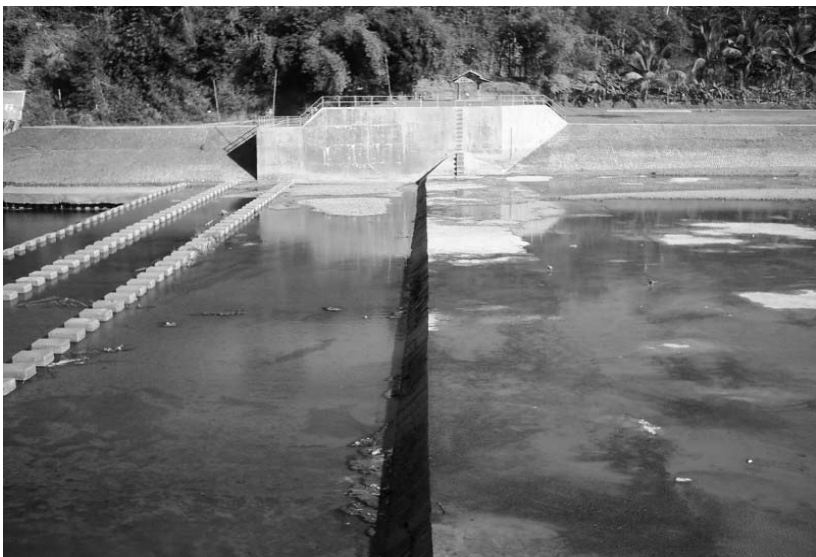
| Scheme | Kaligending | District | Kebumen |
|---|---|---|---|
| | | <u>Structure</u><br>Fixed Weir | |
| | | <u>Condition</u><br><input type="checkbox"/> A <input type="checkbox"/> B <input checked="" type="checkbox"/> C <input type="checkbox"/> D | |

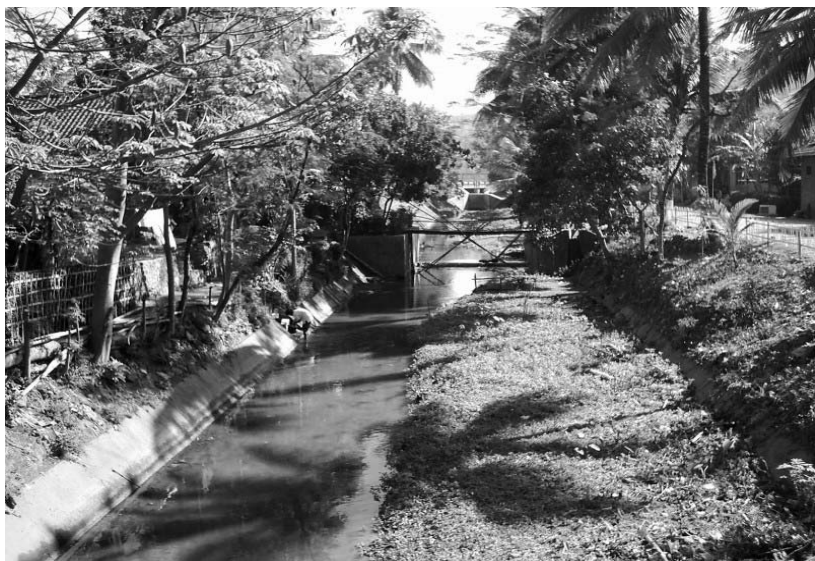
| Scheme | Kaligending | District | Kebumen |
|---|---|---|---|
| | | <u>Structure</u><br>Canal | |
| | | <u>Condition</u><br><input type="checkbox"/> A <input type="checkbox"/> B <input checked="" type="checkbox"/> C <input type="checkbox"/> D | |
| | | <u>Problems</u><br>Found sedimentation / debris at inside of canal | |

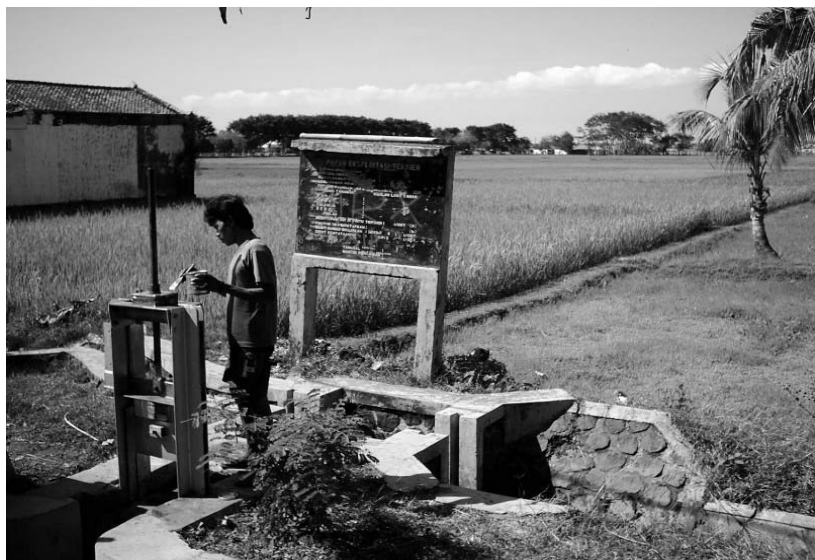
| Scheme | Kaligending | District | Kebumen |
|---|---|---|---|
| | | <u>Structure</u><br>Tertiary Box and Paddy Field | |
| | | <u>Condition</u><br><input type="checkbox"/> A <input checked="" type="checkbox"/> B <input type="checkbox"/> C <input type="checkbox"/> D | |

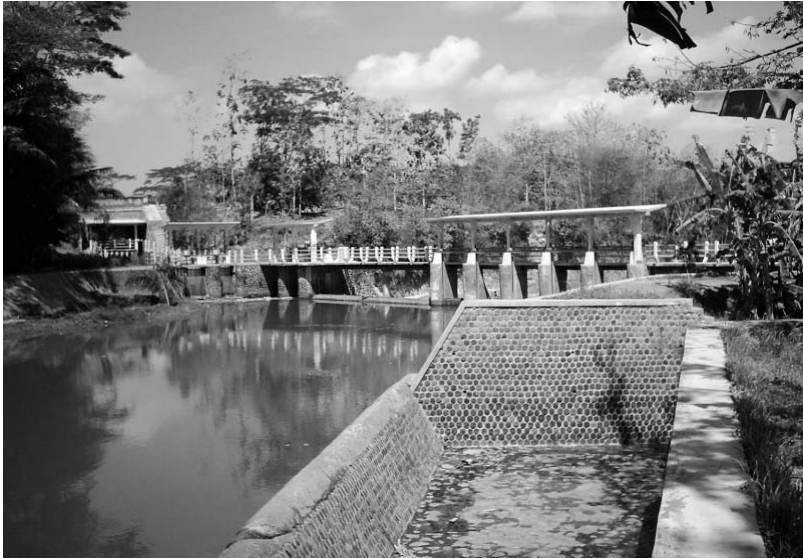
| Scheme | Pesucen | District | Kebumen |
|---|---|---|---|
| | | <u>Structure</u><br>Fixed Weir | |
| | | <u>Condition</u><br><input type="checkbox"/> A <input checked="" type="checkbox"/> B <input type="checkbox"/> C <input type="checkbox"/> D | |
| | | <u>Problems</u><br>Require repair of retaining wall | |

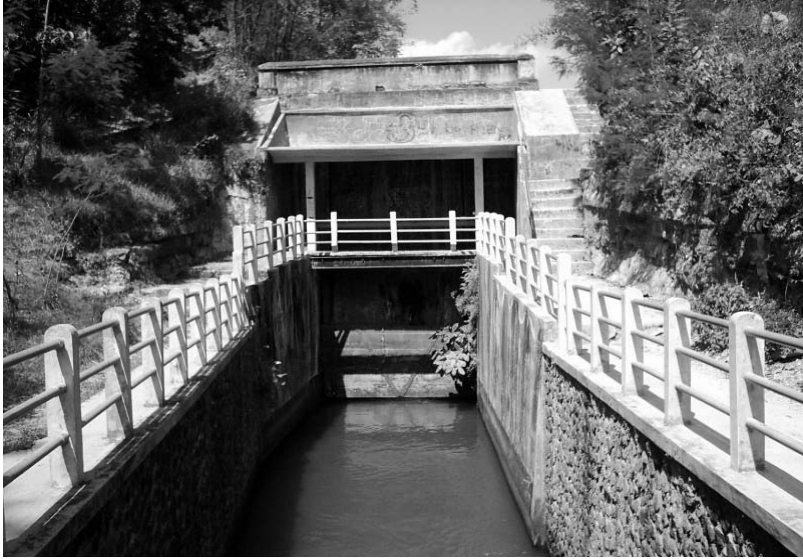
| Scheme | Pesucen | District | Kebumen |
|---|---|---|---|
| | | <u>Structure</u><br>Intake | |
| | | <u>Condition</u><br><input type="checkbox"/> A <input type="checkbox"/> B <input checked="" type="checkbox"/> C <input type="checkbox"/> D | |
| | | <u>Problems</u><br>Require replacement of gates | |

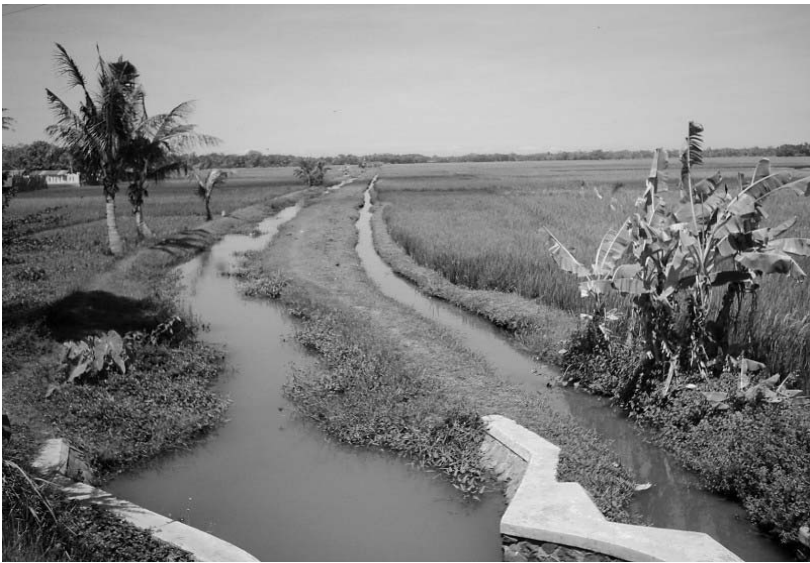
| Scheme | Pesucen | District | Kebumen |
|---|---|---|---|
| | | <u>Structure</u><br>Earth Canal | |
| | | <u>Problems</u><br>Require lining, inspection road | |

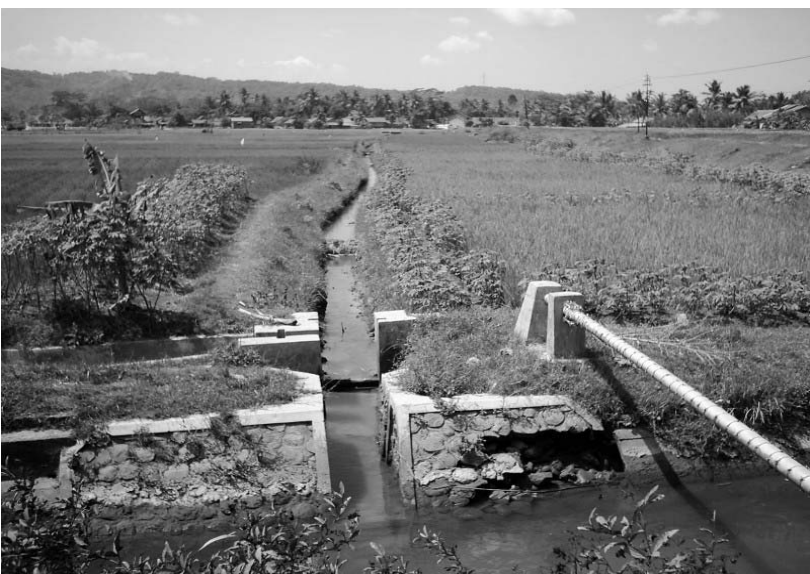
| Scheme | Pesucen | District | Kebumen |
|---|---|---|---|
| | | <u>Structure</u><br>Off-take Structure | |
| | | <u>Problems</u><br>Require minor repair and gate | |

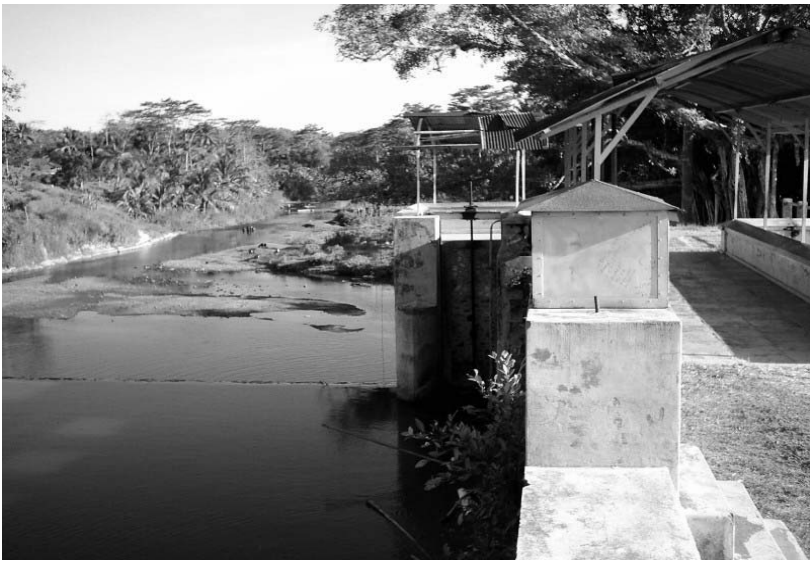
| Scheme | Bedegolan | District | Kebumen | | |
|---|---|---|---|---|---|
| | | <u>Structure</u><br>Fixed Weir | | | |
| | | <u>Problems</u><br>Require repair for weir and intake | | | |

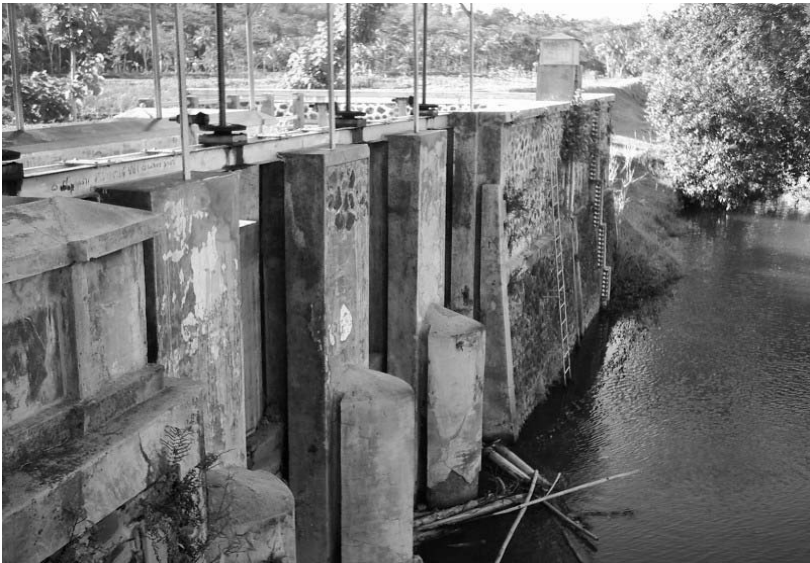
| Scheme | Bedegolan | District | Kebumen | | |
|---|---|---|---|---|---|
| | | <u>Structure</u><br>Intake | | | |
| | | <u>Problems</u><br>Require repair for weir and intake | | | |

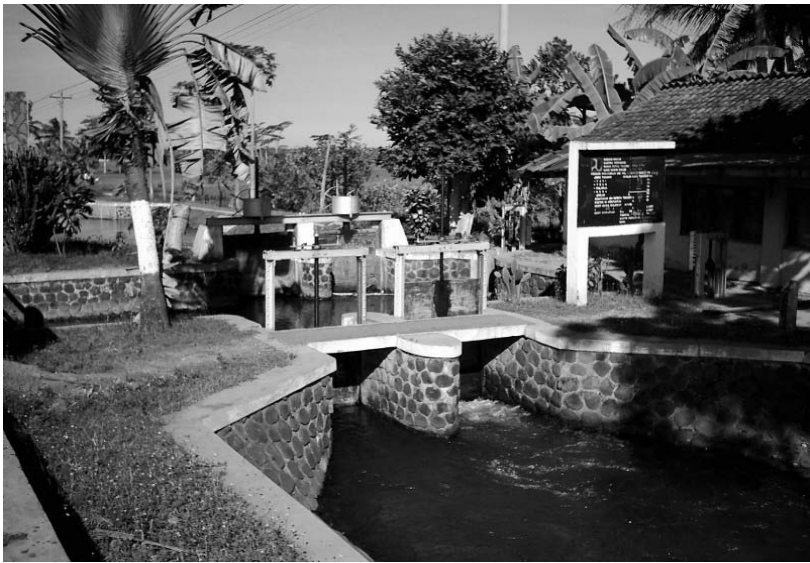
| Scheme | Bedegolan | District | Kebumen | | |
|---|---|---|---|---|---|
| | | <u>Structure</u><br>Division Structure | | | |
| | | <u>Problems</u><br>Require minor repair | | | |

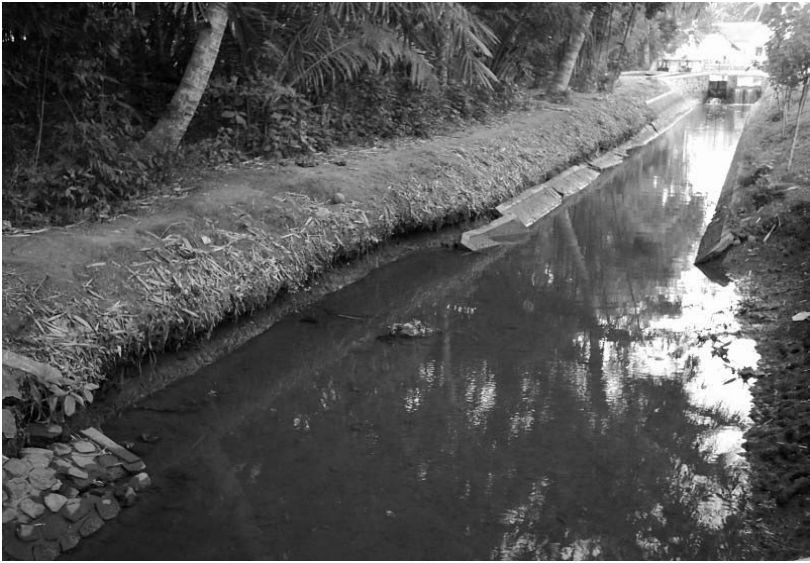
| Scheme | Bedegolan | District | Kebumen | | |
|---|---|---|---|---|---|
| | | <u>Structure</u><br>Lined Canal | | | |
| | | <u>Problems</u><br>Require major repair for lining | | | |
