The Study on Comprehensive Recovery Program
of Irrigation Agriculture

Japan International Cooperation Agency

**Location Map of Irrigation Schemes
in Purworejo District**

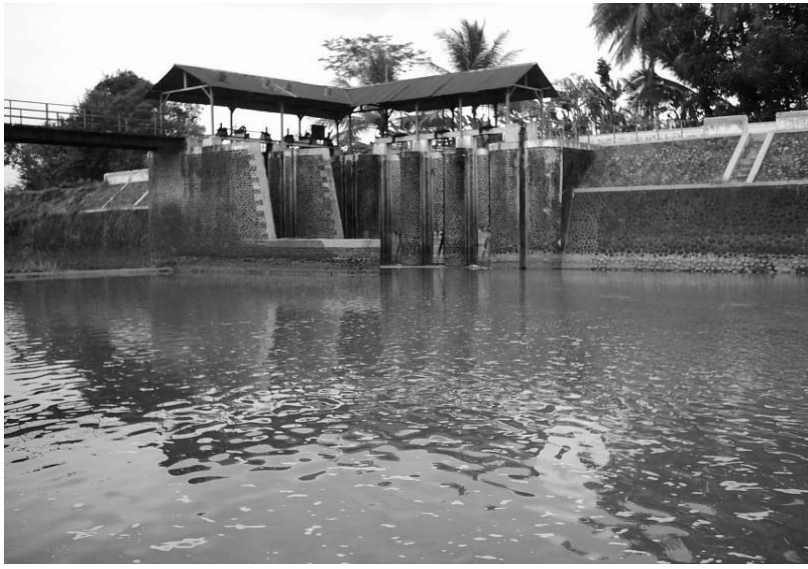
<i>Category</i> Irrigation (Headworks)		
		<i>Structure</i> Fixed Weir, Upstream		
		<i>Condition</i> <input type="checkbox"/> A <input type="checkbox"/> B <input checked="" type="checkbox"/> C <input type="checkbox"/> D

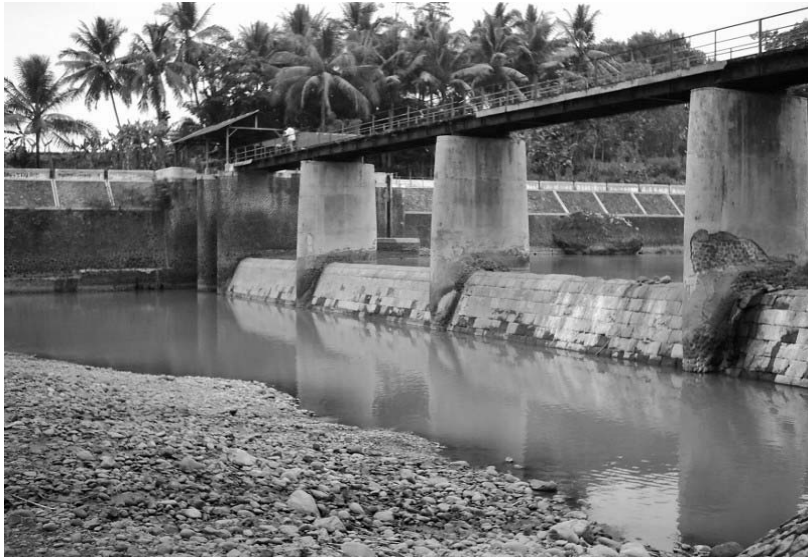
<i>Category</i> Irrigation (Headworks)		
		<i>Structure</i> Fixed Weir, Downstream		
		<i>Condition</i> <input type="checkbox"/> A <input type="checkbox"/> B <input checked="" type="checkbox"/> C <input type="checkbox"/> D

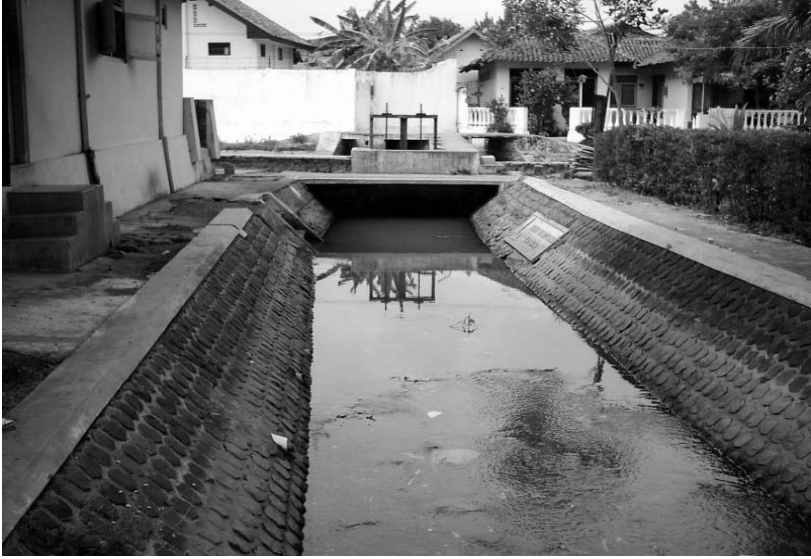
<p><u>Category</u> Irrigation (Secondary Canal)</p>	
		<p><u>Structure</u> Lined Canal and Division Structure</p>	
		<p><u>Condition</u> <input type="checkbox"/> A <input type="checkbox"/> B <input checked="" type="checkbox"/> C <input type="checkbox"/> D</p>	
		<p><u>Problems</u> Require provision of inspection road</p>

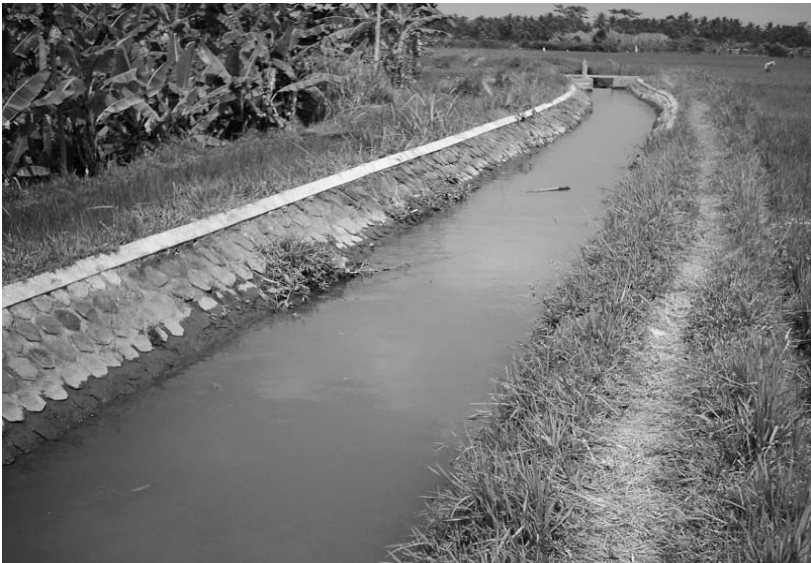
<p><u>Category</u> Irrigation (Secondary Canal)</p>	
		<p><u>Structure</u> Lined Canal</p>	
		<p><u>Condition</u> <input type="checkbox"/> A <input type="checkbox"/> B <input checked="" type="checkbox"/> C <input type="checkbox"/> D</p>	
		<p><u>Problems</u> Require widening of inspection road</p>

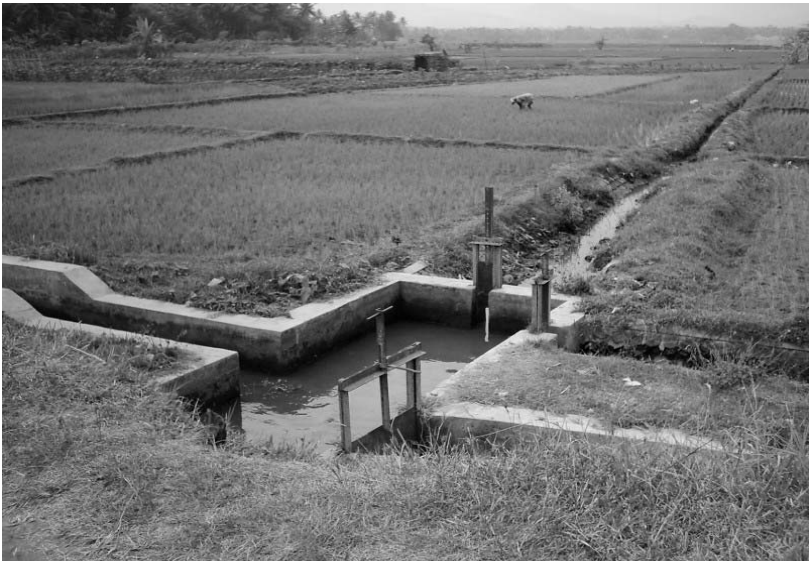
<p><u>Category</u> Irrigation (Paddy Field)</p>	
		<p><u>Structure</u> Division Box</p>	
		<p><u>Condition</u> <input type="checkbox"/> A <input type="checkbox"/> B <input checked="" type="checkbox"/> C <input type="checkbox"/> D</p>

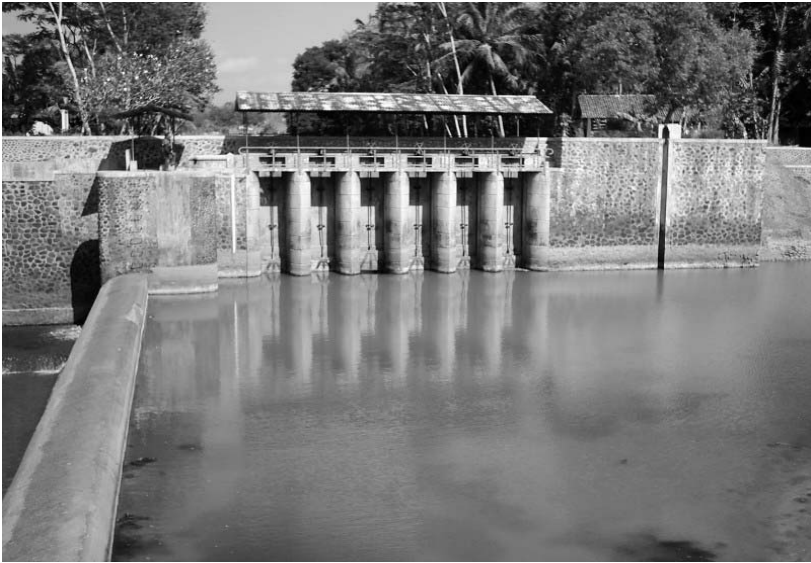
<i>Category</i> Irrigation (Headworks)		
		<i>Structure</i> Fixed Weir, Upstream		
		<i>Condition</i> <input type="checkbox"/> A <input type="checkbox"/> B <input checked="" type="checkbox"/> C <input type="checkbox"/> D		
		<i>Problems</i> Require repair of weir body and gate works

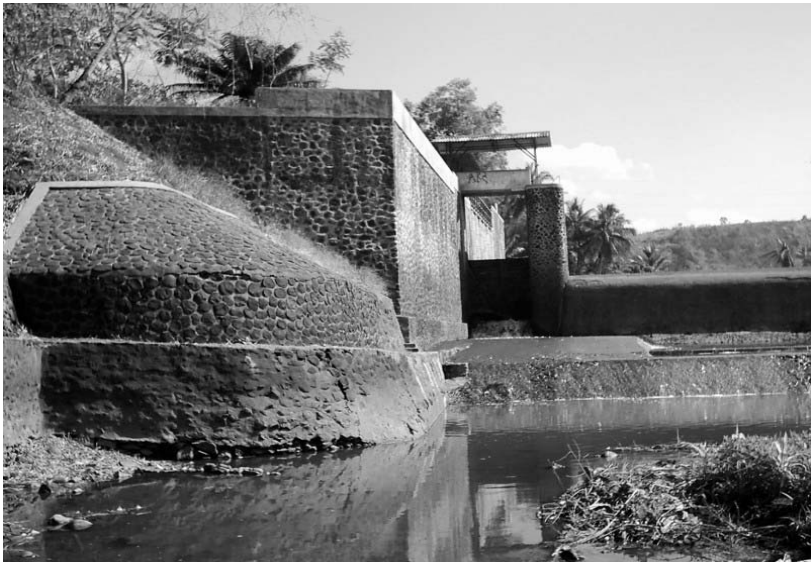
<i>Category</i> Irrigation (Headworks)		
		<i>Structure</i> Fixed Weir, Downstream		
		<i>Condition</i> <input type="checkbox"/> A <input type="checkbox"/> B <input checked="" type="checkbox"/> C <input type="checkbox"/> D		
		<i>Problems</i> Require repair of retaining wall

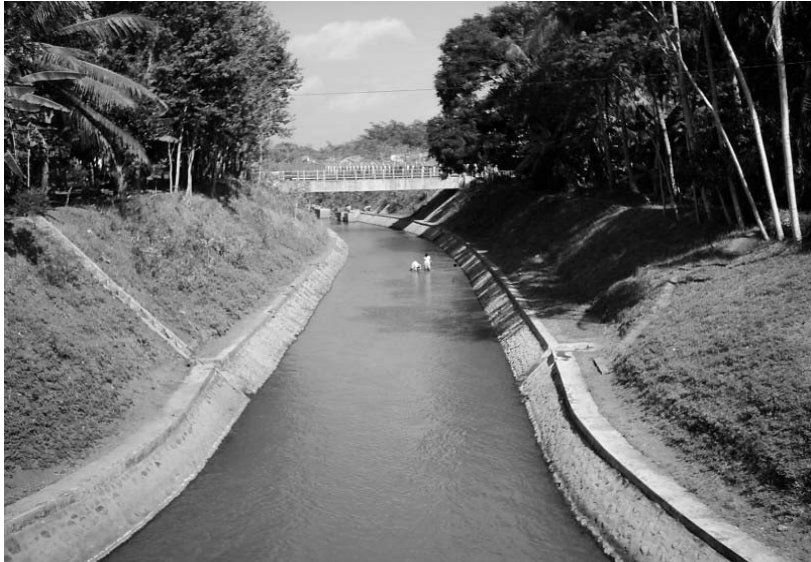
<i>Category</i> Irrigation (Main Canal)		
		<i>Structure</i> Lined Canal		
		<i>Condition</i> <input type="checkbox"/> A <input checked="" type="checkbox"/> B <input type="checkbox"/> C <input type="checkbox"/> D		
		<i>Problems</i> Require minor repair

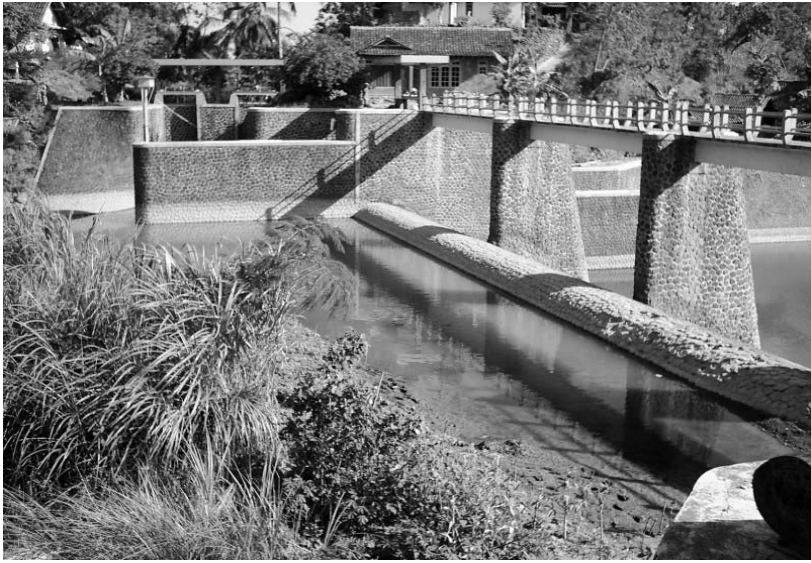
<i>Category</i> Irrigation (Headworks)		
		<i>Structure</i> Fixed Weir, Upstream		
		<i>Condition</i> <input type="checkbox"/> A <input type="checkbox"/> B <input checked="" type="checkbox"/> C <input type="checkbox"/> D		
		<i>Problems</i> Require repair for civil and gate works and removal of sediment

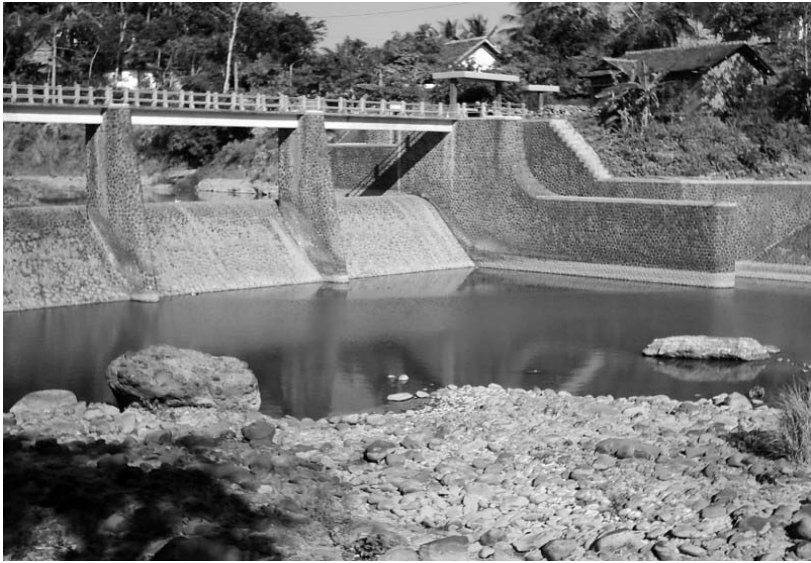
<i>Category</i> Irrigation (Headworks)		
		<i>Structure</i> Fixed Weir, Downstream		
		<i>Condition</i> <input type="checkbox"/> A <input type="checkbox"/> B <input checked="" type="checkbox"/> C <input type="checkbox"/> D		
		<i>Problems</i> Require repair for civil and gate works and removal of sediment

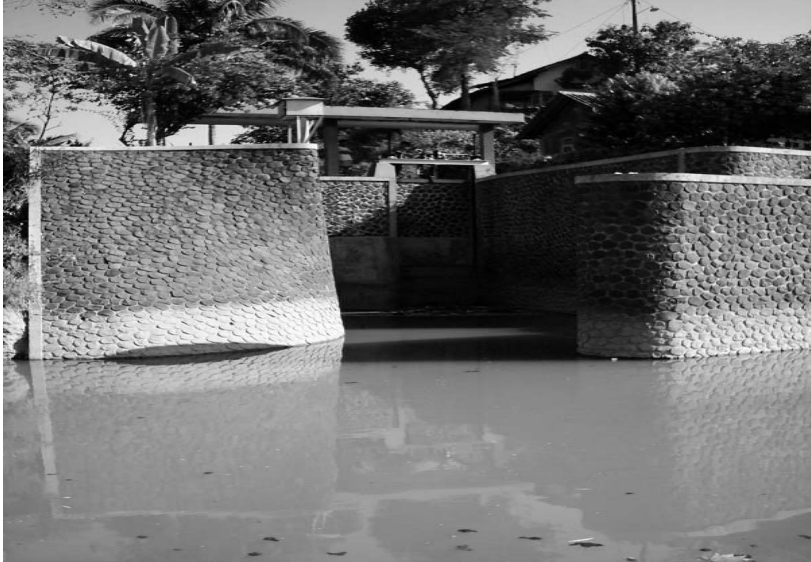
<i>Category</i> Irrigation (Headworks)		
		<i>Structure</i> Intake		
		<i>Condition</i> <input type="checkbox"/> A <input type="checkbox"/> B <input checked="" type="checkbox"/> C <input type="checkbox"/> D

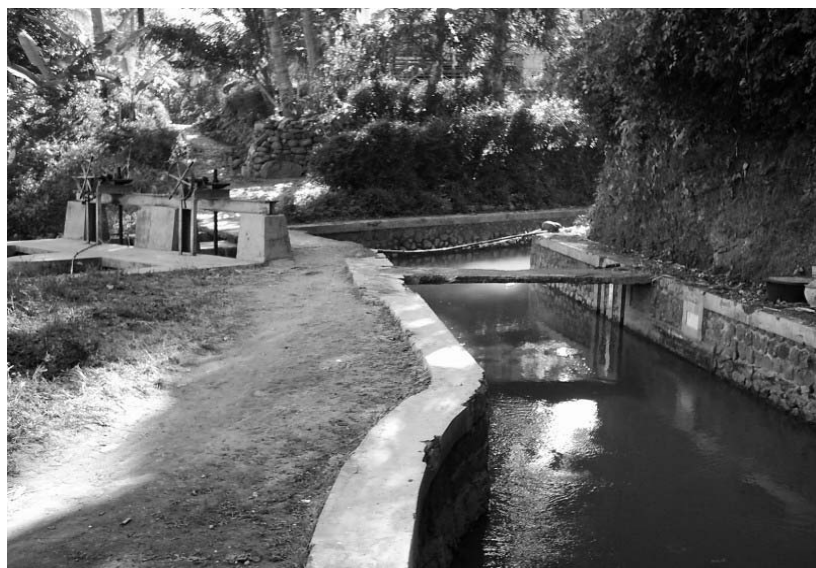
<p><u>Category</u> Irrigation (Main Canal)</p>		
		<p><u>Structure</u> Lined Canal and Division Structure</p>		
		<p><u>Condition</u> <input type="checkbox"/> A <input type="checkbox"/> B <input type="checkbox"/> C <input checked="" type="checkbox"/> D</p>

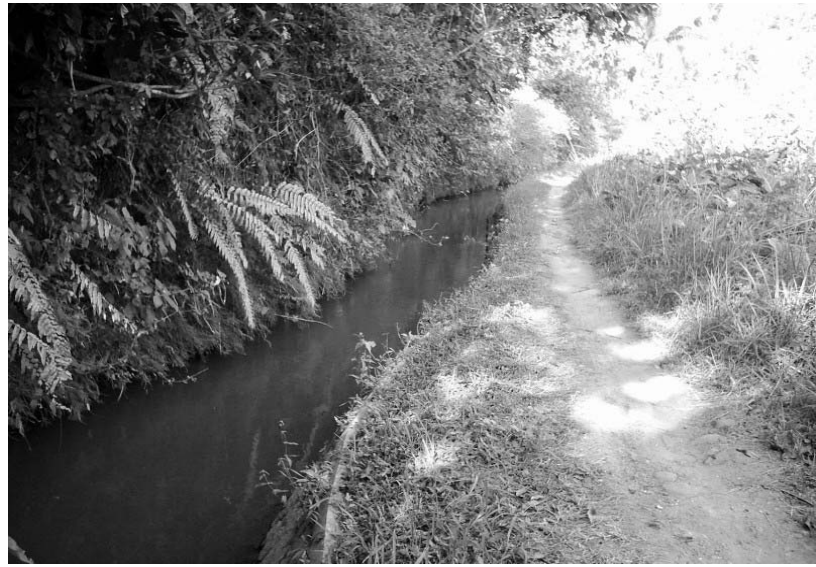
<p><u>Category</u> Irrigation (Main Canal)</p>		
		<p><u>Structure</u> Earth Canal</p>		
		<p><u>Condition</u> <input type="checkbox"/> A <input type="checkbox"/> B <input type="checkbox"/> C <input checked="" type="checkbox"/> D</p>

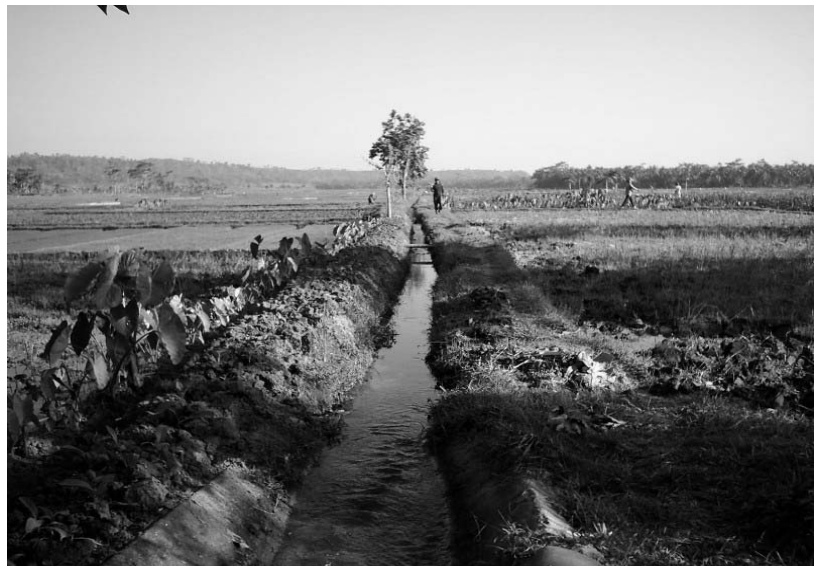
<p><u>Category</u> Irrigation (Paddy Field)</p>		
		<p><u>Structure</u> Tertiary Canal and Paddy Field</p>		
		<p><u>Condition</u> <input type="checkbox"/> A <input type="checkbox"/> B <input type="checkbox"/> C <input checked="" type="checkbox"/> D</p>		
		<p><u>Problems</u> Require provision of division structure with gate</p>

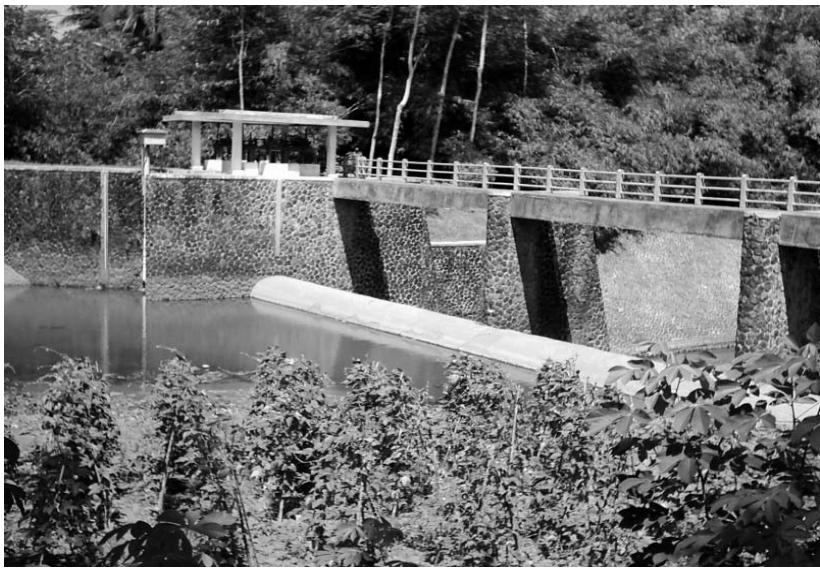
<i>Category</i> Irrigation (Headworks)		
		<i>Structure</i> Fixed Weir		
		<i>Condition</i> <input type="checkbox"/> A <input type="checkbox"/> B <input checked="" type="checkbox"/> C <input type="checkbox"/> D		
		<i>Problems</i> Require removal of sediment in front of weir and intake

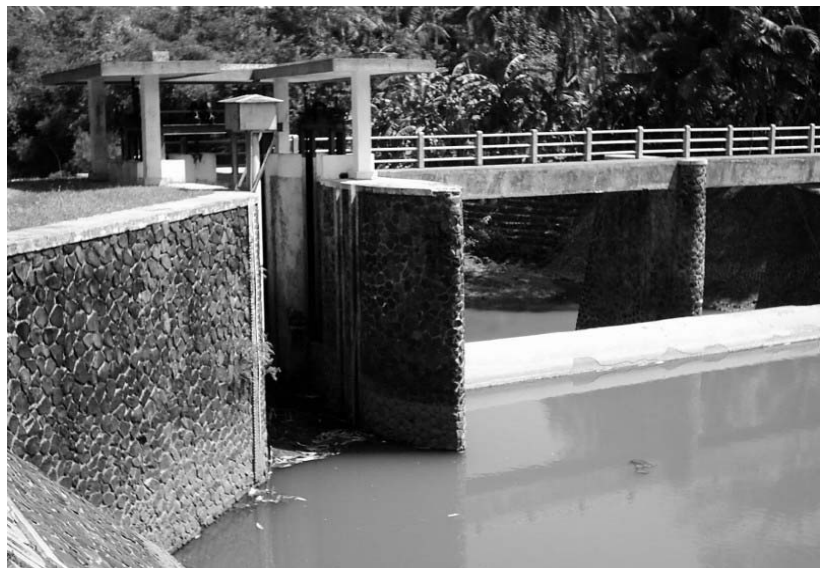
<i>Category</i> Irrigation (Headworks)		
		<i>Structure</i> Fixed Weir		
		<i>Condition</i> <input type="checkbox"/> A <input type="checkbox"/> B <input checked="" type="checkbox"/> C <input type="checkbox"/> D		
		<i>Problems</i> Require removal of sediment in front of weir and intake

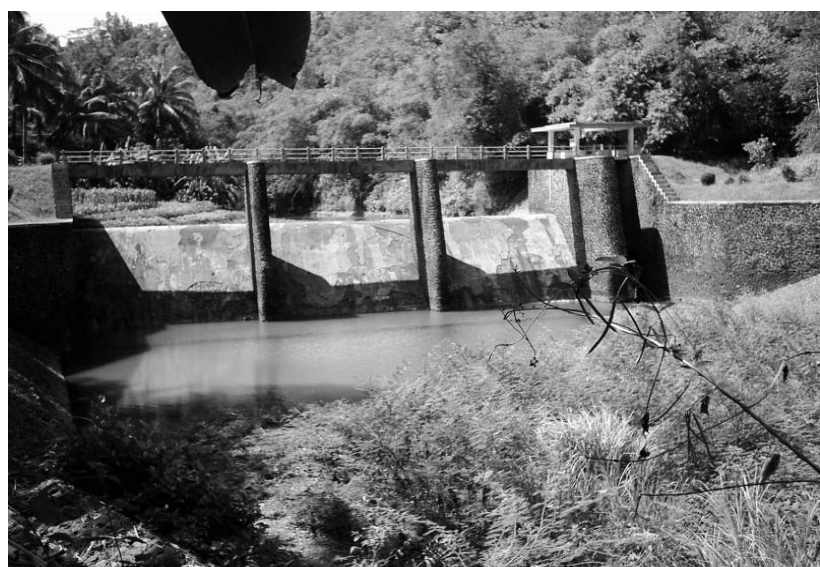
<i>Category</i> Irrigation (Headworks)		
		<i>Structure</i> Fixed Weir, Downstream		
		<i>Condition</i> <input type="checkbox"/> A <input type="checkbox"/> B <input checked="" type="checkbox"/> C <input type="checkbox"/> D

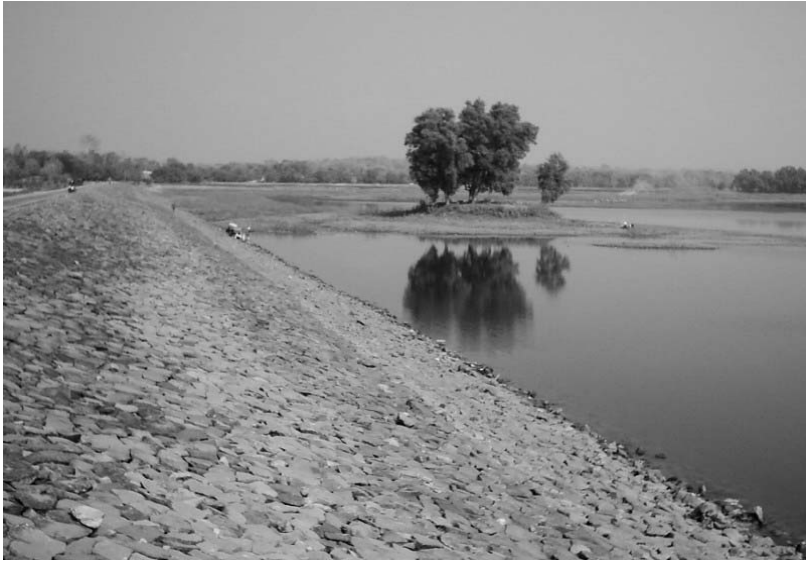
<p><u>Category</u> Irrigation (Dam)</p> <hr/> <p><u>Structure</u> Dam and Reservoir</p> <hr/> <p><u>Condition</u> <input checked="" type="checkbox"/> A <input type="checkbox"/> B <input type="checkbox"/> C <input type="checkbox"/> D</p> <hr/> <p><u>Problems</u> In good condition</p>

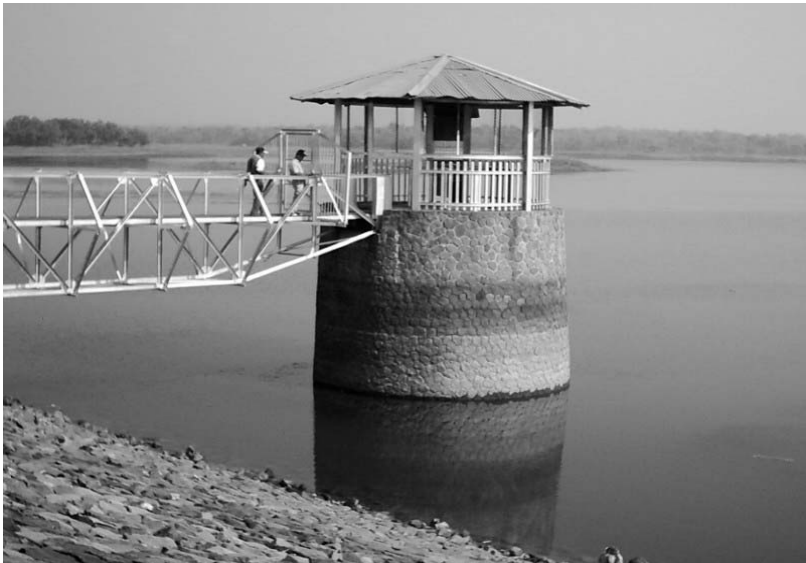
<p><u>Category</u> Irrigation (Dam)</p> <hr/> <p><u>Structure</u> Intake Tower</p> <hr/> <p><u>Condition</u> <input checked="" type="checkbox"/> A <input type="checkbox"/> B <input type="checkbox"/> C <input type="checkbox"/> D</p> <hr/> <p><u>Problems</u> In good condition</p>

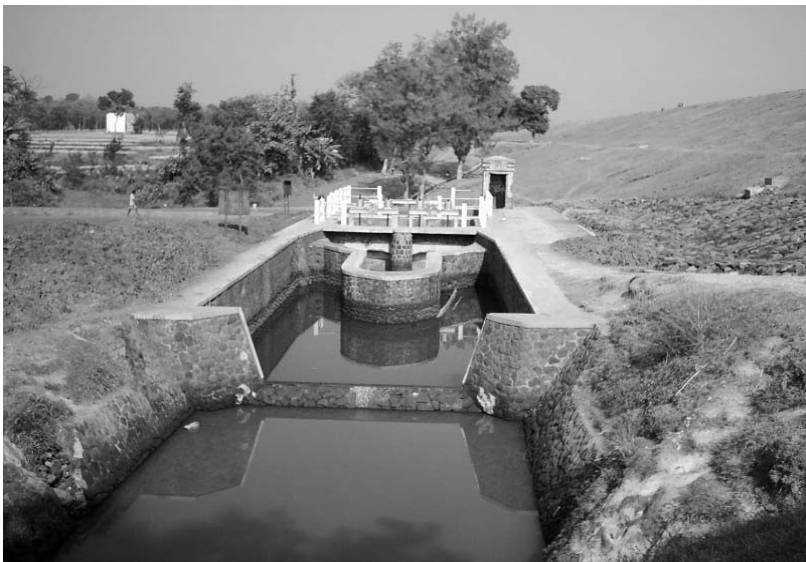
<p><u>Category</u> Irrigation (Dam)</p> <hr/> <p><u>Structure</u> Outlet of Intake</p> <hr/> <p><u>Condition</u> <input checked="" type="checkbox"/> A <input type="checkbox"/> B <input type="checkbox"/> C <input type="checkbox"/> D</p> <hr/> <p><u>Problems</u> In good condition</p>

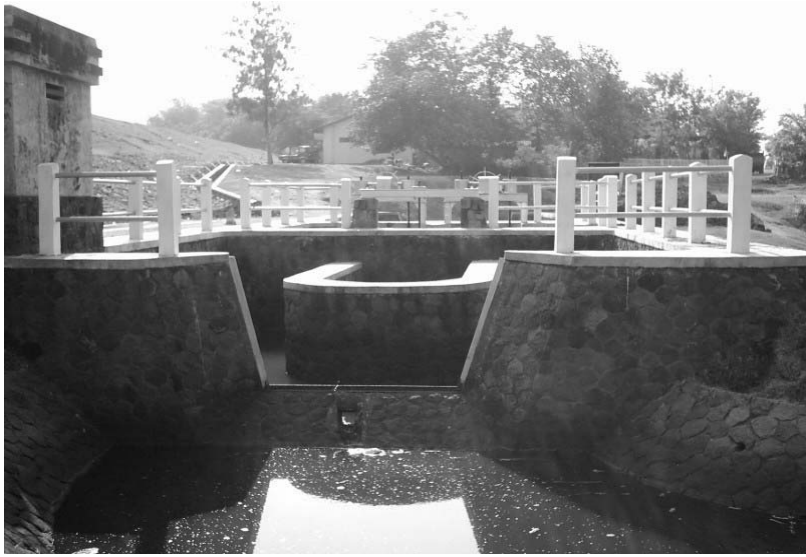
<u>Category</u> Irrigation (Dam)	
		<u>Structure</u> Outlet of Intake, Measuring Device	
		<u>Condition</u> <input checked="" type="checkbox"/> A <input type="checkbox"/> B <input type="checkbox"/> C <input type="checkbox"/> D	
		<u>Problems</u> In good condition

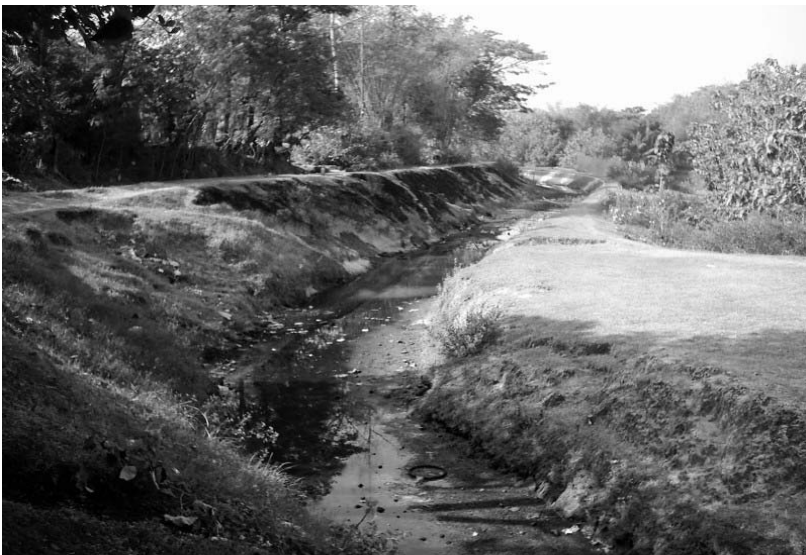
<u>Category</u> Irrigation (Main Canal)	
		<u>Structure</u> Lined Canal	
		<u>Condition</u> <input type="checkbox"/> A <input type="checkbox"/> B <input checked="" type="checkbox"/> C <input type="checkbox"/> D	
		<u>Problems</u> Require major repair work

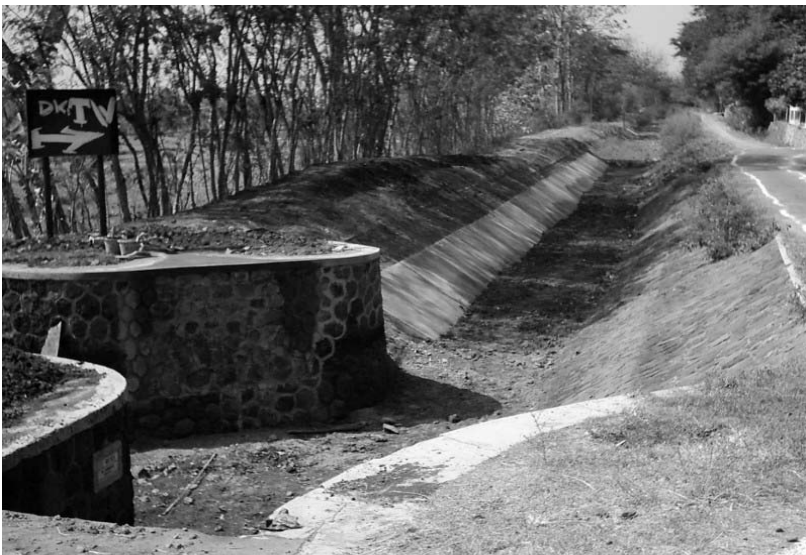
<u>Category</u> Irrigation (Secondary Canal)	
		<u>Structure</u> Lined Canal	
		<u>Condition</u> <input type="checkbox"/> A <input type="checkbox"/> B <input checked="" type="checkbox"/> C <input type="checkbox"/> D	
		<u>Problems</u> Require major repair work for canal and structure

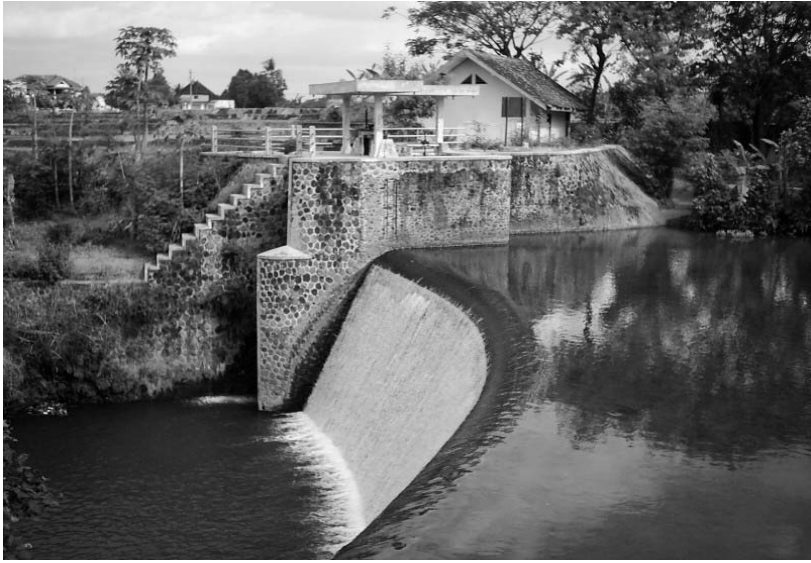
<i>Category</i> Irrigation (Headworks)		
		<i>Structure</i> Fixed Weir, Upstream		
		<i>Condition</i> <input type="checkbox"/> A <input checked="" type="checkbox"/> B <input type="checkbox"/> C <input type="checkbox"/> D		
		<i>Problems</i> Require minor repair for civil and gate works

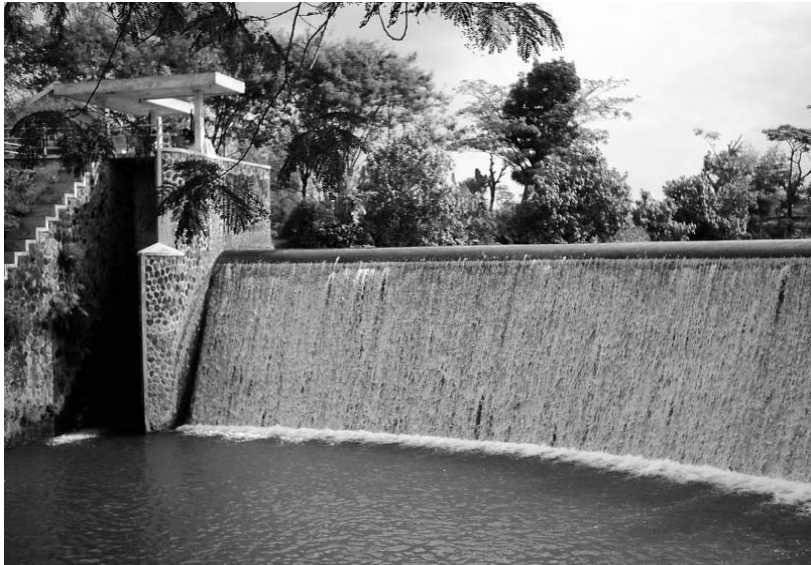
<i>Category</i> Irrigation (Headworks)		
		<i>Structure</i> Fixed Weir, Downstream		
		<i>Condition</i> <input type="checkbox"/> A <input checked="" type="checkbox"/> B <input type="checkbox"/> C <input type="checkbox"/> D		
		<i>Problems</i> Require minor repair for civil and gate works

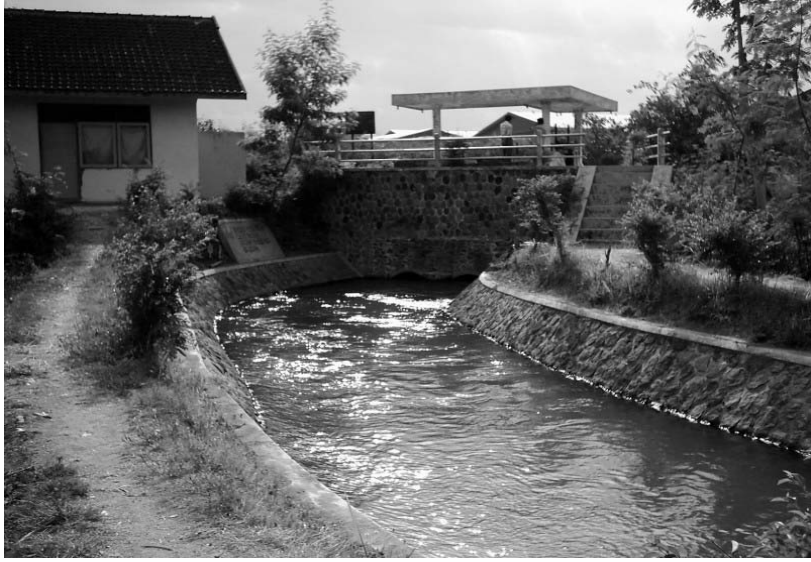
<i>Category</i> Irrigation (Headworks)		
		<i>Structure</i> Intake		
		<i>Condition</i> <input type="checkbox"/> A <input checked="" type="checkbox"/> B <input type="checkbox"/> C <input type="checkbox"/> D

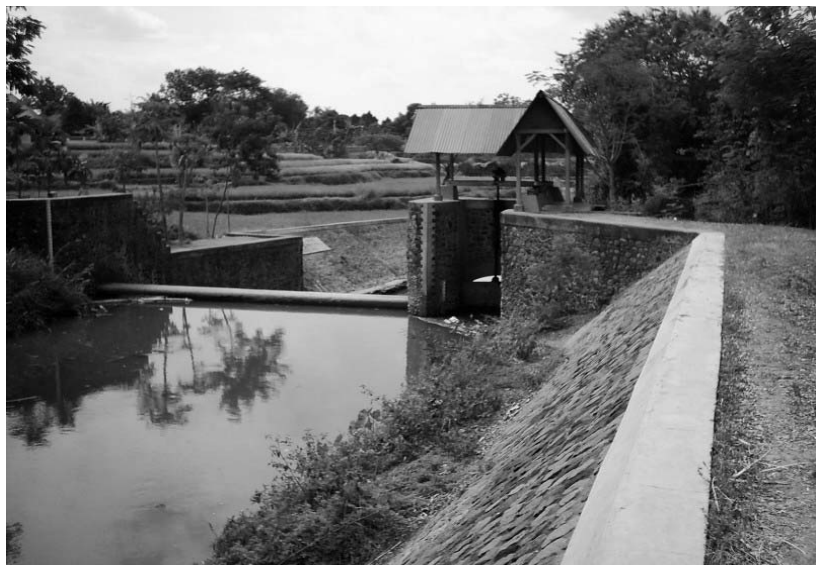
<i>Category</i> Irrigation (Headworks)			
		<i>Structure</i> Fixed Weir			
		<i>Condition</i> <input type="checkbox"/> A <input type="checkbox"/> B <input checked="" type="checkbox"/> C <input type="checkbox"/> D			
		<i>Problems</i> Require repair of civil and gate works

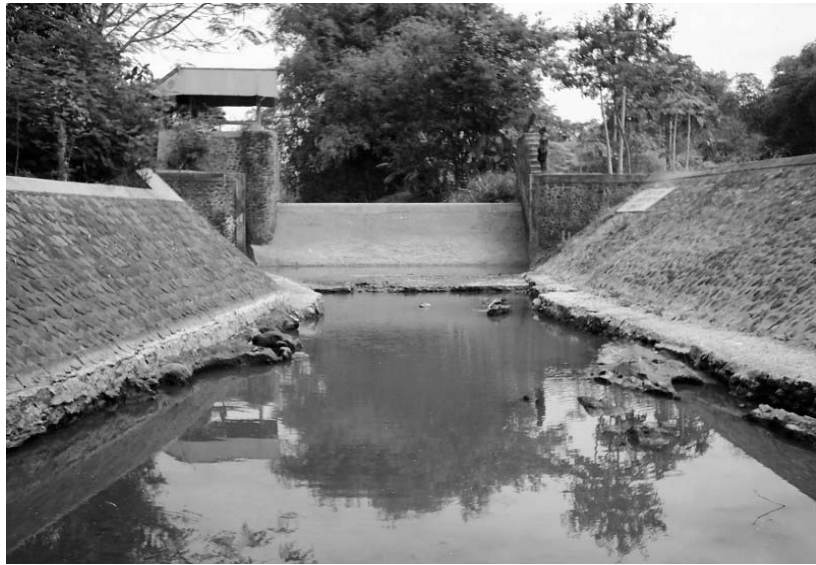
<i>Category</i> Irrigation (Headworks)			
		<i>Structure</i> Fixed Weir			
		<i>Condition</i> <input type="checkbox"/> A <input type="checkbox"/> B <input checked="" type="checkbox"/> C <input type="checkbox"/> D			
		<i>Problems</i> Require repair of civil and gate works

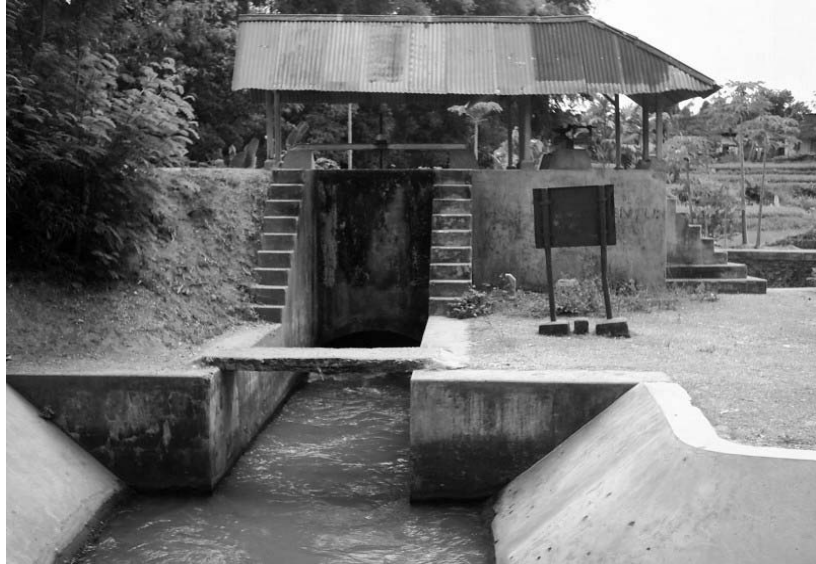
<i>Category</i> Irrigation (Headworks)			
		<i>Structure</i> Intake			
		<i>Condition</i> <input type="checkbox"/> A <input type="checkbox"/> B <input checked="" type="checkbox"/> C <input type="checkbox"/> D			
		<i>Problems</i> Require repair of civil and gate works

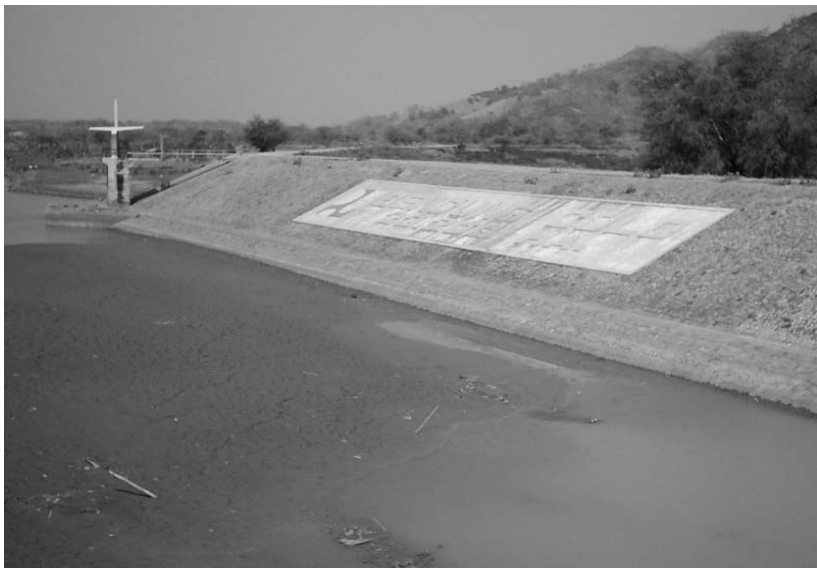
<i>Category</i> Irrigation (Headworks)		
		<i>Structure</i> Fixed Weir, Upstream		
		<i>Condition</i> <input type="checkbox"/> A <input type="checkbox"/> B <input checked="" type="checkbox"/> C <input type="checkbox"/> D		
		<i>Problems</i> Require remove of sediment in front of intake and weir

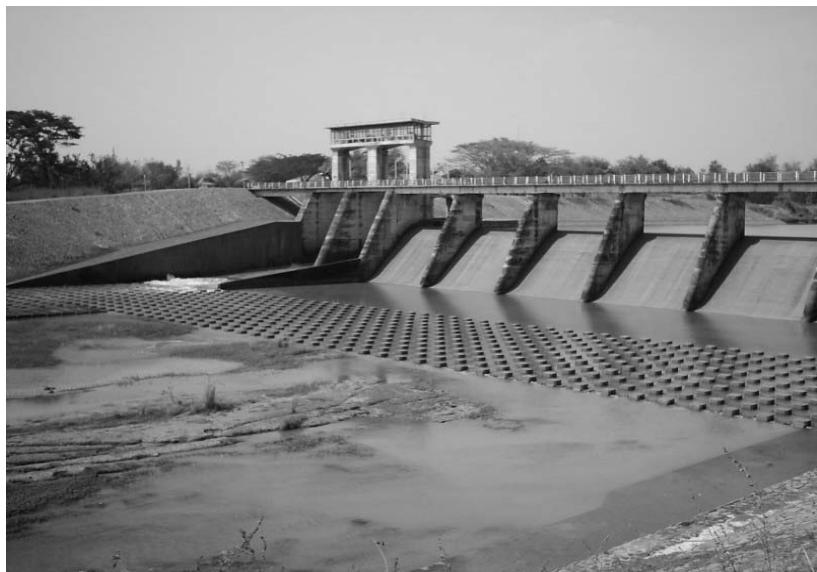
<i>Category</i> Irrigation (Headworks)		
		<i>Structure</i> Fixed Weir, Downstream		
		<i>Condition</i> <input type="checkbox"/> A <input checked="" type="checkbox"/> B <input type="checkbox"/> C <input type="checkbox"/> D		
		<i>Problems</i> Require minor repair of structure

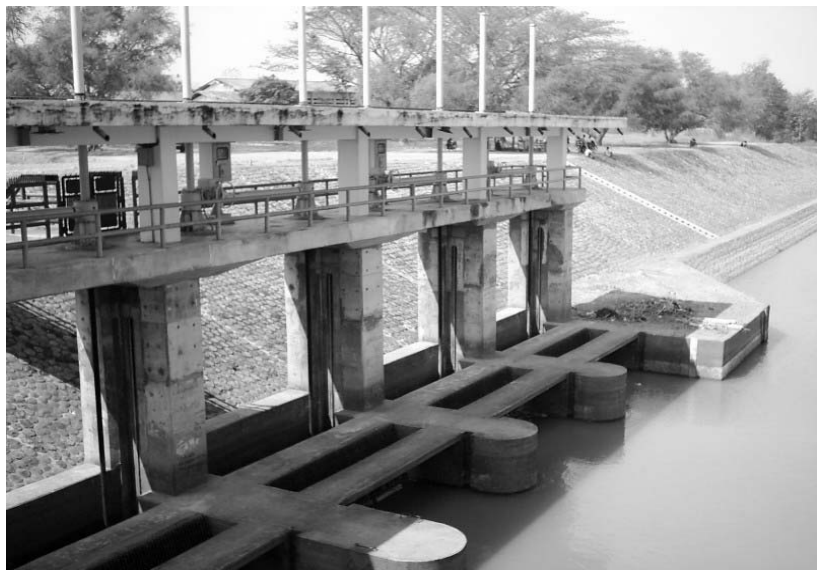
<i>Category</i> Irrigation (Headworks)		
		<i>Structure</i> Intake		
		<i>Condition</i> <input type="checkbox"/> A <input type="checkbox"/> B <input checked="" type="checkbox"/> C <input type="checkbox"/> D

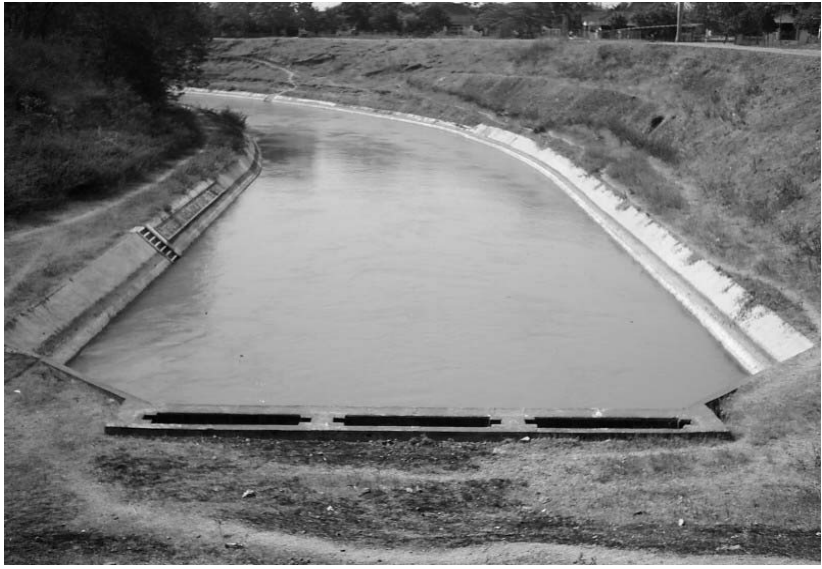
<i>Category</i> Irrigation (Main Canal)			
		<i>Structure</i> Lined Canal			
		<i>Condition</i> <input type="checkbox"/> A <input type="checkbox"/> B <input checked="" type="checkbox"/> C <input type="checkbox"/> D			
		<i>Problems</i> Require repair of embankment slope

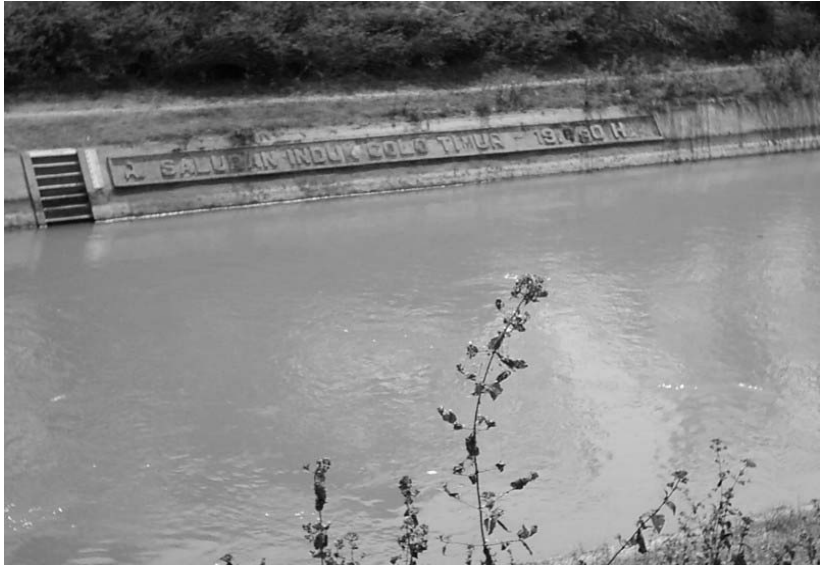
<i>Category</i> Irrigation (Main Canal)			
		<i>Structure</i> Lined Canal			
		<i>Condition</i> <input type="checkbox"/> A <input type="checkbox"/> B <input checked="" type="checkbox"/> C <input type="checkbox"/> D			
		<i>Problems</i> Require lining, removal of sediment and debris from inside of canal

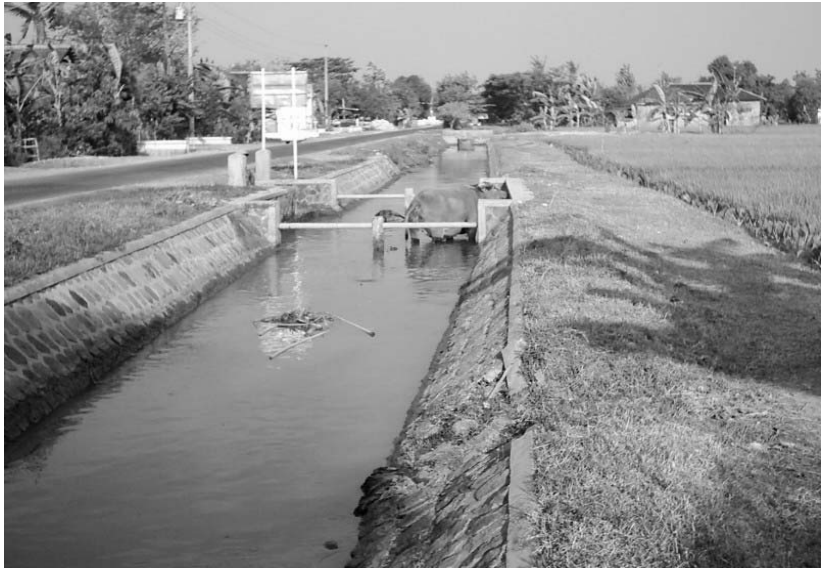
<i>Category</i> Irrigation (Secondary Canal)			
		<i>Structure</i> Canal and Paddy Field			
		<i>Condition</i> <input type="checkbox"/> A <input type="checkbox"/> B <input checked="" type="checkbox"/> C <input type="checkbox"/> D

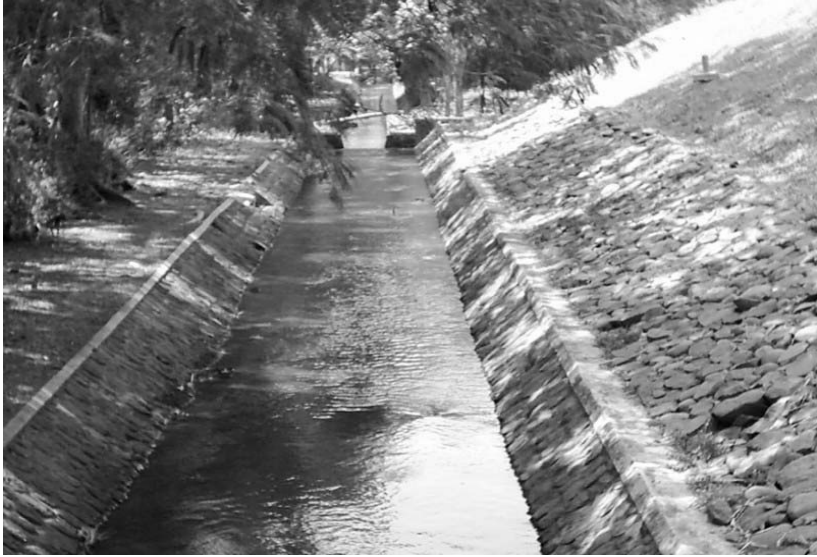
<p><u>Category</u> Irrigation (Secondary Canal)</p>			
		<p><u>Structure</u> Division Structure</p>			
		<p><u>Condition</u> <input type="checkbox"/> A <input type="checkbox"/> B <input checked="" type="checkbox"/> C <input type="checkbox"/> D</p>			
		<p><u>Problems</u> Require provision of inspection road</p>

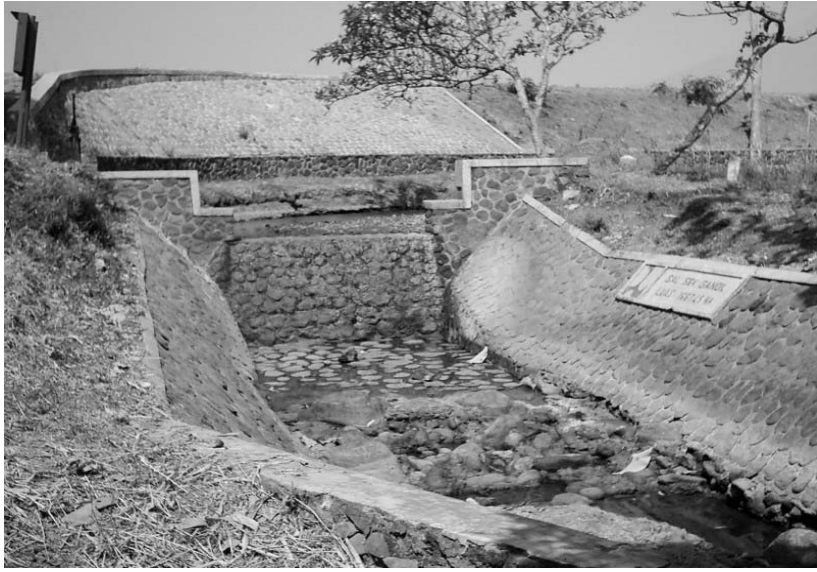
<p><u>Category</u> Irrigation (Secondary Canal)</p>			
		<p><u>Structure</u> Drop</p>			
		<p><u>Condition</u> <input type="checkbox"/> A <input type="checkbox"/> B <input checked="" type="checkbox"/> C <input type="checkbox"/> D</p>			
		<p><u>Problems</u> Require major repair for lining</p>

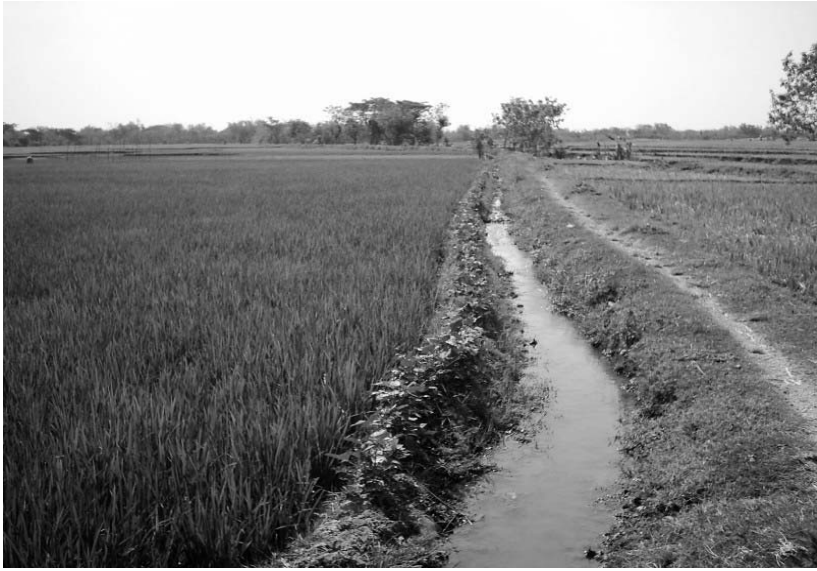
<p><u>Category</u> Irrigation (Tertiary Canal)</p>			
		<p><u>Structure</u> Canal and Paddy Field</p>			
		<p><u>Condition</u> <input type="checkbox"/> A <input type="checkbox"/> B <input checked="" type="checkbox"/> C <input type="checkbox"/> D</p>

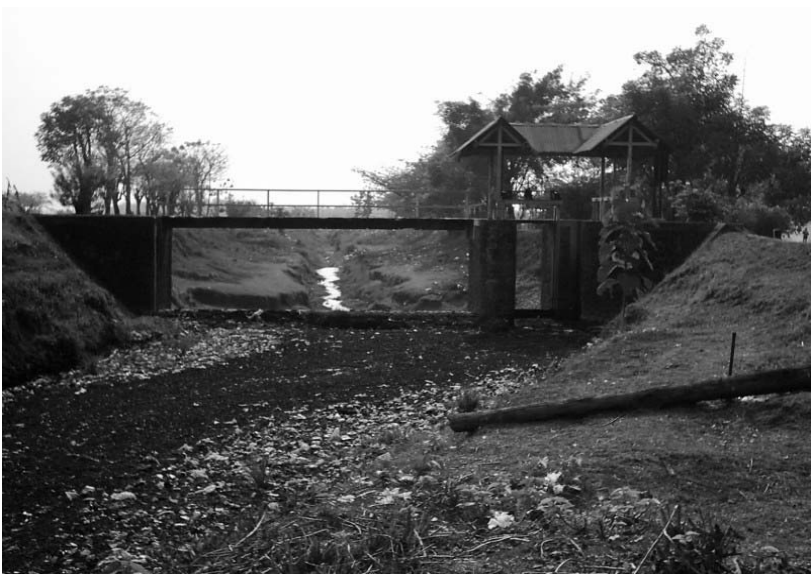
<u>Category</u> Irrigation (Headworks)			
				<u>Structure</u> Fixed Weir, Upstream			
				<u>Condition</u> <input type="checkbox"/> A <input type="checkbox"/> B <input checked="" type="checkbox"/> C <input type="checkbox"/> D			
				<u>Problems</u> Require repair of weir body and gate works, removal of debris and sediment			
 				<u>Category</u> Irrigation (Headworks)			
				<u>Structure</u> Fixed Weir, Downstream			
				<u>Condition</u> <input type="checkbox"/> A <input type="checkbox"/> B <input checked="" type="checkbox"/> C <input type="checkbox"/> D			
				<u>Problems</u> Require repair of weir body and gate works, provision of retaining wall			
 				<u>Category</u> Irrigation (Secondary Canal)			
				<u>Structure</u> Canal			
				<u>Condition</u> <input type="checkbox"/> A <input type="checkbox"/> B <input checked="" type="checkbox"/> C <input type="checkbox"/> D

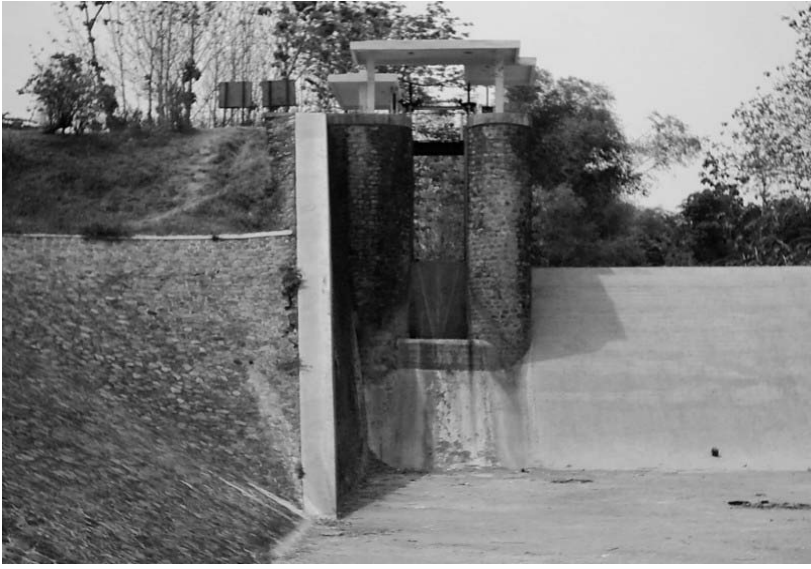
<i>Category</i> Irrigation (Headworks)		
		<i>Structure</i> Fixed Weir, Upstream		
		<i>Condition</i> <input type="checkbox"/> A <input type="checkbox"/> B <input checked="" type="checkbox"/> C <input type="checkbox"/> D

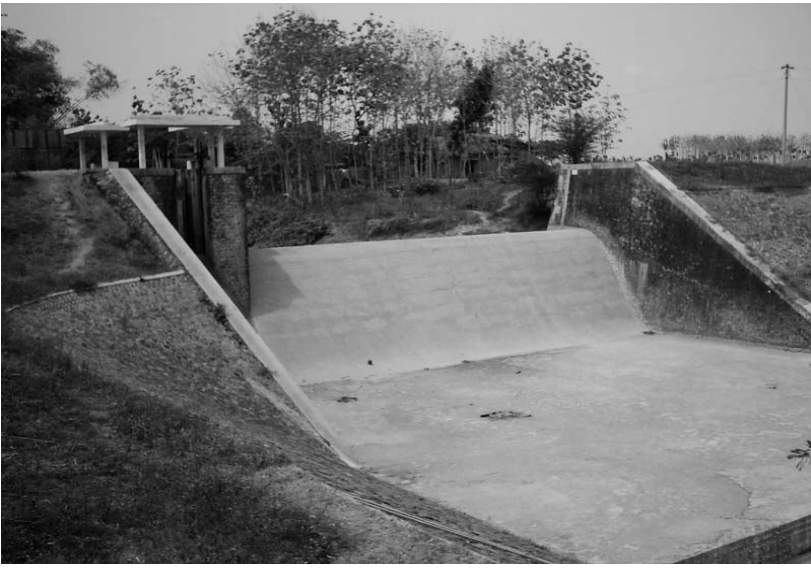
<i>Category</i> Irrigation (Headworks)		
		<i>Structure</i> Fixed Weir, Downstream		
		<i>Condition</i> <input type="checkbox"/> A <input type="checkbox"/> B <input checked="" type="checkbox"/> C <input type="checkbox"/> D

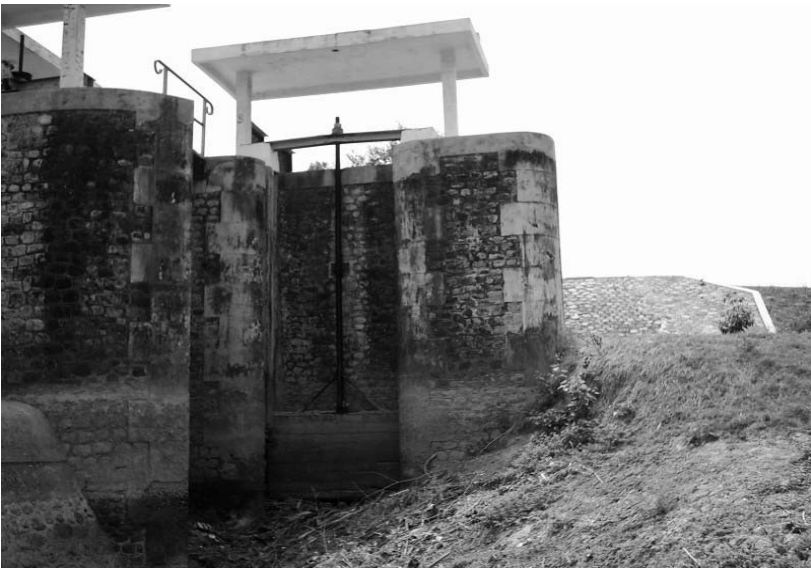
<i>Category</i> Irrigation (Headworks)		
		<i>Structure</i> Intake		
		<i>Condition</i> <input type="checkbox"/> A <input type="checkbox"/> B <input checked="" type="checkbox"/> C <input type="checkbox"/> D		
		<i>Problems</i> Require repair of body and gate works, removal of sediment in front of intake		
		<i>Problems</i> Require repair of retaining wall
