The Study on Comprehensive Recovery Program
of Irrigation Agriculture

Japan International Cooperation Agency

**Location Map of Irrigation Schemes
in Purworejo District**

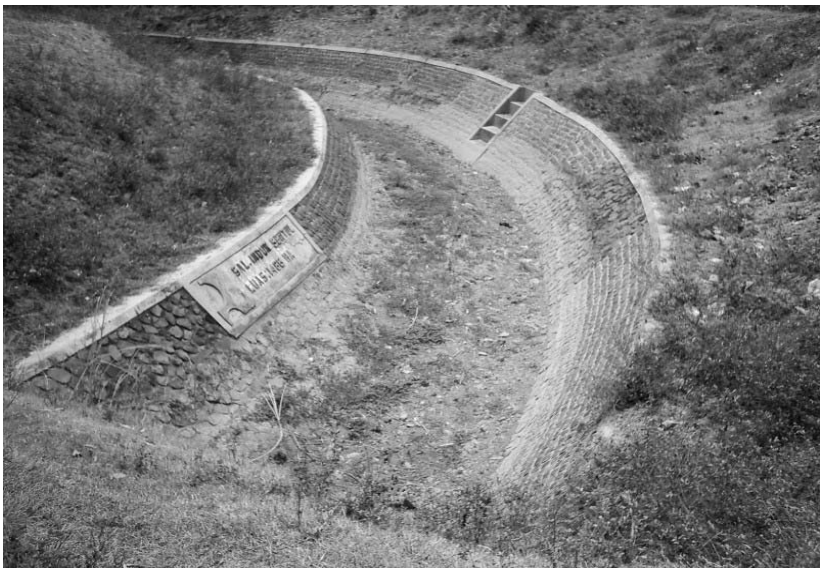
<p><u>Category</u> Irrigation (Main Canal)</p>	
		<p><u>Structure</u> Lined Canal</p>	
		<p><u>Condition</u> <input type="checkbox"/> A <input type="checkbox"/> B <input checked="" type="checkbox"/> C <input type="checkbox"/> D</p>

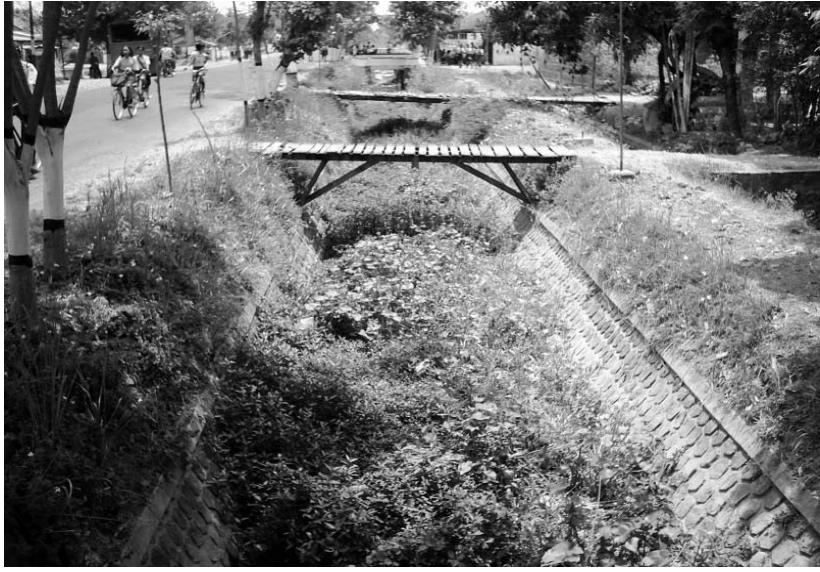
<p><u>Category</u> Irrigation (Secondary Canal)</p>	
		<p><u>Structure</u> Lined Canal</p>	
		<p><u>Condition</u> <input type="checkbox"/> A <input type="checkbox"/> B <input checked="" type="checkbox"/> C <input type="checkbox"/> D</p>

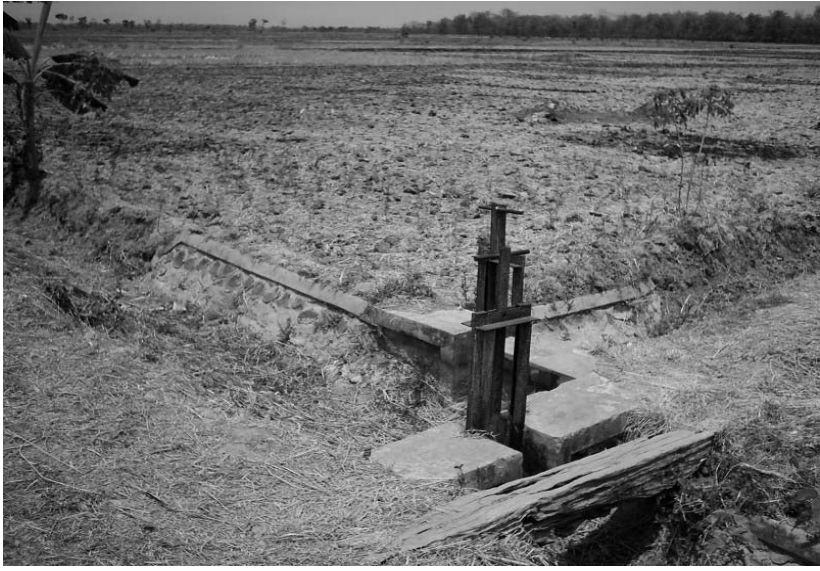
<p><u>Category</u> Irrigation (Tertiary Canal)</p>	
		<p><u>Structure</u> Division Box and Paddy Field</p>	
		<p><u>Condition</u> <input type="checkbox"/> A <input type="checkbox"/> B <input type="checkbox"/> C <input checked="" type="checkbox"/> D</p>	
<p><u>Problems</u> Require removal of sediment and provision of inspection road</p>		<p><u>Problems</u> Require major repair of canal and total removal of sediment at inside of canal</p>

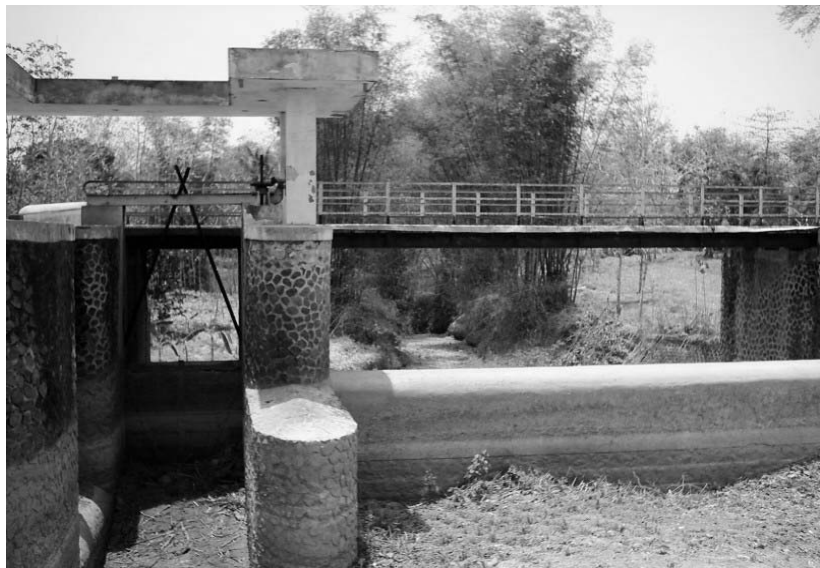
<i>Category</i> Irrigation (Headworks)			
		<i>Structure</i> Fixed Weir, Upstream			
		<i>Condition</i> <input type="checkbox"/> A <input type="checkbox"/> B <input checked="" type="checkbox"/> C <input type="checkbox"/> D			
		<i>Problems</i> Require repair for civil and gate works and removal of sediment

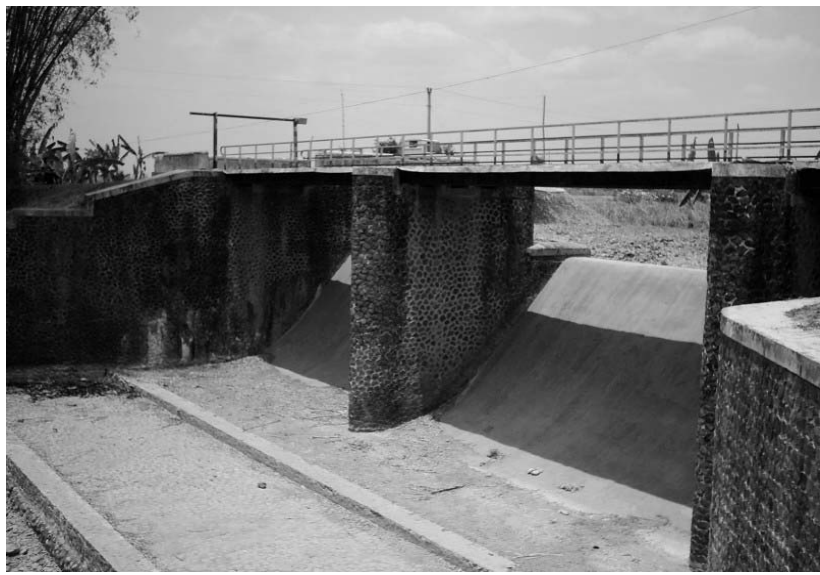
<i>Category</i> Irrigation (Headworks)			
		<i>Structure</i> Fixed Weir, Downstream			
		<i>Condition</i> <input type="checkbox"/> A <input type="checkbox"/> B <input checked="" type="checkbox"/> C <input type="checkbox"/> D			
		<i>Problems</i> Require repair for civil and gate works and removal of sediment

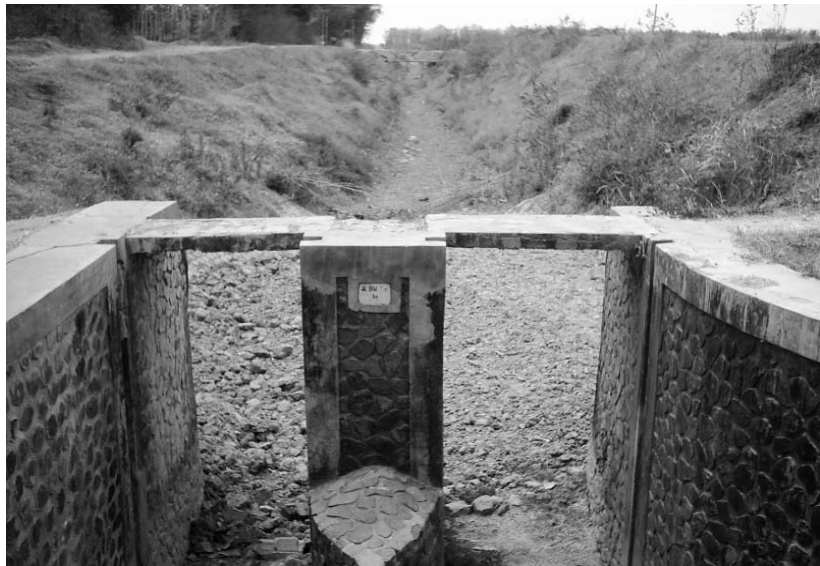
<i>Category</i> Irrigation (Main Canal)			
		<i>Structure</i> Canal and Division Structure			
		<i>Condition</i> <input type="checkbox"/> A <input type="checkbox"/> B <input checked="" type="checkbox"/> C <input type="checkbox"/> D
