I. PROJECT FUNDAMENTALS									
I.1 General									
(1) Code Number	: 33010020-22			(7) Number of Farmers	: 10,638				
(2) Name of Irrigation Scheme	: Jragung			(8) Water Resource River	: Jragung

Scheme	Jragung	District	Demak
Technical Level	Technical	Registered Area	4,597 ha

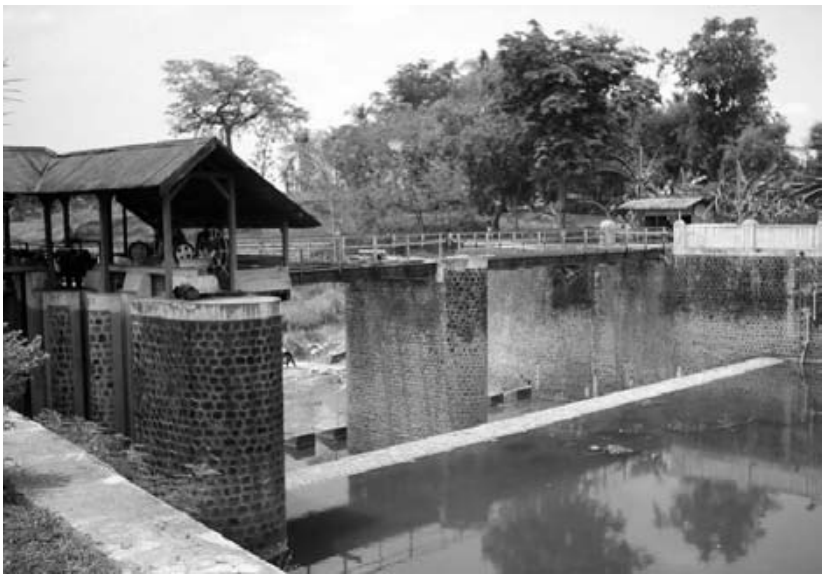
Year of Construction	1989
		<u>Category</u>	Irrigation (Headworks)
		<u>Structure</u>	Fixed Weir
		<u>Condition</u>	<input type="checkbox"/> A <input type="checkbox"/> B <input checked="" type="checkbox"/> C <input type="checkbox"/> D

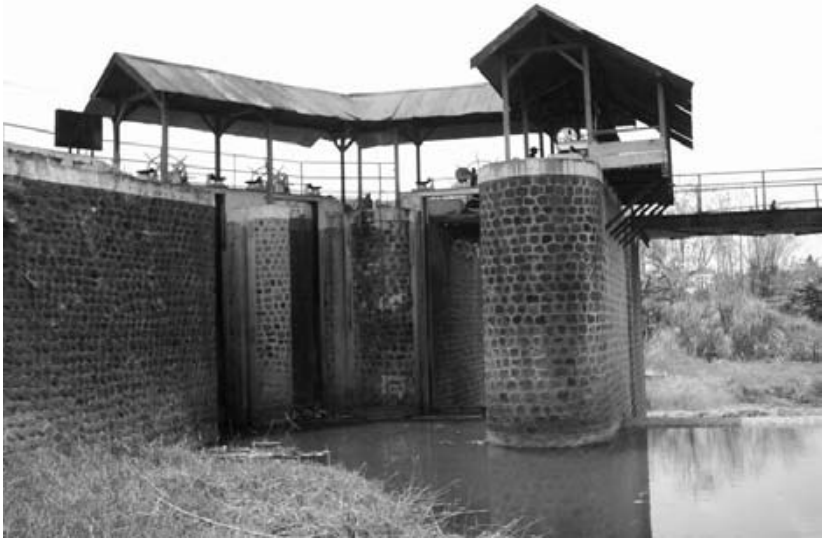
<u>Problems</u>	Require removal of sediment in front of weir and intake
		<u>Category</u>	Irrigation (Headworks)
		<u>Structure</u>	Fixed Weir, Scouring Sluice
		<u>Condition</u>	<input type="checkbox"/> A <input type="checkbox"/> B <input checked="" type="checkbox"/> C <input type="checkbox"/> D

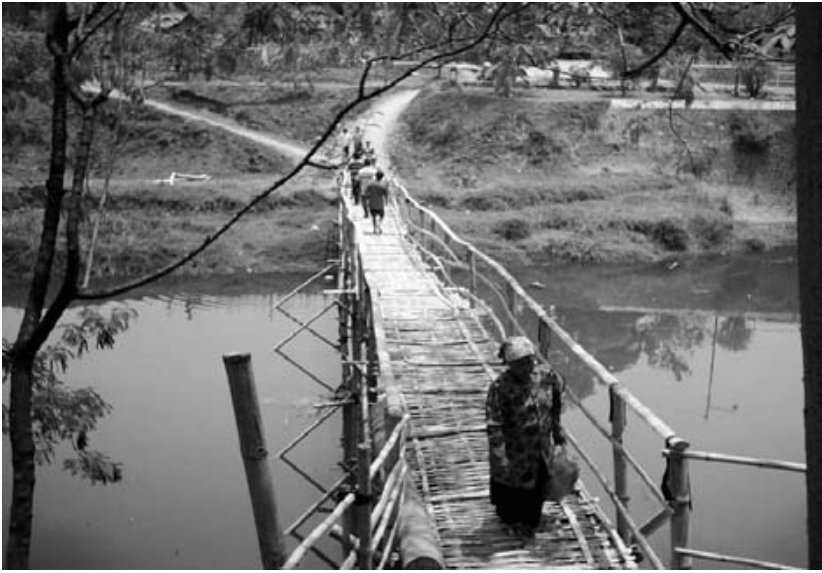
<u>Problems</u>	Require removal of sediment in front of weir and intake
		<u>Category</u>	Irrigation (Main Canal)
		<u>Structure</u>	Temporary Bridge
		<u>Condition</u>	<input type="checkbox"/> A <input type="checkbox"/> B <input type="checkbox"/> C <input checked="" type="checkbox"/> D

<u>Problems</u>	Due to broken of weir bridge, bamboo bridge is provided

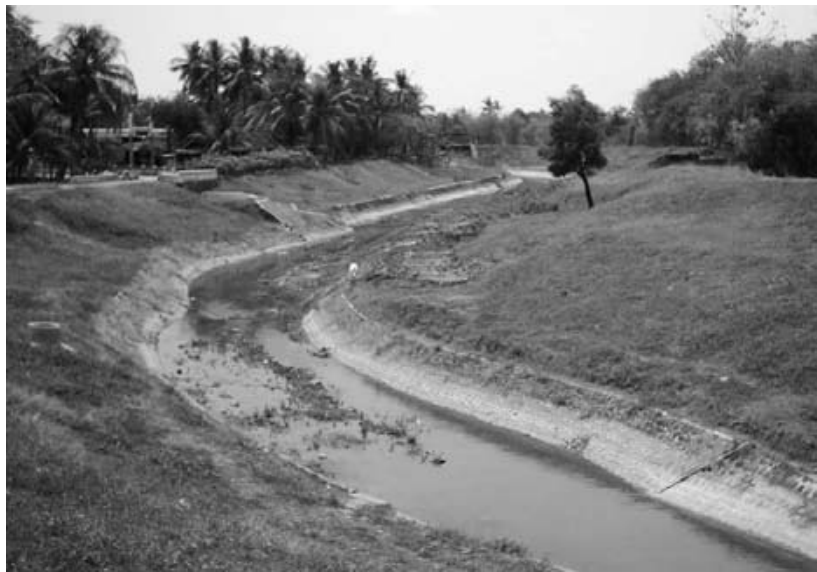
<u>Category</u> Irrigation (Main Canal)	
		<u>Structure</u> Masonry Lined Canal	
		<u>Condition</u> <input type="checkbox"/> A <input type="checkbox"/> B <input checked="" type="checkbox"/> C <input type="checkbox"/> D	
		<u>Problems</u> Require major repair and removal of sediment

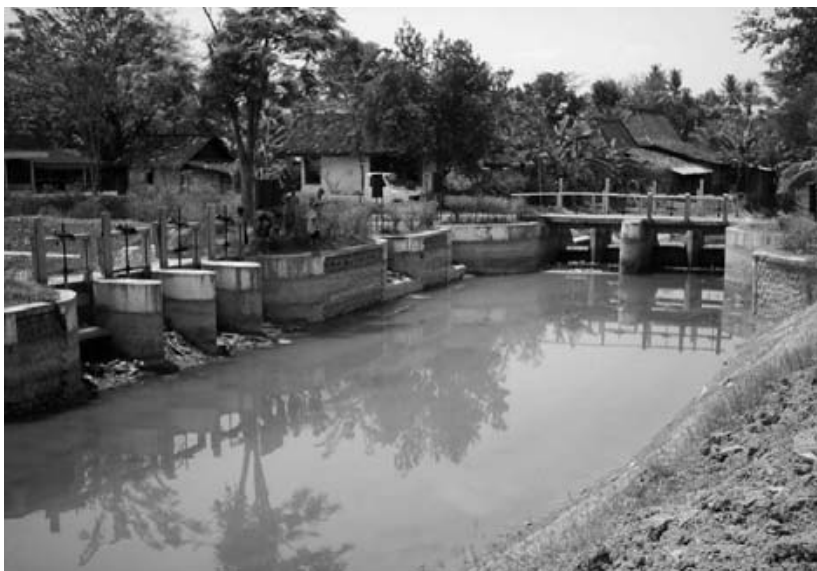
<u>Category</u> Irrigation (Main Canal)	
		<u>Structure</u> Canal and Division Structure	
		<u>Condition</u> <input type="checkbox"/> A <input type="checkbox"/> B <input checked="" type="checkbox"/> C <input type="checkbox"/> D	
		<u>Problems</u> Require major repair and removal of sediment

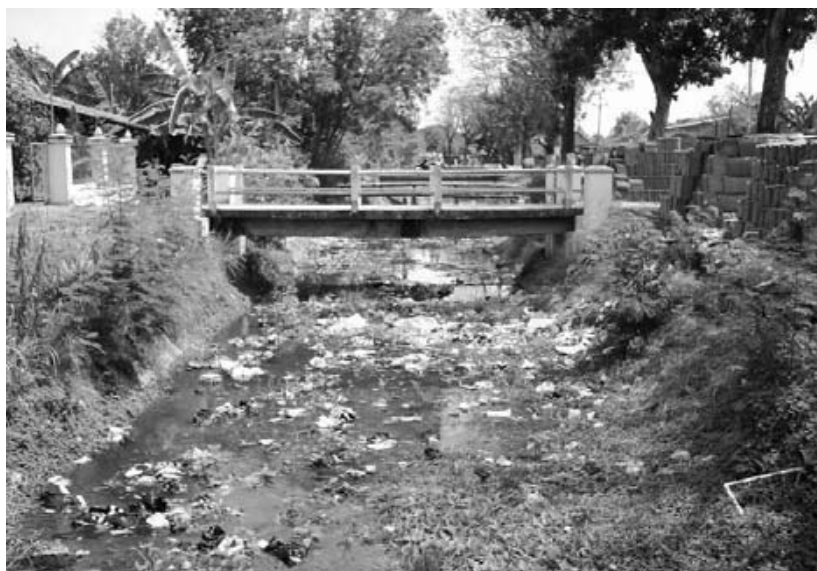
<u>Category</u> Irrigation (Secondary Canal)	
		<u>Structure</u> Canal and Division Structure	
		<u>Condition</u> <input type="checkbox"/> A <input type="checkbox"/> B <input checked="" type="checkbox"/> C <input type="checkbox"/> D

<u>Problems</u> Require major repair, lining and removal of sediment

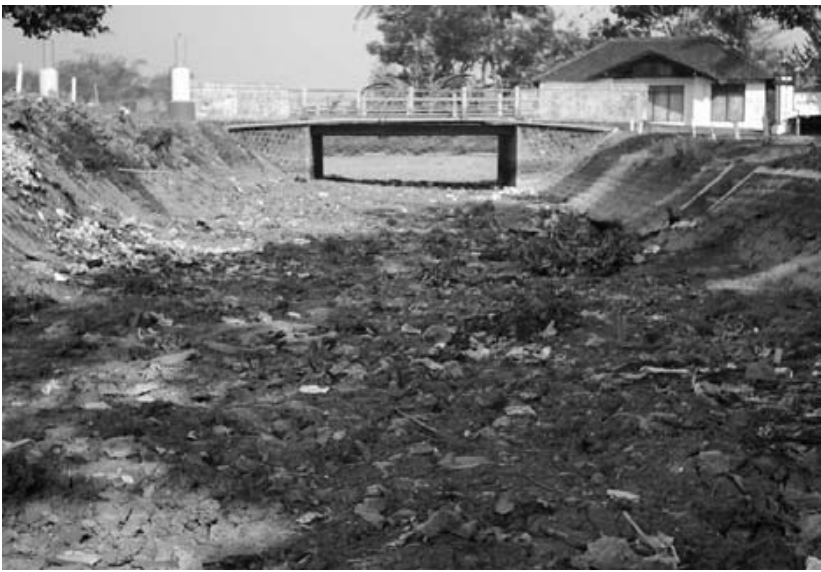
<u>Category</u> Irrigation (Main Canal)	
		<u>Structure</u> Canal and Bridge	
		<u>Condition</u> <input type="checkbox"/> A <input type="checkbox"/> B <input checked="" type="checkbox"/> C <input type="checkbox"/> D	
		<u>Problems</u> Require major repair and removal of sediment

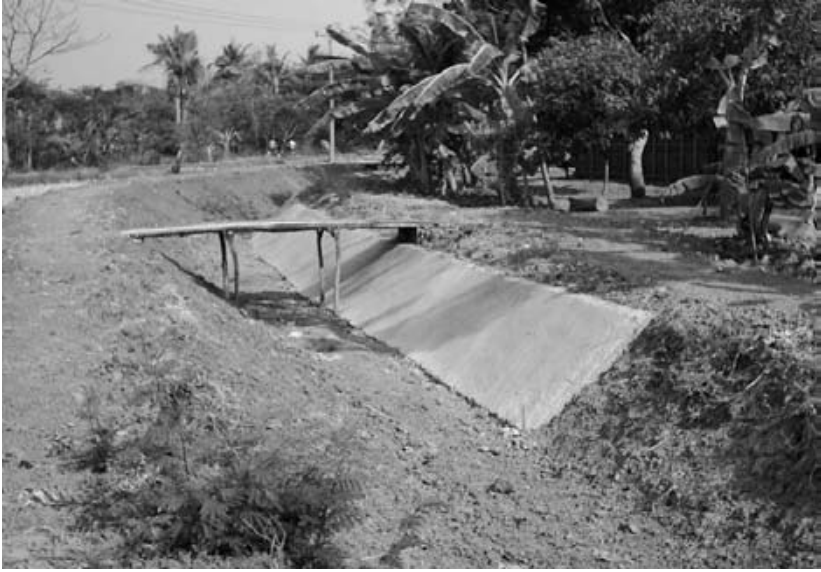
<u>Category</u> Irrigation (Secondary Canal)	
		<u>Structure</u> Canal	
		<u>Condition</u> <input type="checkbox"/> A <input type="checkbox"/> B <input type="checkbox"/> C <input checked="" type="checkbox"/> D	
		<u>Problems</u> Require provision of lining and inspection road

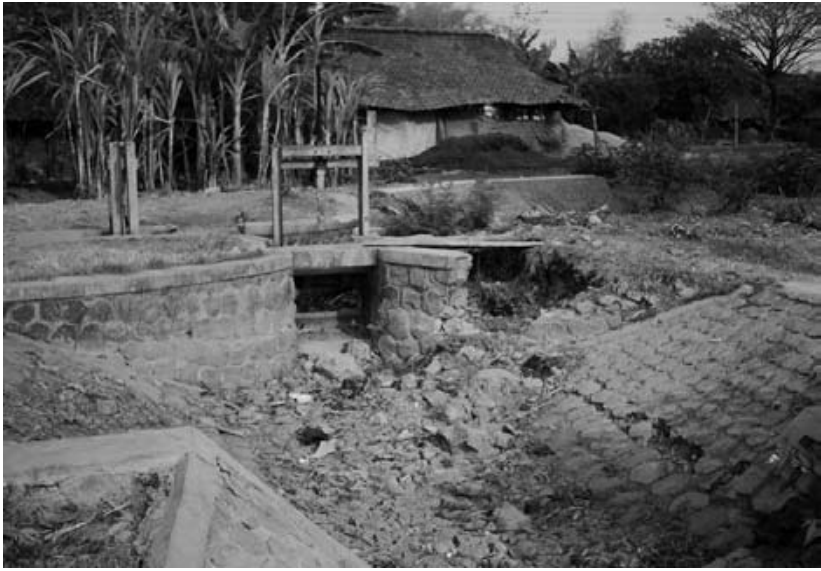
<u>Category</u> Irrigation (Secondary Canal)	
		<u>Structure</u> Division Structure	
		<u>Condition</u> <input type="checkbox"/> A <input type="checkbox"/> B <input type="checkbox"/> C <input checked="" type="checkbox"/> D

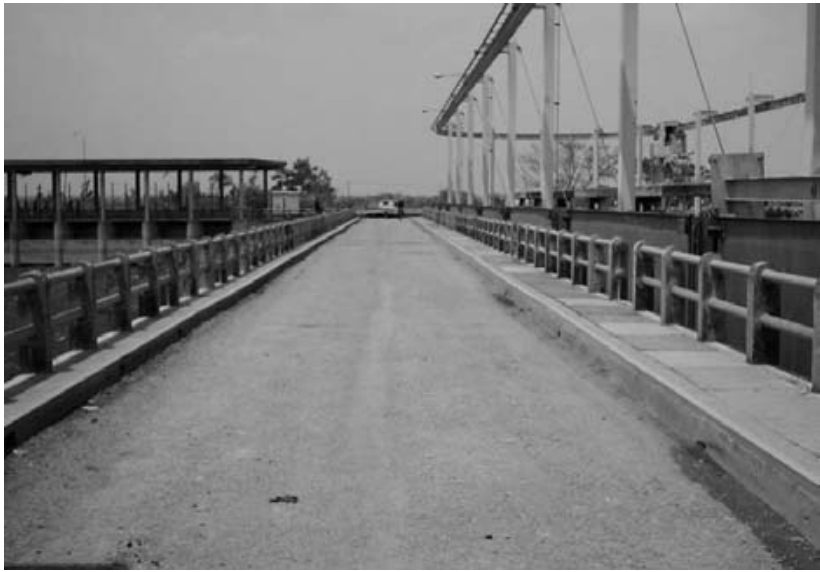
<u>Category</u> Irrigation (Headworks)	
		<u>Structure</u> Movable Weir	
		<u>Condition</u> <input type="checkbox"/> A <input checked="" type="checkbox"/> B <input type="checkbox"/> C <input type="checkbox"/> D	
		<u>Problems</u> Require minor repair for civil and gate works

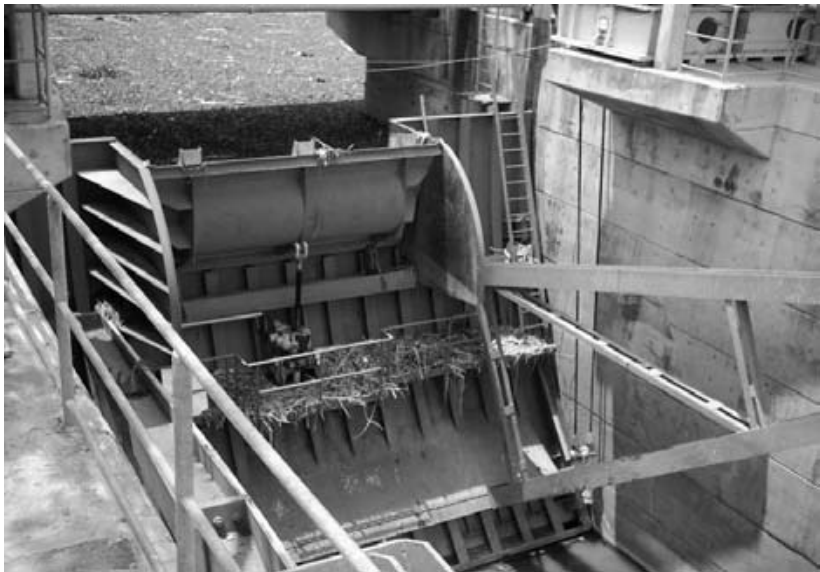
<u>Category</u> Irrigation (Headworks)	
		<u>Structure</u> Movable Weir, Steel Gate (Radial Type)	
		<u>Condition</u> <input type="checkbox"/> A <input checked="" type="checkbox"/> B <input type="checkbox"/> C <input type="checkbox"/> D	
		<u>Problems</u> Require minor repair for civil and gate works

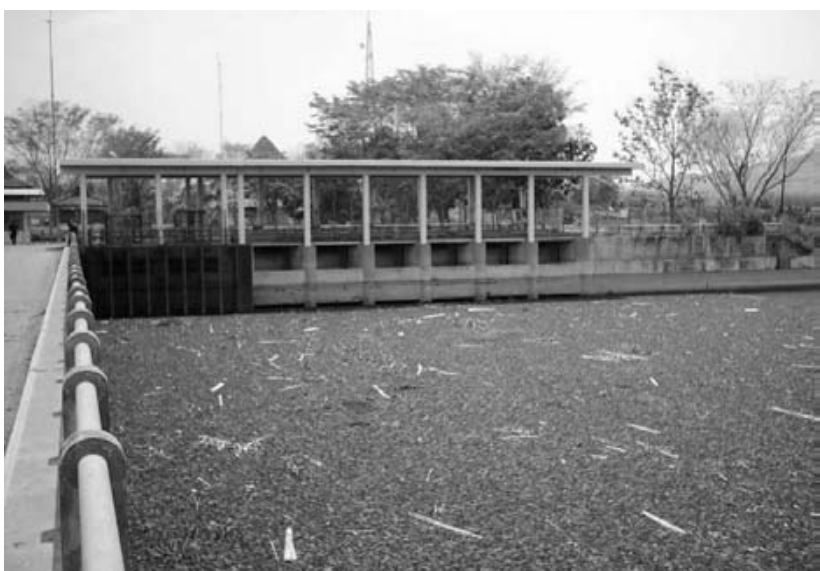
<u>Category</u> Irrigation (Headworks)	
		<u>Structure</u> Intake	
		<u>Condition</u> <input type="checkbox"/> A <input type="checkbox"/> B <input checked="" type="checkbox"/> C <input type="checkbox"/> D

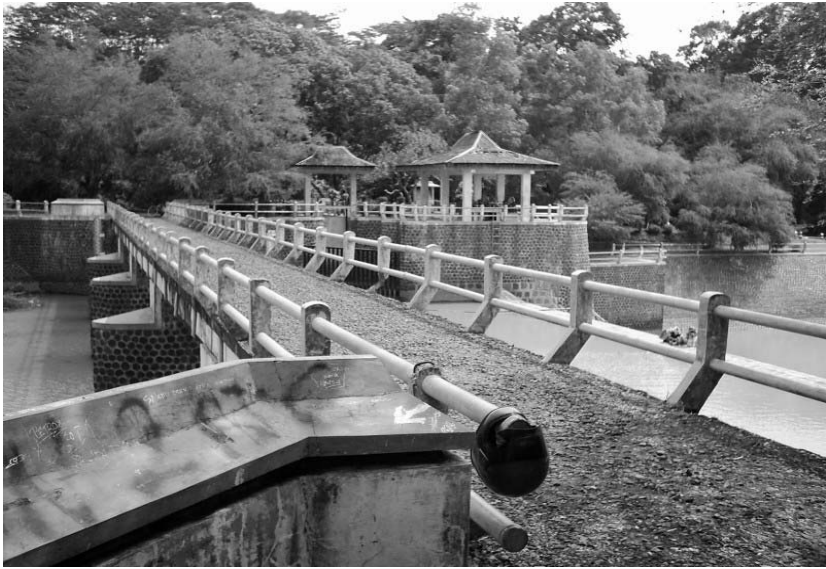
Category Irrigation (Headworks)	
		Structure Fixed Weir, Upstream	
		Condition <input type="checkbox"/> A <input type="checkbox"/> B <input checked="" type="checkbox"/> C <input type="checkbox"/> D	
		Problems Require repair of civil and gate works

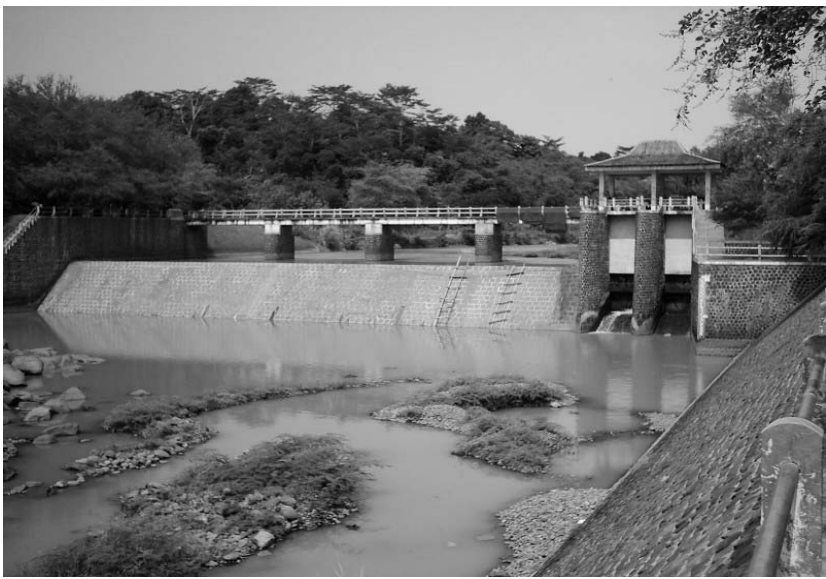
Category Irrigation (Headworks)	
		Structure Fixed Weir, Downstream	
		Condition <input type="checkbox"/> A <input type="checkbox"/> B <input checked="" type="checkbox"/> C <input type="checkbox"/> D	
		Problems Require repair of civil and gate works

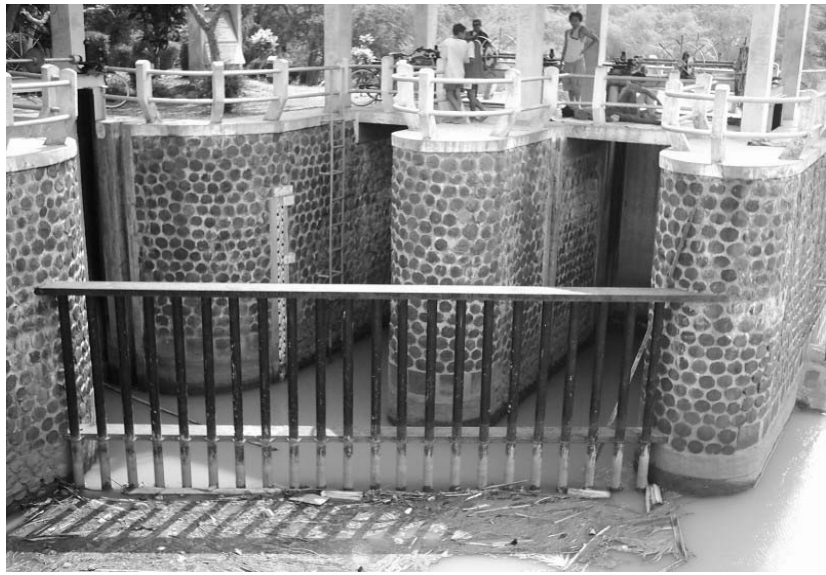
Category Irrigation (Headworks)	
		Structure Intake and Scouring Sluice	
		Condition <input type="checkbox"/> A <input type="checkbox"/> B <input checked="" type="checkbox"/> C <input type="checkbox"/> D	
		Problems Require repair of civil and gate works

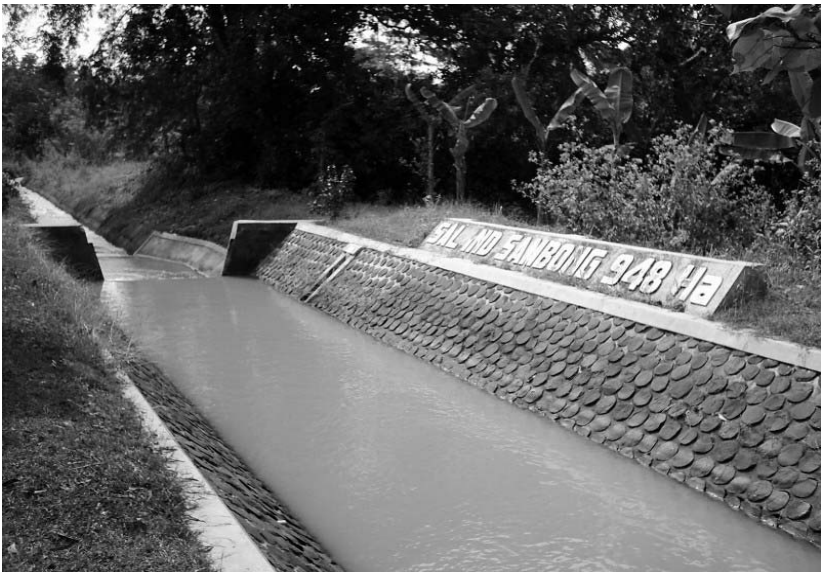
<u>Category</u> Irrigation (Main Canal)	
		<u>Structure</u> Masonry Lined Canal	
		<u>Condition</u> <input type="checkbox"/> A <input type="checkbox"/> B <input checked="" type="checkbox"/> C <input type="checkbox"/> D	
		<u>Problems</u> Require minor repair for canal and provision of inspection road

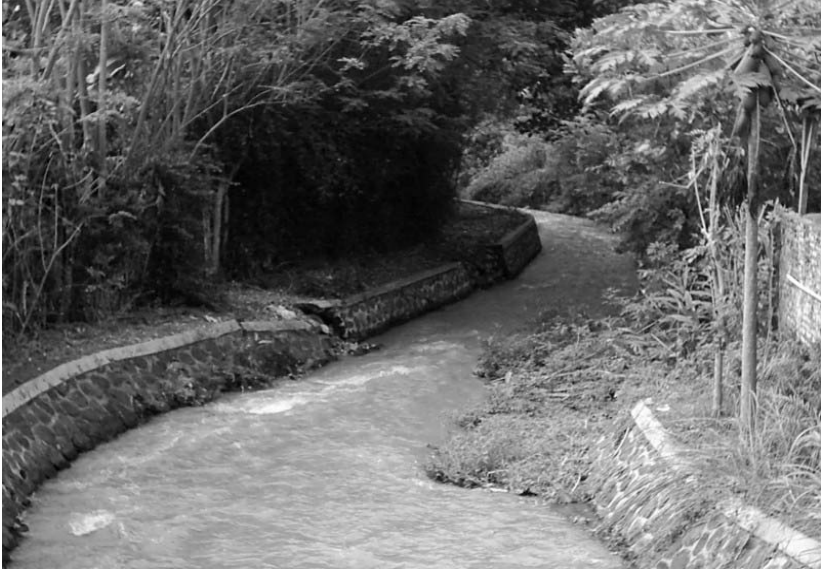
<u>Category</u> Irrigation (Main Canal)	
		<u>Structure</u> Masonry Lined Canal	
		<u>Condition</u> <input type="checkbox"/> A <input type="checkbox"/> B <input checked="" type="checkbox"/> C <input type="checkbox"/> D	
		<u>Problems</u> Require minor repair for canal and provision of inspection road

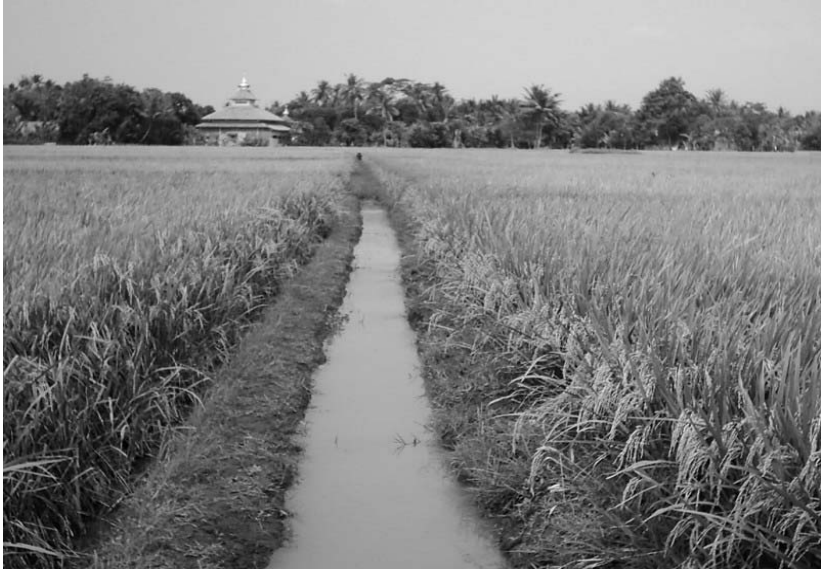
<u>Category</u> Irrigation (Tertiary Canal)	
		<u>Structure</u> Tertiary Canal and Paddy Field	
		<u>Condition</u> <input type="checkbox"/> A <input type="checkbox"/> B <input checked="" type="checkbox"/> C <input type="checkbox"/> D

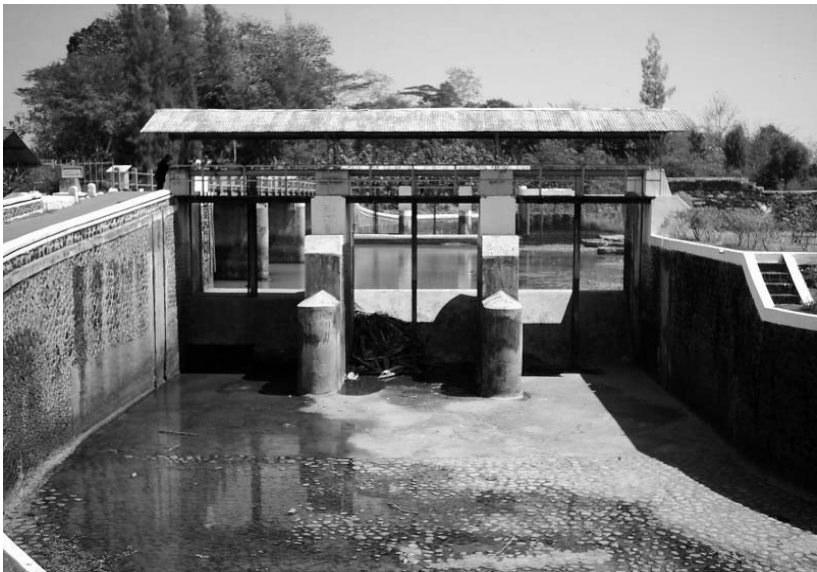
<u>Category</u> Irrigation (Headworks)	
		<u>Structure</u> Fixed Weir, Downstream	
		<u>Condition</u> <input type="checkbox"/> A <input type="checkbox"/> B <input checked="" type="checkbox"/> C <input type="checkbox"/> D	
		<u>Problems</u> Require repair of civil and gate works

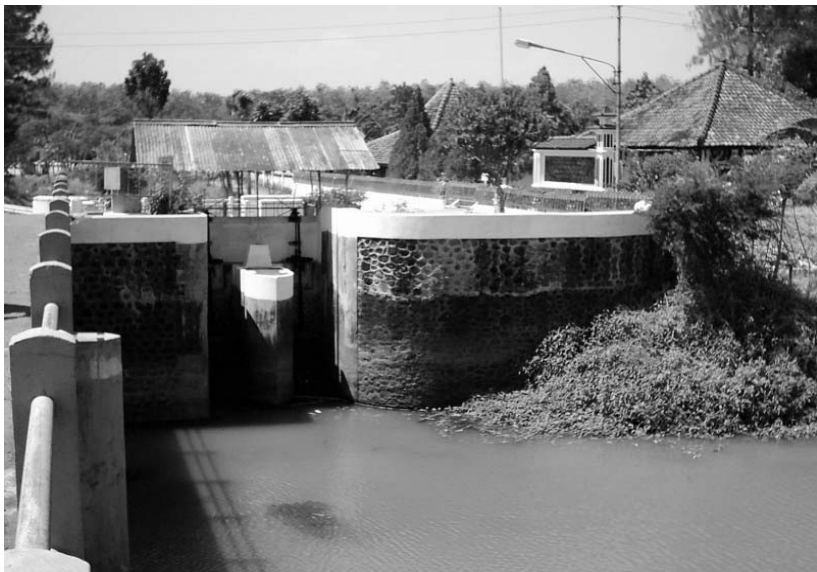
<u>Category</u> Irrigation (Headworks)	
		<u>Structure</u> Intake	
		<u>Condition</u> <input type="checkbox"/> A <input type="checkbox"/> B <input checked="" type="checkbox"/> C <input type="checkbox"/> D	
		<u>Problems</u> Require repair of civil and gate works

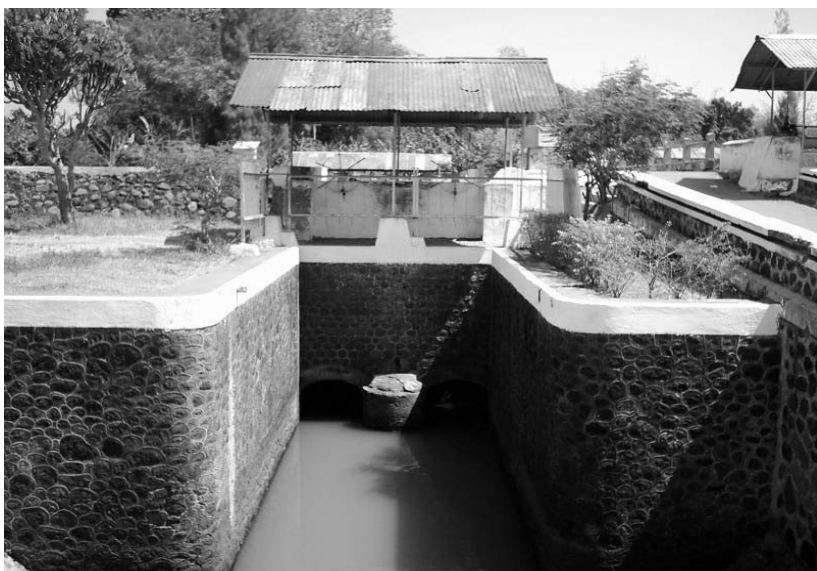
<u>Category</u> Irrigation (Headworks)	
		<u>Structure</u> Intake and Settling Basin	
		<u>Condition</u> <input type="checkbox"/> A <input type="checkbox"/> B <input checked="" type="checkbox"/> C <input type="checkbox"/> D	
		<u>Problems</u> Require remove of sediment and provision of inspection road

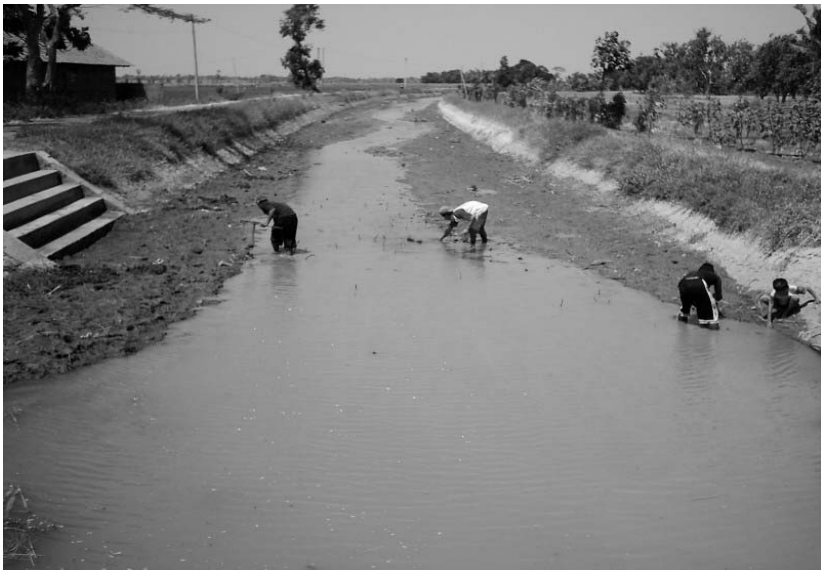
Category Irrigation (Main Canal)	
		Structure Lined Canal	
		Condition <input type="checkbox"/> A <input type="checkbox"/> B <input checked="" type="checkbox"/> C <input type="checkbox"/> D	
		Problems Require remove of sediment, repair of lining and provision of bottom lining	
 		Category Irrigation (Main Canal)	
		Structure Canal and Inspection Road	
		Condition <input type="checkbox"/> A <input type="checkbox"/> B <input checked="" type="checkbox"/> C <input type="checkbox"/> D	
		Problems Require remove of sediment, repair of lining and provision of bottom lining	
 		Category Irrigation (Tertiary Canal)	
		Structure Division Box	
		Condition <input type="checkbox"/> A <input type="checkbox"/> B <input type="checkbox"/> C <input checked="" type="checkbox"/> D	
		Problems Require reconstruction

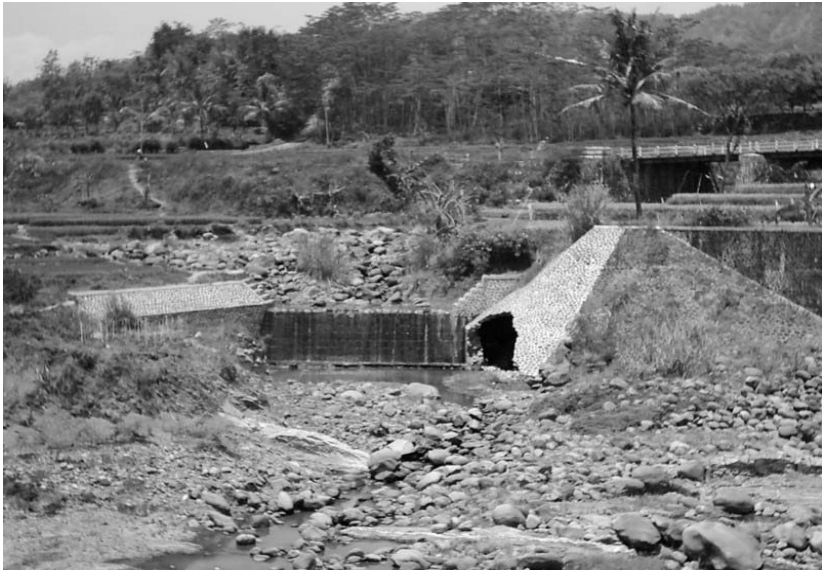
Year of Construction	1974~1992
		<i>Category</i> Irrigation (Headworks)	
		<i>Structure</i> Fixed Weir, Downstream	
		<i>Condition</i> <input type="checkbox"/> A <input type="checkbox"/> B <input checked="" type="checkbox"/> C <input type="checkbox"/> D

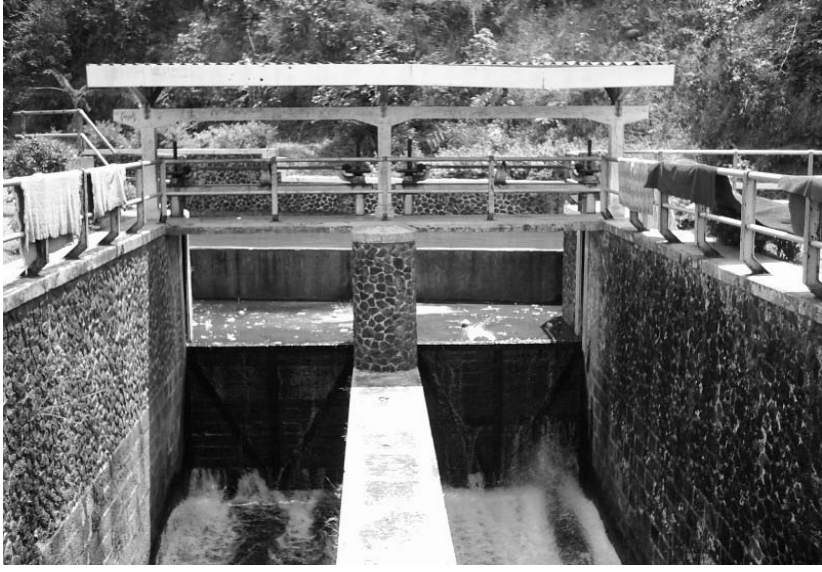
<i>Category</i> Irrigation (Headworks)	
		<i>Structure</i> Intake	
		<i>Condition</i> <input type="checkbox"/> A <input type="checkbox"/> B <input checked="" type="checkbox"/> C <input type="checkbox"/> D	
		<i>Problems</i> Require repair for weir and intake

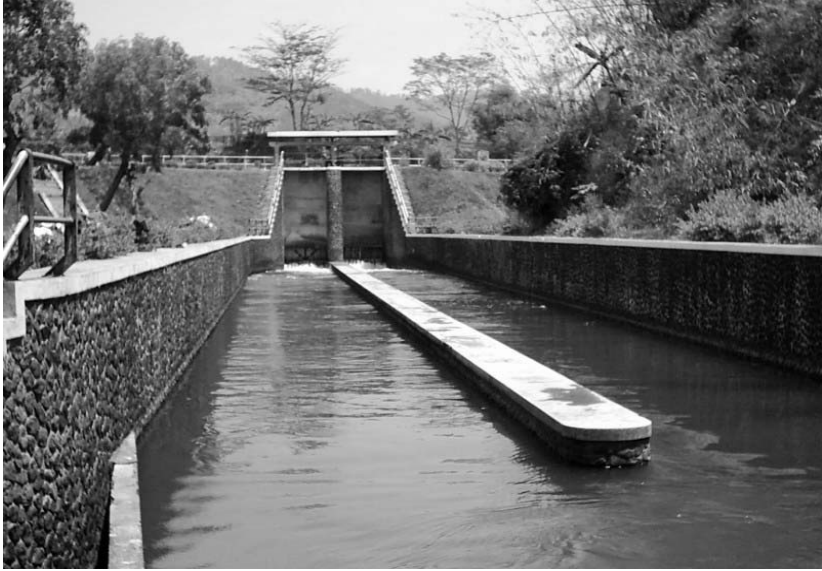
<i>Category</i> Irrigation (Headworks)	
		<i>Structure</i> Intake and Settling Basin	
		<i>Condition</i> <input type="checkbox"/> A <input type="checkbox"/> B <input checked="" type="checkbox"/> C <input type="checkbox"/> D	
		<i>Problems</i> Require provision of stilling basin and retaining wall

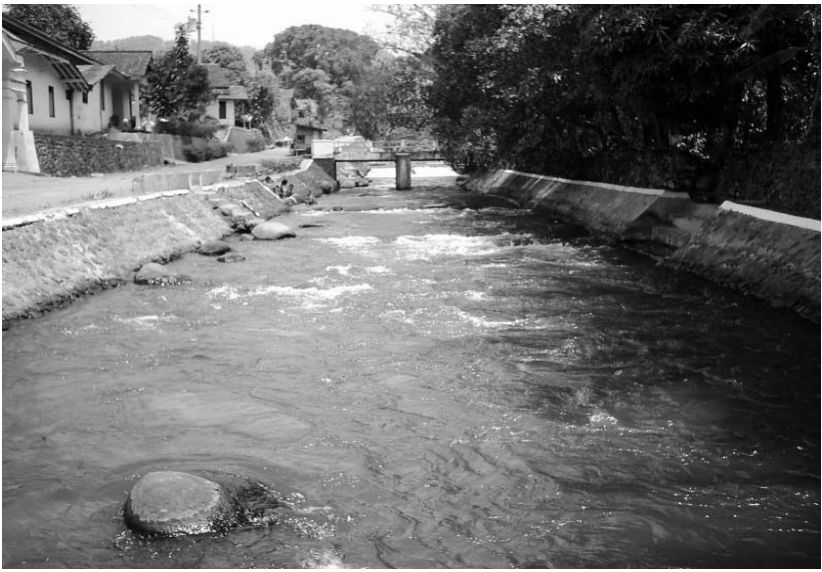
Category Irrigation (Main Canal)	
		Structure Masonry Lined Canal	
		Condition <input type="checkbox"/> A <input type="checkbox"/> B <input checked="" type="checkbox"/> C <input type="checkbox"/> D	
		Problems Require remove of sediment, repair of lining and provision of bottom lining

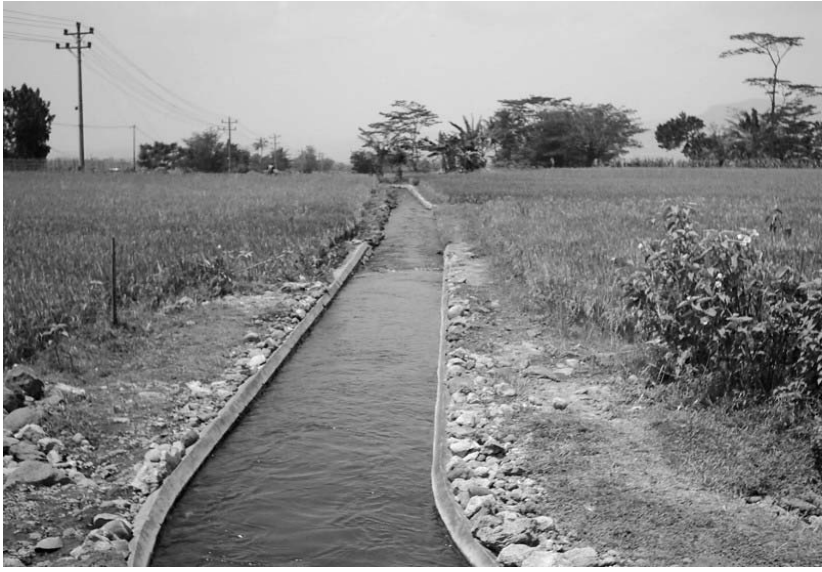
Category Irrigation (Secondary Canal)	
		Structure Canal	
		Condition <input type="checkbox"/> A <input type="checkbox"/> B <input checked="" type="checkbox"/> C <input type="checkbox"/> D	
		Problems Require major repair, lining and provision of inspection road

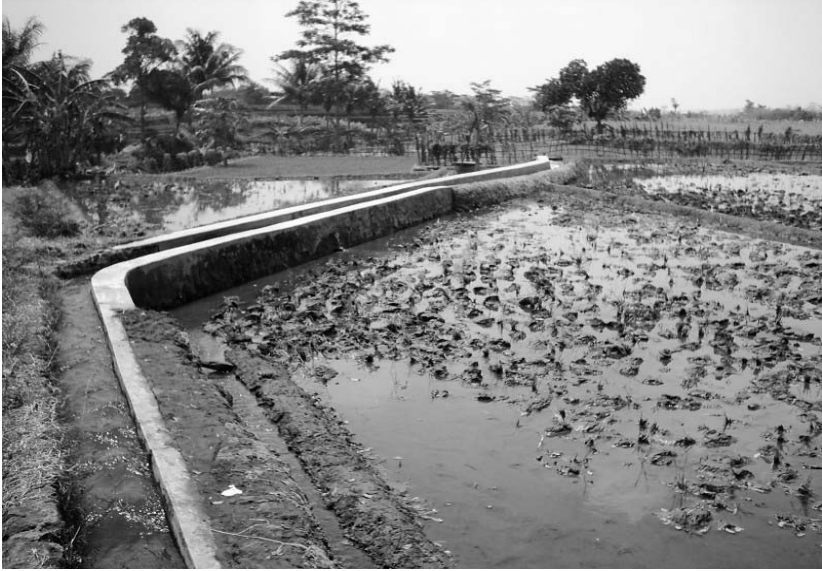
Category Irrigation (Tertiary Canal)	
		Structure Canal and Paddy Field	
		Condition <input type="checkbox"/> A <input type="checkbox"/> B <input checked="" type="checkbox"/> C <input type="checkbox"/> D	
		Problems Require farm road and farm ditch

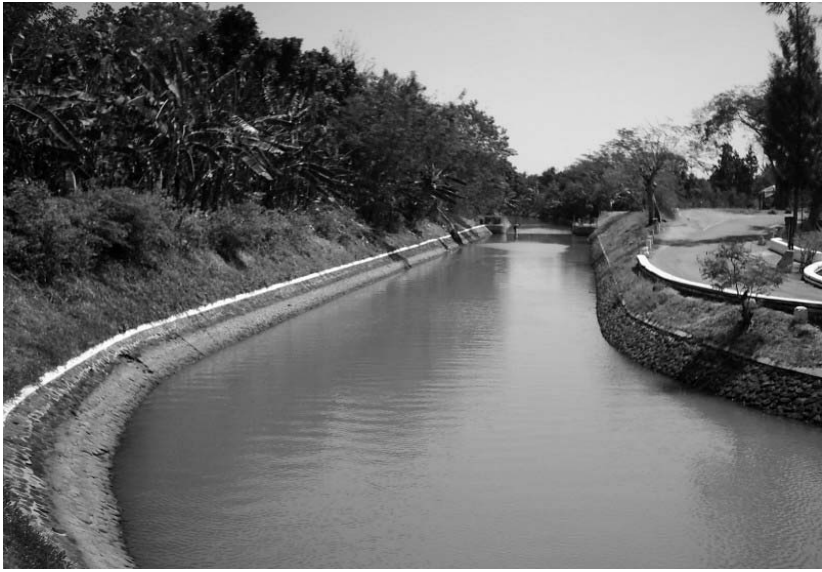
<u>Category</u> Irrigation (Main canal)	
		<u>Structure</u> Masonry Lined Canal	
		<u>Condition</u> <input type="checkbox"/> A <input checked="" type="checkbox"/> B <input type="checkbox"/> C <input type="checkbox"/> D	
		<u>Problems</u> Require minor repair of lining works

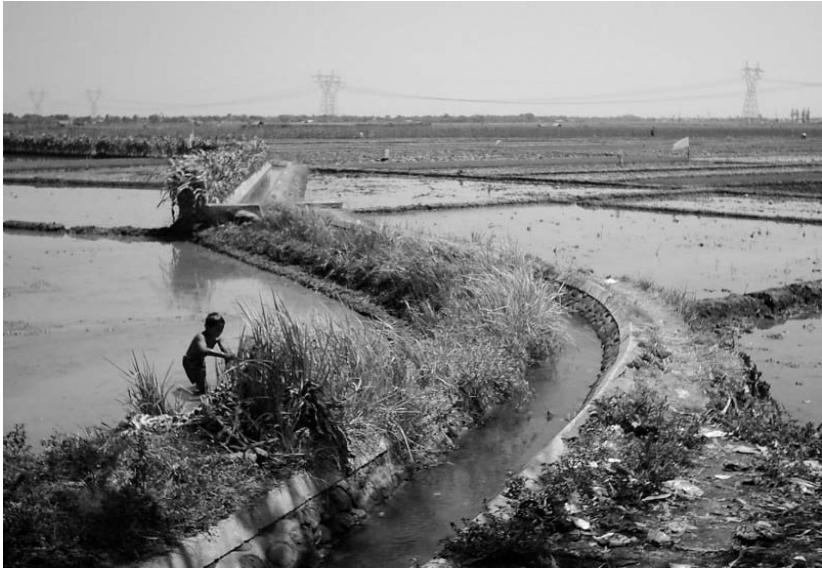
<u>Category</u> Irrigation (Tertiary Canal)	
		<u>Structure</u> Tertiary Canal and Paddy Field	
		<u>Condition</u> <input type="checkbox"/> A <input type="checkbox"/> B <input checked="" type="checkbox"/> C <input type="checkbox"/> D	
		<u>Problems</u> Require provision of division box, farm road and farm ditch

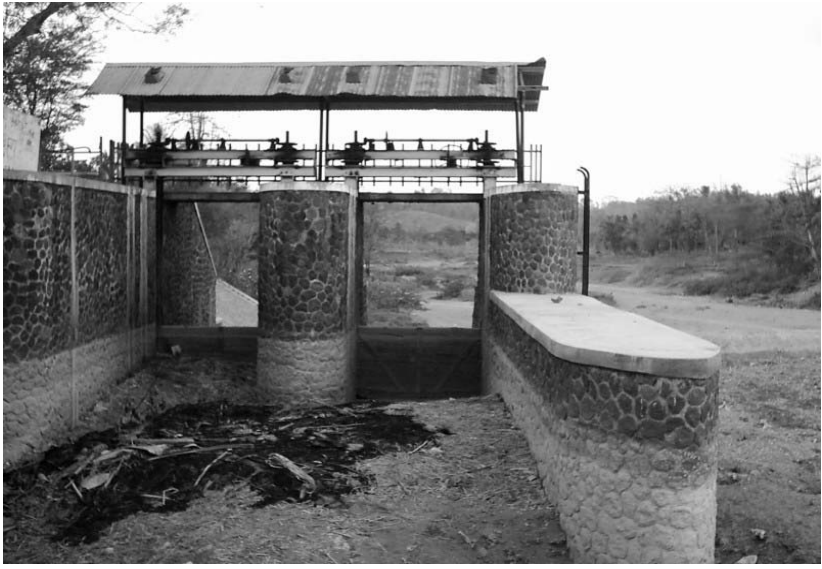
Category Irrigation (Headworks)	
		Structure Fixed Weir, Upstream	
		Condition <input type="checkbox"/> A <input type="checkbox"/> B <input checked="" type="checkbox"/> C <input type="checkbox"/> D	
		Problems Require repair for civil and gate works and removal of sediment

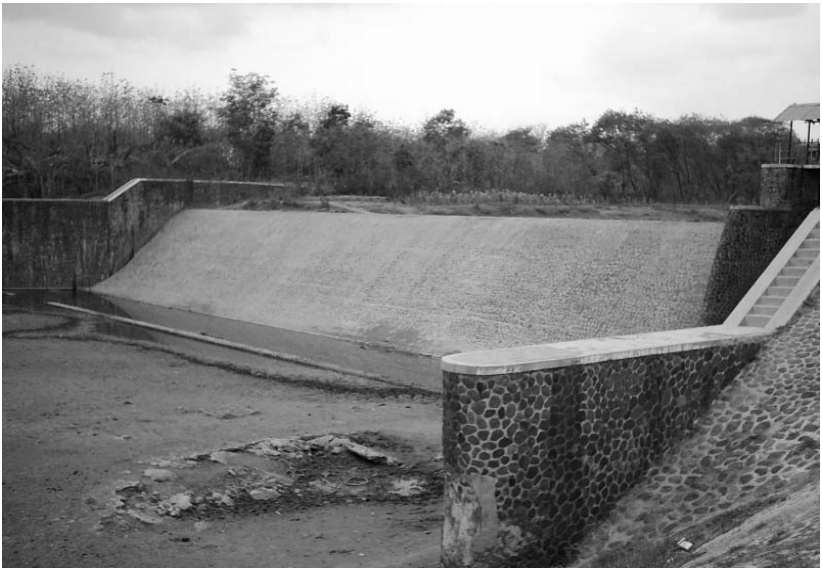
Category Irrigation (Headworks)	
		Structure Fixed Weir, Downstream	
		Condition <input type="checkbox"/> A <input type="checkbox"/> B <input checked="" type="checkbox"/> C <input type="checkbox"/> D	
		Problems Require repair for civil and gate works and removal of sediment

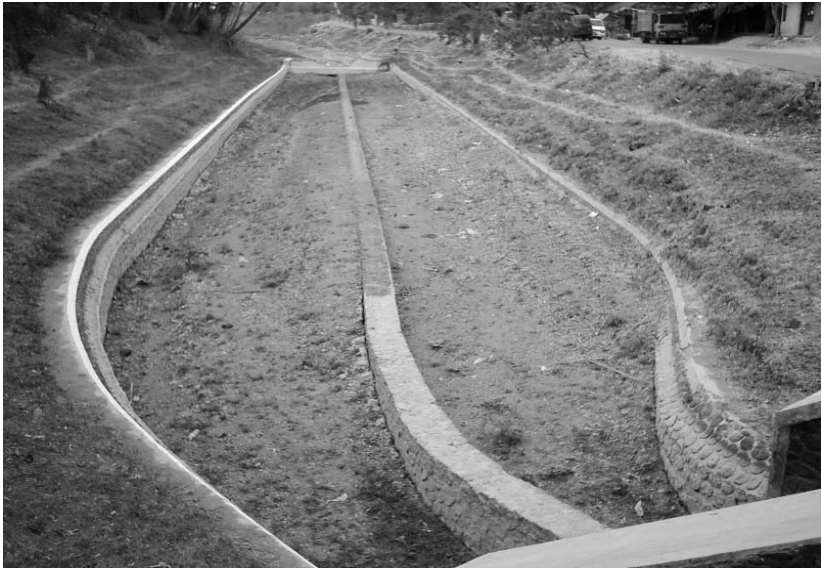
Category Irrigation (Headworks)	
		Structure Settling Basin	
		Condition <input type="checkbox"/> A <input type="checkbox"/> B <input type="checkbox"/> C <input checked="" type="checkbox"/> D	
		Problems Require redesign of settling basin

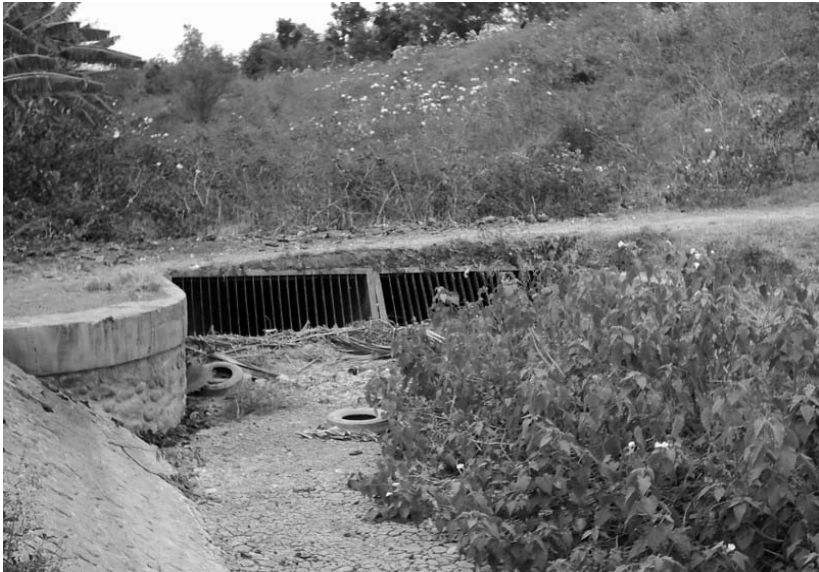
<u>Category</u> Irrigation (Main Canal)	
		<u>Structure</u> Culvert	
		<u>Condition</u> <input type="checkbox"/> A <input type="checkbox"/> B <input type="checkbox"/> C <input checked="" type="checkbox"/> D	
		<u>Problems</u> Require removal of sediment

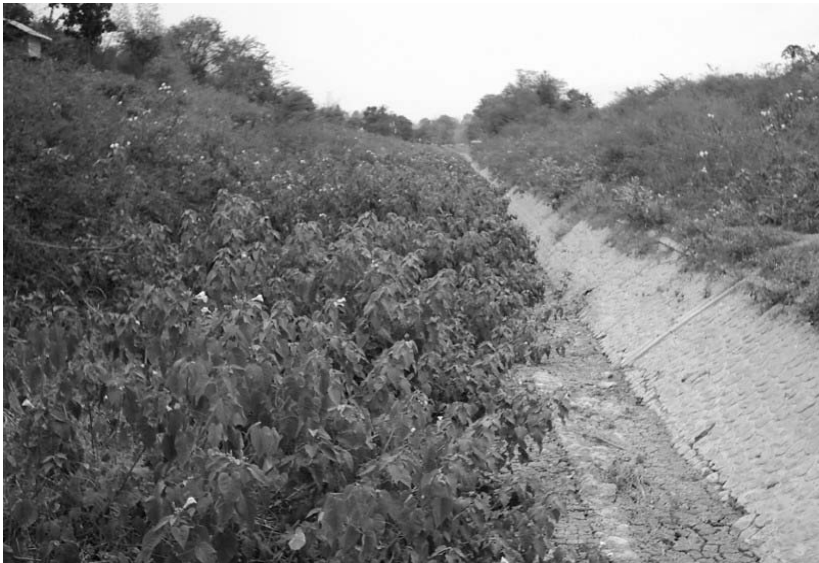
<u>Category</u> Irrigation (Main Canal)	
		<u>Structure</u> Masonry Lined Canal	
		<u>Condition</u> <input type="checkbox"/> A <input type="checkbox"/> B <input type="checkbox"/> C <input checked="" type="checkbox"/> D	
		<u>Problems</u> Require removal of sediment

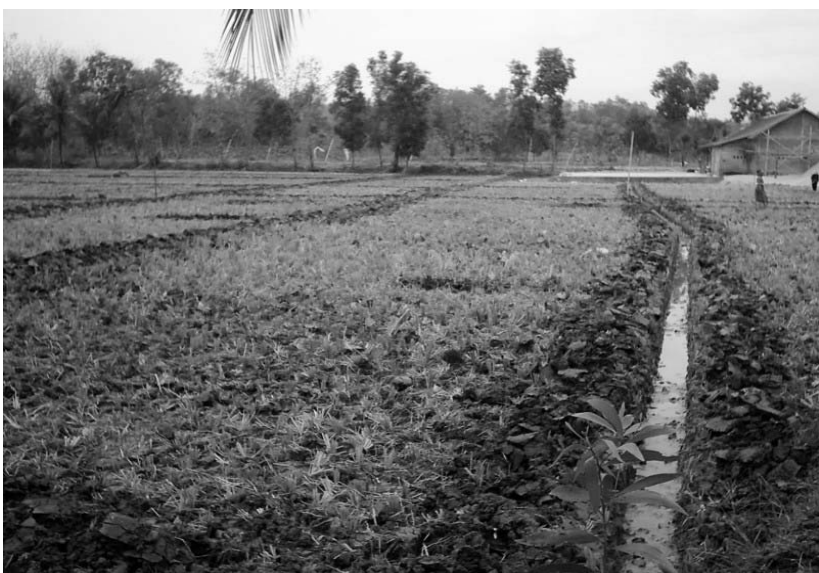
<u>Category</u> Irrigation (Paddy Field)	
		<u>Structure</u> Farm Ditch and Paddy Field	
		<u>Condition</u> <input type="checkbox"/> A <input type="checkbox"/> B <input type="checkbox"/> C <input checked="" type="checkbox"/> D	
		<u>Problems</u> Require farm ditch and road

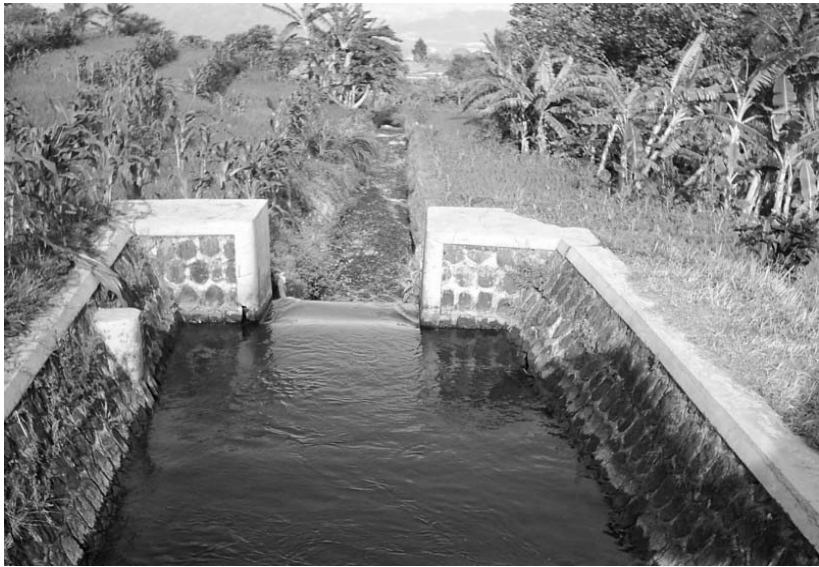
<u>Category</u> Irrigation (Secondary Canal)	
		<u>Structure</u> Drop	
		<u>Condition</u> <input type="checkbox"/> A <input type="checkbox"/> B <input checked="" type="checkbox"/> C <input type="checkbox"/> D	
		<u>Problems</u> Require inspection road

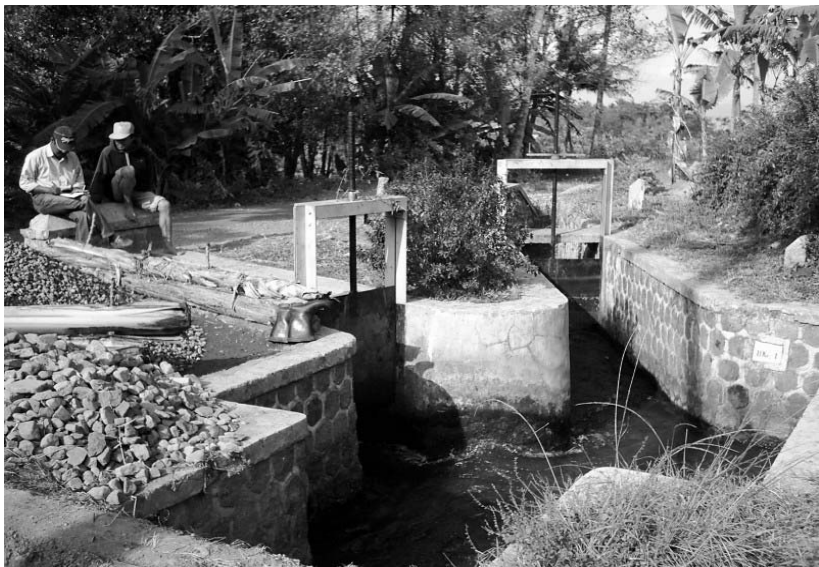
<u>Category</u> Irrigation (Secondary Canal)	
		<u>Structure</u> Bifurcation	
		<u>Condition</u> <input type="checkbox"/> A <input type="checkbox"/> B <input checked="" type="checkbox"/> C <input type="checkbox"/> D	
		<u>Problems</u> Require provision of measuring facility

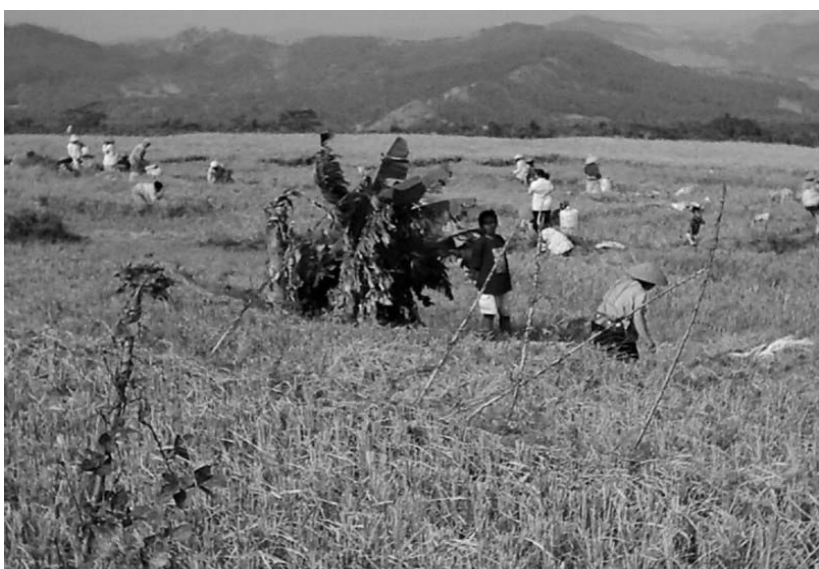
<u>Category</u> Irrigation (Paddy Field)	
		<u>Structure</u> Paddy Field	
		<u>Condition</u> <input type="checkbox"/> A <input type="checkbox"/> B <input checked="" type="checkbox"/> C <input type="checkbox"/> D	
		<u>Problems</u> Require farm road

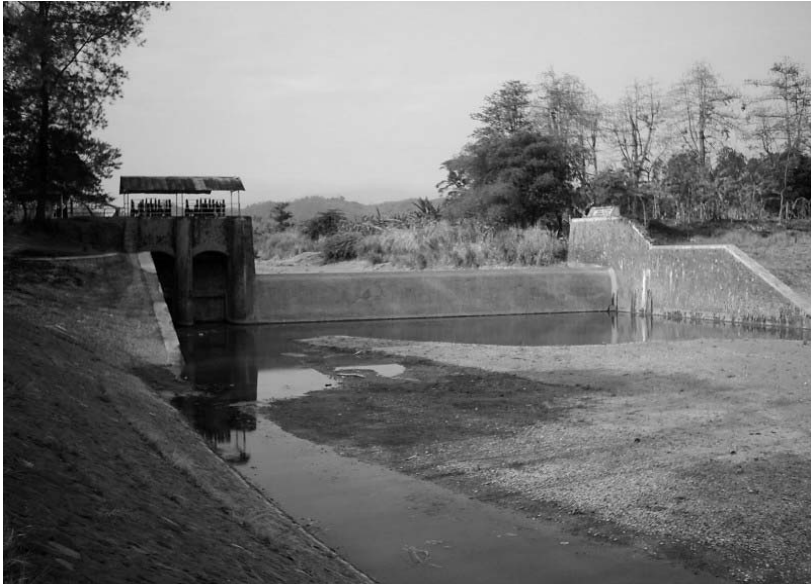
Irrigation (Headworks)	
		<u>Structure</u> Fixed Weir, Downstream View	
		<u>Condition</u> <input type="checkbox"/> A <input type="checkbox"/> B <input checked="" type="checkbox"/> C <input type="checkbox"/> D	
		<u>Problems</u> Require replacement of scoring sluice and intake gates, wooden to steel

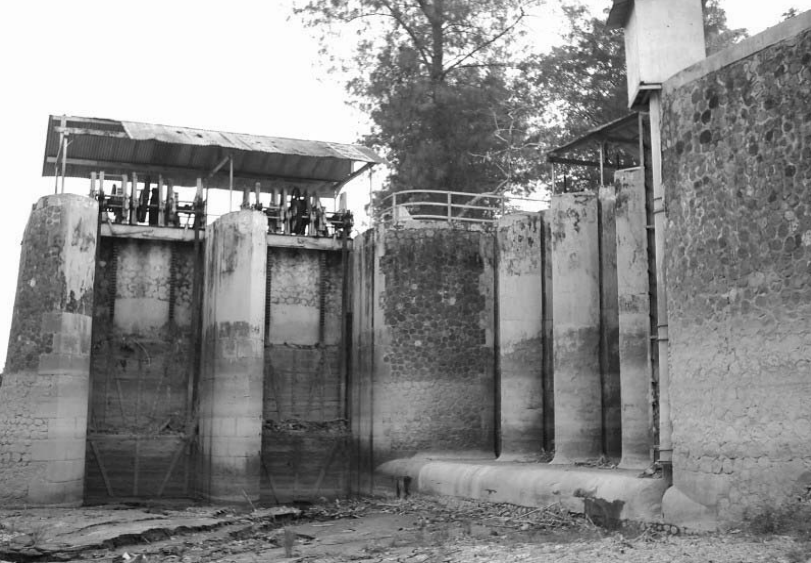
<u>Category</u> Irrigation (Headworks)	
		<u>Structure</u> Scouring Sluice and Intake	
		<u>Condition</u> <input type="checkbox"/> A <input type="checkbox"/> B <input checked="" type="checkbox"/> C <input type="checkbox"/> D	
		<u>Problems</u> Require replacement of gates, wooden to steel

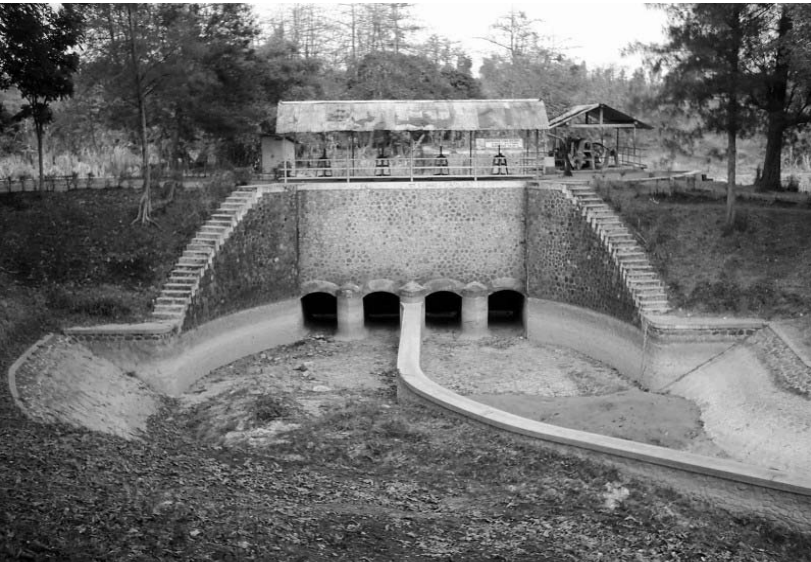
<u>Category</u> Irrigation (Headworks)	
		<u>Structure</u> Intake, Rear View	
		<u>Condition</u> <input type="checkbox"/> A <input type="checkbox"/> B <input checked="" type="checkbox"/> C <input type="checkbox"/> D
